LIVING RIVERS WSUD ASSET AUDIT

MAY 2017

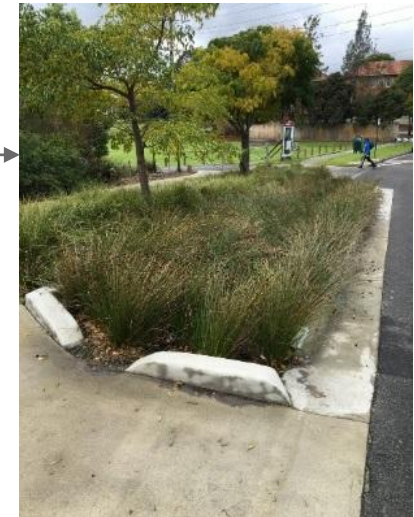
Asset 3
Plants in good health and close to 100 % cover

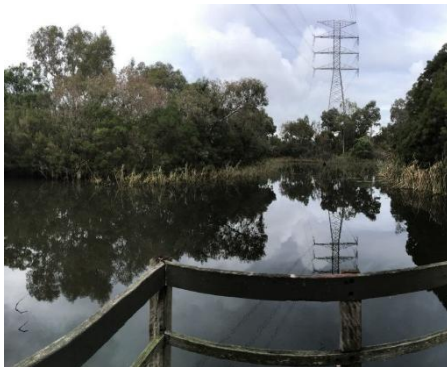
Asset 79
Plant density < 40 %

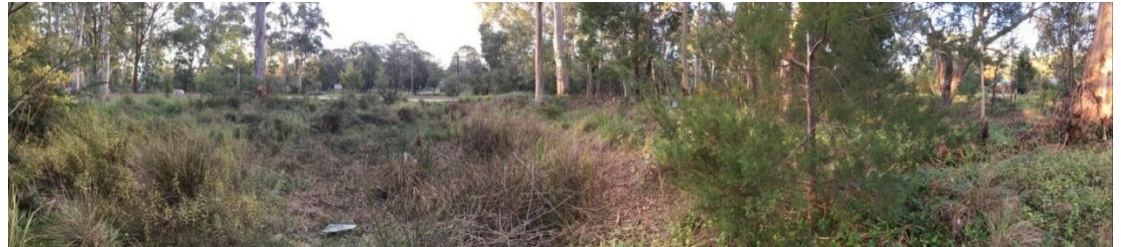
Asset 86

Moderate perception of care associated with significant presence of dead vegetation, significant section of batters and landscaped area requiring vegetation.

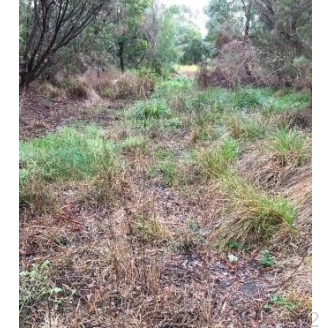
Asset 81 (dry wetland – blocked inlet)
