**WATERWAY ASSESSMENT IN THE  
DANDENONG VALLEY:**

**THE HEALTH OF CORHANWARRABUL,  
MONBULK AND FERNY CREEKS**

**Report Prepared for  
Melbourne Water Corporation**

October 1998

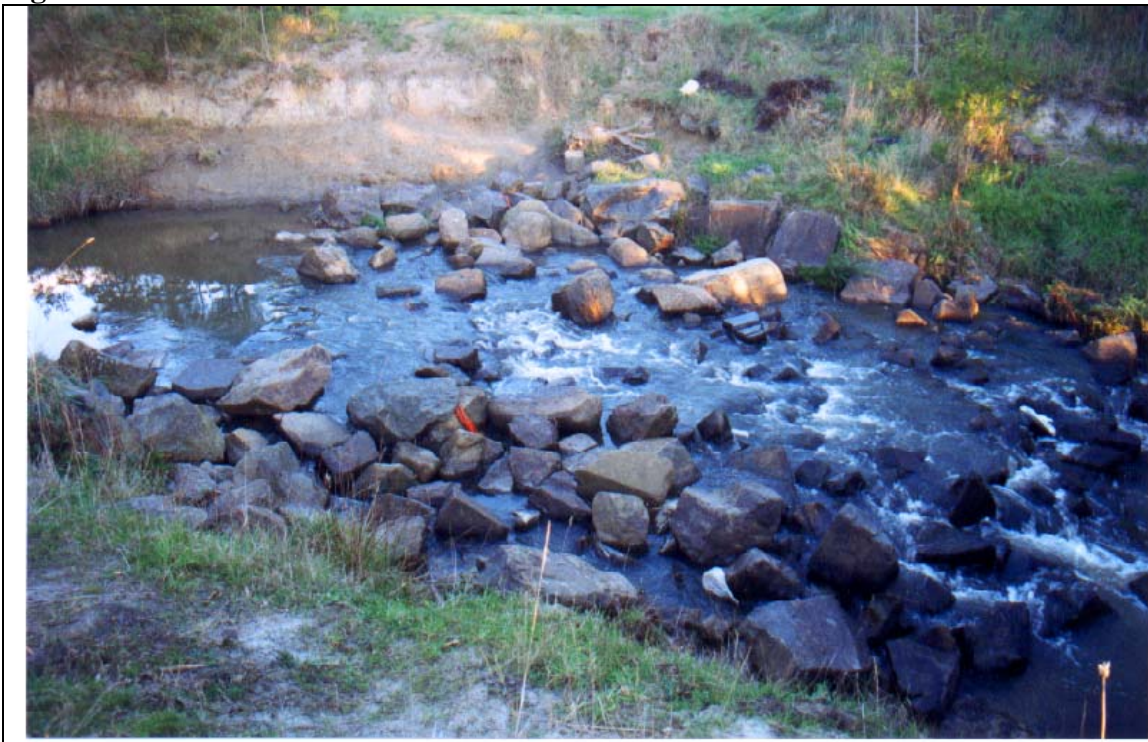
**Figure 4: Bank erosion at a rock chute in Corhanwarrabul Creek**

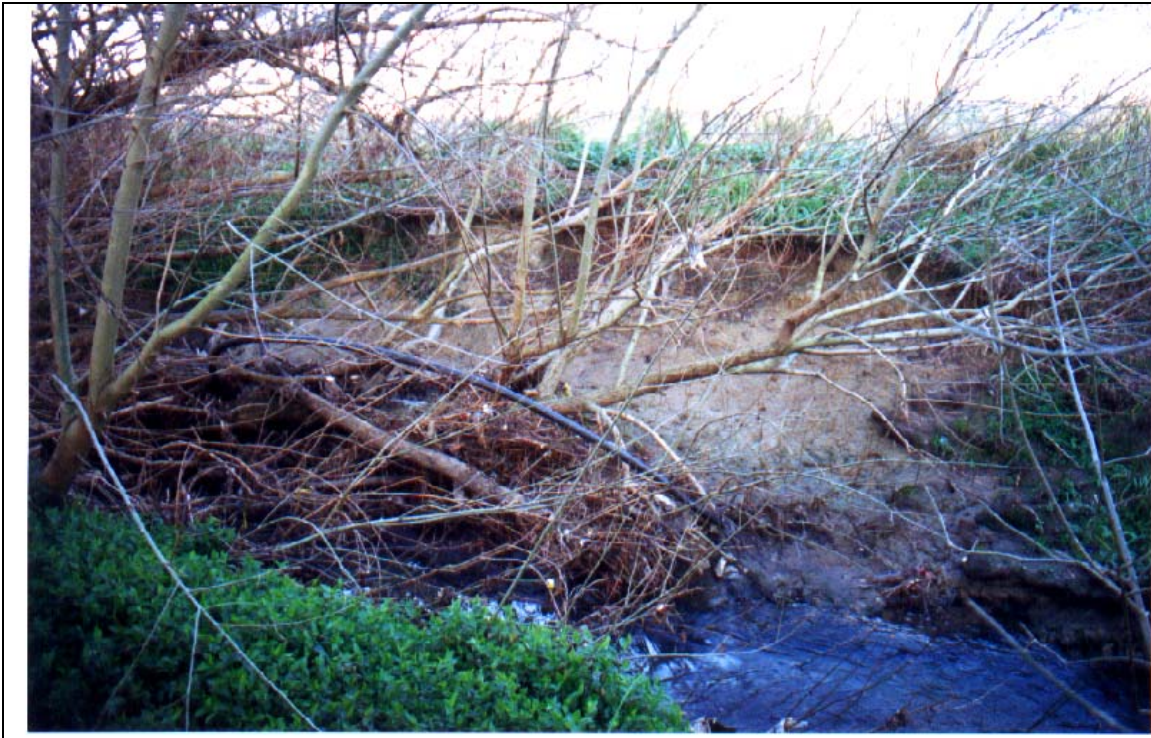
The lower section of Ferny Creek, between Corhanwarrabul Creek and the pipeline near Hancock Drive, has moderate to severe bed degradation and bank erosion problems. The worst section is below Knox Park, where existing rock chutes have been largely destroyed by a combination of

**Figure 5: Willow obstruction and associated bank wash-out in Ferny Creek near Hancock Road**

It is recommended that a willow removal program is established and willow-infested riparian zones are revegetated with native species. Willow removal should be given a high priority in waterways, such as in Ferny Creek near Hancock Drive, where the willows are reducing the hydraulic capacity of the stream.

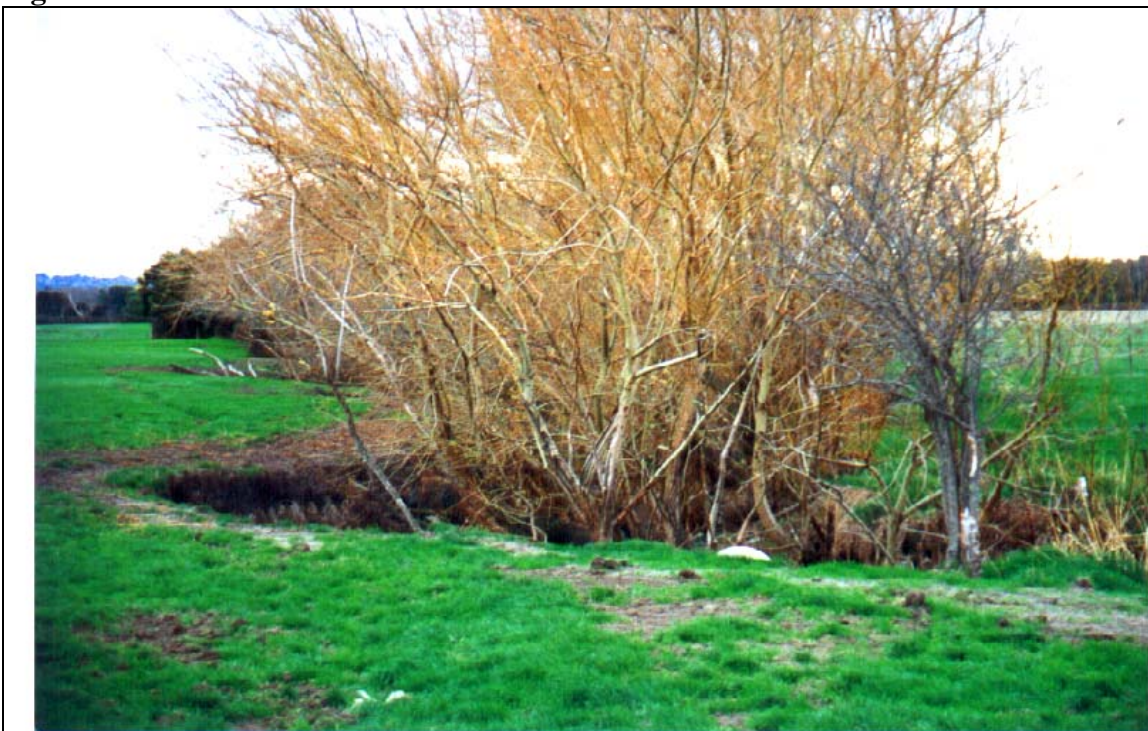
Monbulk Creek (18.5 km in length) has similar, but less severe, stream condition problems than in Ferny Creek. Lateral instability is a typical characteristic of its tortuous middle reaches downstream of Belgrave-Hallam Road to Monbulk Creek Retarding Basin. Restoration of remnant riparian vegetation and revegetation is required to sustain the condition of the riparian zone.

**Figure 7: Monbulk Creek downstream of Nixon Road**

stabilisation is not likely to be sustainable in this section, except to protect important assets (including major remnant overstorey trees).

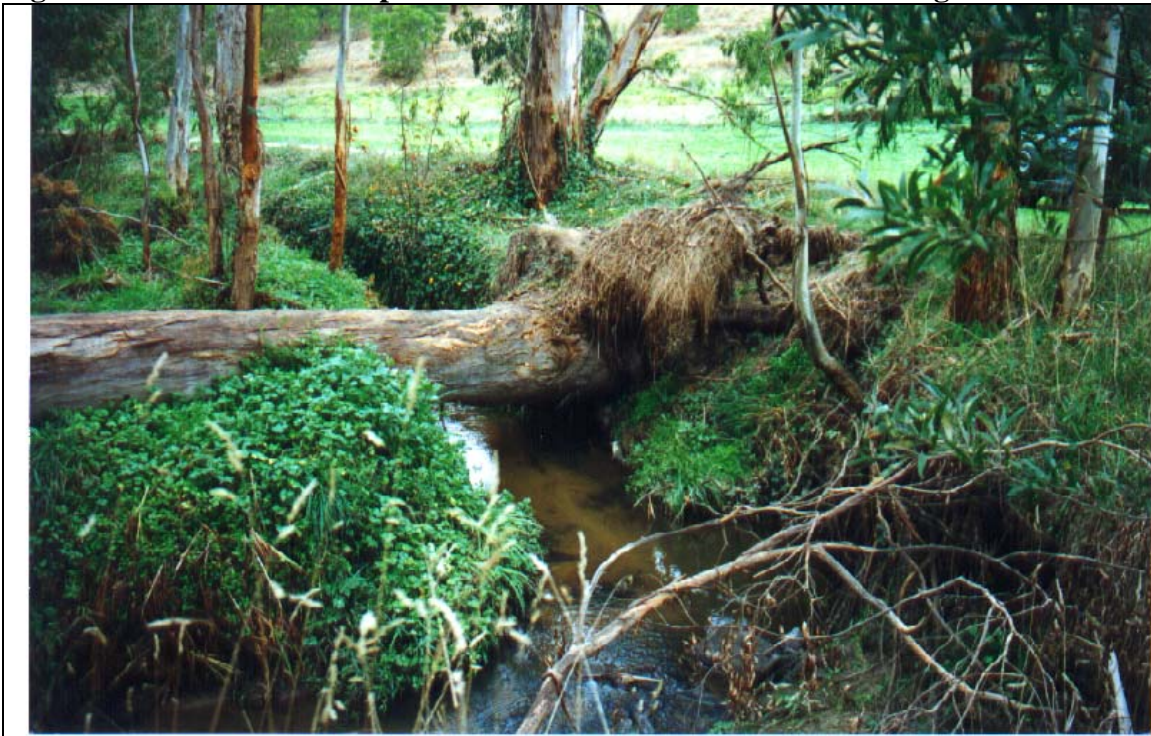
Downstream of the Monbulk Creek Retarding Basin, Monbulk Creek is straight and dominated by exotic trees, principally willows. The stream has moderate bed and bank erosion downstream of Blackwood Park Road to the Ferny Creek confluence; a large section of this stream is proposed to be incorporated into a golf course development. This area also has a severe infestation of blackberries and there has been widespread dumping of refuse. The poor bed and bank condition of Monbulk and Ferny Creeks within the Knox Reserve are of concern and will need to be considered as part of any future development in the area.

**Figure 8: Monbulk Creek upstream of the Monbulk Creek Retarding Basin**

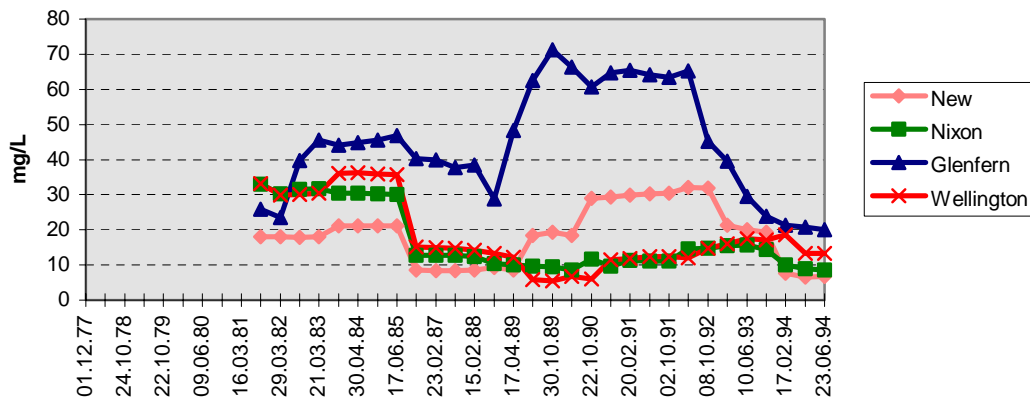
**Figure 28: Moving average of turbidities in Corhanwarrabul (Wellington Rd.), Monbulk (Nixon Rd.) and Ferny (New St. and Glenfern Rd.) between 1978 and 1993**

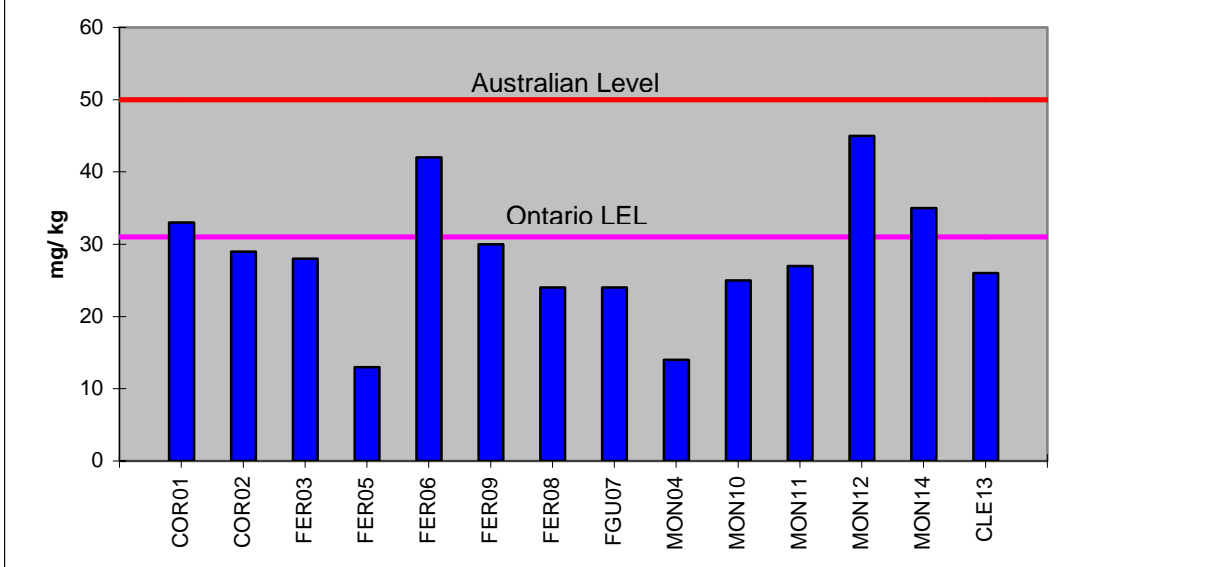
**Figure 30: Chromium concentrations in fine sediments from Corhanwarrabul Creek and tributaries**

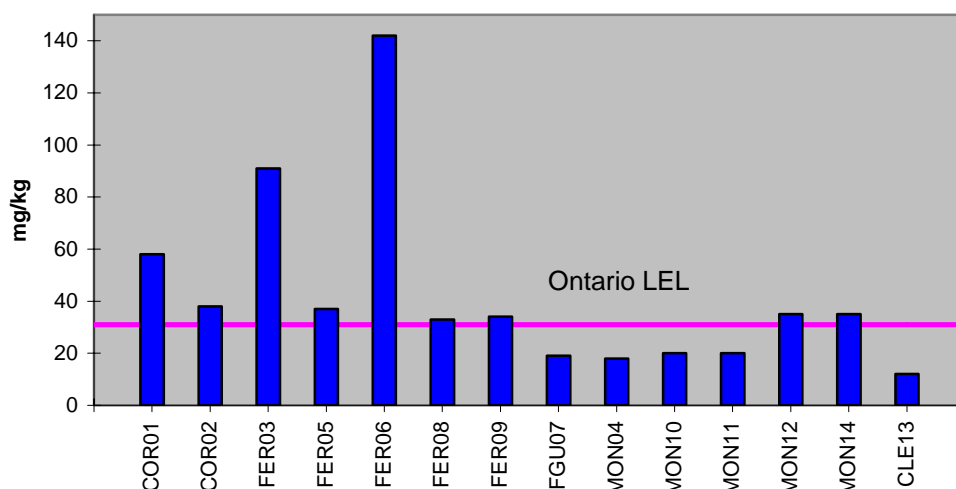
Lead concentrations in fine sediments collected from the study sites are presented in Figure 33. All sites had lead concentrations below the Australian Level B of 300 mg/kg, but lead concentrations exceeded the Ontario LEL in the lower sections of Ferny Creek (at Lysterfield Road, Hancock Drive and Rushdale Street), both sites in Corhanwarrabul Creek and in headwaters of Monbulk Creek (Puffing Billy Bridge and downstream of Belgrave Lake Park).

**Figure 33: Lead concentrations in fine sediments from Corhanwarrabul Creek and tributaries**

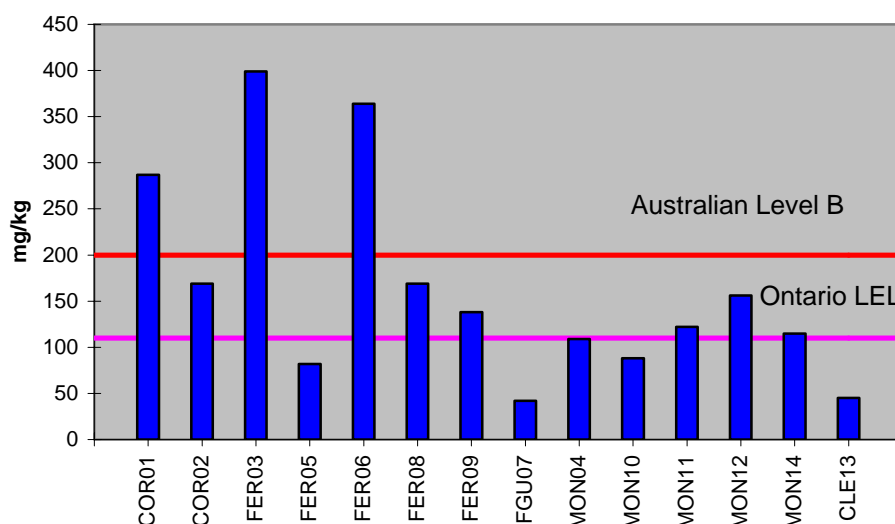
Zinc concentrations in fine sediments collected from Corhanwarrabul Creek and its tributaries are presented in Figure 34. Almost all sites exceeded the Ontario LEL objective of 110 mg/kg: the only sites which met this objectives were Ferny Creek at Hancock Road, Ferntree Gully Creek, Clematis Creek and Monbulk Creek at Napoleon Road and Karoo Court. The Australian Level B objective of 200 mg/kg was exceeded in Corhanwarrabul Creek at Wellington Road and in Ferny Creek at Lysterfield and Rushdale Street.

**Figure 34: Zinc concentrations in fine sediment from Corhanwarrabul Creek and tributaries**

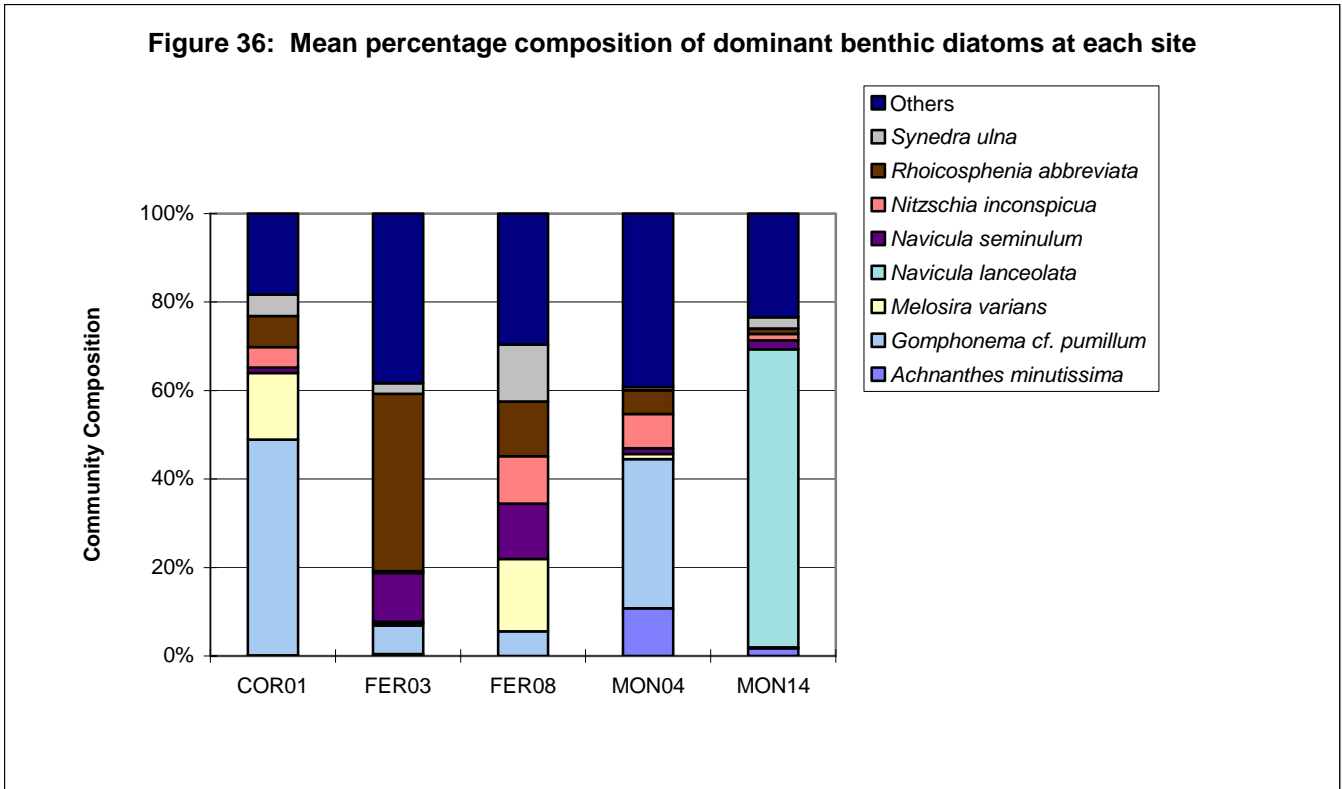
A list of all identified taxa and their mean percentage composition at each site is given in Appendix 8.2. Of the 48 taxa identified, eight were dominant (ie. mean percentage composition greater than 10%) at one or more sites. These common species were *Achnanthes minutissima*, *Gomphonema cf. pumillum*, *Melosira varians*, *Navicula lanceolata*, *Navicula seminulum*, *Nitzschia inconspicua*, *Rhoicosphenia abbreviata* and *Synedra ulna*. The mean percentage composition of the dominant species at each site is illustrated in Figure 36.

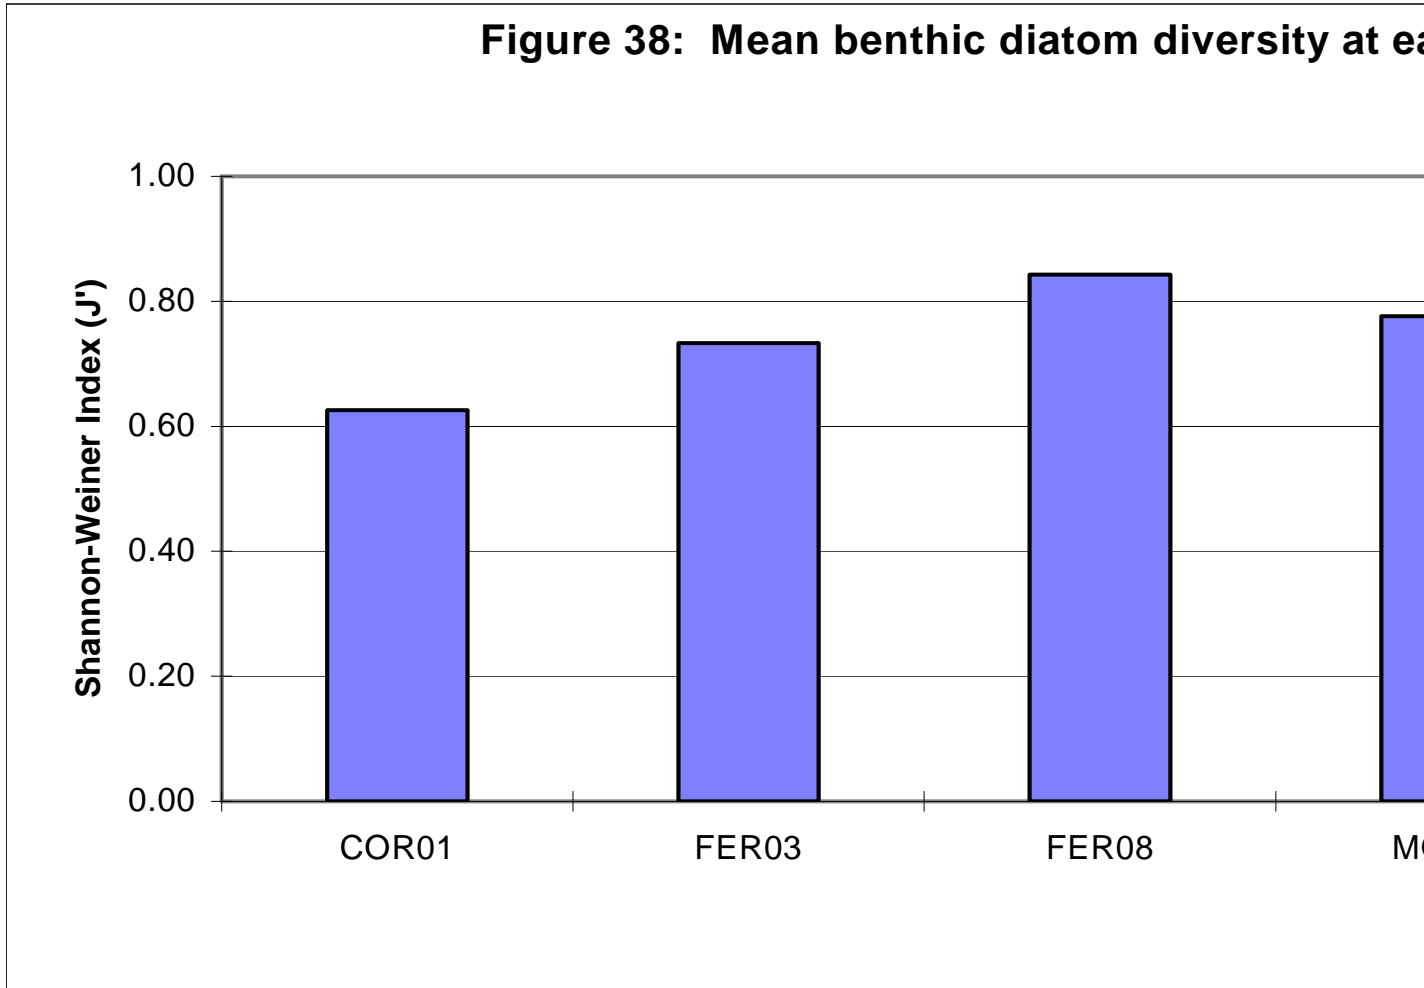
The relative diversity of the benthic diatom communities ( $J'$ ) at each site (Figure 38) was calculated using the Shannon-Weiner Index of diversity ( $H'$ ) and dividing this by the maximum possible

diversity ( $H'_{max}$ ). Diatom diversity was greatest in Ferny Creek at New Road (FER08) and lowest in Monbulk Creek at Belgrave-Gembrook Road (MON14). There was a downstream decrease in diversity in Ferny Creek, and an downstream increase in diversity in Monbulk Creek. Corhanwarrabul Creek at Wellington Road (COR01) had a slightly lower diversity than the lower sections of Monbulk and Ferny Creeks.

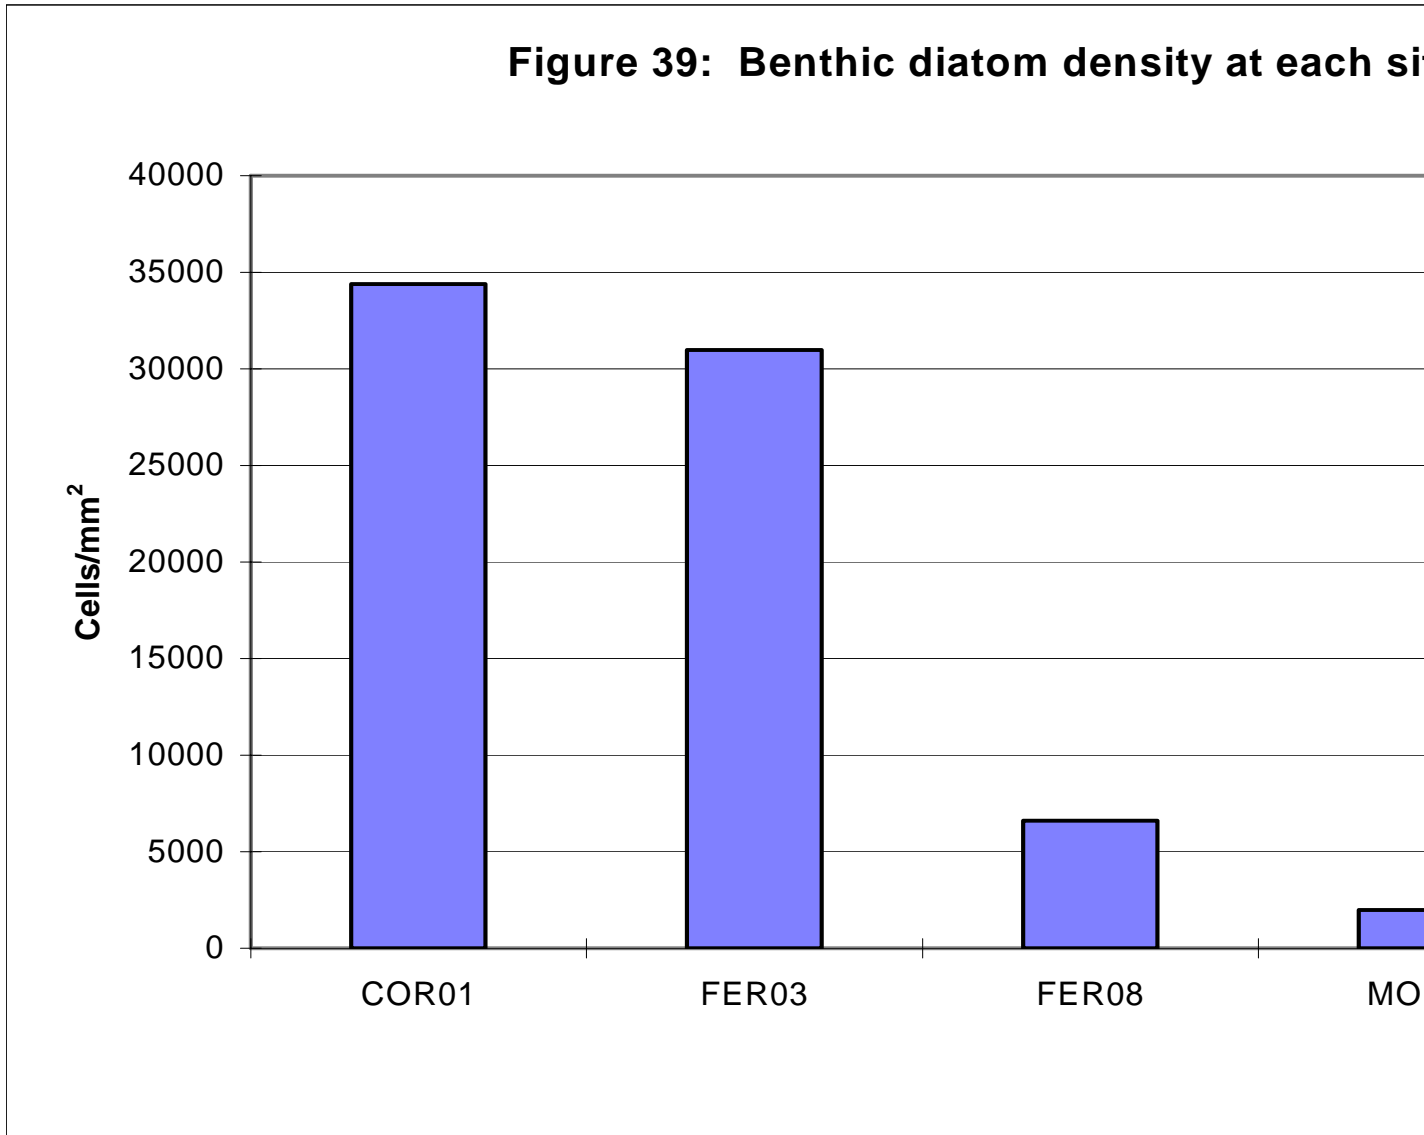
The density of benthic diatoms was greatest in Corhanwarrabul Creek at Wellington Road (COR01) and lowest in Monbulk Creek at Karoo Road (MON04) (Figure 39). Diatom densities increased downstream in Ferny Creek, but decreased downstream in Monbulk Creek.

**Figure 39: Benthic diatom density at each site**

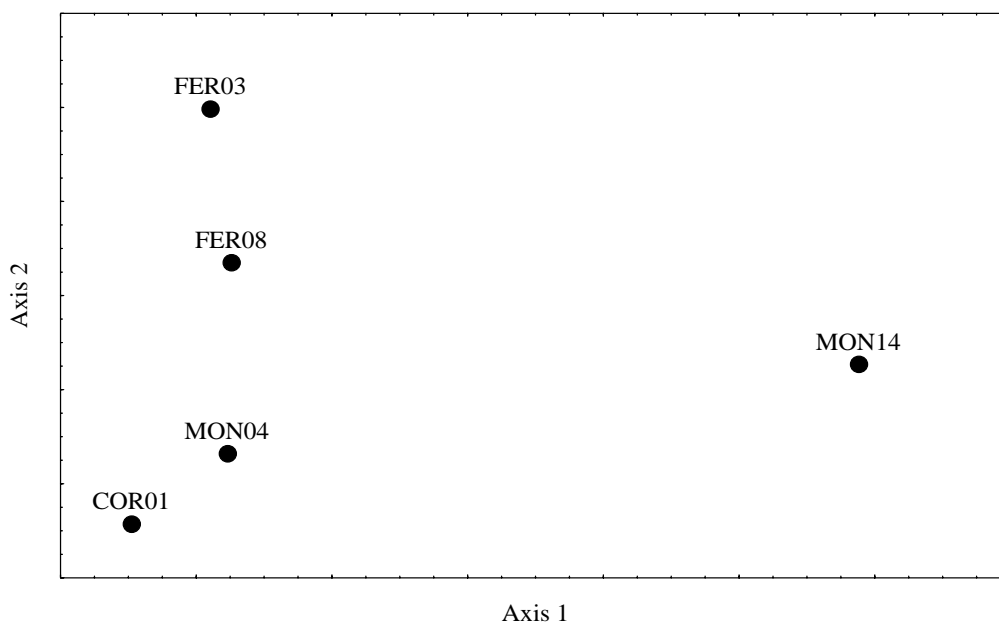
**Figure 41: Ordination of diatom communities using multi-dimensional scaling.**  
(Stress = 0.00)
