# Melbourne's Rivers and Creeks 2004

# Protecting our natural assets

This report supports the Victorian Government's River Health Strategy to ensure the long-term health of the State's waterways. Melbourne Water and the Port Phillip and Westernport Catchment Management Authority are working together to prepare a Regional River Health Strategy for the Port Phillip and Westernport catchment.

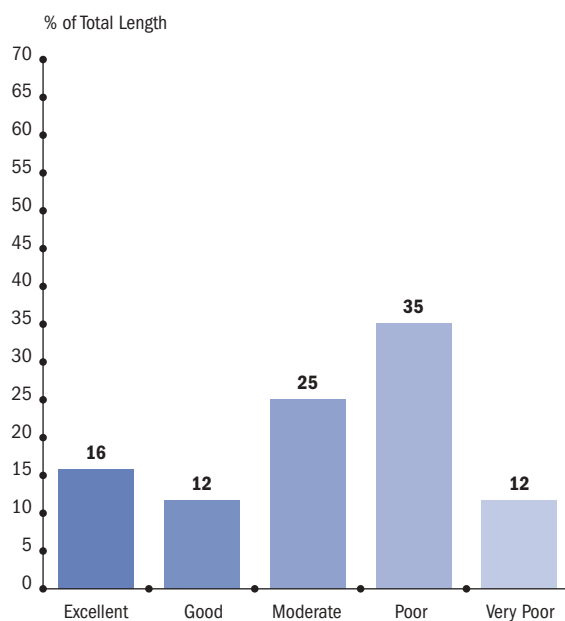
### Condition ratings for rivers and creeks in Melbourne Water's operating area.

Recent analysis shows that in Melbourne Water's operating area, 28% of rivers and creeks are in good or excellent condition, and 25% are in moderate condition.

Forty-seven per cent are in poor or very poor condition, mostly due to changes in flow, poor water quality and changes in land use.

Generally, the condition of rivers and creeks closer to the city worsen due to run-off from buildings and roads, loss of vegetation and litter.

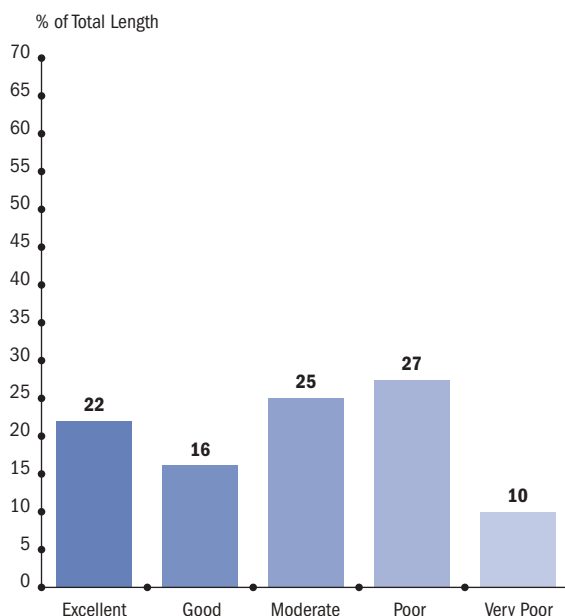
Waterway condition in the Yarra catchment.

The upper reaches of the Yarra River and its major tributaries flow through forested, mountainous areas, which have been reserved for water supply purposes for more than 100 years. The rivers and creeks are relatively undisturbed and in excellent condition. The lower slopes and floodplains have been extensively cleared for agricultural use, which impacted on waterway health. Development of urban areas in the lower catchment has also contributed to poor health.

Water quality is generally good in the upper catchment, but deteriorates downstream because of changes in land use. Over the past few decades, there has been a general improvement in many of the water quality parameters we test, such as nutrients, bacteria and suspended solids, especially in urban rivers and creeks. A good deal of this can be attributed to improvements in sewerage infrastructure, regulation against industrial discharges to waterways, and works to prevent erosion.

While the forested upper catchment offers excellent habitat, both the quality and amount of habitat in a number of rural and urban waterways is poor as a result of erosion, weeds, farming techniques and changes to river flows. Despite this, native plants and endangered or threatened species can still be found in many rural and urban waterways. In recent years, we have managed to slow the loss of habitat and, in some cases, have extended the range of certain species with a range of works including replanting indigenous plants, enhancing habitat and removing fish barriers.

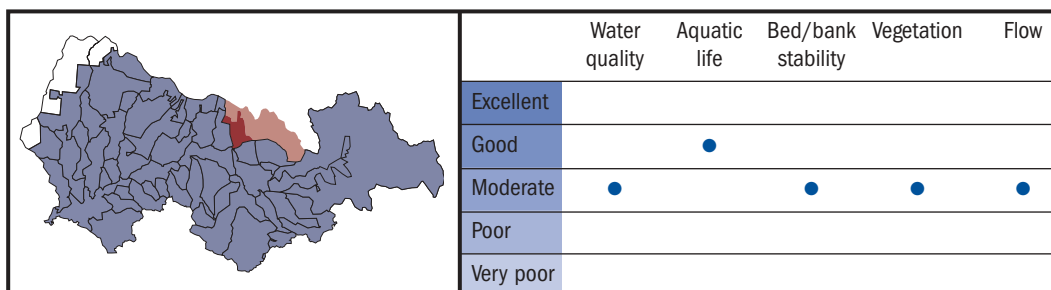
## Watts River

Source: Excellent

Rural Sections: Moderate

This river is largely contained within the forested Maroondah Reservoir water supply catchment area. Below the reservoir, the river runs mostly through rural areas, with the town of Healesville in its floodplain.

The river has been affected by loss of vegetation, reduced flows, erosion, pollution from rural and urban run-off, willow and weeds and barriers to fish and fauna moving through the river.

**Improvement works:** Recent works have focused on weeds, including willows, and stabilising the bed and bank of the river. Further works will improve a 1.3 kilometre section of the river downstream of Walkers Lane, Healesville. The project includes weed and willow control and replanting on both sides of the river.

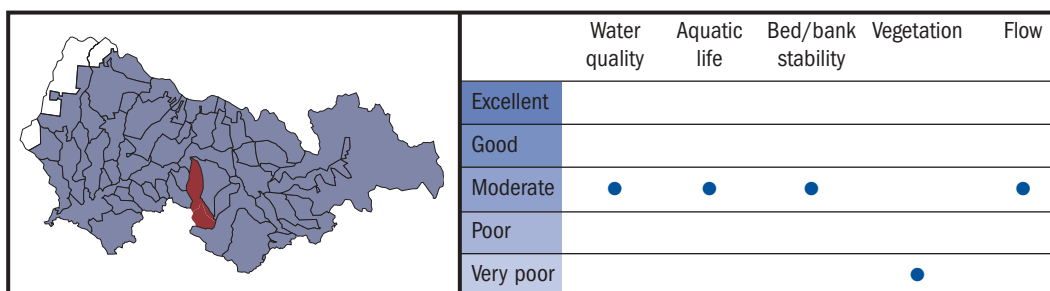
## Olinda Creek

Moderate

Olinda Creek rises up in the forested south-eastern slopes of the Dandenong Ranges. It is a major tributary of the Yarra River, with a largely rural catchment interspersed with several towns including Lilydale, Montrose, Olinda and Mount Evelyn. The Dandenong Fresh Water Amphipod, a rare crustacean, lives in its upper tributaries.

**Improvement works:** In recent years, the bed and banks of the creek have been stabilised, willows and other weeds removed, and wetlands built nearby. Through Melbourne Water's Healthy Rivers Program, we have supported studies on the endangered Powerful Owl to identify how we can minimise potential impacts to this species from our works in the area. Weed removal and stabilisation works will be undertaken on the banks of the creek where it runs through the Melba Park area in Lilydale, followed by a major replanting program.

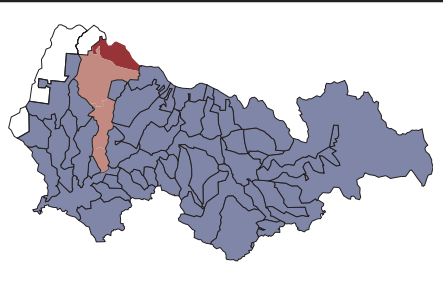
**Plenty River**

**Source: Good**

Water quality	Aquatic life	Bed/bank stability	Vegetation	Flow	
	Excellent	●	●			
	Good			●		
	Moderate				●	●
	Poor					
Very poor

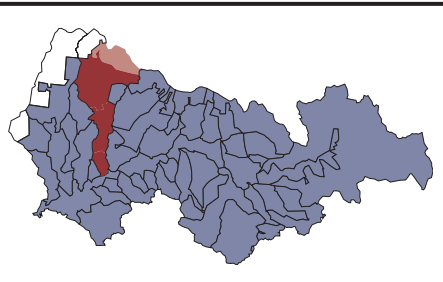
**Lower Sections: Poor**

Water quality	Aquatic life	Bed/bank stability	Vegetation	Flow
	Excellent				
	Good			●	
	Moderate		●		
	Poor	●			●
Very poor					●

Originating in the forested slopes of Mount Disappointment, the Plenty River is the source of Melbourne’s first major water supply. Below the forests, where the river is in good condition and has an excellent rating for aquatic life and water quality, the river has a largely rural catchment with two major towns at Mernda and Whittlesea. Downstream of South Morang, the catchment becomes fully urbanised. Flows are a serious issue in terms of waterway health.

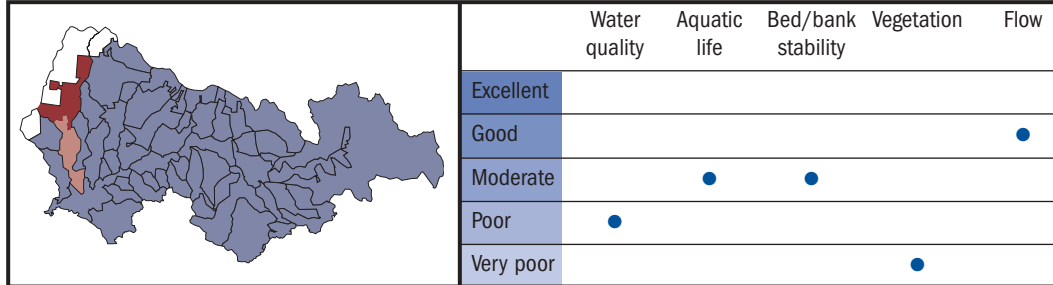
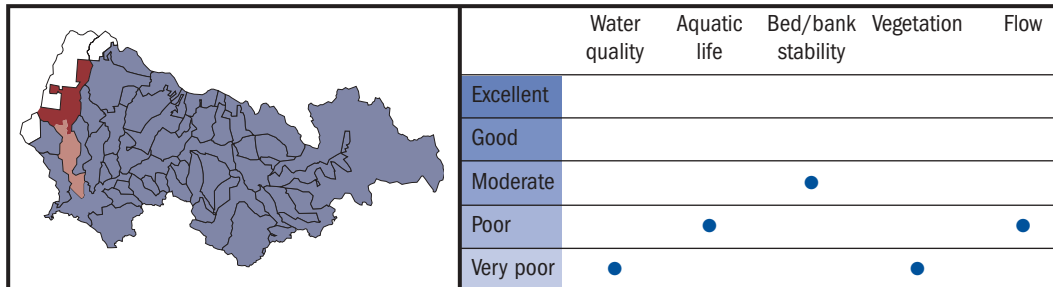
## Merri Creek

### Rural Sections: Poor

### Urban Sections: Very Poor

Merri Creek flows from the foothills of the Great Dividing Range north of Wallan on the Hume Highway. A major tributary, it crosses more than 50 kilometres of basalt plain to meet the Yarra River at Fairfield. The upper and middle sections are mostly rural, and dotted with small townships like Wallan, Beveridge and Kalkallo. The creek's middle sections are surrounded by the growing suburb of Craigieburn and other northern suburbs. Blackfish are still found in the upper sections and, although there are no platypus found there at present, they could return in the future. There are major native grasslands alongside the creek that will soon be included in an extended waterway park.

**Improvement works:** Work is ongoing to control weeds, remove willows, replant areas and stabilise the banks of the creek. We have also reinstated the fish passage around the wall at Coburg Lake. Replanting and minor stabilisation works will continue between the Northcote Golf Course frontage and the Preston Main Drain, and at Phillips Reserve in Brunswick. Other creek bank works, removal of willow and ash trees, weed control and replanting is planned downstream of the Sumner Park footbridge.

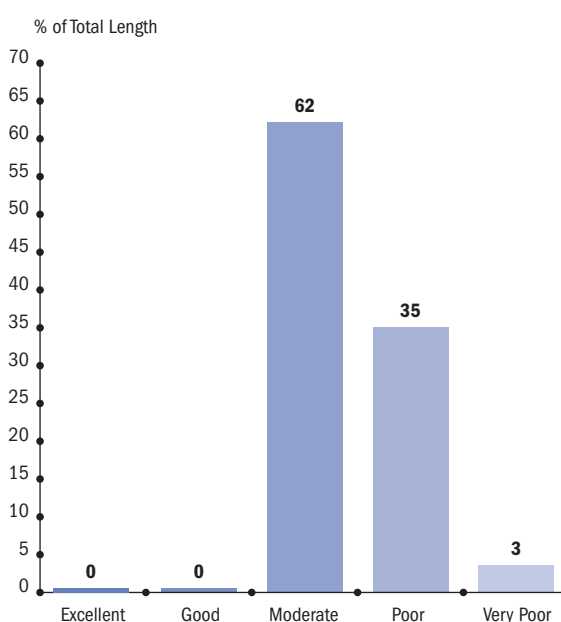
Waterway condition in the Western catchment.

Despite the declining condition of the catchment's waterways, platypus are still widespread and a number of significant fish species can be found, such as the endangered Yarra Pigmy Perch and Australian Grayling. Recent and ongoing works to improve fish passage in the lower Maribyrnong River aim to increase the numbers and types of fish found there.

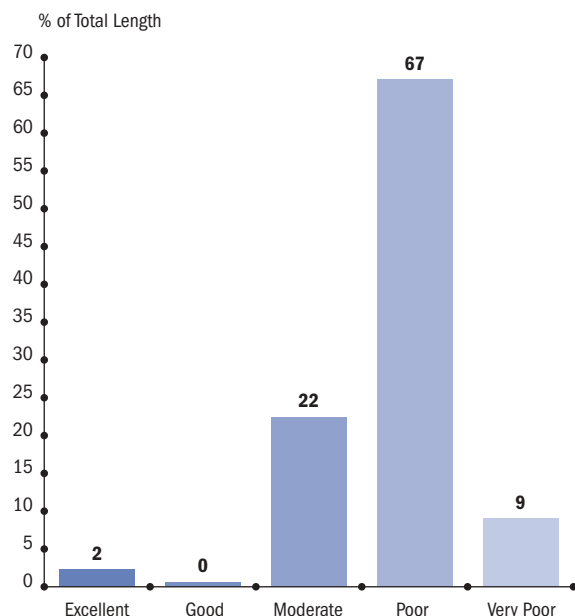
Waterway condition in the Dandenong catchment.

Vegetation along these waterways is mostly poor to very poor, but there are still some fair to excellent sections. The condition of the beds and banks is largely good to moderate, with some sections in a poorer state. Poor ratings are largely due to lack of habitat and barriers that hamper fish migration. A large number of species live in the area, including the nationally significant Dwarf Galaxias fish, platypus, the Growling Grass Frog and threatened plant species.

Although flow diversions may stress waterways, increased stormwater run-off in urban areas also impacts on the environment. While the level of run-off and quality of stormwater is degrading parts of the catchment, there has been a significant improvement in water quality in the last 30 years as the sewerage system has been extended to areas under development, and industrial discharges to rivers and creeks have been phased out.

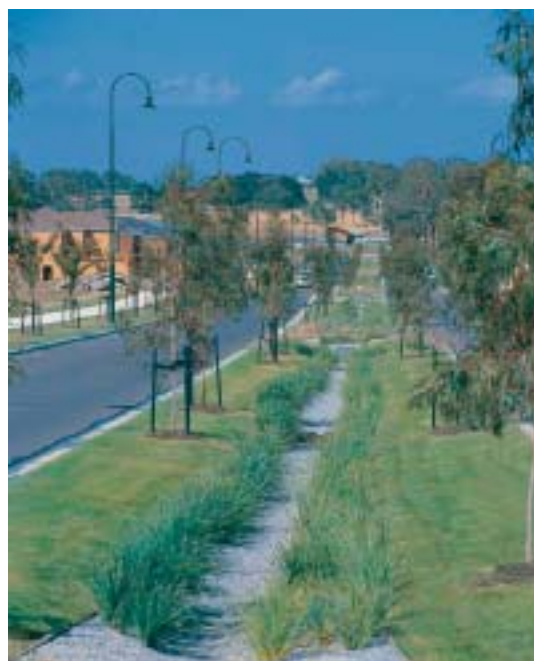
Innovative drainage systems at developments such as Lynbrook Estate treat stormwater to improve the quality of rivers and creeks.

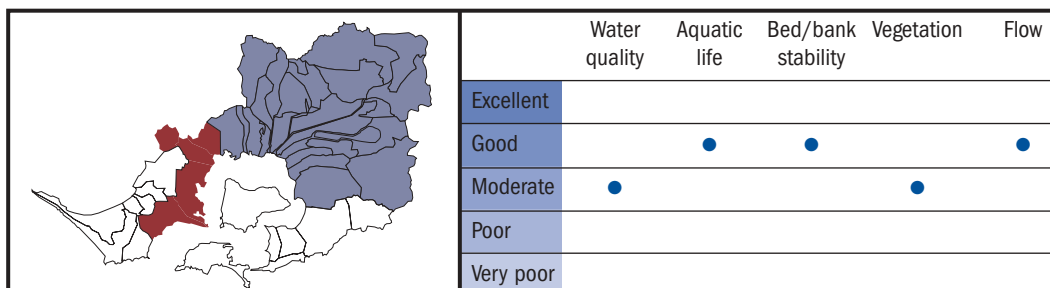
## South East Mornington Peninsula Waterways

Moderate

There are several small waterways on the Mornington Peninsula, including Watsons (Somerville), Merricks (Balnarring) and Stony (Shoreham) creeks. The region is a combination of rural and urban areas, with some industry. Urban areas are growing, and the amount of intensive agriculture (particularly viticulture) has increased in recent years. Key issues in the region are the protection of threatened flora and fauna, damage to water quality in intensive agricultural regions, stormwater run-off, the continued extension of the sewerage system, lack of habitat and loss of vegetation along the edge of the waterways.

**Improvement works:** Works are being undertaken to stabilise the bed and banks of the waterways, control willow and weeds, and replant some areas.

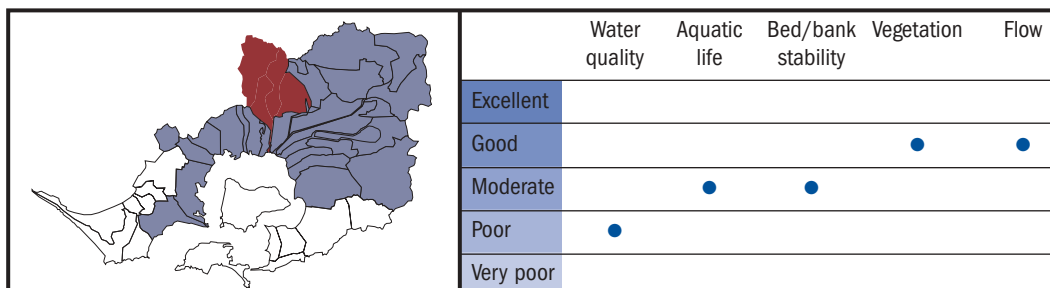
## Cardinia, Toomuc, Deep and Ararat Creeks

Moderate

These are largely agricultural waterways that are generally in good condition near the source, and moderate to poor condition downstream of Princes Highway. Key issues in the region are protecting threatened flora and fauna (eg. Dwarf Galaxias, Australian Grayling and Growling Grass Frog), damage to water quality from agriculture, stormwater run-off, septic tanks, loss of vegetation and barriers to fish movement.

**Improvement works:** The fishways already in place have recently been upgraded and others are being proposed. Other works have included erosion control, removing willows, building sediment traps and replanting vegetation. A new sediment trap will be built on the Northern Boundary Drain, downstream of the junction with Ararat Creek in Nar Nar Goon.
