## **Nation Partners**

# **Northern Sewers Relining Project Southern Section**

## **Construction Impact Report**

**Wednesday 4<sup>th</sup> December 2024**

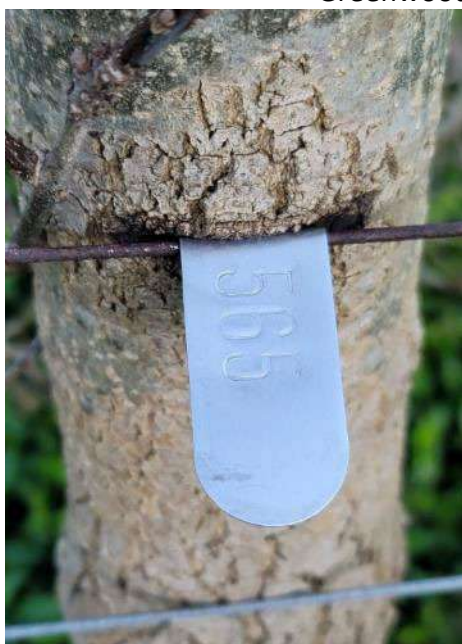
Example of tag attached to a fence

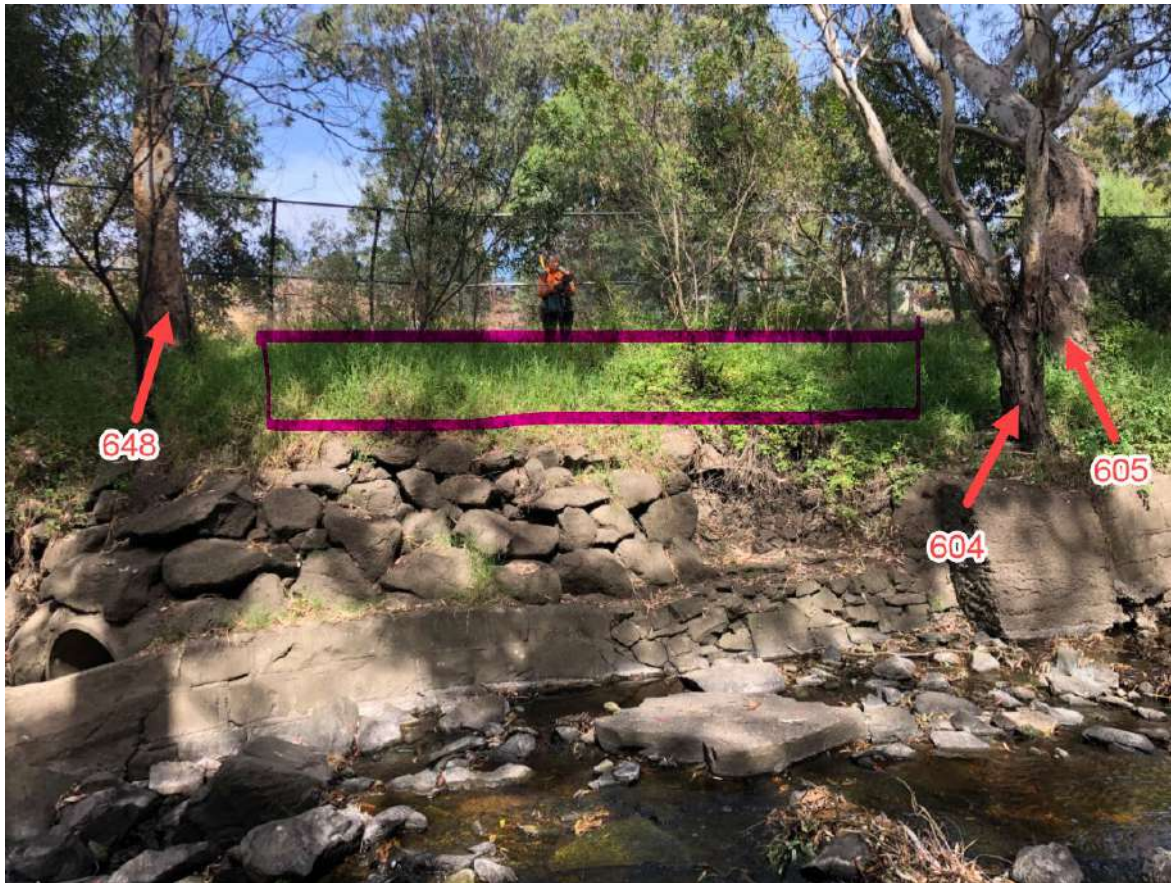
Figure 1 Indicative location of temporary crane pad, adjacent to Darebin Creek.

The pruning of four Trees (Trees 604, 605, 643 and 645) is required to enable access between this maintenance hole (NYM078) and NYM091 (which is located on the other side of Darebin Creek in the City of Banyule).

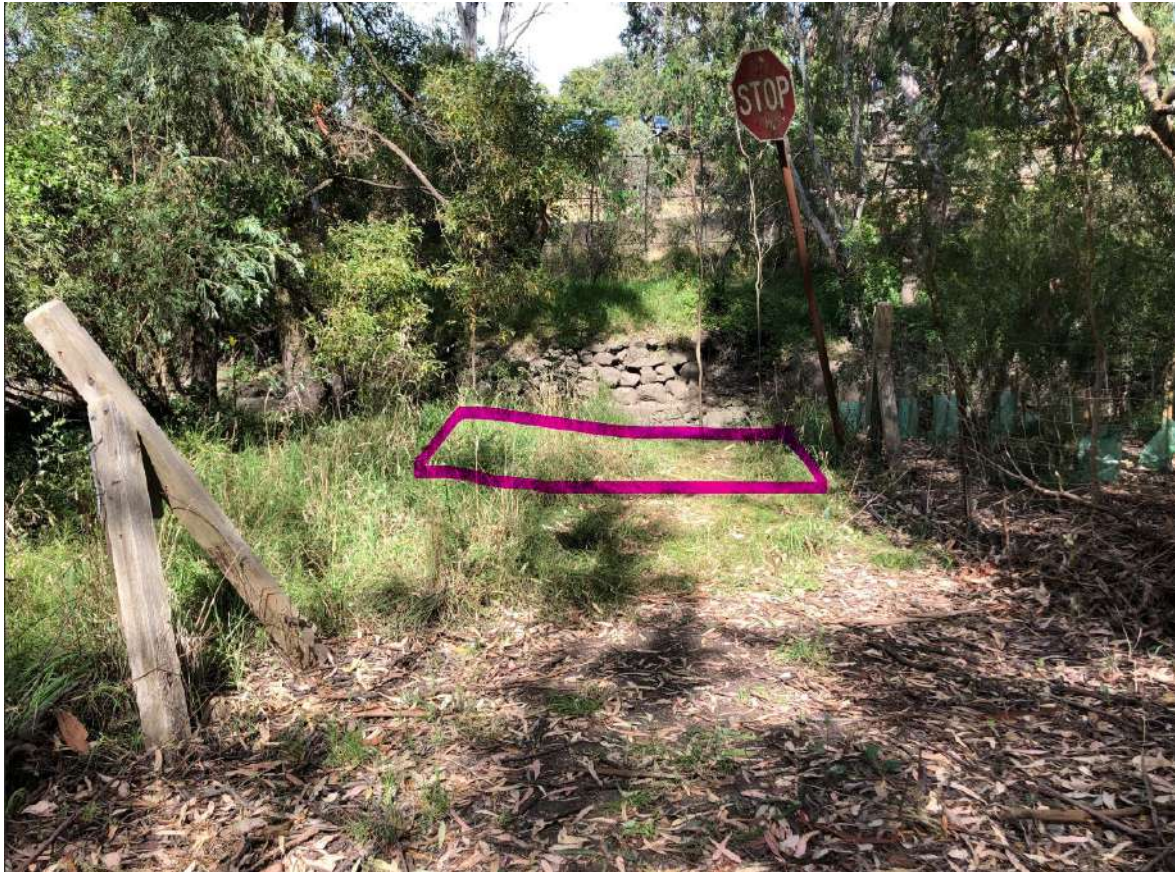
**Figure 3 Indicative location of where materials will be deposited on the bank opposite the temporary crane pad.**

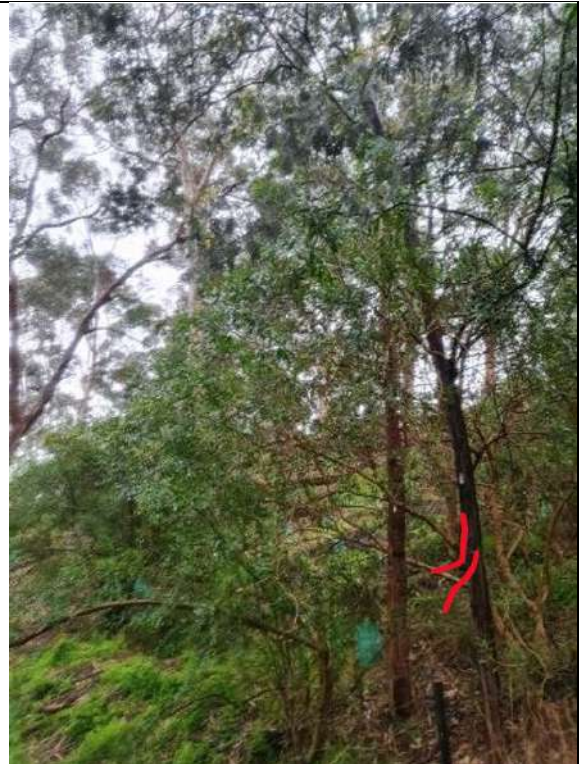
**NYM091 Tree 327 pruning**

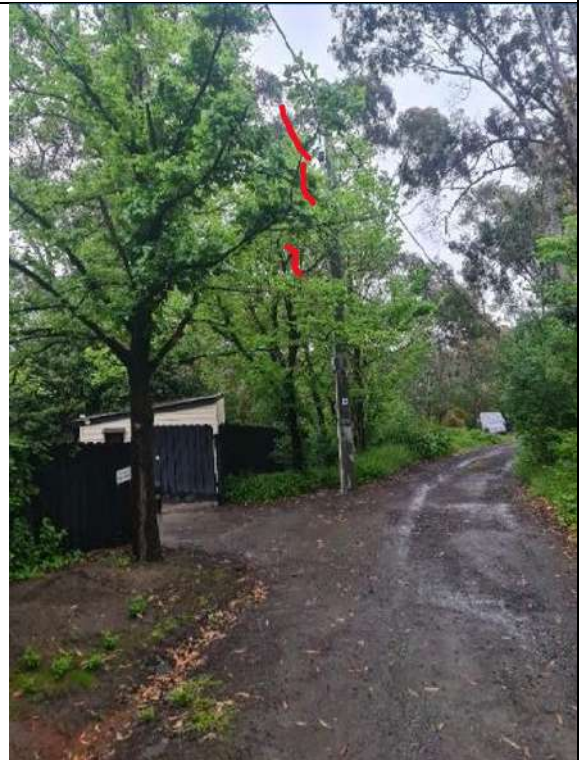
**NYM091 Tree 357 pruning**

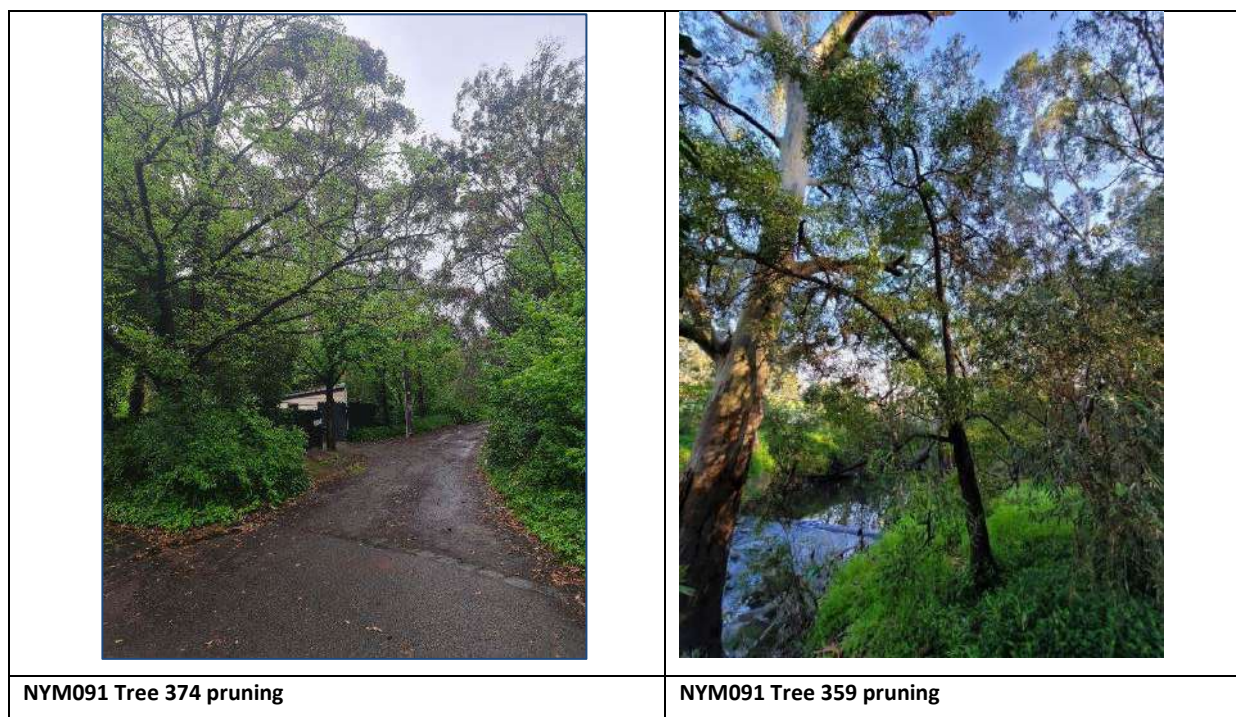
**Figure 4 NYM091 Pruning**

The removal of these branches from each of these trees will remove less than 15% of the canopy volume of each individual tree. Provided that the pruning works are undertaken in accordance with *AS 4373 - 2007 Pruning of Amenity Trees*, it will have little or no impact on the health or longevity of these trees.

The pruning of nine Trees (Trees 285, 323, 327, 357, 359, 360, 361, 373 and 374) is required to enable access to NYM091.

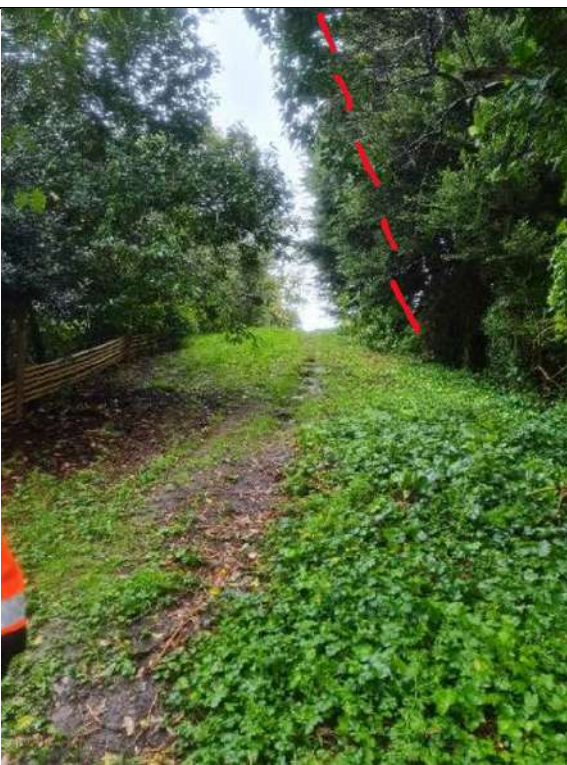
<p>A photograph of a large, dense tree with dark green foliage. Red dashed lines are drawn vertically on the right side of the tree, indicating pruning points. A wooden fence is visible in the foreground, and a dark structure is on the left.</p>	  <p>A photograph of a tree with dense green foliage. Red dashed lines are drawn vertically on the right side of the tree, indicating pruning points. A wooden fence is visible in the foreground.</p>
<p><b>NYM093 Tree 98 pruning</b></p>	<p><b>NYM093 Tree 99 pruning</b></p>

A permit is not required for the pruning of Tree 99 (*Ligustrum lucidum*) and Tree 104 (*Cotoneaster glaucophyllus*) as these trees are identified as environmental weed species in the *Banyule Weed Management Strategy* Banyule City Council, 2006).

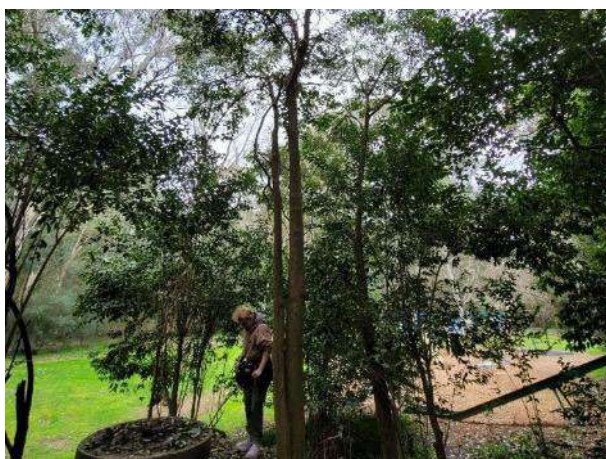
As outlined within the scope significant vegetation is broadly defined as being trees larger than 5 metres in height and/or with a DBH (Diameter at Breast Height) of greater than 15cm. Trees under 5 metres tall, with a DBH of less than 15cm were typically not individually assessed or tagged. Adjacent to maintenance hole NYM097 there are numerous immature *Ligustrum lucidum* (see Figure 5, below) that have self-seeded, these trees were under 4m and have a DBH of less than 15cm. This species is identified as an environmental weed species in the *Banyule Weed Management Strategy* (Banyule City Council, 2006). This vegetation will need to be cleared to enable access to the maintenance hole.

**Figure 8 NYM097 Example of Immature Trees adjacent to the maintenance hole**

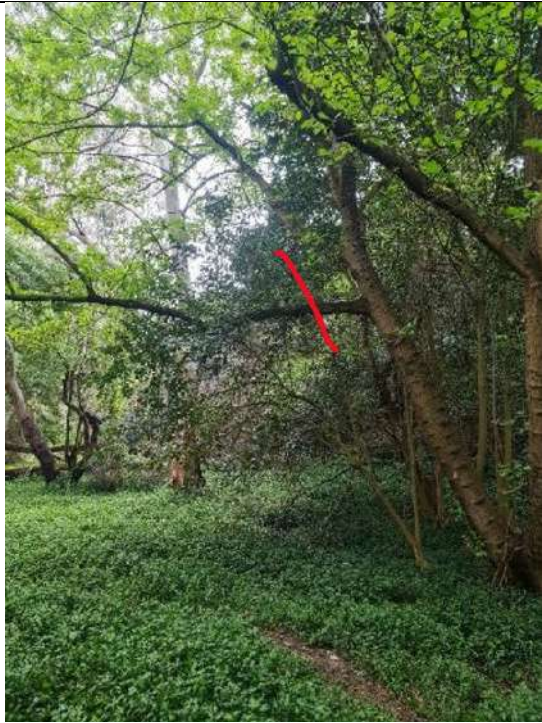
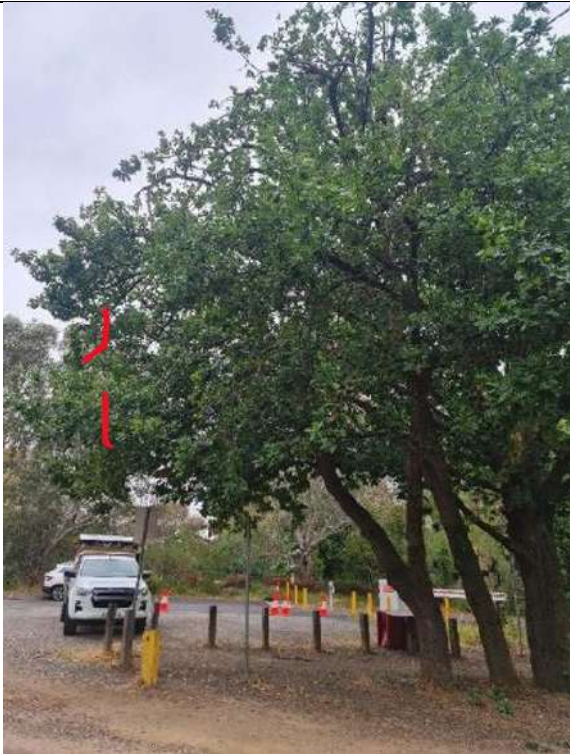
NYM098 and NYM099 Tree 452 pruning	NYM098 and NYM 099 Tree 616 pruning

The pruning of 12 Trees (Trees 452, 616, 617, 618, 622, 623, 624, 625, 626, 627, 628 and 629) is required to enable access to NYM98 and NYM99.

Tree 452 (*Acer negundo*) is identified as an environmental weed species in the *Banyule Weed Management Strategy* (Banyule City Council, 2006).

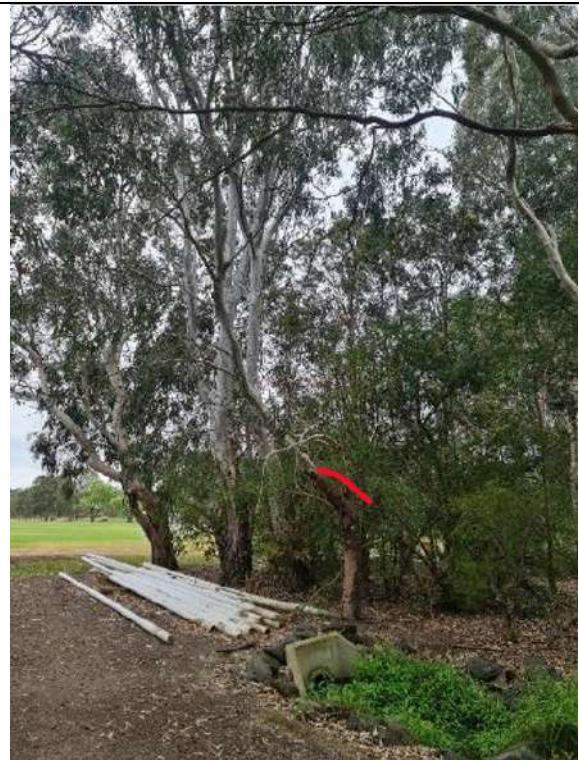
**NYM098 and NYM099 Tree 626 pruning**

Pruning of Tree 626 involves the removal of the lowest branch (270mm diameter). This will result in approximately 25% canopy loss. Provided that the pruning works are undertaken in accordance with AS 4373 - 2007 Pruning of Amenity Trees, Tree 626 is likely to remain viable.

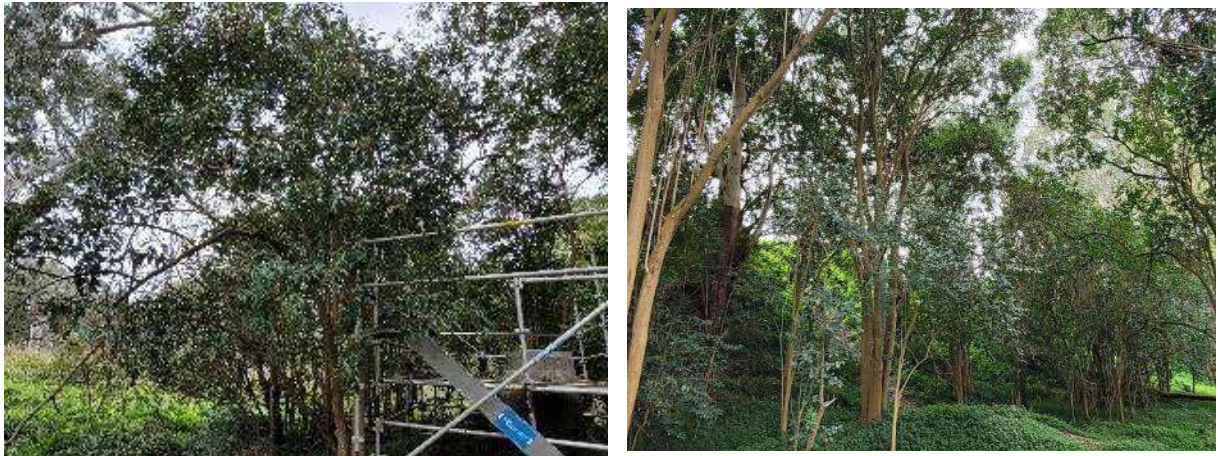
Adjacent to maintenance hole NYM098 and NYM099 there are numerous immature *Ligustrum lucidum* (see Figure 8, below) that have self-seeded, these trees were under 4m and have a DBH of less than 15cm. This species is identified as an environmental weed species in the *Banyule Weed Management Strategy* (Banyule City Council, 2006). This vegetation will need to be cleared to enable access to the maintenance hole.

**Figure 10 NYM098 (left) and NYM099 (right) Example of Immature Trees adjacent to the maintenance holes.**

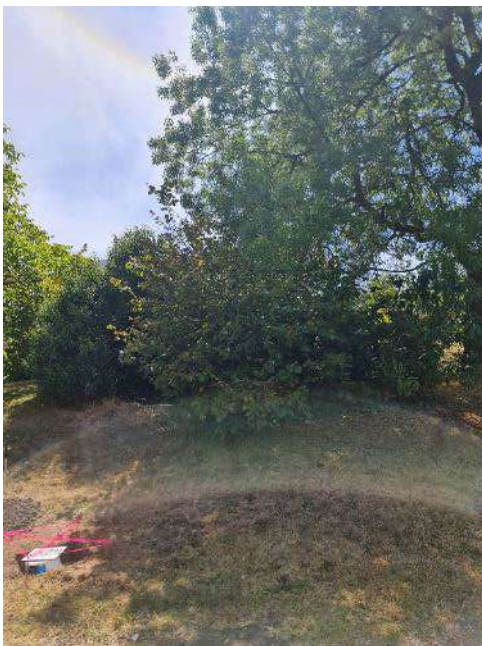
This vegetation (which is all exotic) is under 3m in height with an estimated DBH of 12cm. This patch of vegetation will need to be removed to enable access to NYM110.

**Figure 13 Patch of vegetation adjacent to NYM102**

No permit is required for this vegetation removal under the provisions of ESO4.

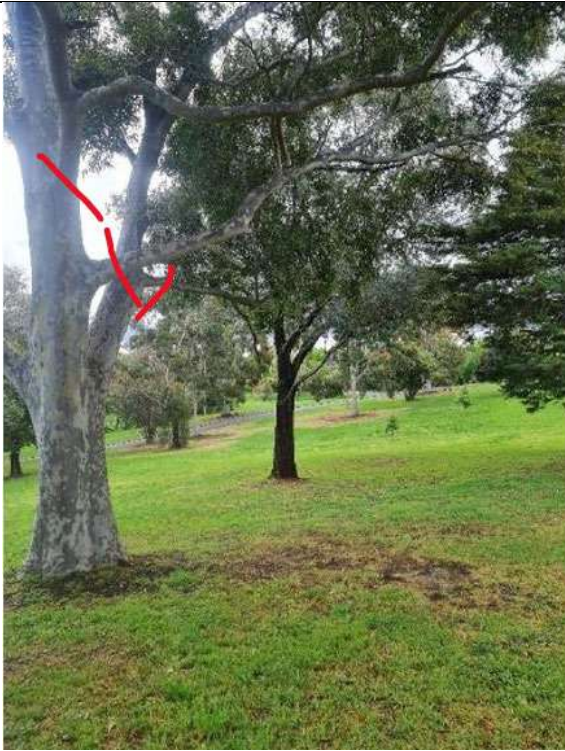
**NYM105-A Tree 493 pruning**

The pruning of three Trees (Trees 490, 492 and 493) for access paths to NYM105 and NYM105-A.

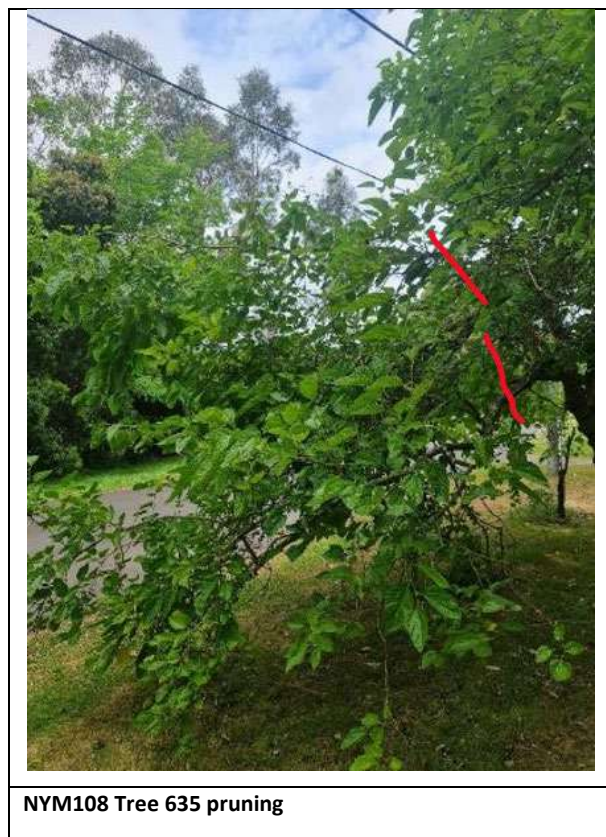
**Figure 16 NYM108 Pruning**

The removal of these branches from this tree will remove less than 15% of the canopy volume of the tree. Provided that the pruning works are undertaken in accordance with *AS 4373 - 2007 Pruning of Amenity Trees*, it will have little or no impact on the health or longevity of the tree.

The pruning of one Tree (Tree 635) is required to enable access to NYM108.

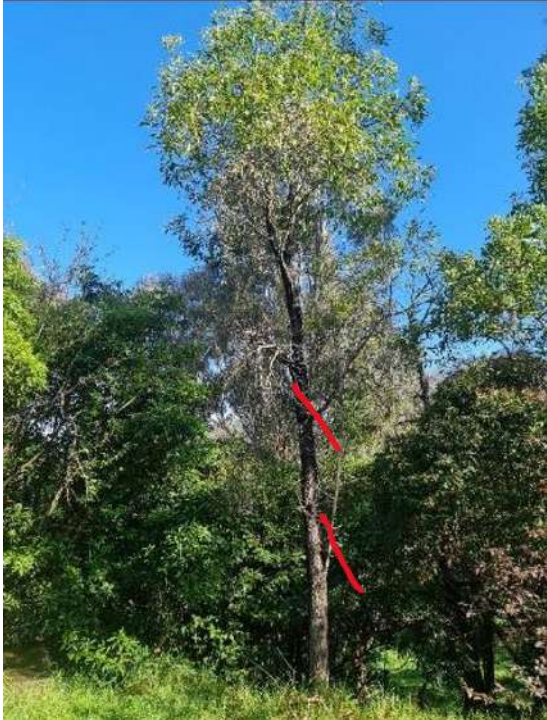
NYM111 Tree 550 pruning	NYM111 Tree 551 pruning

The pruning of three trees (Trees 550, 551 and 552) is required to enable access to NYM111.

A permit is not required for the pruning of Tree 550 (*Pittosporum undulatum*) and Tree 552 (*Cotoneaster glaucophyllus*) as they are identified as environmental weed species in the *Banyule Weed Management Strategy* (Banyule City Council, 2006).

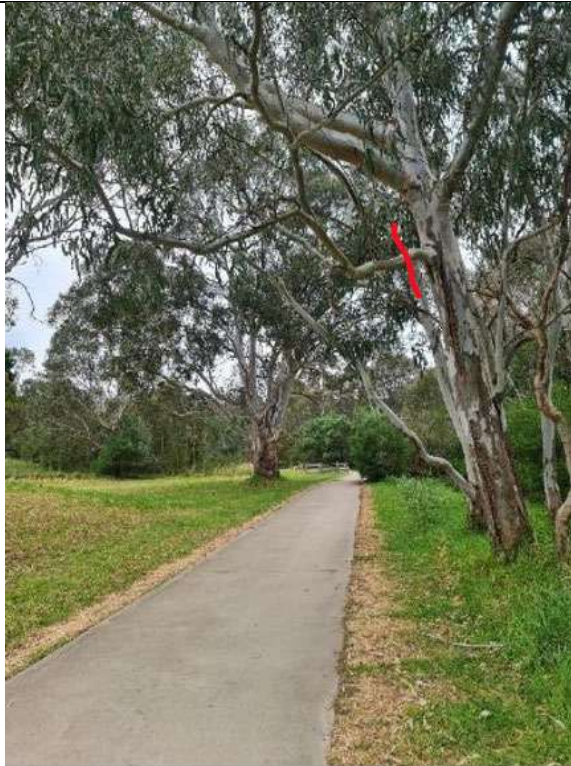
**Bypass Tree 514 pruning**

The pruning of 22 trees (Trees 497, 514, 520, 525, 526, 535, 537 to 545, 547, 548, 630 to 633 and 660) is required to enable access along the bypass.

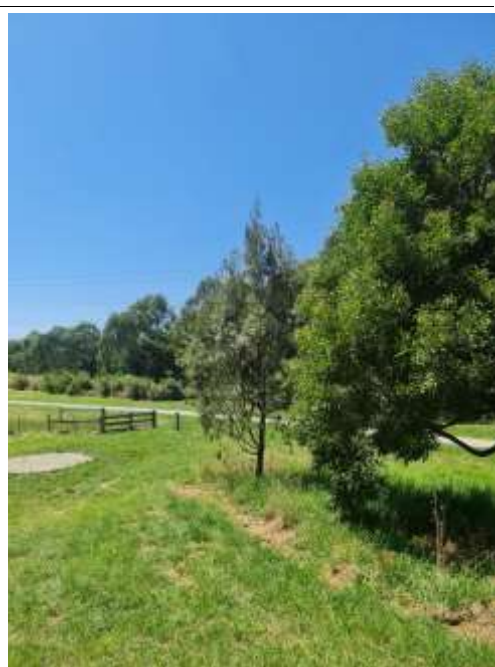
**Tree ID: 15****Genus / species:** *Callistemon citrinus*

Evergreen Crimson Bottle Brush

**Height (m):** 10      **Structure:** Good  
**Width (m):** 8      **Health:** Good  
**DBH (cm):** 23 Measured **Maturity:** Mature  
**Origin:** Victorian **ULE (years):** 30 - 60  
**Retained?:** Retained **Form:** Good

**Retention Value:** Moderate**Removal / retention reason:** N/A.**Amenity value:** Moderate**Works Required:** Canopy lift.**SRZ (m):** 1.9      **Works priority:** Very low**TPZ (m):** 2.8      **Construction Proximity:** 0.1**mTPZ (m):**

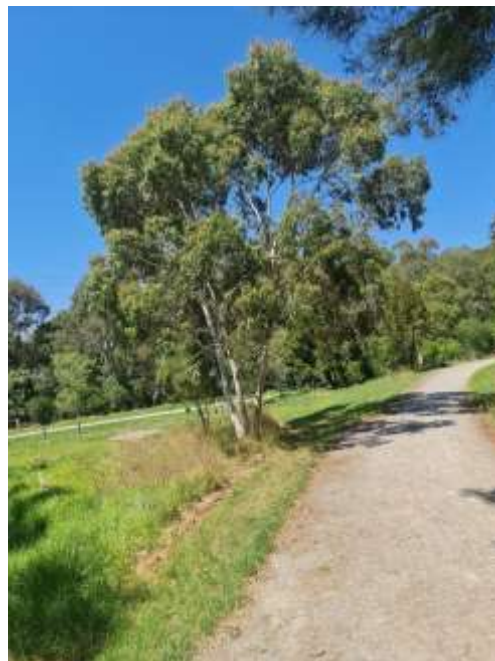
**Tree ID: 16****Genus / species:** *Casuarina cunninghamiana*

Evergreen River She - Oak

**Height (m):** 10      **Structure:** Good  
**Width (m):** 6      **Health:** Good  
**DBH (cm):** 39 Measured **Maturity:** Mature  
**Origin:** Australian **ULE (years):** 15 - 30  
**Retained?:** Retained **Form:** Good

**Retention Value:** Moderate**Removal / retention reason:** N/A.**Amenity value:** Moderate**Works Required:** Canopy lift.**SRZ (m):** 2.3      **Works priority:** Very low**TPZ (m):** 4.7      **Construction Proximity:** 0.1**mTPZ (m):**

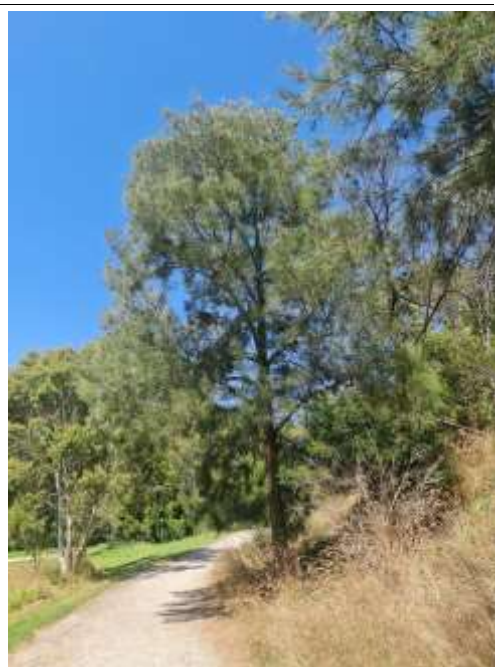
**Tree ID: 17****Genus / species:** *Casuarina cunninghamiana*

Evergreen River She - Oak

**Height (m):** 10      **Structure:** Good  
**Width (m):** 6      **Health:** Good  
**DBH (cm):** 33 Measured **Maturity:** Mature  
**Origin:** Australian **ULE (years):** 30 - 60  
**Retained?:** Retained **Form:** Good

**Retention Value:** Moderate**Removal / retention reason:** N/A.**Amenity value:** Moderate**Works Required:** N/A.**SRZ (m):** 2.2      **Works priority:** N/A**TPZ (m):** 4.0      **Construction Proximity:** 0.1**mTPZ (m):**

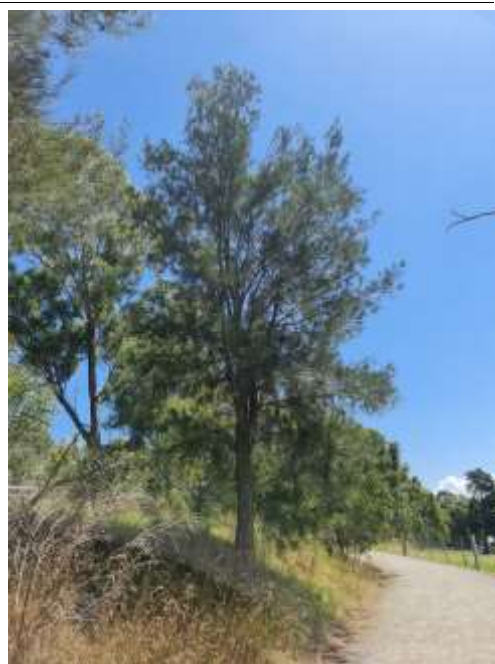
**Tree ID: 18****Genus / species:** *Acacia melanoxylon*

Evergreen Blackwood

**Height (m):** 7      **Structure:** Fair  
**Width (m):** 5      **Health:** Fair  
**DBH (cm):** 39 Measured **Maturity:** Over mature  
**Origin:** Melbourne **ULE (years):** 5 - 15  
**Retained?:** Retained **Form:** Fair  
**Retention Value:** Low  
**Removal / retention reason:** N/A.  
**Amenity value:** Low  
**Works Required:** N/A.

**SRZ (m):** 2.3      **Works priority:** N/A  
**TPZ (m):** 4.7      **Construction Proximity:** 0.1  
**mTPZ (m):**

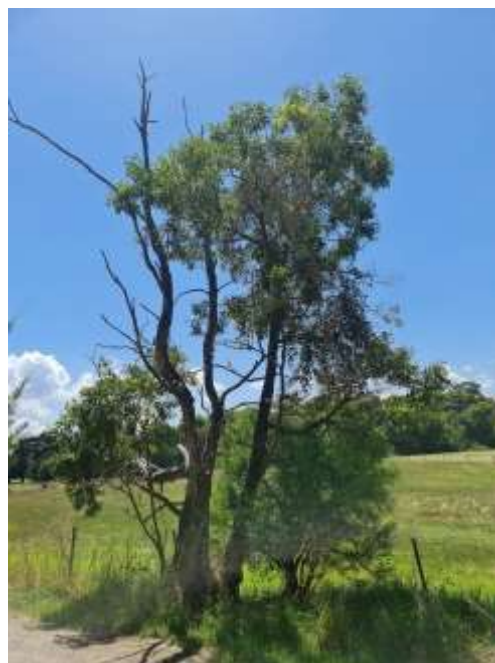
**Tree ID: 19****Genus / species:** *Acacia melanoxylon*

Evergreen Blackwood

**Height (m):** 6      **Structure:** Good  
**Width (m):** 5      **Health:** Good  
**DBH (cm):** 15 Estimated **Maturity:** Young  
**Origin:** Melbourne **ULE (years):** 30 - 60  
**Retained?:** Removed **Form:** Good  
**Retention Value:** Remove.  
**Removal / retention reason:** N/A.  
**Amenity value:** Low  
**Works Required:** N/A.

**SRZ (m):** 1.6      **Works priority:** N/A  
**TPZ (m):** 2.0      **Construction Proximity:** 0.1  
**mTPZ (m):**

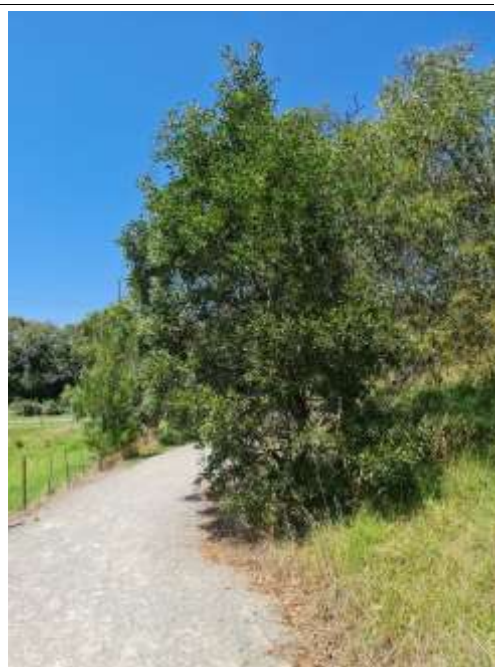
**Tree ID: 20****Genus / species:** *Eucalyptus camaldulensis*

Evergreen River Red Gum

**Height (m):** 6      **Structure:** Good  
**Width (m):** 3      **Health:** Good  
**DBH (cm):** 15 Estimated **Maturity:** Young  
**Origin:** Melbourne **ULE (years):** 30 - 60  
**Retained?:** Retained **Form:** Good  
**Retention Value:** Low  
**Removal / retention reason:** N/A.  
**Amenity value:** Low  
**Works Required:** Canopy lift.

**SRZ (m):** 1.6      **Works priority:** Very low  
**TPZ (m):** 2.0      **Construction Proximity:** 0.1  
**mTPZ (m):**

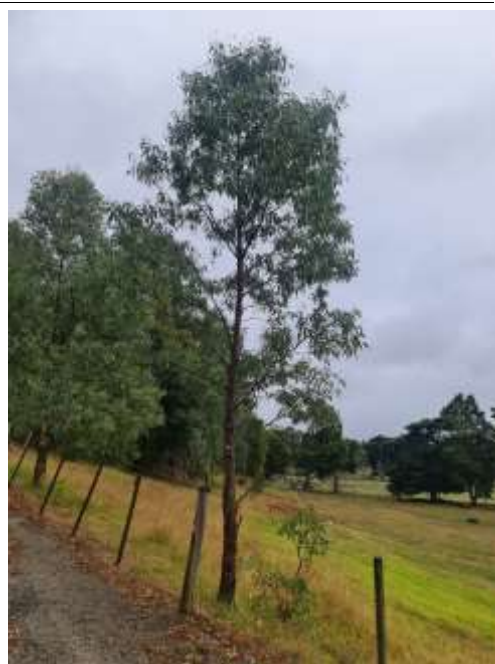
**Tree ID: 21****Genus / species:** *Eucalyptus camaldulensis*

Evergreen River Red Gum

**Height (m):** 6 **Structure:** Good**Width (m):** 3 **Health:** Good**DBH (cm):** 15 Measured **Maturity:** Young**Origin:** Melbourne **ULE (years):** 30 - 60**Retained?:** Retained **Form:** Good**Retention Value:** Low**Removal / retention reason:** N/A.**Amenity value:** Low**Works Required:** Canopy lift.**SRZ (m):** 1.6 **Works priority:** Very low**TPZ (m):** 2.0 **Construction Proximity:** 0.1**mTPZ (m):**

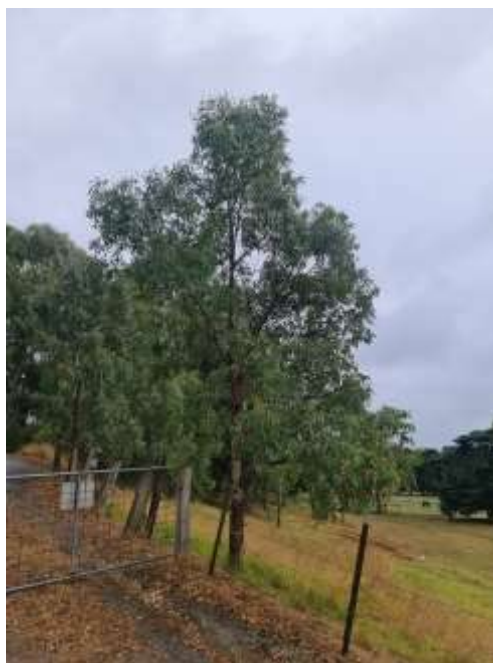
**Tree ID: 22****Genus / species:** *Eucalyptus camaldulensis*

Evergreen River Red Gum

**Height (m):** 6 **Structure:** Good**Width (m):** 3 **Health:** Good**DBH (cm):** 15 Estimated **Maturity:** Young**Origin:** Melbourne **ULE (years):** 30 - 60**Retained?:** Retained **Form:** Good**Retention Value:** Low**Removal / retention reason:** N/A.**Amenity value:** Low**Works Required:** N/A.**SRZ (m):** 1.6 **Works priority:** N/A**TPZ (m):** 2.0 **Construction Proximity:** 0.1**mTPZ (m):**

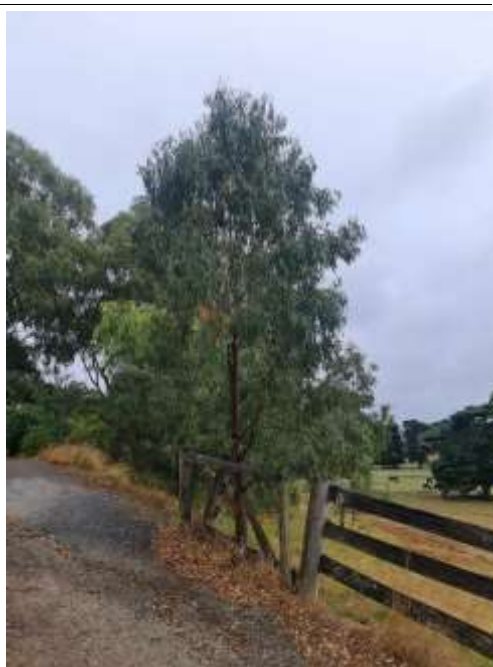
**Tree ID: 69****Genus / species:** *Acacia mearnsii*

Evergreen Black Wattle

**Height (m):** 12 **Structure:** Good**Width (m):** 8 **Health:** Good**DBH (cm):** 24 Measured **Maturity:** Mature**Origin:** Melbourne **ULE (years):** 5 - 15**Retained?:** Retained **Form:** Fair**Retention Value:** Low**Removal / retention reason:** N/A.**Amenity value:** Moderate**Works Required:** Canopy lift.**SRZ (m):** 1.9 **Works priority:** Very low**TPZ (m):** 2.9 **Construction Proximity:** 0.1**mTPZ (m):**

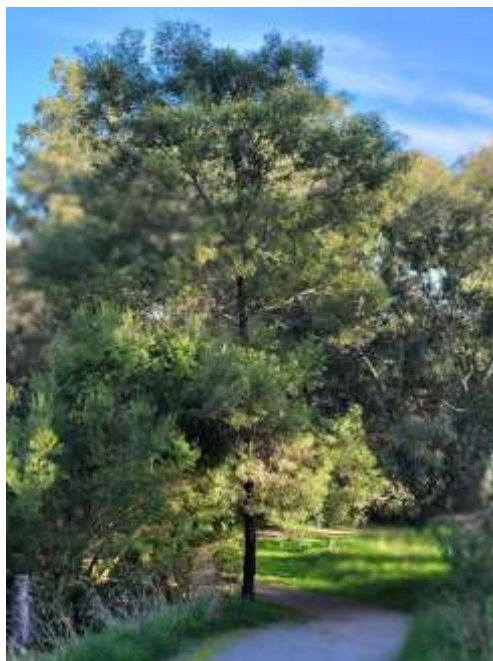
**Tree ID: 70****Genus / species:** *Eucalyptus camaldulensis*

Evergreen River Red Gum

**Height (m):** 14      **Structure:** Good  
**Width (m):** 12      **Health:** Good  
**DBH (cm):** 50      Estimated **Maturity:** Mature  
**Origin:** Melbourne      **ULE (years):** > 60  
**Retained?:** Retained      **Form:** Fair

**Retention Value:** High**Removal / retention reason:** N/A.**Amenity value:** Moderate**Works Required:** Canopy lift.**SRZ (m):** 2.6      **Works priority:** Very low**TPZ (m):** 6.0      **Construction Proximity:** 0.1**mTPZ (m):**

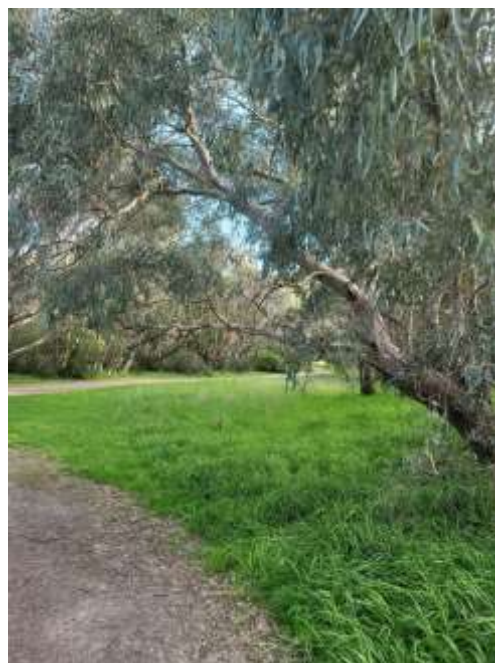
**Tree ID: 71****Genus / species:** *Eucalyptus camaldulensis*

Evergreen River Red Gum

**Height (m):** 23      **Structure:** Fair  
**Width (m):** 18      **Health:** Good  
**DBH (cm):** 80      Measured **Maturity:** Mature  
**Origin:** Melbourne      **ULE (years):** 30 - 60  
**Retained?:** Retained      **Form:** Good

**Retention Value:** High**Removal / retention reason:** N/A.**Amenity value:** High**Works Required:** Canopy lift.**SRZ (m):** 3.2      **Works priority:** Very low**TPZ (m):** 9.6      **Construction Proximity:** 0.1**mTPZ (m):**

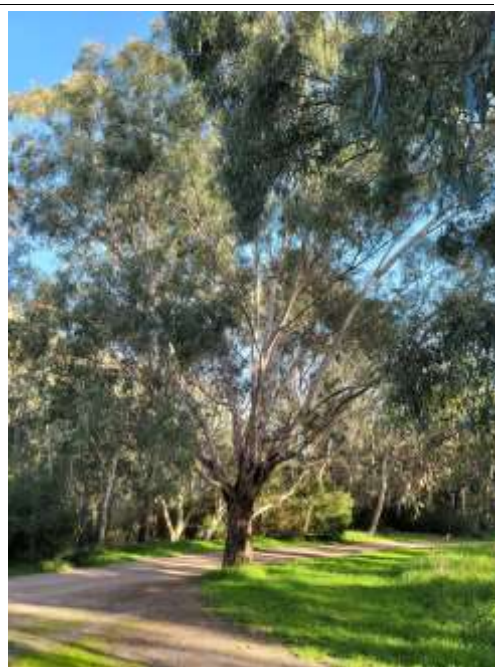
**Tree ID: 72****Genus / species:** *Eucalyptus camaldulensis*

Evergreen River Red Gum

**Height (m):** 14      **Structure:** Good  
**Width (m):** 9      **Health:** Good  
**DBH (cm):** 35      Estimated **Maturity:** Mature  
**Origin:** Melbourne      **ULE (years):** > 60  
**Retained?:** Retained      **Form:** Fair

**Retention Value:** High**Removal / retention reason:** N/A.**Amenity value:** Moderate**Works Required:** Canopy lift.**SRZ (m):** 2.2      **Works priority:** Very low**TPZ (m):** 4.2      **Construction Proximity:** 0.1**mTPZ (m):**

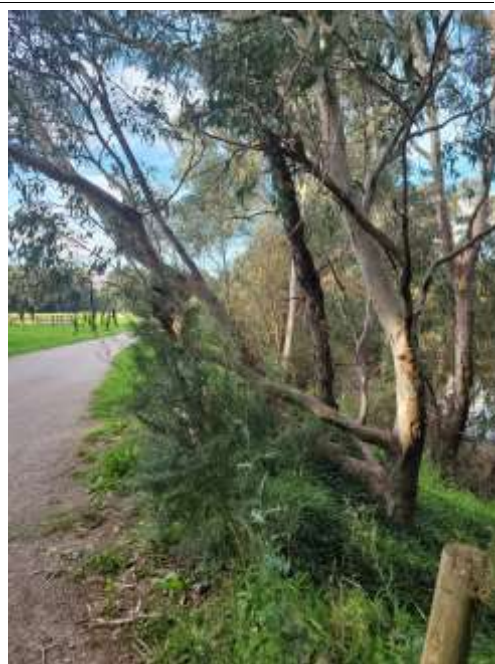
**Tree ID: 73****Genus / species:** *Eucalyptus camaldulensis*

Evergreen River Red Gum

**Height (m):** 13      **Structure:** Good  
**Width (m):** 7      **Health:** Fair  
**DBH (cm):** 22 Measured **Maturity:** Immature  
**Origin:** Melbourne **ULE (years):** 15 - 30  
**Retained?:** Retained **Form:** Poor  
**Retention Value:** Moderate  
**Removal / retention reason:** N/A.  
**Amenity value:** Moderate  
**Works Required:** Canopy lift.

**SRZ (m):** 1.9      **Works priority:** Very low  
**TPZ (m):** 2.6      **Construction Proximity:** 0.1  
**mTPZ (m):**

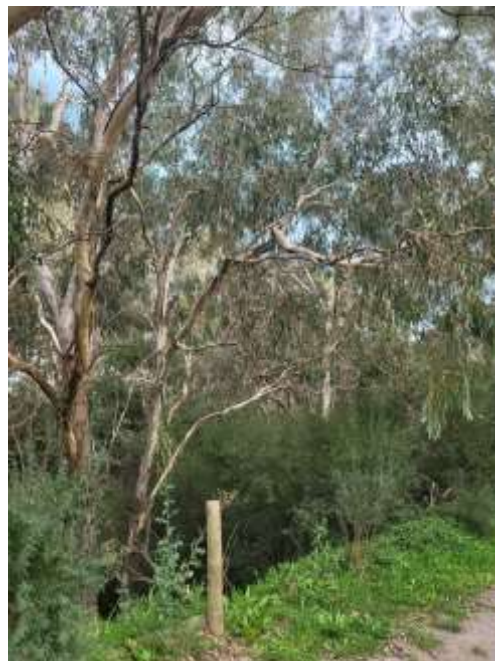
**Tree ID: 74****Genus / species:** *Allocasuarina torulosa*

Evergreen Forest Oak

**Height (m):** 7      **Structure:** Fair  
**Width (m):** 5      **Health:** Good  
**DBH (cm):** 20 Estimated **Maturity:** Mature  
**Origin:** Australian **ULE (years):** 30 - 60  
**Retained?:** Retained **Form:** Good  
**Retention Value:** Low  
**Removal / retention reason:** N/A.  
**Amenity value:** Low  
**Works Required:** N/A.

**SRZ (m):** 1.8      **Works priority:** N/A  
**TPZ (m):** 2.4      **Construction Proximity:** 0.1  
**mTPZ (m):**

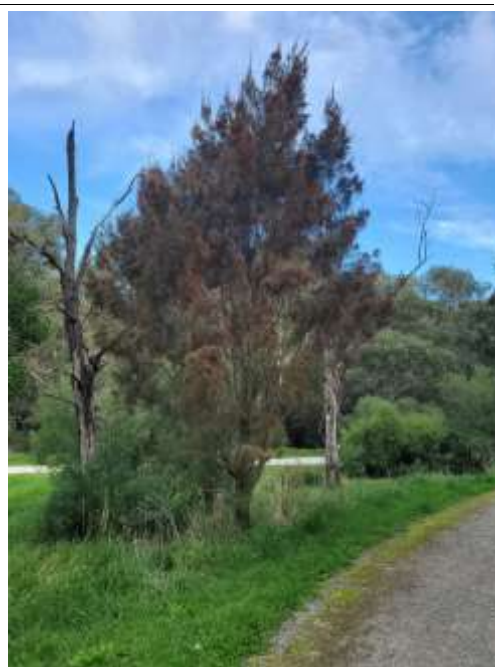
**Tree ID: 75****Genus / species:** *Acacia melanoxylon*

Evergreen Blackwood

**Height (m):** 7      **Structure:** Poor  
**Width (m):** 5      **Health:** Poor  
**DBH (cm):** 30 Estimated **Maturity:** Over mature  
**Origin:** Melbourne **ULE (years):** 1 - 5  
**Retained?:** Removed **Form:** Poor  
**Retention Value:** Remove.  
**Removal / retention reason:** N/A.  
**Amenity value:** Very low  
**Works Required:** N/A.

**SRZ (m):** 2.1      **Works priority:** N/A  
**TPZ (m):** 3.6      **Construction Proximity:** 0.1  
**mTPZ (m):**

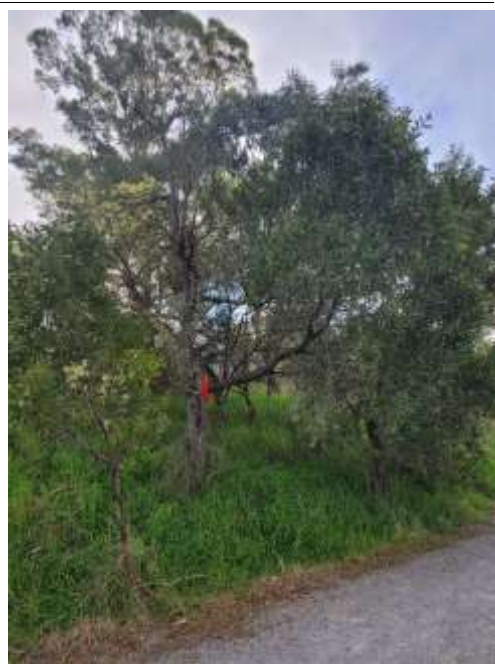
**Tree ID: 79****Genus / species:** *Eucalyptus camaldulensis*

Evergreen River Red Gum

**Retention Value:** Very high**Removal / retention reason:** N/A.**Amenity value:** High**Works Required:** N/A.

**SRZ (m):** 2.7      **Works priority:** N/A  
**TPZ (m):** 6.8      **Construction Proximity:** 0.1  
**mTPZ (m):**

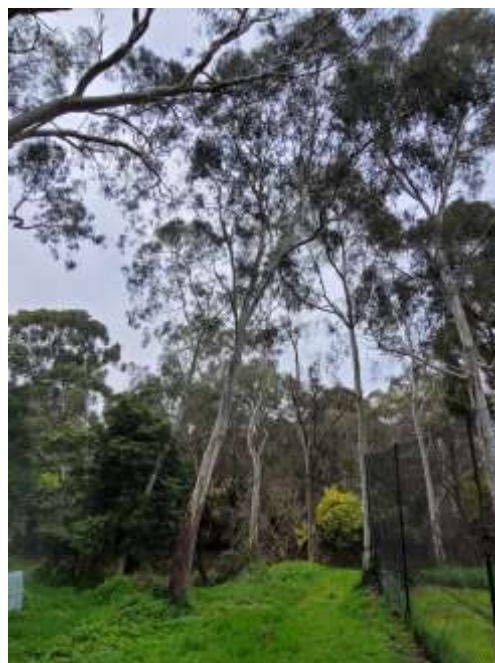
**Tree ID: 80****Genus / species:** *Eucalyptus camaldulensis*

Evergreen River Red Gum

**Retention Value:** Very high**Removal / retention reason:** N/A.**Amenity value:** High**Works Required:** N/A.

**SRZ (m):** 2.1      **Works priority:** N/A  
**TPZ (m):** 3.6      **Construction Proximity:** 0.1  
**mTPZ (m):**

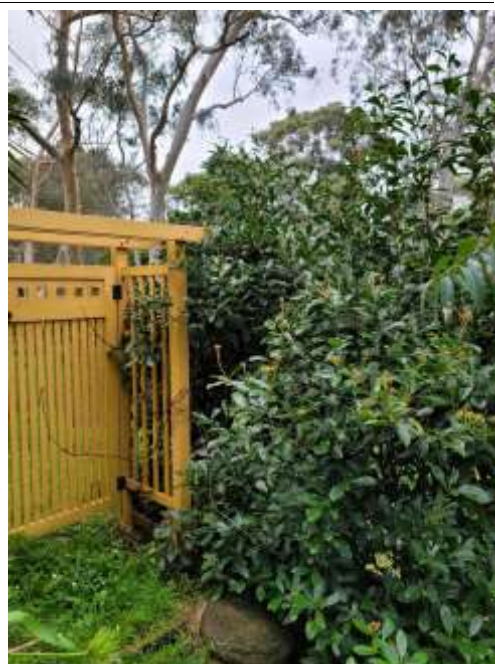
**Tree ID: 82****Genus / species:** *Photinia serrulata*

Evergreen Chinese Hawthorn

**Height (m):** 3      **Structure:** Good  
**Width (m):** 1      **Health:** Good  
**DBH (cm):** 5 Measured **Maturity:** Immature  
**Origin:** Exotic      **ULE (years):** > 60  
**Retained?:** Retained      **Form:** Fair  
**Retention Value:** Low  
**Removal / retention reason:** N/A  
**Amenity value:** Very low  
**Works Required:** N/A.

**SRZ (m):** 1.6      **Works priority:** N/A  
**TPZ (m):** 2.0      **Construction Proximity:** 0.1  
**mTPZ (m):**

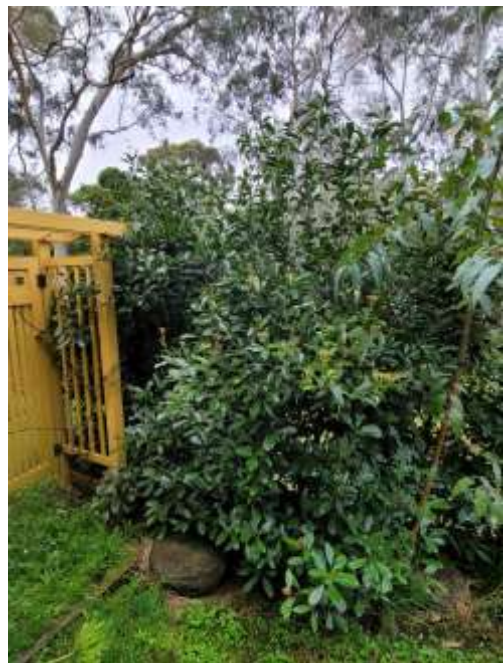
**Tree ID: 83****Genus / species:** *Photinia serrulata*

Evergreen Chinese Hawthorn

**Height (m):** 3      **Structure:** Good  
**Width (m):** 1      **Health:** Good  
**DBH (cm):** 5 Measured **Maturity:** Immature  
**Origin:** Exotic      **ULE (years):** > 60  
**Retained?:** Retained      **Form:** Fair  
**Retention Value:** Low  
**Removal / retention reason:** N/A  
**Amenity value:** Very low  
**Works Required:** N/A.

**SRZ (m):** 1.6      **Works priority:** N/A  
**TPZ (m):** 2.0      **Construction Proximity:** 0.1  
**mTPZ (m):**

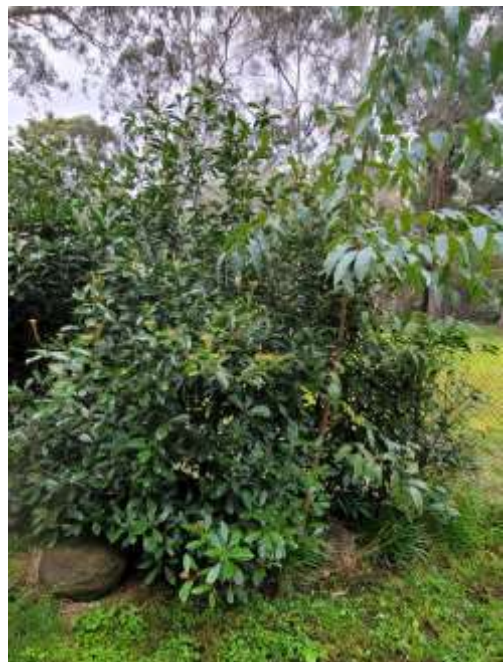
**Tree ID: 84****Genus / species:** *Eucalyptus botryoides*

Evergreen Southern Mahogany

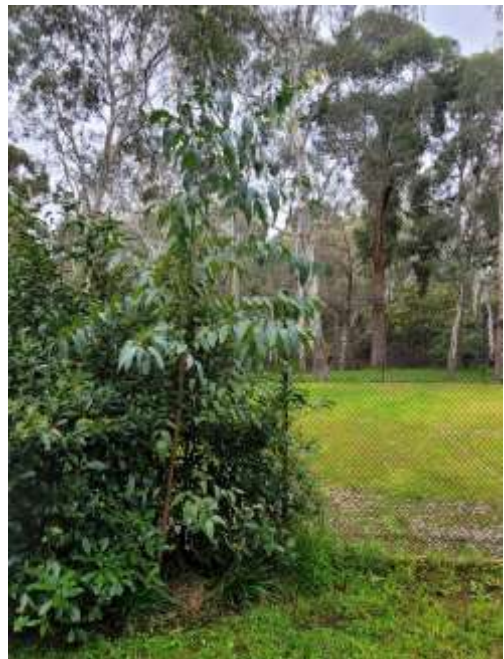
**Height (m):** 4      **Structure:** Good  
**Width (m):** 2      **Health:** Good  
**DBH (cm):** 5 Estimated **Maturity:** Young  
**Origin:** Victorian      **ULE (years):** > 60  
**Retained?:** Retained      **Form:** Good  
**Retention Value:** Low  
**Removal / retention reason:** N/A  
**Amenity value:** Very low  
**Works Required:** N/A.

**SRZ (m):** 1.6      **Works priority:** N/A  
**TPZ (m):** 2.0      **Construction Proximity:** 0.1  
**mTPZ (m):**

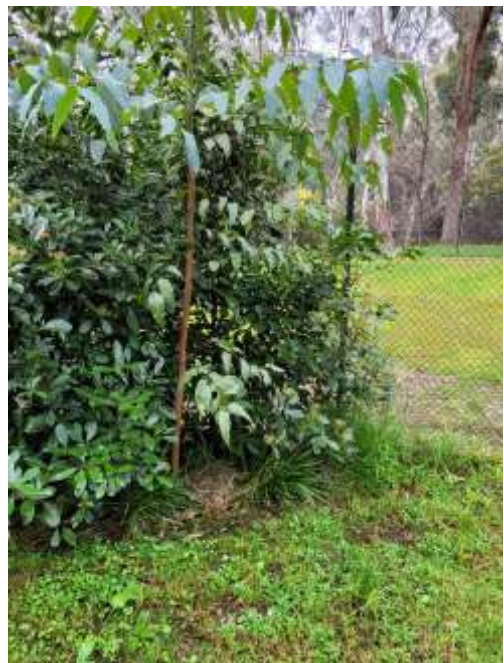
**Tree ID: 85****Genus / species:** *Photinia serrulata*

Evergreen Chinese Hawthorn

**Height (m):** 3      **Structure:** Good  
**Width (m):** 1      **Health:** Good  
**DBH (cm):** 5      Estimated **Maturity:** Immature  
**Origin:** Exotic      **ULE (years):** > 60  
**Retained?:** Retained      **Form:** Fair  
**Retention Value:** Low  
**Removal / retention reason:** N/A  
**Amenity value:** Very low  
**Works Required:** N/A.

**SRZ (m):** 1.6      **Works priority:** N/A  
**TPZ (m):** 2.0      **Construction Proximity:** 0.1  
**mTPZ (m):**

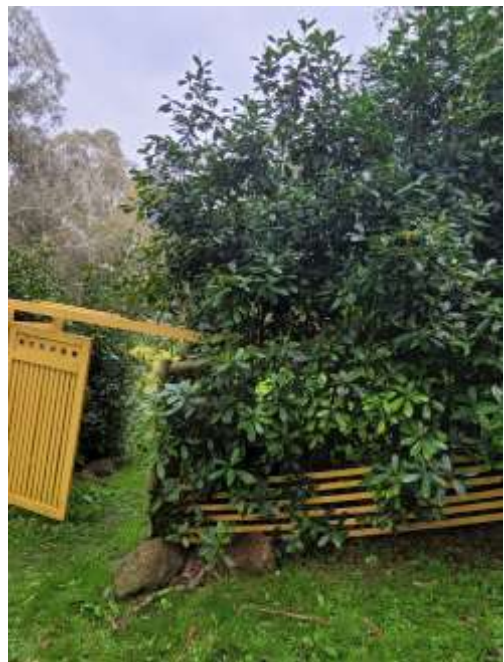
**Tree ID: 86****Genus / species:** *Photinia serrulata*

Evergreen Chinese Hawthorn

**Height (m):** 4      **Structure:** Good  
**Width (m):** 2      **Health:** Good  
**DBH (cm):** 7      Estimated **Maturity:** Immature  
**Origin:** Exotic      **ULE (years):** > 60  
**Retained?:** Retained      **Form:** Fair  
**Retention Value:** Low  
**Removal / retention reason:** N/A  
**Amenity value:** Very low  
**Works Required:** N/A.

**SRZ (m):** 1.6      **Works priority:** N/A  
**TPZ (m):** 2.0      **Construction Proximity:** 0.1  
**mTPZ (m):**

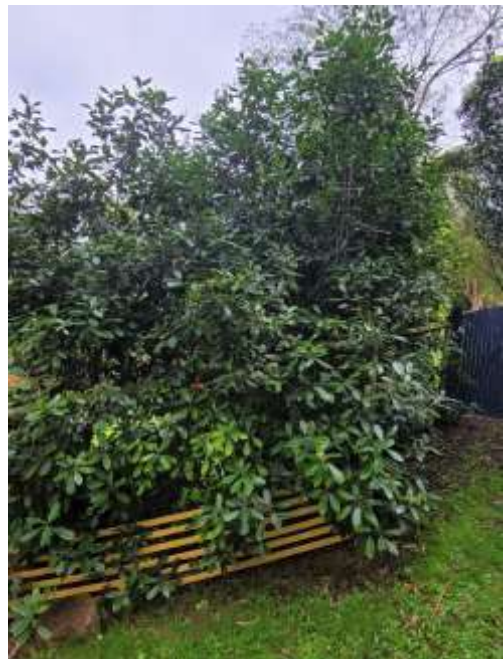
**Tree ID: 87****Genus / species:** *Photinia serrulata*

Evergreen Chinese Hawthorn

**Height (m):** 4      **Structure:** Good  
**Width (m):** 2      **Health:** Good  
**DBH (cm):** 7      Estimated **Maturity:** Immature  
**Origin:** Exotic      **ULE (years):** > 60  
**Retained?:** Retained      **Form:** Fair  
**Retention Value:** Low  
**Removal / retention reason:** N/A  
**Amenity value:** Very low  
**Works Required:** N/A.

**SRZ (m):** 1.6      **Works priority:** N/A  
**TPZ (m):** 2.0      **Construction Proximity:** 0.1  
**mTPZ (m):**

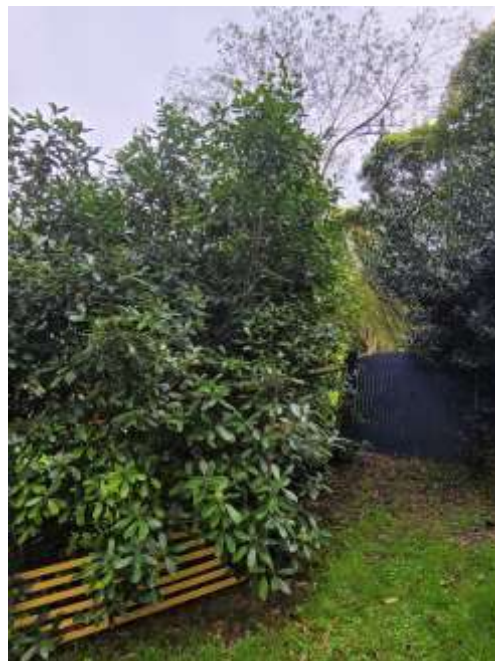
**Tree ID: 88****Genus / species:** *Photinia serrulata*

Evergreen Chinese Hawthorn

**Height (m):** 5      **Structure:** Good  
**Width (m):** 2      **Health:** Good  
**DBH (cm):** 7 Measured **Maturity:** Immature  
**Origin:** Exotic      **ULE (years):** > 60  
**Retained?:** Retained      **Form:** Fair  
**Retention Value:** Moderate  
**Removal / retention reason:** N/A  
**Amenity value:** Low  
**Works Required:** N/A.

**SRZ (m):** 1.6      **Works priority:** N/A  
**TPZ (m):** 2.0      **Construction Proximity:** 0.1  
**mTPZ (m):**

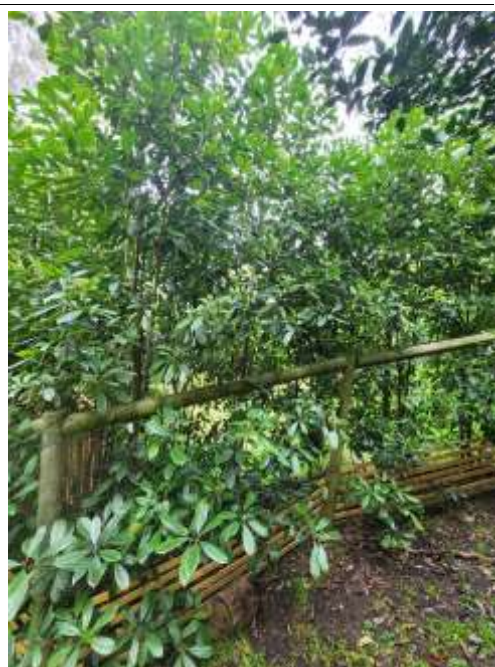
**Tree ID: 89****Genus / species:** *Photinia serrulata*

Evergreen Chinese Hawthorn

**Height (m):** 5      **Structure:** Good  
**Width (m):** 2      **Health:** Good  
**DBH (cm):** 5 Estimated **Maturity:** Immature  
**Origin:** Exotic      **ULE (years):** > 60  
**Retained?:** Retained      **Form:** Fair  
**Retention Value:** Moderate  
**Removal / retention reason:** N/A  
**Amenity value:** Low  
**Works Required:** N/A.

**SRZ (m):** 1.6      **Works priority:** N/A  
**TPZ (m):** 2.0      **Construction Proximity:** 0.1  
**mTPZ (m):**
