## **Nation Partners**

# **Northern Sewers Relining Project Southern Section**

## **Construction Impact Report**

**Wednesday 4<sup>th</sup> December 2024**

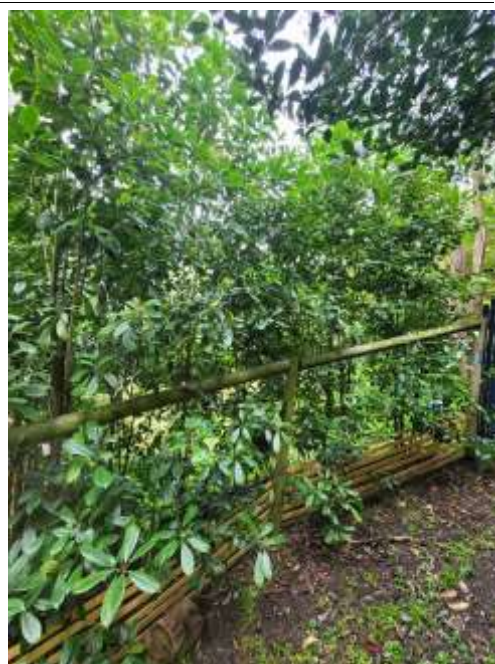
**Tree ID: 90****Genus / species:** *Photinia serrulata*

Evergreen Chinese Hawthorn

**Height (m):** 4      **Structure:** Good  
**Width (m):** 1      **Health:** Good  
**DBH (cm):** 5 Estimated **Maturity:** Immature  
**Origin:** Exotic      **ULE (years):** > 60  
**Retained?:** Retained      **Form:** Fair  
**Retention Value:** Low  
**Removal / retention reason:** N/A  
**Amenity value:** Very low  
**Works Required:** N/A.

**SRZ (m):** 1.6      **Works priority:** N/A  
**TPZ (m):** 2.0      **Construction Proximity:** 0.1  
**mTPZ (m):**

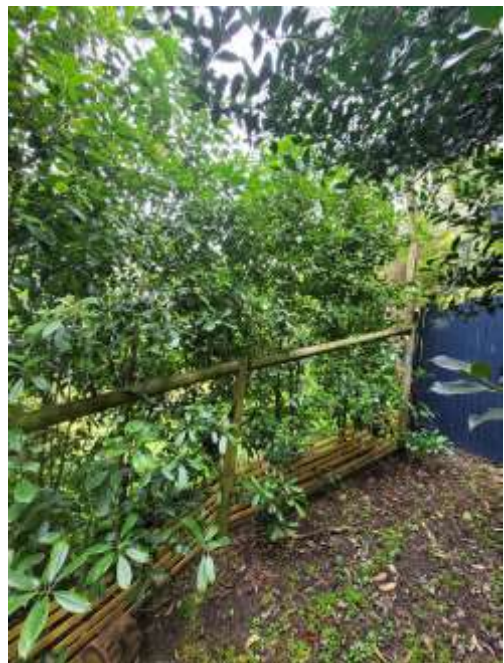
**Tree ID: 91****Genus / species:** *Photinia serrulata*

Evergreen Chinese Hawthorn

**Height (m):** 4      **Structure:** Good  
**Width (m):** 2      **Health:** Good  
**DBH (cm):** 5      Estimated **Maturity:** Immature  
**Origin:** Exotic      **ULE (years):** > 60  
**Retained?:** Retained      **Form:** Fair  
**Retention Value:** Low  
**Removal / retention reason:** N/A  
**Amenity value:** Very low  
**Works Required:** N/A.

**SRZ (m):** 1.6      **Works priority:** N/A  
**TPZ (m):** 2.0      **Construction Proximity:** 0.1  
**mTPZ (m):**

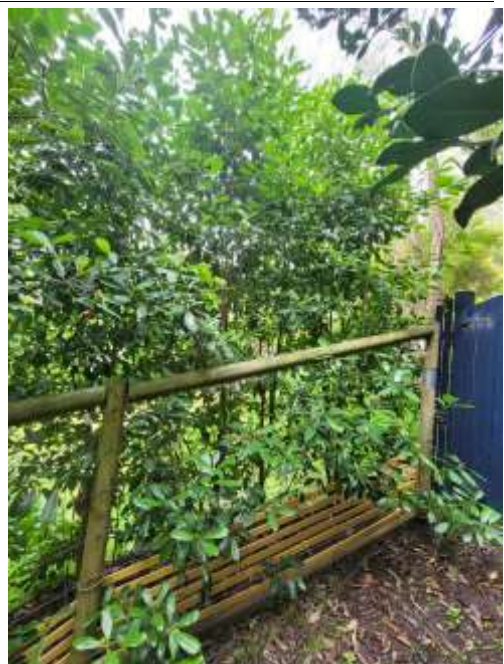
**Tree ID: 92****Genus / species:** *Photinia serrulata*

Evergreen Chinese Hawthorn

**Height (m):** 4      **Structure:** Good  
**Width (m):** 2      **Health:** Good  
**DBH (cm):** 5      Estimated **Maturity:** Immature  
**Origin:** Exotic      **ULE (years):** > 60  
**Retained?:** Retained      **Form:** Fair  
**Retention Value:** Low  
**Removal / retention reason:** N/A  
**Amenity value:** Very low  
**Works Required:** N/A.

**SRZ (m):** 1.6      **Works priority:** N/A  
**TPZ (m):** 2.0      **Construction Proximity:** 0.1  
**mTPZ (m):**

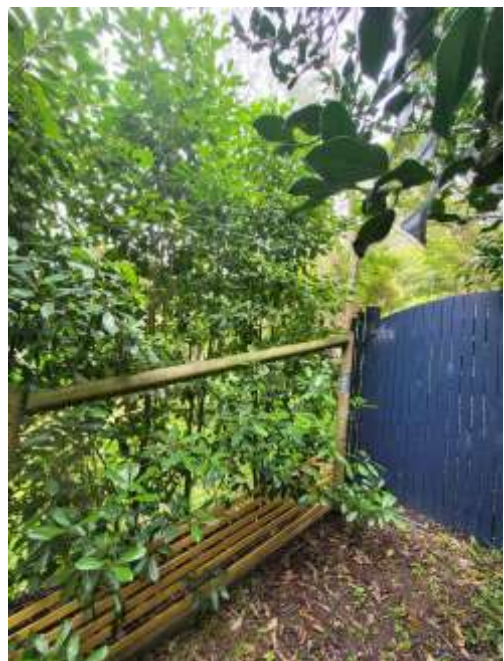
**Tree ID: 93****Genus / species:** *Photinia serrulata*

Evergreen Chinese Hawthorn

**Height (m):** 4      **Structure:** Good  
**Width (m):** 2      **Health:** Good  
**DBH (cm):** 5      Estimated **Maturity:** Immature  
**Origin:** Exotic      **ULE (years):** > 60  
**Retained?:** Retained      **Form:** Fair  
**Retention Value:** Low  
**Removal / retention reason:** N/A  
**Amenity value:** Very low  
**Works Required:** N/A.

**SRZ (m):** 1.6      **Works priority:** N/A  
**TPZ (m):** 2.0      **Construction Proximity:** 0.1  
**mTPZ (m):**

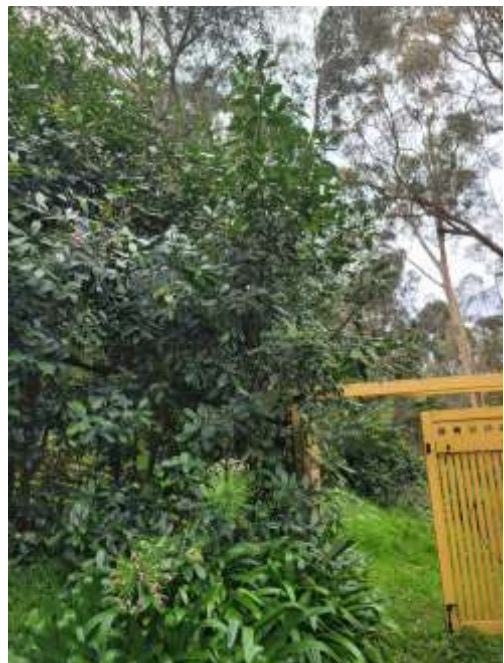
**Tree ID: 94****Genus / species:** *Photinia serrulata*

Evergreen Chinese Hawthorn

<b>Height (m):</b>	4	<b>Structure:</b>	Good
<b>Width (m):</b>	2	<b>Health:</b>	Good
<b>DBH (cm):</b>	5	<b>Maturity:</b>	Immature
<b>Origin:</b>	Exotic	<b>ULE (years):</b>	> 60
<b>Retained?:</b>	Retained	<b>Form:</b>	Fair
<b>Retention Value:</b>	Low		
<b>Removal / retention reason:</b>	N/A		
<b>Amenity value:</b>	Very low		
<b>Works Required:</b>	N/A.

<b>SRZ (m):</b>	1.6	<b>Works priority:</b>	N/A
<b>TPZ (m):</b>	2.0	<b>Construction Proximity:</b>	0.1
<b>mTPZ (m):</b>

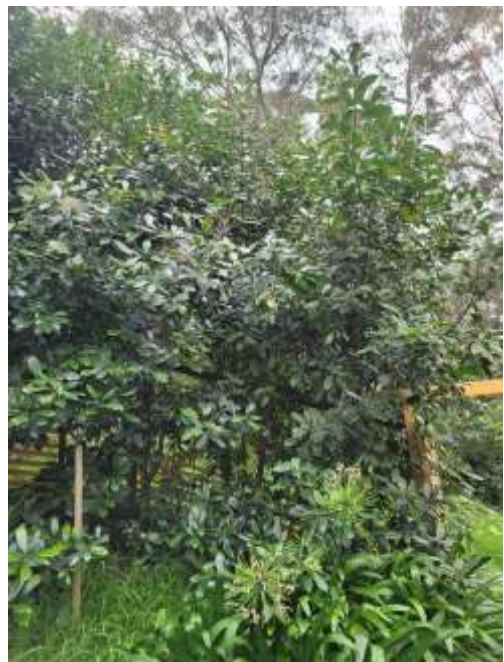
**Tree ID: 95****Genus / species:** *Photinia serrulata*

Evergreen Chinese Hawthorn

<b>Height (m):</b>	4	<b>Structure:</b>	Good
<b>Width (m):</b>	2	<b>Health:</b>	Good
<b>DBH (cm):</b>	5	<b>Maturity:</b>	Immature
<b>Origin:</b>	Exotic	<b>ULE (years):</b>	> 60
<b>Retained?:</b>	Retained	<b>Form:</b>	Fair
<b>Retention Value:</b>	Low		
<b>Removal / retention reason:</b>	N/A		
<b>Amenity value:</b>	Very low		
<b>Works Required:</b>	N/A.

<b>SRZ (m):</b>	1.6	<b>Works priority:</b>	N/A
<b>TPZ (m):</b>	2.0	<b>Construction Proximity:</b>	0.1
<b>mTPZ (m):</b>

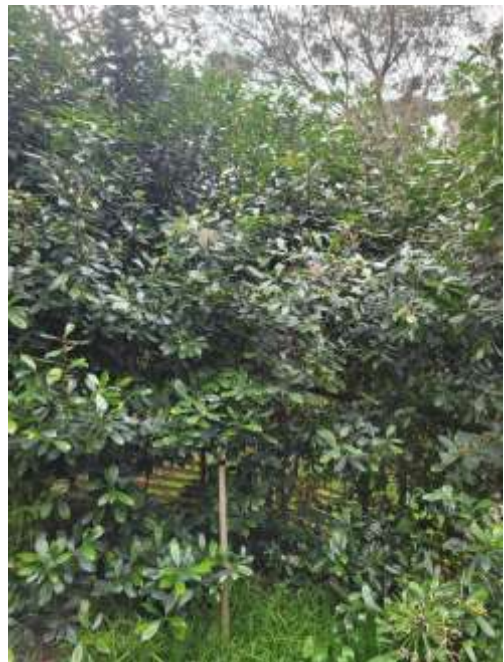
**Tree ID: 96****Genus / species:** *Photinia serrulata*

Evergreen Chinese Hawthorn

<b>Height (m):</b>	4	<b>Structure:</b>	Good
<b>Width (m):</b>	2	<b>Health:</b>	Good
<b>DBH (cm):</b>	5	<b>Maturity:</b>	Immature
<b>Origin:</b>	Exotic	<b>ULE (years):</b>	> 60
<b>Retained?:</b>	Retained	<b>Form:</b>	Fair
<b>Retention Value:</b>	Low		
<b>Removal / retention reason:</b>	N/A		
<b>Amenity value:</b>	Very low		
<b>Works Required:</b>	N/A.

<b>SRZ (m):</b>	1.6	<b>Works priority:</b>	N/A
<b>TPZ (m):</b>	2.0	<b>Construction Proximity:</b>	0.1
<b>mTPZ (m):</b>

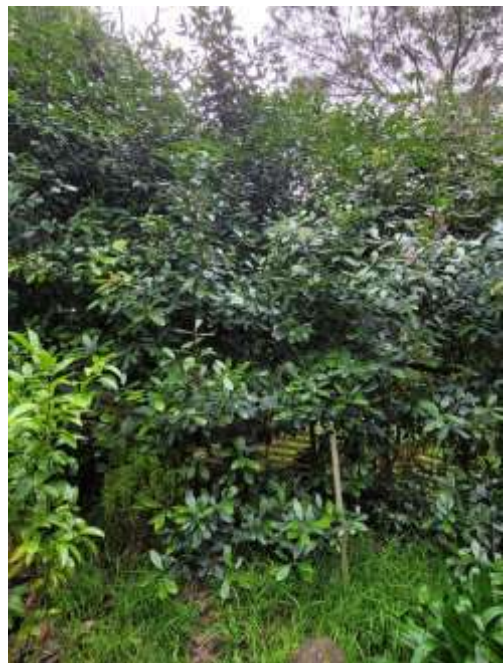
**Tree ID: 97****Genus / species:** *Photinia serrulata*

Evergreen Chinese Hawthorn

**Height (m):** 4      **Structure:** Good  
**Width (m):** 2      **Health:** Good  
**DBH (cm):** 5      Estimated **Maturity:** Immature  
**Origin:** Exotic      **ULE (years):** > 60  
**Retained?:** Retained      **Form:** Fair  
**Retention Value:** Low  
**Removal / retention reason:** N/A  
**Amenity value:** Very low  
**Works Required:** N/A.

**SRZ (m):** 1.6      **Works priority:** N/A  
**TPZ (m):** 2.0      **Construction Proximity:** 0.1  
**mTPZ (m):**

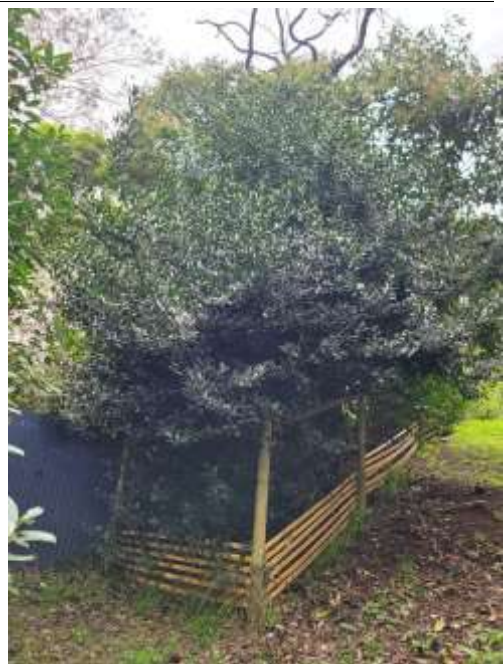
**Tree ID: 98****Genus / species:** *Ilex aquifolium*

Evergreen English Holly

**Height (m):** 6      **Structure:** Good  
**Width (m):** 7      **Health:** Good  
**DBH (cm):** 20      Estimated **Maturity:** Mature  
**Origin:** Exotic      **ULE (years):** 30 - 60  
**Retained?:** Retained      **Form:** Good  
**Retention Value:** Low  
**Removal / retention reason:** N/A  
**Amenity value:** Low  
**Works Required:** Canopy lift

**SRZ (m):** 1.8      **Works priority:** Very low  
**TPZ (m):** 2.4      **Construction Proximity:** 0.1  
**mTPZ (m):**

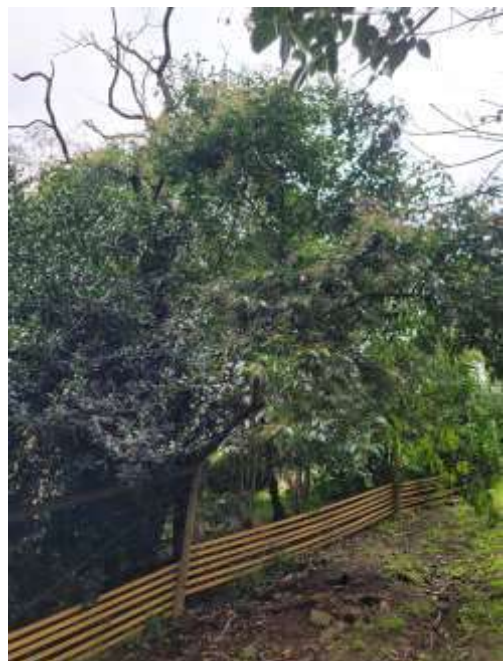
**Tree ID: 99****Genus / species:** *Ligustrum lucidum*

Evergreen Privet

**Height (m):** 8      **Structure:** Good  
**Width (m):** 9      **Health:** Good  
**DBH (cm):** 33      Estimated **Maturity:** Mature  
**Origin:** Exotic      **ULE (years):** 15 - 30  
**Retained?:** Retained      **Form:** Good  
**Retention Value:** Low  
**Removal / retention reason:** N/A  
**Amenity value:** Low  
**Works Required:** Canopy lift

**SRZ (m):** 2.2      **Works priority:** Very low  
**TPZ (m):** 4.0      **Construction Proximity:** 0.1  
**mTPZ (m):**

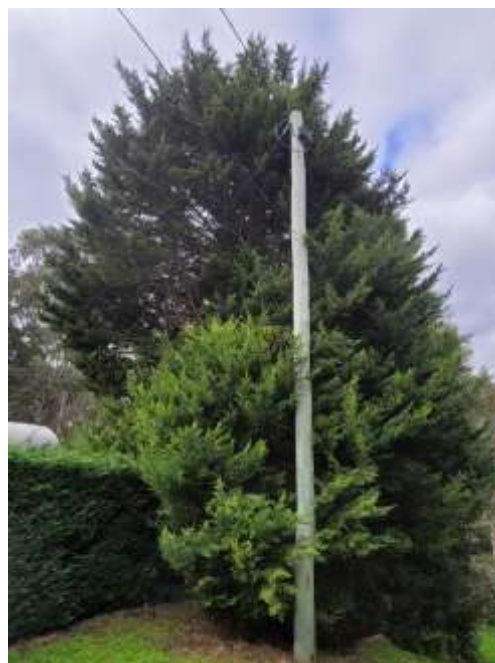
**Tree ID: 100****Genus / species:** *x cupressocyparis leylandii*

Evergreen Leyland Cypress

**Height (m):** 16      **Structure:** Fair  
**Width (m):** 10      **Health:** Good  
**DBH (cm):** 45      Estimated **Maturity:** Mature  
**Origin:** Exotic      **ULE (years):** 30 - 60  
**Retained?:** Retained      **Form:** Fair

**Retention Value:** High**Removal / retention reason:** N/A**Amenity value:** High**Works Required:** Canopy lift**SRZ (m):** 2.5      **Works priority:** Very low**TPZ (m):** 5.4      **Construction Proximity:** 0.1**mTPZ (m):**

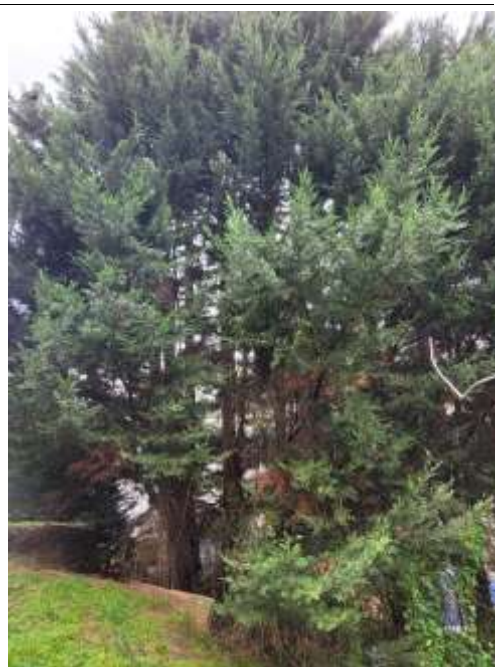
**Tree ID: 101****Genus / species:** *x cupressocyparis leylandii*

Evergreen Leyland Cypress

**Height (m):** 16      **Structure:** Fair  
**Width (m):** 6      **Health:** Good  
**DBH (cm):** 35      Estimated **Maturity:** Mature  
**Origin:** Exotic      **ULE (years):** 30 - 60  
**Retained?:** Retained      **Form:** Poor

**Retention Value:** High**Removal / retention reason:** N/A**Amenity value:** High**Works Required:** Canopy lift**SRZ (m):** 2.2      **Works priority:** Very low**TPZ (m):** 4.2      **Construction Proximity:** 0.1**mTPZ (m):**

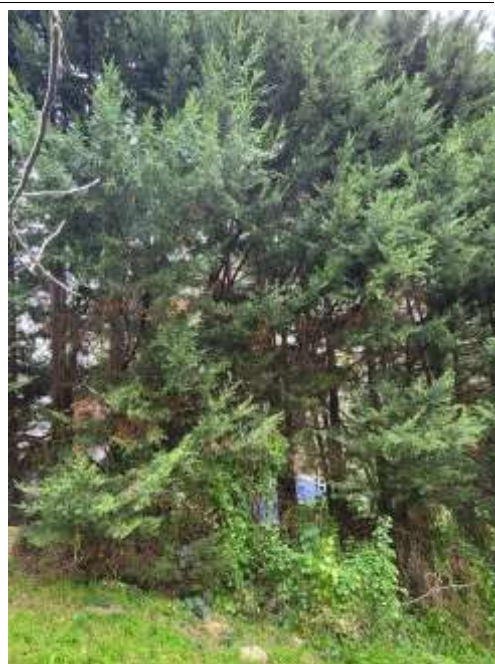
**Tree ID: 102****Genus / species:** *x cupressocyparis leylandii*

Evergreen Leyland Cypress

**Height (m):** 18      **Structure:** Fair  
**Width (m):** 6      **Health:** Good  
**DBH (cm):** 30      Estimated **Maturity:** Mature  
**Origin:** Exotic      **ULE (years):** 30 - 60  
**Retained?:** Retained      **Form:** Poor

**Retention Value:** High**Removal / retention reason:** N/A**Amenity value:** High**Works Required:** Canopy lift**SRZ (m):** 2.1      **Works priority:** Very low**TPZ (m):** 3.6      **Construction Proximity:** 0.1**mTPZ (m):**

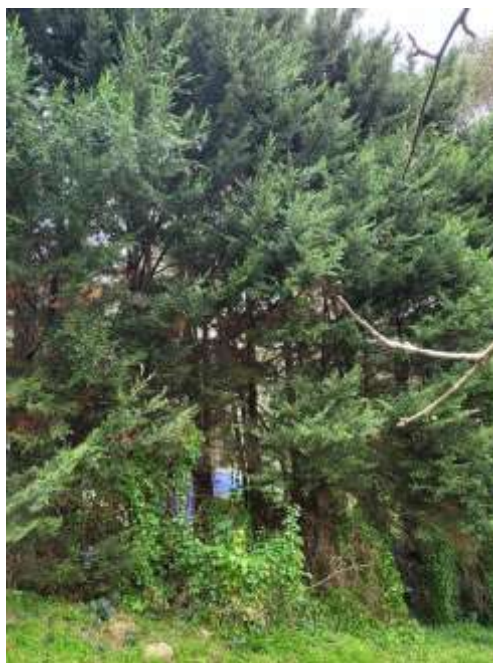
**Tree ID: 103****Genus / species:** *x cupressocyparis leylandii*

Evergreen Leyland Cypress

<b>Height (m):</b>	18	<b>Structure:</b>	Fair
<b>Width (m):</b>	6	<b>Health:</b>	Good
<b>DBH (cm):</b>	30	Estimated	<b>Maturity:</b> Mature
<b>Origin:</b>	Exotic	<b>ULE (years):</b>	30 - 60
<b>Retained?:</b>	Retained	<b>Form:</b>	Poor

**Retention Value:** High**Removal / retention reason:** N/A**Amenity value:** High**Works Required:** Canopy lift**SRZ (m):** 2.1 **Works priority:** Very low**TPZ (m):** 3.6 **Construction Proximity:** 0.1**mTPZ (m):**

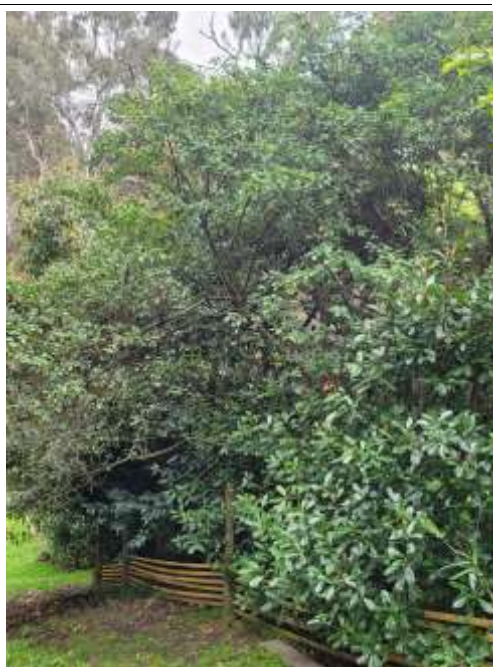
**Tree ID: 104****Genus / species:** *Cotoneaster glaucophyllus*

Evergreen Cotoneaster

<b>Height (m):</b>	7	<b>Structure:</b>	Fair
<b>Width (m):</b>	9	<b>Health:</b>	Good
<b>DBH (cm):</b>	15	Estimated	<b>Maturity:</b> Mature
<b>Origin:</b>	Exotic	<b>ULE (years):</b>	15 - 30
<b>Retained?:</b>	Retained	<b>Form:</b>	Fair

**Retention Value:** Low**Removal / retention reason:** N/A**Amenity value:** Low**Works Required:** Canopy lift**SRZ (m):** 1.6 **Works priority:** Very low**TPZ (m):** 2.0 **Construction Proximity:** 0.1**mTPZ (m):**

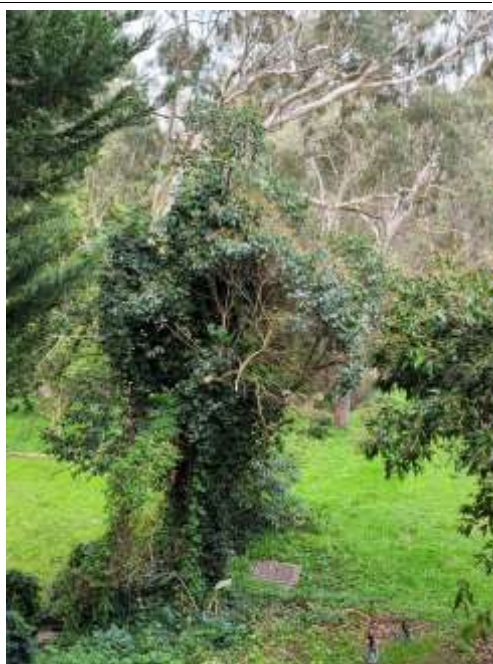
**Tree ID: 105****Genus / species:** *Ligustrum lucidum*

Evergreen Privet

<b>Height (m):</b>	9	<b>Structure:</b>	Poor
<b>Width (m):</b>	6	<b>Health:</b>	Poor
<b>DBH (cm):</b>	30	Estimated	<b>Maturity:</b> Mature
<b>Origin:</b>	Exotic	<b>ULE (years):</b>	5 - 15
<b>Retained?:</b>	Removed	<b>Form:</b>	Poor

**Retention Value:** Low**Removal / retention reason:** N/A.**Amenity value:** Low**Works Required:** N/A.**SRZ (m):** 2.1 **Works priority:** N/A**TPZ (m):** 3.6 **Construction Proximity:** 0.1**mTPZ (m):**

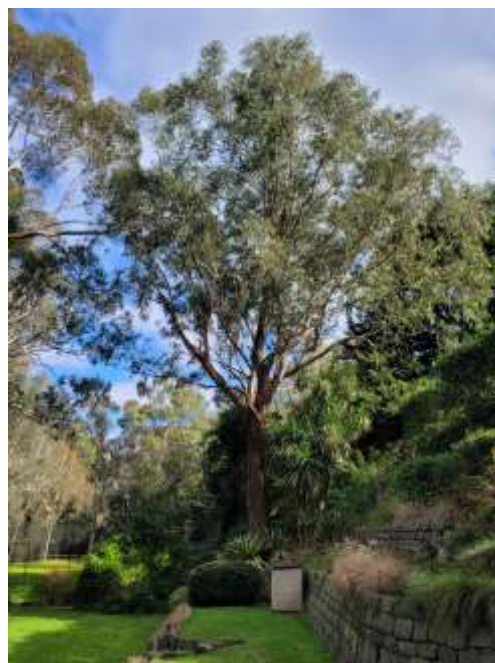
**Tree ID: 106****Genus / species:** *Eucalyptus botryoides*

Evergreen Southern Mahogany

**Retention Value:** High**Removal / retention reason:** N/A.**Amenity value:** High**Works Required:** N/A.

**SRZ (m):** 3.2      **Works priority:** N/A  
**TPZ (m):** 9.8      **Construction Proximity:** 0.1  
**mTPZ (m):**

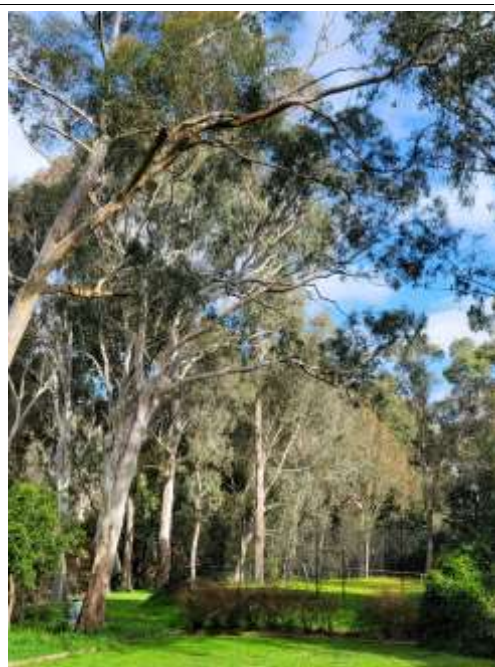
**Tree ID: 107****Genus / species:** *Eucalyptus camaldulensis*

Evergreen River Red Gum

**Retention Value:** High**Removal / retention reason:** N/A.**Amenity value:** High**Works Required:** N/A.

**SRZ (m):** 3      **Works priority:** N/A  
**TPZ (m):** 8.6      **Construction Proximity:** 0.1  
**mTPZ (m):**

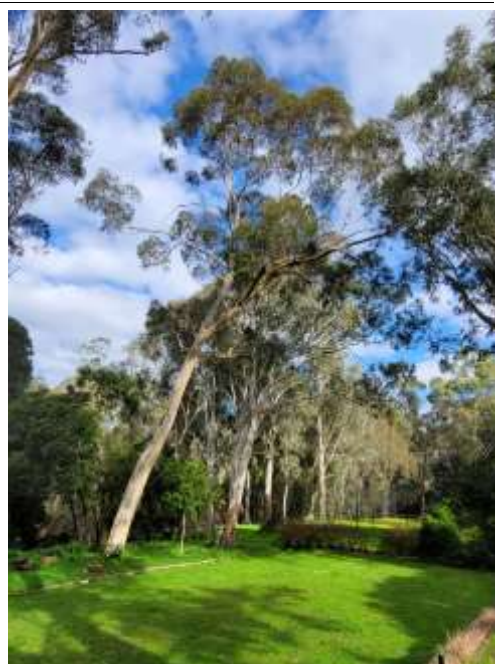
**Tree ID: 108****Genus / species:** *Eucalyptus cladocalyx*

Evergreen Sugar Gum

**Retention Value:** High**Removal / retention reason:** N/A.**Amenity value:** High**Works Required:** N/A.

**SRZ (m):** 3      **Works priority:** N/A  
**TPZ (m):** 9.1      **Construction Proximity:** 0.1  
**mTPZ (m):**

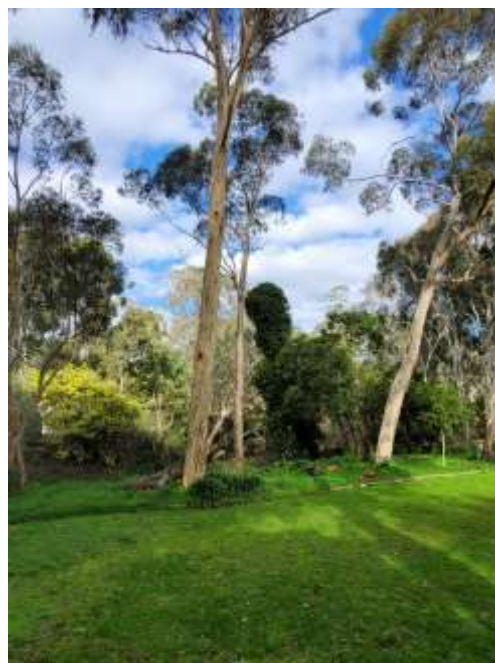
**Tree ID: 109****Genus / species:** *Eucalyptus cladocalyx*

Evergreen Sugar Gum

**Retention Value:** High**Removal / retention reason:** N/A.**Amenity value:** High**Works Required:** N/A.

**SRZ (m):** 2.5      **Works priority:** N/A  
**TPZ (m):** 5.5      **Construction Proximity:** 0.1  
**mTPZ (m):**

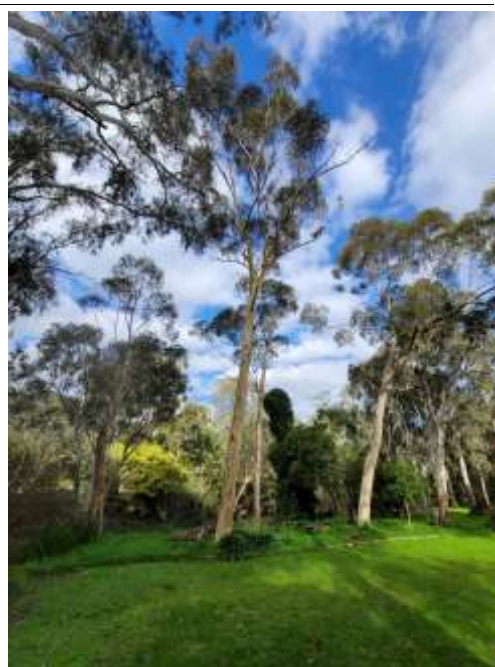
**Tree ID: 110****Genus / species:** *Eucalyptus cladocalyx*

Evergreen Sugar Gum

**Retention Value:** High**Removal / retention reason:** N/A.**Amenity value:** High**Works Required:** N/A.

**SRZ (m):** 3.3      **Works priority:** N/A  
**TPZ (m):** 10.1      **Construction Proximity:** 0.1  
**mTPZ (m):**

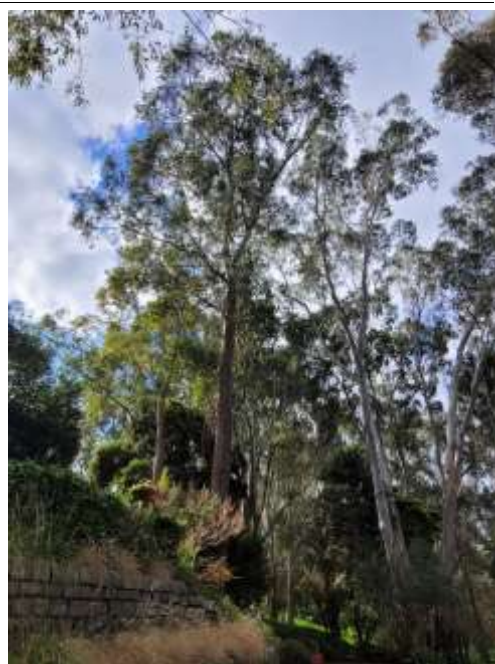
**Retention Value:** Very high**Removal / retention reason:** N/A.**Amenity value:** High**Works Required:** N/A.

**SRZ (m):** 3.3      **Works priority:** N/A  
**TPZ (m):** 10.6      **Construction Proximity:** 0.1  
**mTPZ (m):**

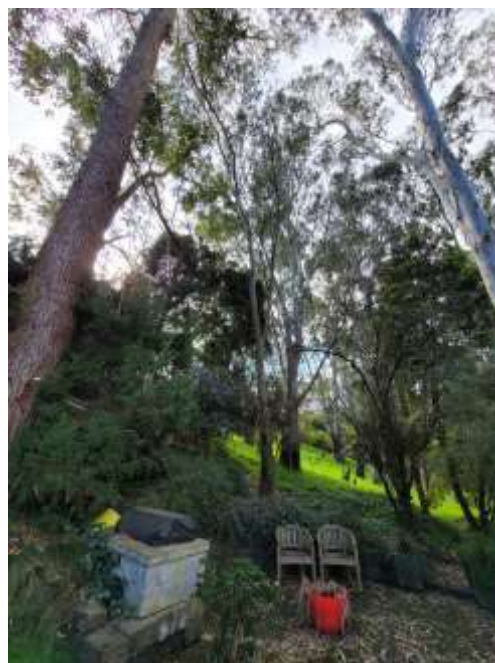
**Tree ID: 112****Genus / species:** *Eucalyptus camaldulensis*

**Retention Value:** Low**Removal / retention reason:** N/A.**Amenity value:** Moderate**Works Required:** N/A.

**SRZ (m):** 2.1      **Works priority:** N/A  
**TPZ (m):** 3.6      **Construction Proximity:** 0.1  
**mTPZ (m):**

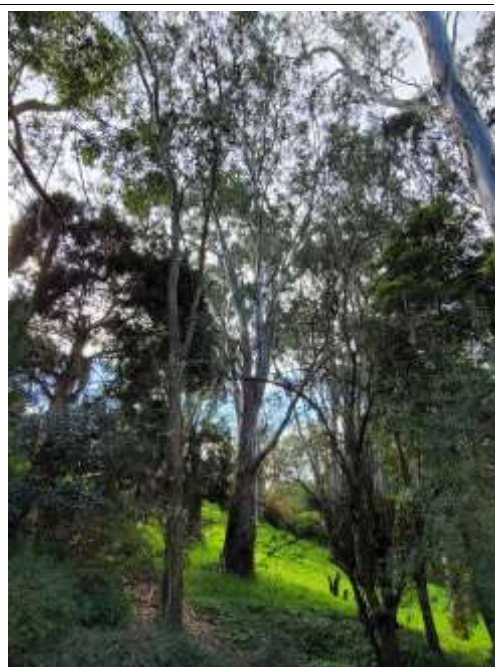
**Tree ID: 113****Genus / species:** *Eucalyptus camaldulensis*

**Retention Value:** Very high**Removal / retention reason:** N/A.**Amenity value:** High**Works Required:** N/A.

**SRZ (m):** 3.2      **Works priority:** N/A  
**TPZ (m):** 9.7      **Construction Proximity:** 0.1  
**mTPZ (m):**

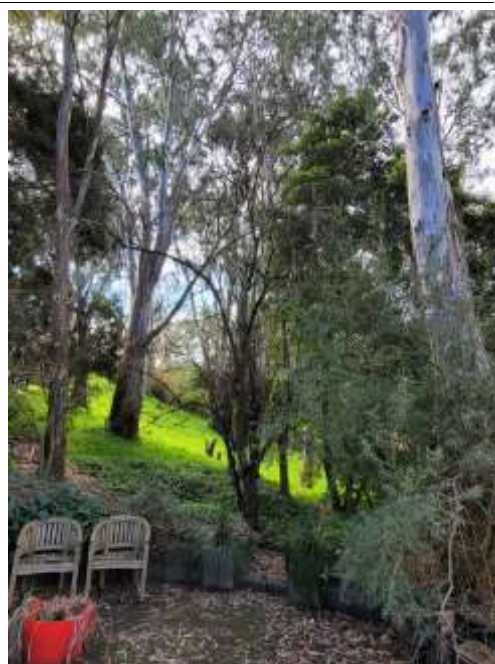
**Tree ID: 114****Genus / species:** *Prunus cerasifera*

**Retention Value:** Low**Removal / retention reason:** N/A.**Amenity value:** Low**Works Required:** N/A.

**SRZ (m):** 1.7      **Works priority:** N/A  
**TPZ (m):** 2.2      **Construction Proximity:** 0.1  
**mTPZ (m):**

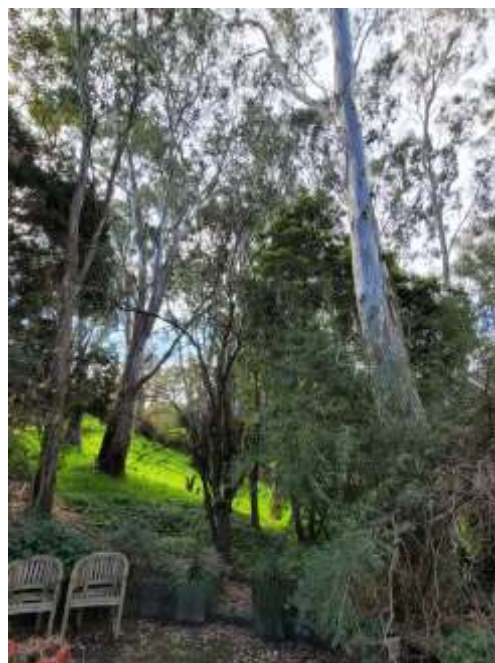
**Tree ID: 115****Genus / species:** *Eucalyptus camaldulensis*

**Height (m):** 16      **Structure:** Poor  
**Width (m):** 3      **Health:** Dead  
**DBH (cm):** 25      **Estimated Maturity:** Immature  
**Origin:** Melbourne      **ULE (years):** 0  
**Retained?:** Retained      **Form:** Very poor  
**Retention Value:** Remove.  
**Removal / retention reason:** N/A.  
**Amenity value:** Very low  
**Works Required:** N/A.

**SRZ (m):** 1.9      **Works priority:** N/A  
**TPZ (m):** 3.0      **Construction Proximity:** 0.1  
**mTPZ (m):**

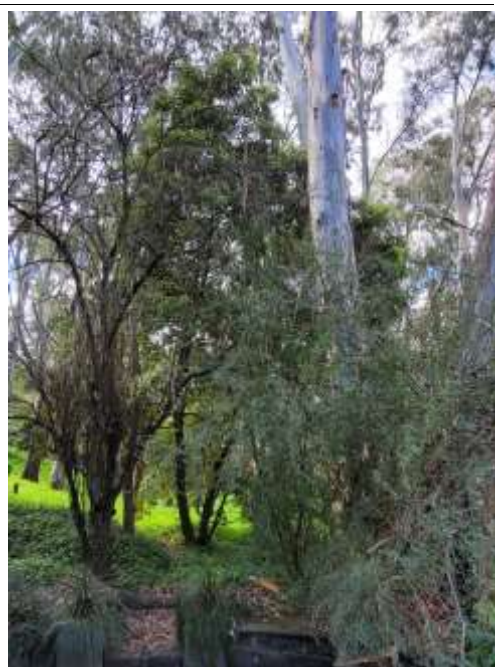
**Tree ID: 116****Genus / species:** *Pittosporum undulatum*

**Height (m):** 9      **Structure:** Fair  
**Width (m):** 8      **Health:** Good  
**DBH (cm):** 25      **Estimated Maturity:** Mature  
**Origin:** Victorian      **ULE (years):** 15 - 30  
**Retained?:** Retained      **Form:** Good  
**Retention Value:** Low  
**Removal / retention reason:** N/A.  
**Amenity value:** Low  
**Works Required:** N/A.

**SRZ (m):** 1.9      **Works priority:** N/A  
**TPZ (m):** 3.0      **Construction Proximity:** 0.1  
**mTPZ (m):**

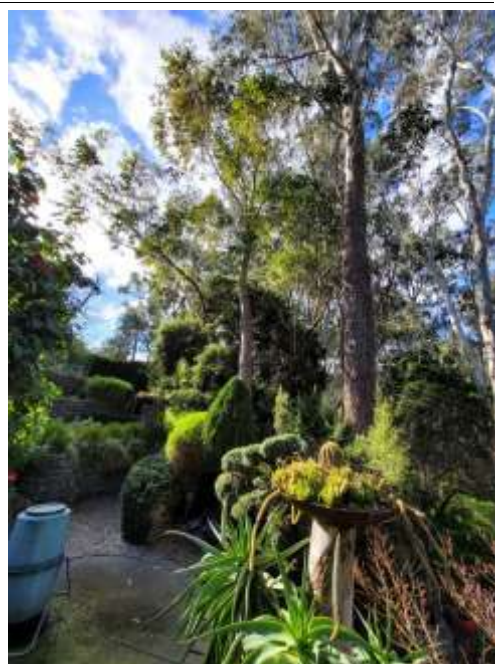
**Tree ID: 117****Genus / species:** *Eucalyptus botryoides*

**Height (m):** 22      **Structure:** Fair  
**Width (m):** 8      **Health:** Good  
**DBH (cm):** 47      **Measured Maturity:** Mature  
**Origin:** Victorian      **ULE (years):** 30 - 60  
**Retained?:** Retained      **Form:** Fair  
**Retention Value:** High  
**Removal / retention reason:** N/A.  
**Amenity value:** High  
**Works Required:** N/A.

**SRZ (m):** 2.5      **Works priority:** N/A  
**TPZ (m):** 5.6      **Construction Proximity:** 0.1  
**mTPZ (m):**

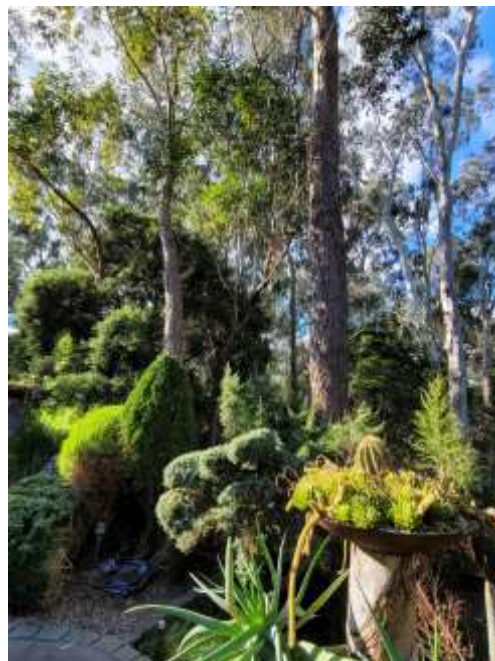
**Tree ID: 118****Genus / species:** *Eucalyptus botryoides*

**Retention Value:** Moderate**Removal / retention reason:** N/A.**Amenity value:** Moderate**Works Required:** N/A.

**SRZ (m):** 1.9      **Works priority:** N/A  
**TPZ (m):** 2.8      **Construction Proximity:** 0.1  
**mTPZ (m):**

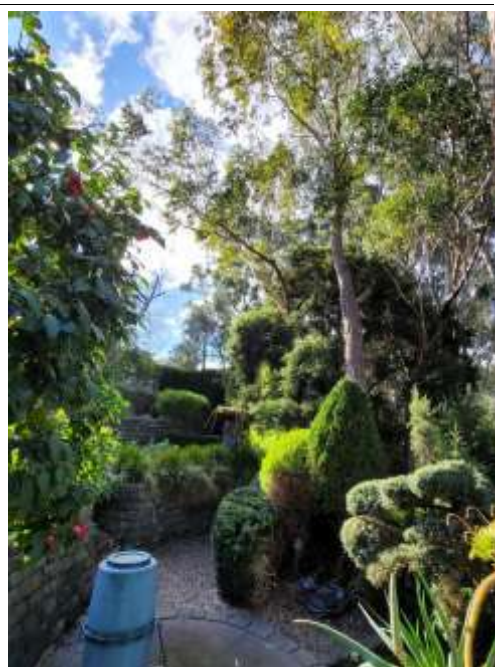
**Tree ID: 119****Genus / species:** *Eucalyptus botryoides*

**Retention Value:** Moderate**Removal / retention reason:** N/A.**Amenity value:** Moderate**Works Required:** N/A.

**SRZ (m):** 2      **Works priority:** N/A  
**TPZ (m):** 3.4      **Construction Proximity:** 0.1  
**mTPZ (m):**

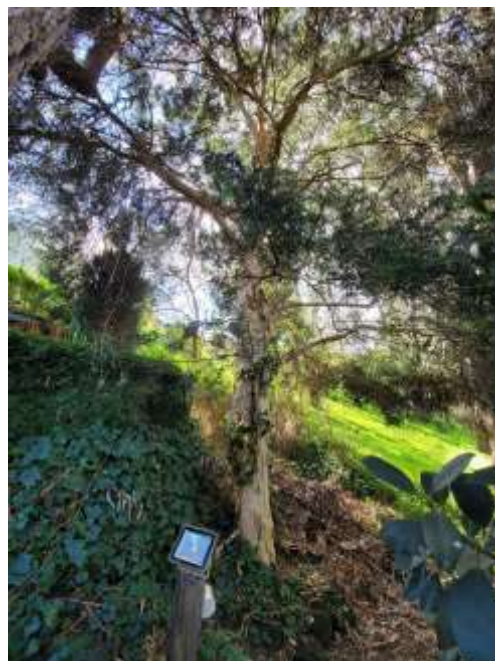
**Tree ID: 120****Genus / species:** *Melaleuca styphelioides*

**Retention Value:** Moderate**Removal / retention reason:** N/A.**Amenity value:** Moderate**Works Required:** N/A.

**SRZ (m):** 2.2      **Works priority:** N/A  
**TPZ (m):** 4.1      **Construction Proximity:** 0.1  
**mTPZ (m):**

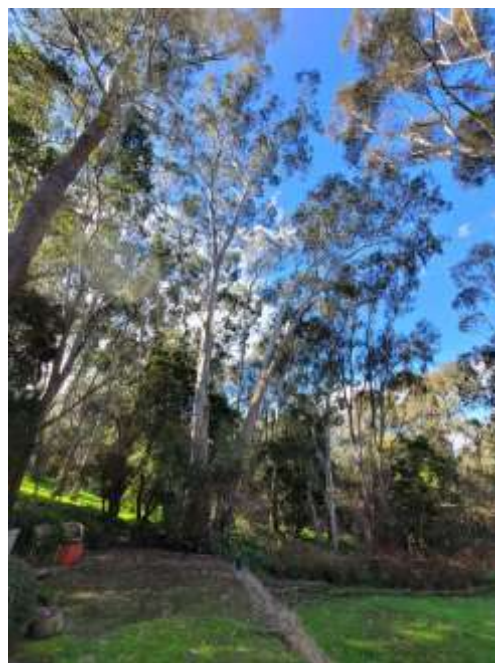
**Tree ID: 121****Genus / species:** *Eucalyptus camaldulensis*

**Retention Value:** Very high**Removal / retention reason:** N/A.**Amenity value:** High**Works Required:** N/A.

**SRZ (m):** 3.8      **Works priority:** N/A  
**TPZ (m):** 14.6      **Construction Proximity:** 0.1  
**mTPZ (m):**

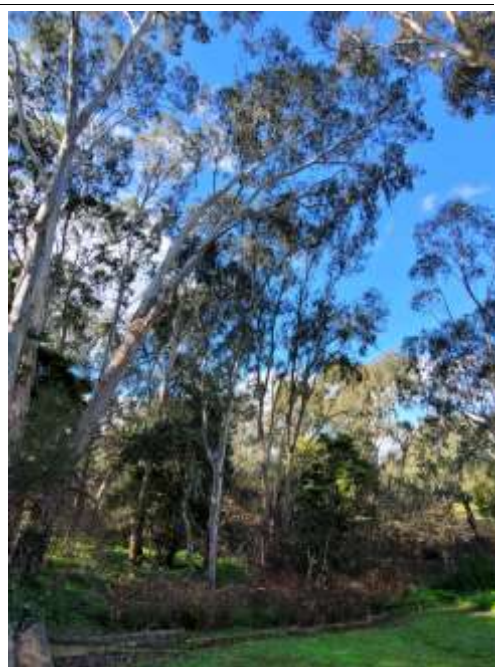
**Tree ID: 122****Genus / species:** *Eucalyptus camaldulensis*

**Retention Value:** High**Removal / retention reason:** N/A.**Amenity value:** High**Works Required:** N/A.

**SRZ (m):** 2.5      **Works priority:** N/A  
**TPZ (m):** 5.6      **Construction Proximity:** 0.1  
**mTPZ (m):**

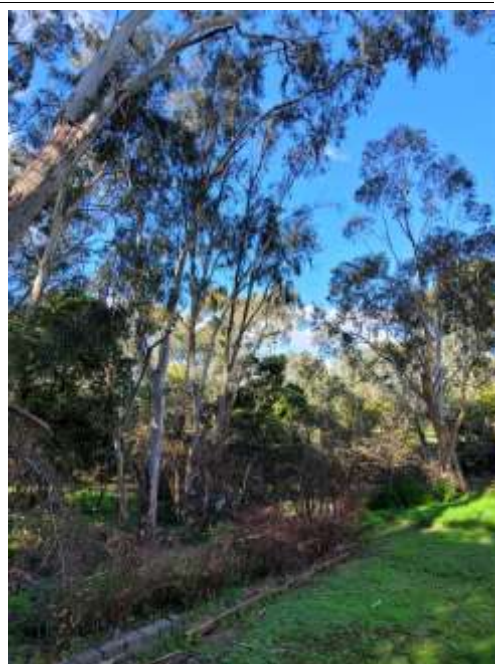
**Tree ID: 123****Genus / species:** *Eucalyptus camaldulensis*

**Retention Value:** High**Removal / retention reason:** N/A.**Amenity value:** High**Works Required:** N/A.

**SRZ (m):** 2.7      **Works priority:** N/A  
**TPZ (m):** 6.5      **Construction Proximity:** 0.1  
**mTPZ (m):**

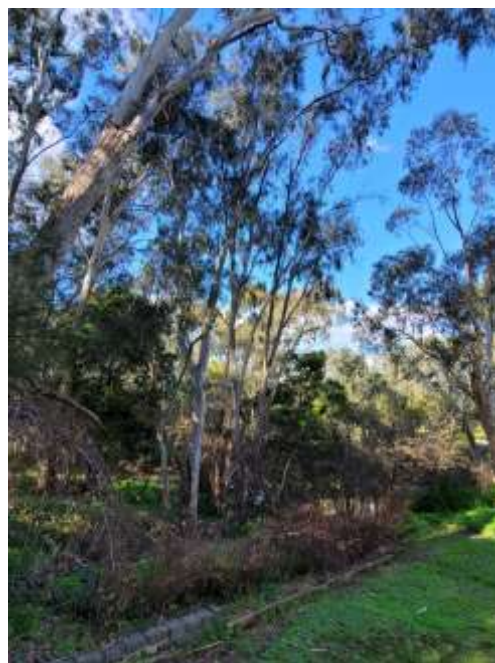
**Tree ID: 124****Genus / species:** *Eucalyptus camaldulensis*

**Retention Value:** High**Removal / retention reason:** N/A.**Amenity value:** High**Works Required:** N/A.

**SRZ (m):** 2.4      **Works priority:** N/A  
**TPZ (m):** 4.8      **Construction Proximity:** 0.1  
**mTPZ (m):**

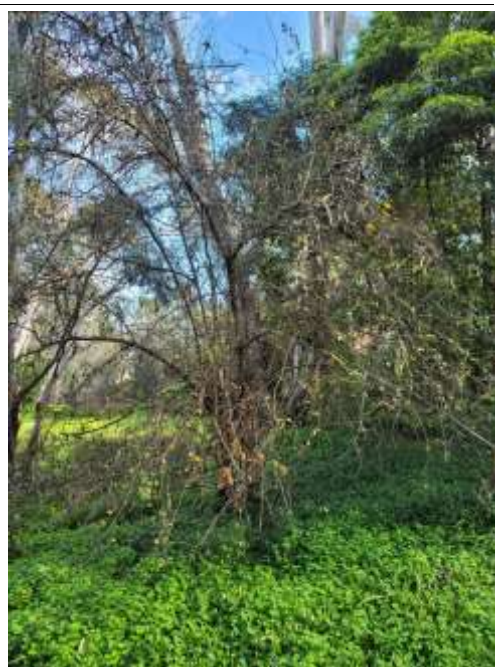
**Tree ID: 125****Genus / species:** *Crataegus monogyna*

**Retention Value:** Low**Removal / retention reason:** N/A.**Amenity value:** Low**Works Required:** N/A.

**SRZ (m):** 1.8      **Works priority:** N/A  
**TPZ (m):** 2.4      **Construction Proximity:** 0.1  
**mTPZ (m):**

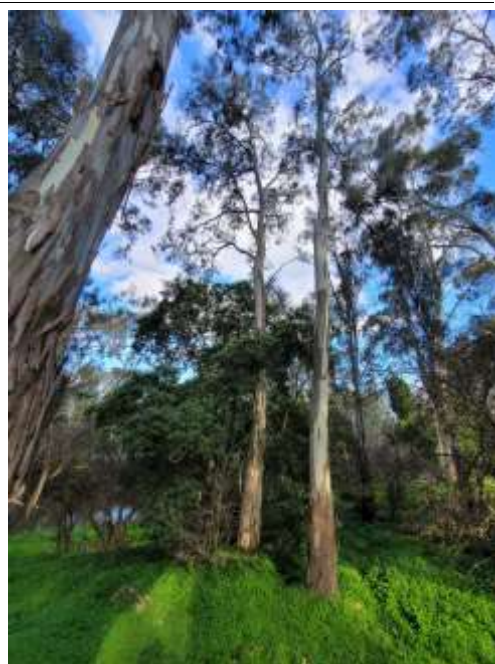
**Tree ID: 126****Genus / species:** *Eucalyptus camaldulensis*

**Retention Value:** Very high**Removal / retention reason:** N/A.**Amenity value:** High**Works Required:** N/A.

**SRZ (m):** 2.8      **Works priority:** N/A  
**TPZ (m):** 7.3      **Construction Proximity:** 0.1  
**mTPZ (m):**

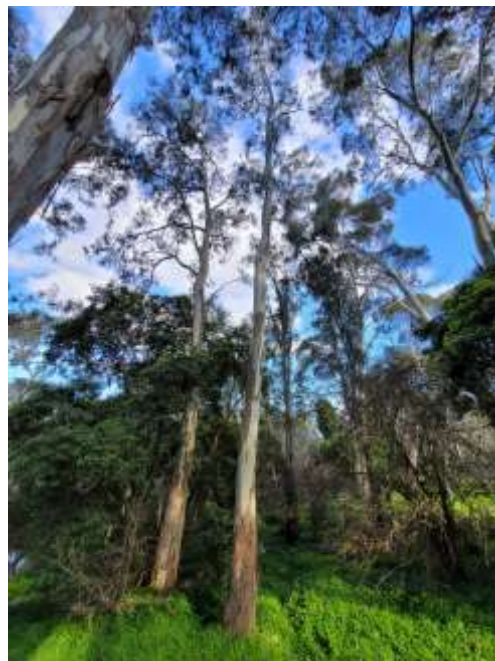
**Tree ID: 127****Genus / species:** *Eucalyptus camaldulensis*

**Retention Value:** Very high**Removal / retention reason:** N/A.**Amenity value:** High**Works Required:** N/A.

**SRZ (m):** 2.5      **Works priority:** N/A  
**TPZ (m):** 5.6      **Construction Proximity:** 0.1  
**mTPZ (m):**

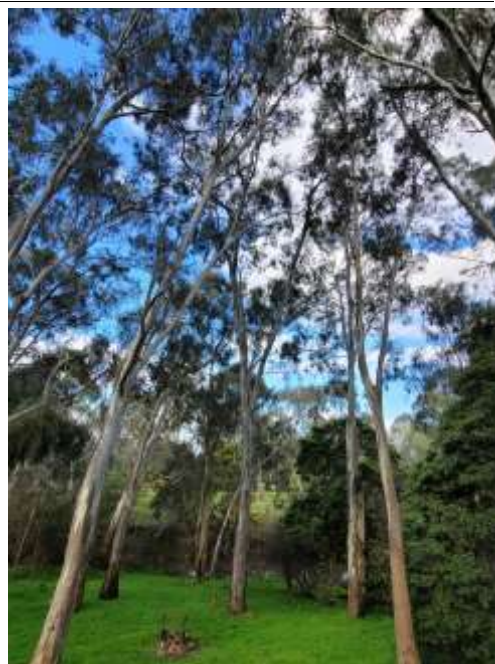
**Tree ID: 128****Genus / species:** *Eucalyptus camaldulensis*

**Retention Value:** Very high**Removal / retention reason:** N/A.**Amenity value:** High**Works Required:** N/A.

**SRZ (m):** 3      **Works priority:** N/A  
**TPZ (m):** 8.5      **Construction Proximity:** 0.1  
**mTPZ (m):**

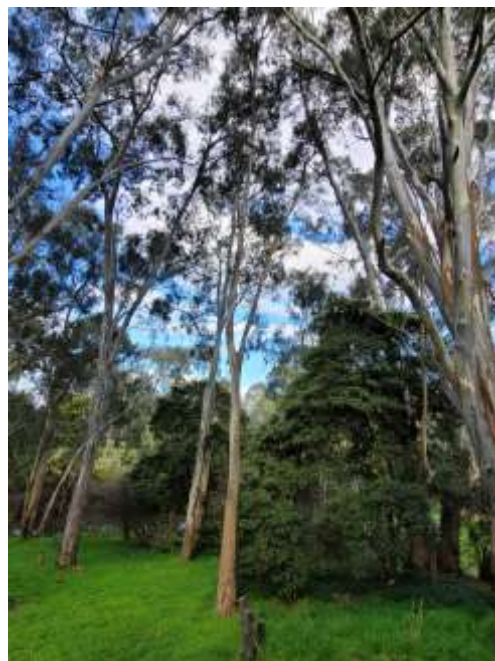
**Tree ID: 129****Genus / species:** *Eucalyptus camaldulensis*

**Retention Value:** High**Removal / retention reason:** N/A.**Amenity value:** High**Works Required:** N/A.

**SRZ (m):** 2.3      **Works priority:** N/A  
**TPZ (m):** 4.7      **Construction Proximity:** 0.1  
**mTPZ (m):**

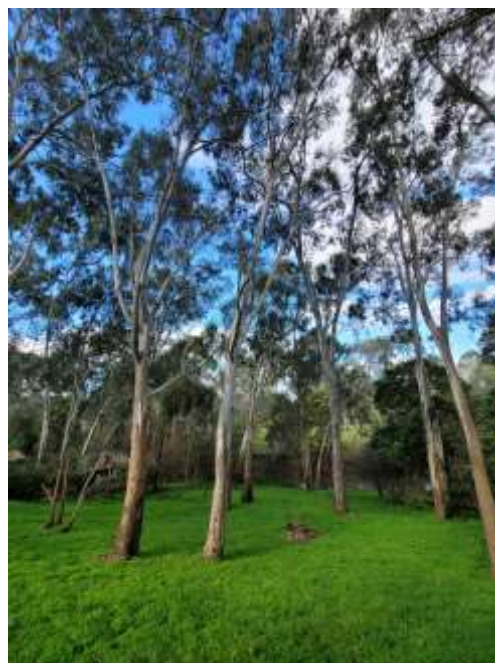
**Tree ID: 130****Genus / species:** *Eucalyptus camaldulensis*

**Removal / retention reason:** N/A.**Amenity value:** High**Works Required:** N/A.

**SRZ (m):** 2.5      **Works priority:** N/A  
**TPZ (m):** 5.6      **Construction Proximity:** 0.1  
**mTPZ (m):**

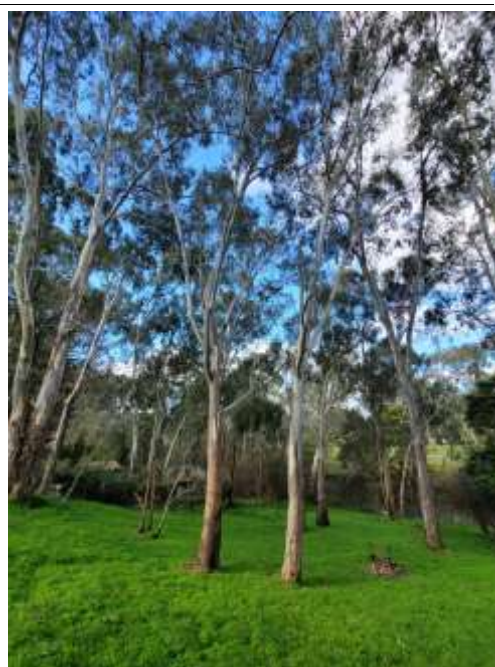
**Tree ID: 131****Genus / species:** *Eucalyptus camaldulensis*

**Removal / retention reason:** N/A.**Amenity value:** High**Works Required:** N/A.

**SRZ (m):** 2.7      **Works priority:** N/A  
**TPZ (m):** 6.6      **Construction Proximity:** 0.1  
**mTPZ (m):**

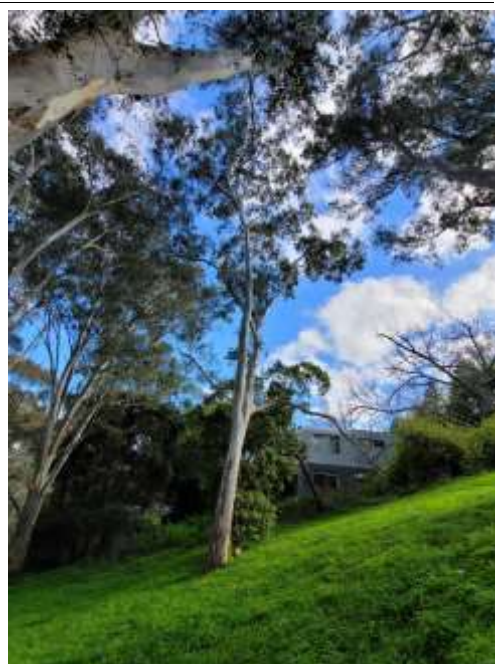
**Tree ID: 132****Genus / species:** *Eucalyptus camaldulensis*

**Removal / retention reason:** N/A.**Amenity value:** High**Works Required:** N/A.

**SRZ (m):** 2.8      **Works priority:** N/A  
**TPZ (m):** 7.6      **Construction Proximity:** 0.1  
**mTPZ (m):**

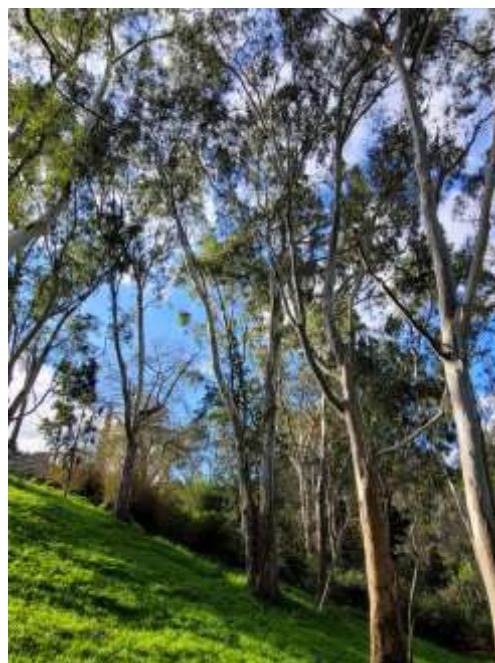
**Tree ID: 133****Genus / species:** *Eucalyptus camaldulensis*

**Retention Value:** Very high**Removal / retention reason:** N/A.**Amenity value:** High**Works Required:** N/A.

**SRZ (m):** 3.6      **Works priority:** N/A  
**TPZ (m):** 12.6      **Construction Proximity:** 0.1  
**mTPZ (m):**

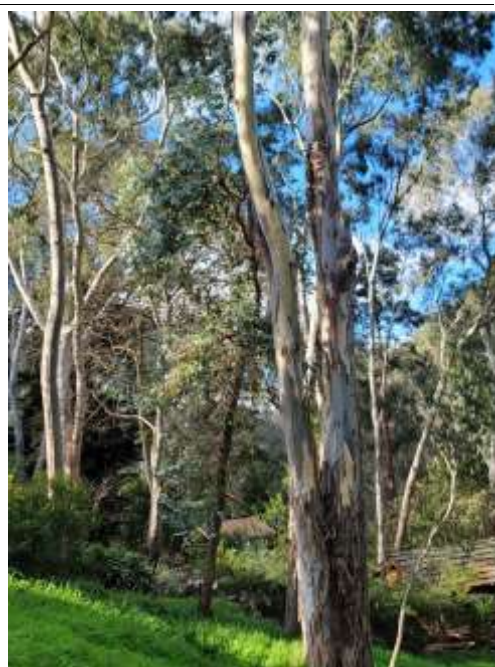
**Tree ID: 134****Genus / species:** *Eucalyptus cinerea*

**Retention Value:** Low**Removal / retention reason:** N/A.**Amenity value:** Low**Works Required:** N/A.

**SRZ (m):** 1.8      **Works priority:** N/A  
**TPZ (m):** 2.4      **Construction Proximity:** 0.1  
**mTPZ (m):**

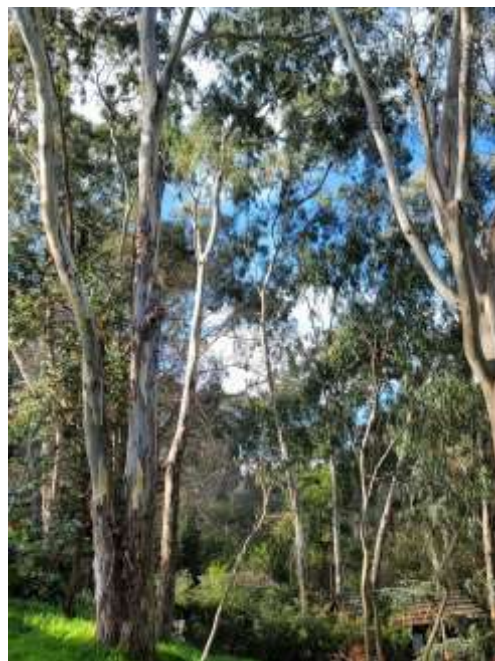
**Tree ID: 135****Genus / species:** *Eucalyptus camaldulensis*

**Retention Value:** High**Removal / retention reason:** N/A.**Amenity value:** High**Works Required:** N/A.

**SRZ (m):** 2.4      **Works priority:** N/A  
**TPZ (m):** 5.2      **Construction Proximity:** 0.1  
**mTPZ (m):**

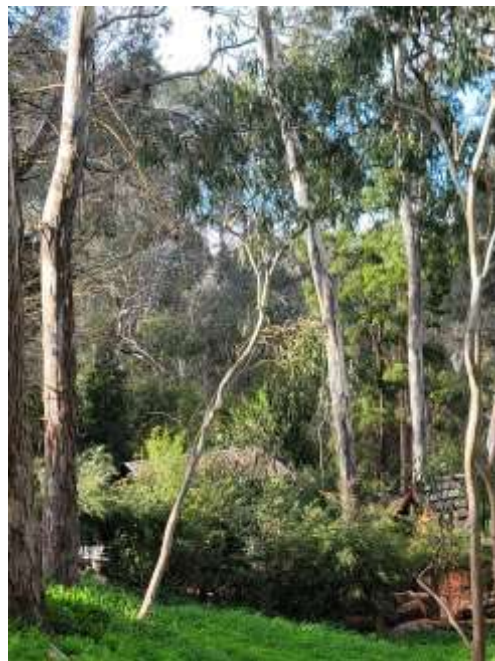
**Tree ID: 136****Genus / species:** *Eucalyptus camaldulensis*

**Height (m):** 6      **Structure:** Good  
**Width (m):** 2      **Health:** Fair  
**DBH (cm):** 9      Estimated **Maturity:** Immature  
**Origin:** Melbourne      **ULE (years):** 5 - 15  
**Retained?:** Retained      **Form:** Fair  
**Retention Value:** Low  
**Removal / retention reason:** N/A.  
**Amenity value:** Low  
**Works Required:** N/A.

**SRZ (m):** 1.6      **Works priority:** N/A  
**TPZ (m):** 2.0      **Construction Proximity:** 0.1  
**mTPZ (m):**

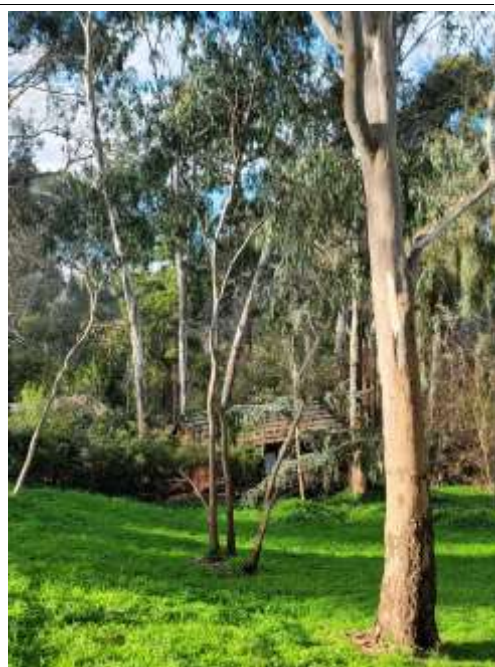
**Tree ID: 137****Genus / species:** *Eucalyptus camaldulensis*

**Height (m):** 10      **Structure:** Poor  
**Width (m):** 6      **Health:** Fair  
**DBH (cm):** 18      Estimated **Maturity:** Immature  
**Origin:** Melbourne      **ULE (years):** 15 - 30  
**Retained?:** Retained      **Form:** Fair  
**Retention Value:** Low  
**Removal / retention reason:** N/A.  
**Amenity value:** Low  
**Works Required:** N/A.

**SRZ (m):** 1.7      **Works priority:** N/A  
**TPZ (m):** 2.2      **Construction Proximity:** 0.1  
**mTPZ (m):**

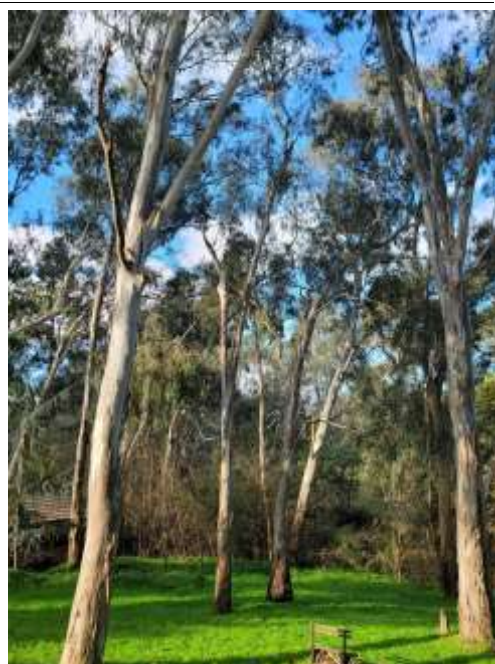
**Tree ID: 138****Genus / species:** *Eucalyptus camaldulensis*

**Height (m):** 30      **Structure:** Fair  
**Width (m):** 7      **Health:** Poor  
**DBH (cm):** 38      Measured **Maturity:** Mature  
**Origin:** Melbourne      **ULE (years):** 5 - 15  
**Retained?:** Retained      **Form:** Fair  
**Retention Value:** Low  
**Removal / retention reason:** N/A.  
**Amenity value:** Low  
**Works Required:** N/A.

**SRZ (m):** 2.3      **Works priority:** N/A  
**TPZ (m):** 4.6      **Construction Proximity:** 0.1  
**mTPZ (m):**

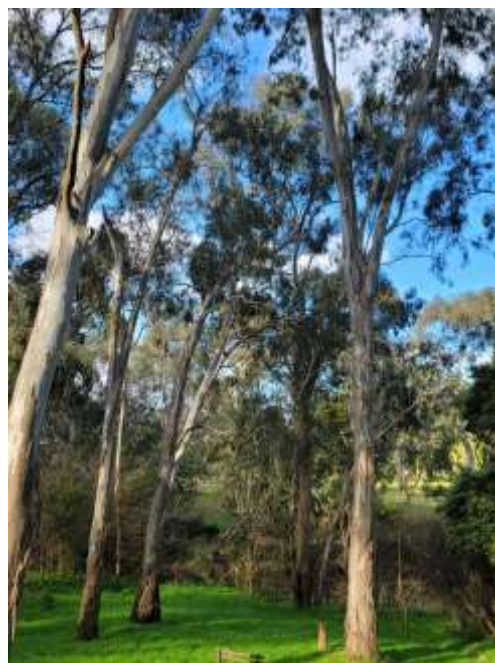
**Tree ID: 139****Genus / species:** *Eucalyptus camaldulensis*

**Retention Value:** High**Removal / retention reason:** N/A.**Amenity value:** High**Works Required:** N/A.

**SRZ (m):** 2.6      **Works priority:** N/A  
**TPZ (m):** 5.9      **Construction Proximity:** 0.1  
**mTPZ (m):**

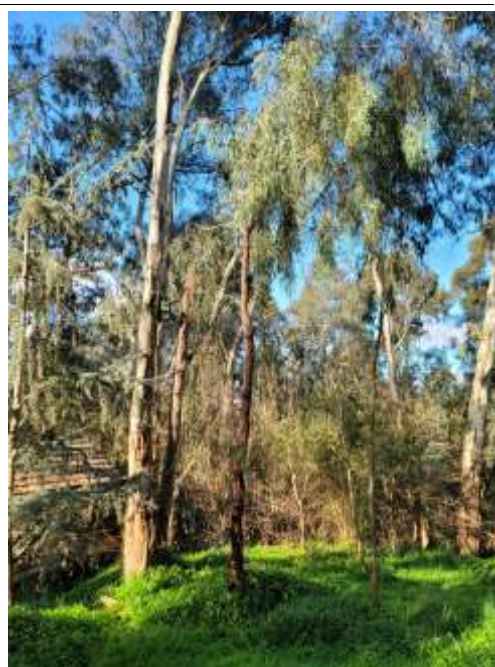
**Tree ID: 140****Genus / species:** *Eucalyptus sideroxylon*

**Retention Value:** Low**Removal / retention reason:** N/A.**Amenity value:** Low**Works Required:** N/A.

**SRZ (m):** 1.7      **Works priority:** N/A  
**TPZ (m):** 2.3      **Construction Proximity:** 0.1  
**mTPZ (m):**
