## **Nation Partners**

# **Northern Sewers Relining Project Southern Section**

## **Construction Impact Report**

**Wednesday 4<sup>th</sup> December 2024**

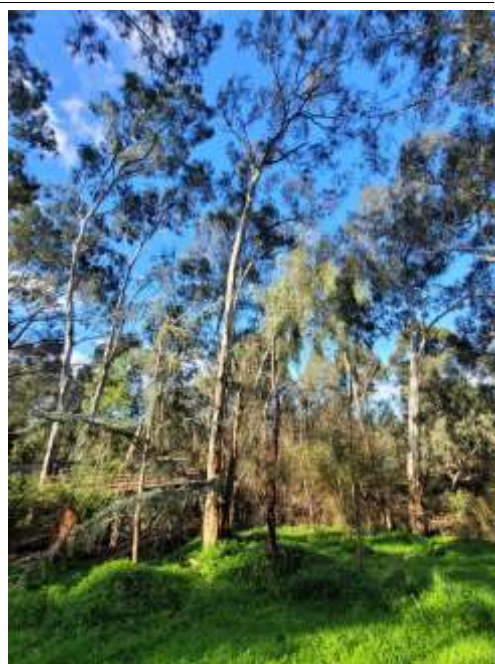
**Tree ID: 141****Genus / species:** *Eucalyptus camaldulensis*

**Retention Value:** High**Removal / retention reason:** N/A.**Amenity value:** High**Works Required:** N/A.

**SRZ (m):** 2.7      **Works priority:** N/A  
**TPZ (m):** 6.7      **Construction Proximity:** 0.1  
**mTPZ (m):**

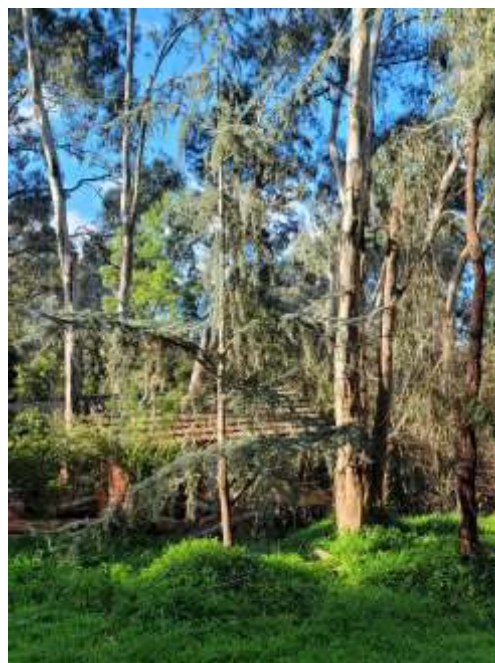
**Tree ID: 142****Genus / species:** *Cedrus atlantica* 'Glauca'

**Height (m):** 9      **Structure:** Good  
**Width (m):** 6      **Health:** Good  
**DBH (cm):** 14      Estimated **Maturity:** Immature  
**Origin:** Exotic      **ULE (years):** > 60  
**Retained?:** Retained      **Form:** Good  
**Retention Value:** Moderate  
**Removal / retention reason:** N/A.  
**Amenity value:** Low  
**Works Required:** N/A.

**SRZ (m):** 1.6      **Works priority:** N/A  
**TPZ (m):** 2.0      **Construction Proximity:** 0.1  
**mTPZ (m):**

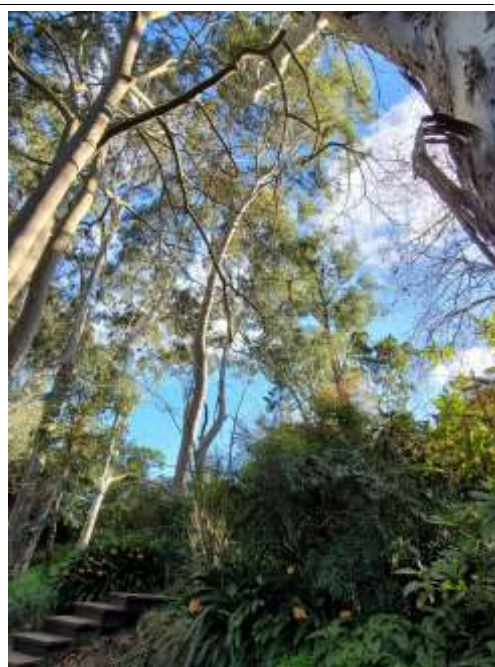
**Tree ID: 143****Genus / species:** *Corymbia maculata*

**Height (m):** 38      **Structure:** Good  
**Width (m):** 12      **Health:** Good  
**DBH (cm):** 49      Measured **Maturity:** Mature  
**Origin:** Victorian      **ULE (years):** > 60  
**Retained?:** Retained      **Form:** Good  
**Retention Value:** Very high  
**Removal / retention reason:** N/A.  
**Amenity value:** High  
**Works Required:** N/A.

**SRZ (m):** 2.6      **Works priority:** N/A  
**TPZ (m):** 5.9      **Construction Proximity:** 0.1  
**mTPZ (m):**

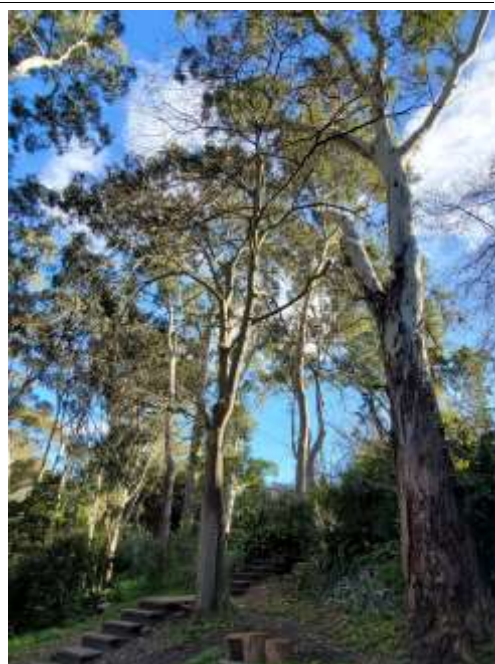
**Tree ID: 144****Genus / species:** *Zelkova serrata*

**Height (m):** 21      **Structure:** Good  
**Width (m):** 14      **Health:** Good  
**DBH (cm):** 59      Measured **Maturity:** Mature  
**Origin:** Exotic      **ULE (years):** > 60  
**Retained?:** Retained      **Form:** Good  
**Retention Value:** Very high  
**Removal / retention reason:** N/A.  
**Amenity value:** High  
**Works Required:** N/A.

**SRZ (m):** 2.8      **Works priority:** N/A  
**TPZ (m):** 7.1      **Construction Proximity:** 0.1  
**mTPZ (m):**

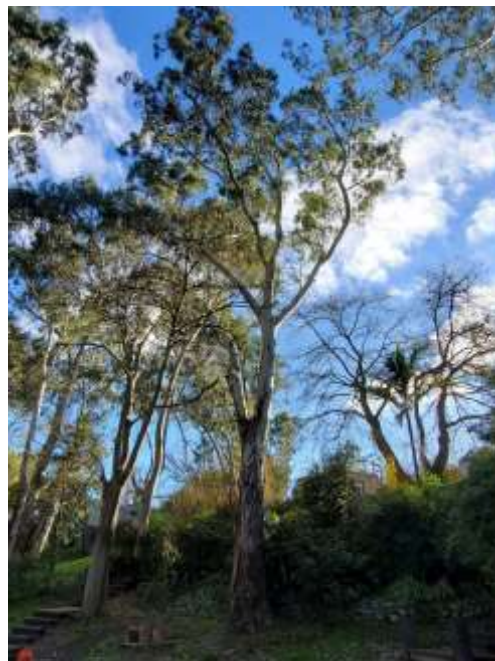
**Tree ID: 145****Genus / species:** *Acacia maidenii*

**Retention Value:** Very high**Removal / retention reason:** N/A.**Amenity value:** High**Works Required:** N/A.

**SRZ (m):** 3.2      **Works priority:** N/A  
**TPZ (m):** 9.4      **Construction Proximity:** 0.1  
**mTPZ (m):**

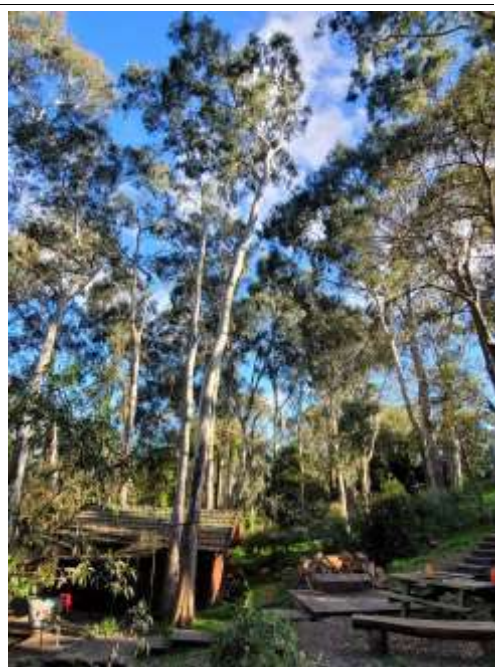
**Retention Value:** Very high**Removal / retention reason:** N/A.**Amenity value:** High**Works Required:** N/A.

**SRZ (m):** 2.4      **Works priority:** N/A  
**TPZ (m):** 5.3      **Construction Proximity:** 0.1  
**mTPZ (m):**

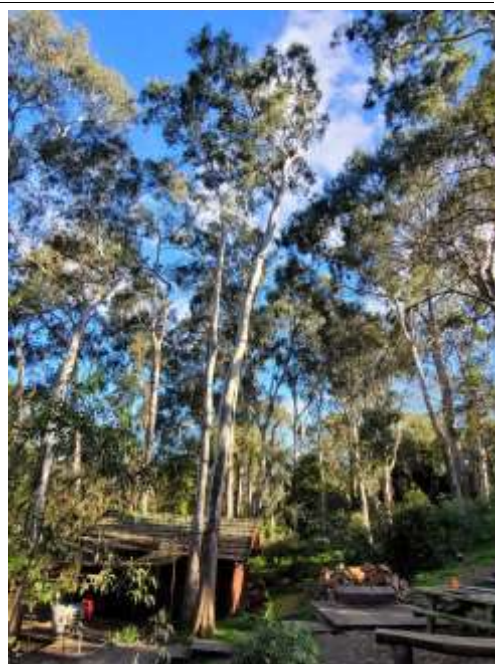
**Tree ID: 147****Genus / species:** *Eucalyptus camaldulensis*

**Retention Value:** Very high**Removal / retention reason:** N/A.**Amenity value:** High**Works Required:** N/A.

**SRZ (m):** 2.3      **Works priority:** N/A  
**TPZ (m):** 4.7      **Construction Proximity:** 0.1  
**mTPZ (m):**

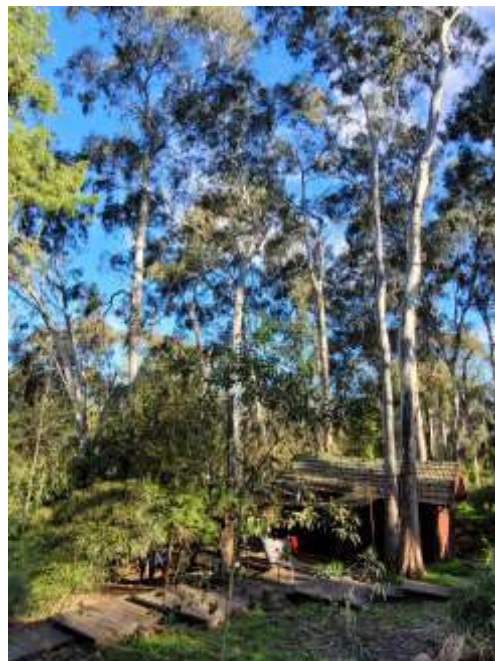
**Tree ID: 148****Genus / species:** *Eucalyptus camaldulensis*

**Retention Value:** High**Removal / retention reason:** N/A.**Amenity value:** High**Works Required:** N/A.

**SRZ (m):** 2.6      **Works priority:** N/A  
**TPZ (m):** 6.0      **Construction Proximity:** 0.1  
**mTPZ (m):**

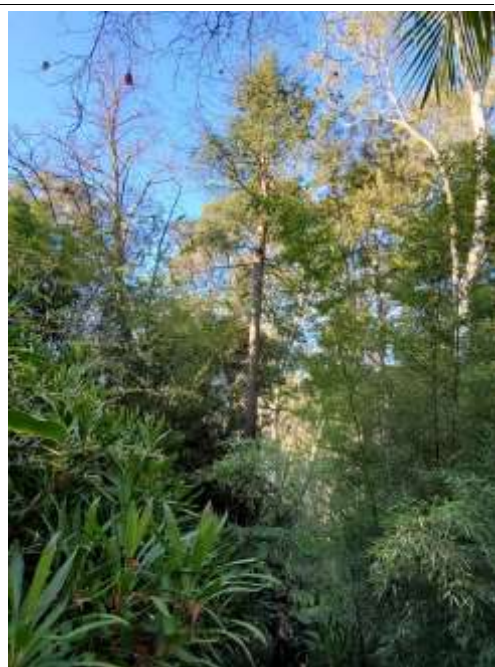
**Tree ID: 149****Genus / species:** *Cedrus atlantica*

**Retention Value:** High**Removal / retention reason:** N/A**Amenity value:** High**Works Required:** N/A.

**SRZ (m):** 2.4      **Works priority:** N/A  
**TPZ (m):** 4.8      **Construction Proximity:** 0.1  
**mTPZ (m):**

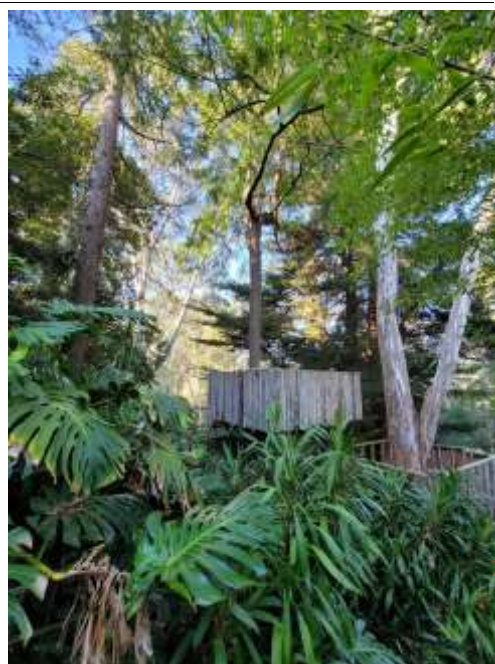
**Tree ID: 150****Genus / species:** *Grevillea robusta*

**Retention Value:** High**Removal / retention reason:** N/A**Amenity value:** High**Works Required:** N/A.

**SRZ (m):** 2.2      **Works priority:** N/A  
**TPZ (m):** 4.2      **Construction Proximity:** 0.1  
**mTPZ (m):**

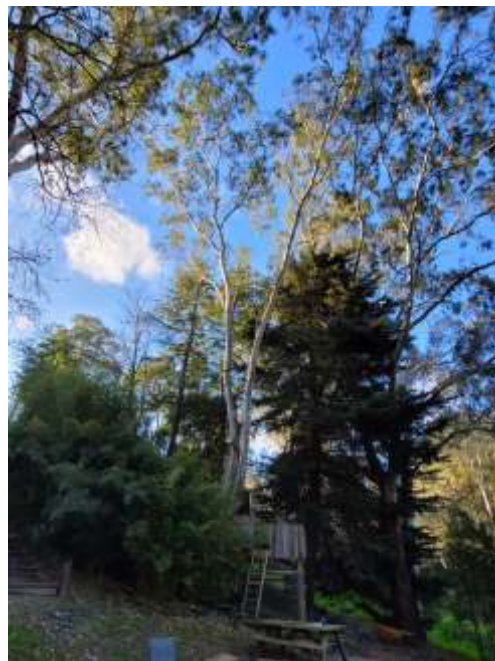
**Tree ID: 151****Genus / species:** *Eucalyptus camaldulensis*

**Retention Value:** High**Removal / retention reason:** N/A**Amenity value:** High**Works Required:** N/A.

**SRZ (m):** 3.3      **Works priority:** N/A  
**TPZ (m):** 10.6      **Construction Proximity:** 0.1  
**mTPZ (m):**

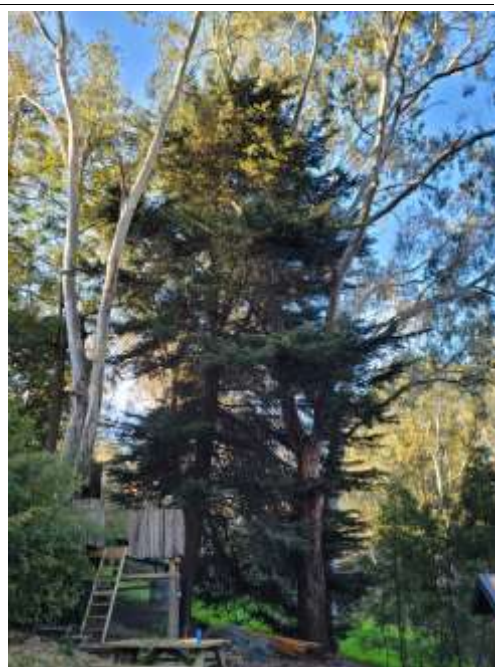
**Tree ID: 152****Genus / species:** *Hesperocyparis macrocarpa*

**Retention Value:** High**Removal / retention reason:** N/A.**Amenity value:** High**Works Required:** N/A.

**SRZ (m):** 3      **Works priority:** N/A  
**TPZ (m):** 8.5      **Construction Proximity:** 0.1  
**mTPZ (m):**

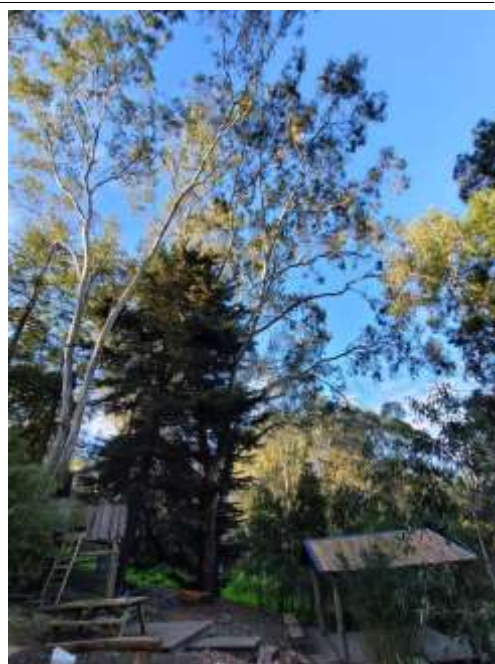
**Tree ID: 153****Genus / species:** *Eucalyptus camaldulensis*

**Retention Value:** High**Removal / retention reason:** N/A.**Amenity value:** High**Works Required:** N/A.

**SRZ (m):** 3.4      **Works priority:** N/A  
**TPZ (m):** 11.0      **Construction Proximity:** 0.1  
**mTPZ (m):**

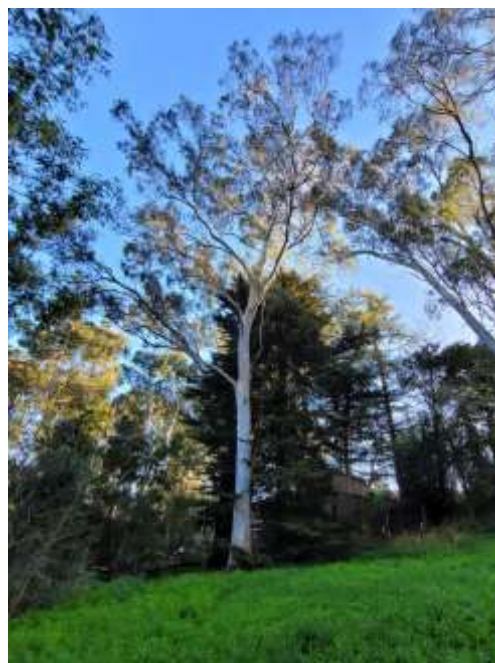
**Tree ID: 154****Genus / species:** *Eucalyptus camaldulensis*

**Retention Value:** Very high**Removal / retention reason:** N/A.**Amenity value:** High**Works Required:** N/A.

<b>SRZ (m):</b>	3	<b>Works priority:</b>	N/A
<b>TPZ (m):</b>	9.0	<b>Construction Proximity:</b>	0.1
<b>mTPZ (m):</b>

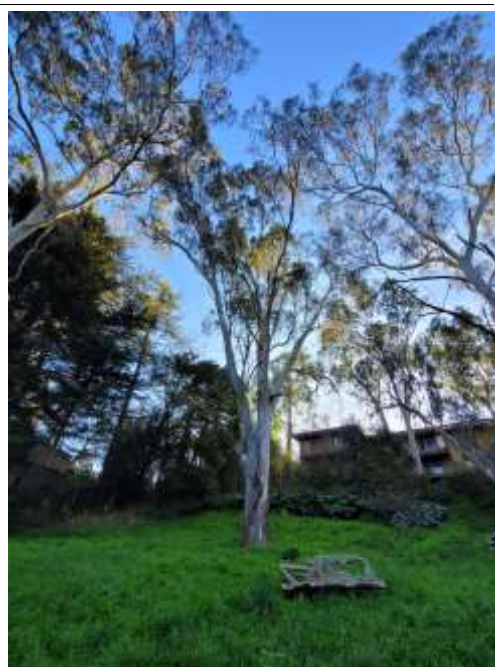
**Tree ID: 155****Genus / species:** *Eucalyptus camaldulensis*

**Retention Value:** Very high**Removal / retention reason:** N/A.**Amenity value:** High**Works Required:** N/A.

<b>SRZ (m):</b>	3.6	<b>Works priority:</b>	N/A
<b>TPZ (m):</b>	12.4	<b>Construction Proximity:</b>	0.1
<b>mTPZ (m):</b>

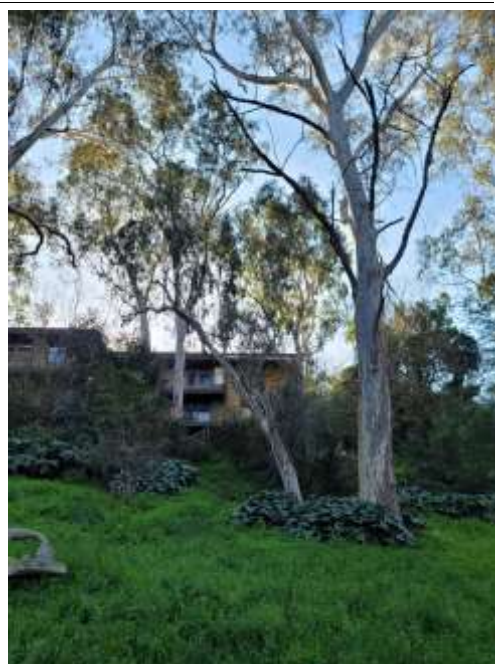
**Tree ID: 156****Genus / species:** *Eucalyptus camaldulensis*

**Retention Value:** Remove.**Removal / retention reason:** N/A.**Amenity value:** High**Works Required:** N/A.

<b>SRZ (m):</b>	2.4	<b>Works priority:</b>	N/A
<b>TPZ (m):</b>	5.0	<b>Construction Proximity:</b>	0.1
<b>mTPZ (m):</b>

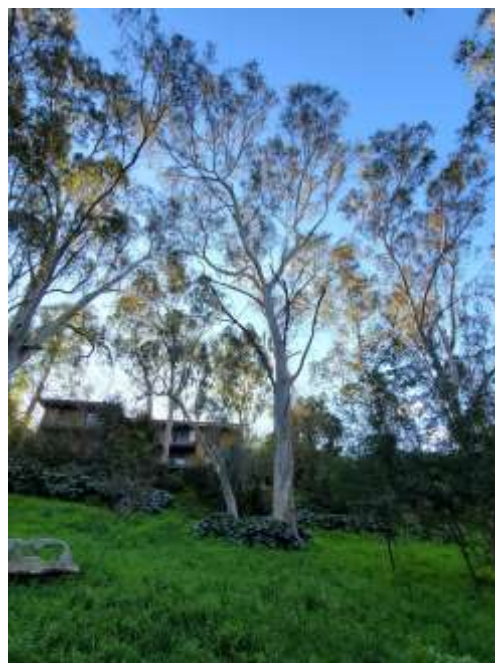
**Tree ID: 157****Genus / species:** *Eucalyptus camaldulensis*

**Retention Value:** High**Removal / retention reason:** N/A.**Amenity value:** High**Works Required:** N/A.

**SRZ (m):** 3.5      **Works priority:** N/A  
**TPZ (m):** 11.5      **Construction Proximity:** 0.1  
**mTPZ (m):**

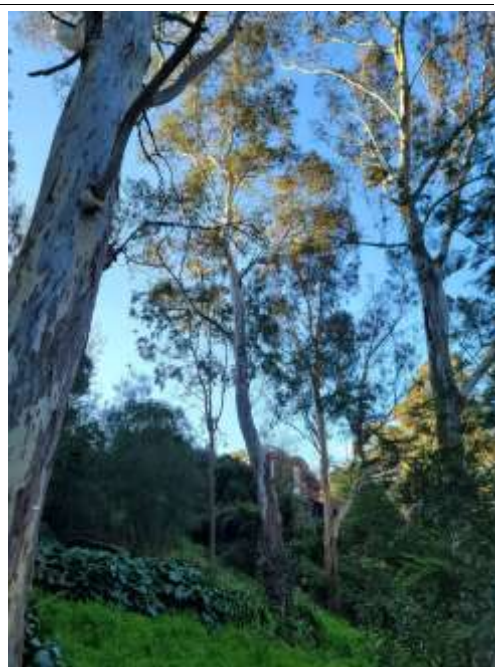
**Tree ID: 158****Genus / species:** *Eucalyptus camaldulensis*

**Retention Value:** Moderate**Removal / retention reason:** N/A.**Amenity value:** High**Works Required:** N/A.

**SRZ (m):** 2.9      **Works priority:** N/A  
**TPZ (m):** 7.9      **Construction Proximity:** 0.1  
**mTPZ (m):**

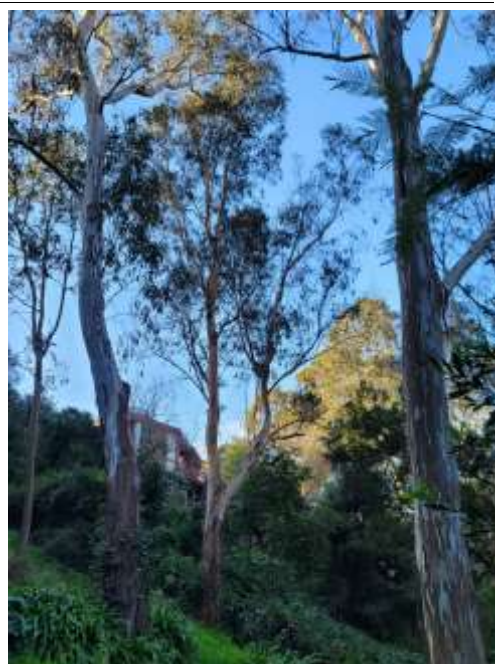
**Tree ID: 159****Genus / species:** *Eucalyptus camaldulensis*

**Retention Value:** High**Removal / retention reason:** N/A.**Amenity value:** High**Works Required:** N/A.

**SRZ (m):** 2.7      **Works priority:** N/A  
**TPZ (m):** 6.6      **Construction Proximity:** 0.1  
**mTPZ (m):**

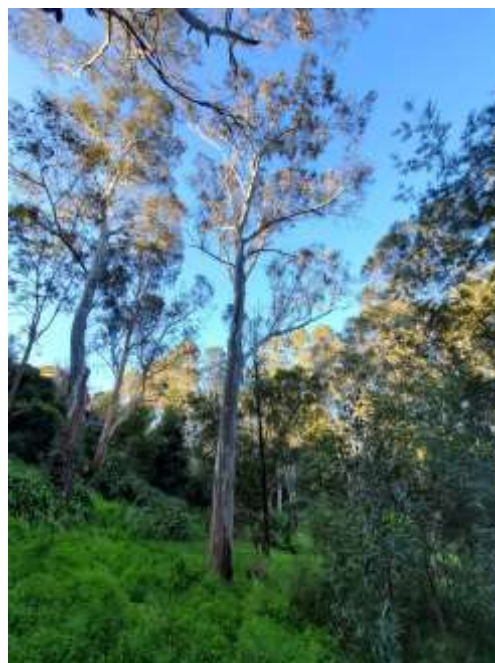
**Tree ID: 160****Genus / species:** *Eucalyptus camaldulensis*

**Retention Value:** High**Removal / retention reason:** N/A.**Amenity value:** High**Works Required:** N/A.

**SRZ (m):** 2.9      **Works priority:** N/A  
**TPZ (m):** 7.9      **Construction Proximity:** 0.1  
**mTPZ (m):**

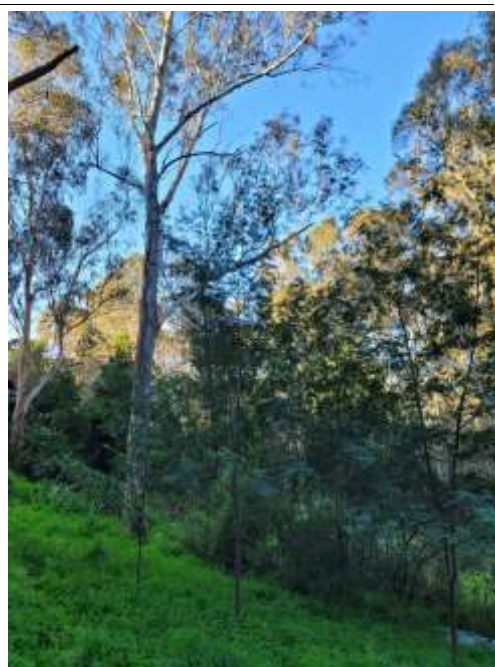
**Tree ID: 161****Genus / species:** *Acacia mearnsii*

**Retention Value:** Low**Removal / retention reason:** N/A.**Amenity value:** Low**Works Required:** N/A.

**SRZ (m):** 1.6      **Works priority:** N/A  
**TPZ (m):** 2.0      **Construction Proximity:** 0.1  
**mTPZ (m):**

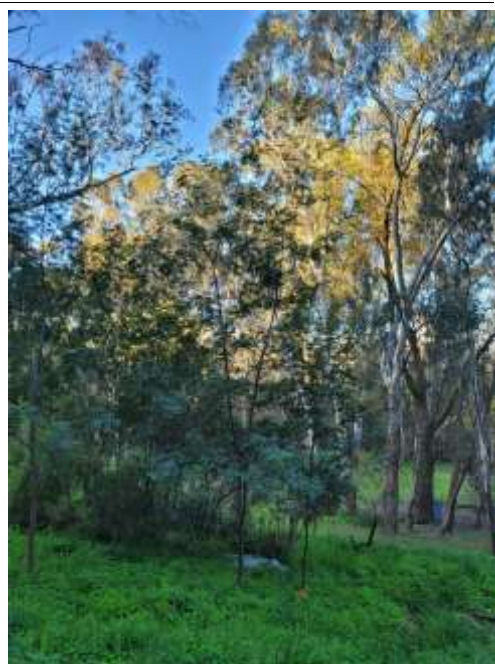
**Tree ID: 162****Genus / species:** *Acacia mearnsii*

**Retention Value:** Low**Removal / retention reason:** N/A.**Amenity value:** Low**Works Required:** N/A.

**SRZ (m):** 1.6      **Works priority:** N/A  
**TPZ (m):** 2.0      **Construction Proximity:** 0.1  
**mTPZ (m):**

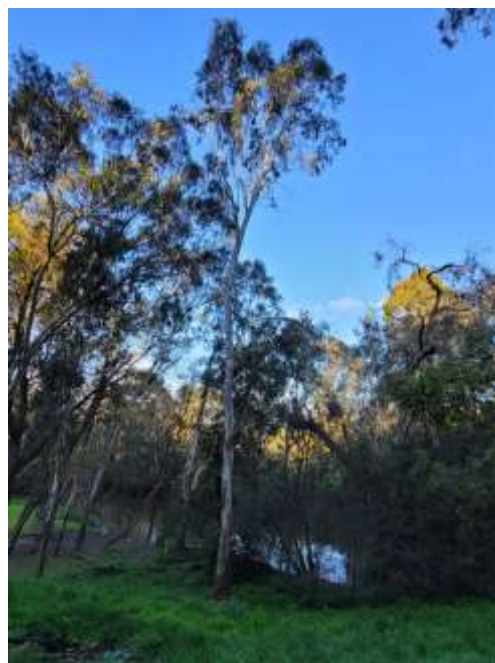
**Tree ID: 163****Genus / species:** *Eucalyptus camaldulensis*

**Retention Value:** Very high**Removal / retention reason:** N/A.**Amenity value:** High**Works Required:** N/A.

**SRZ (m):** 2      **Works priority:** N/A  
**TPZ (m):** 3.1      **Construction Proximity:** 0.1  
**mTPZ (m):**

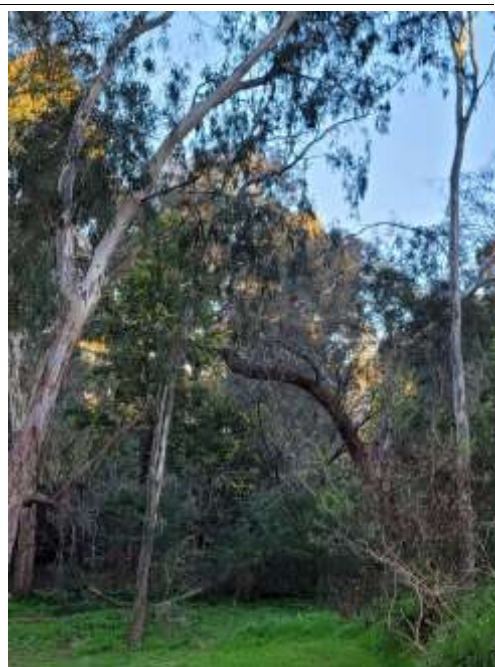
**Tree ID: 164****Genus / species:** *Eucalyptus camaldulensis*

**Retention Value:** High**Removal / retention reason:** N/A.**Amenity value:** High**Works Required:** N/A.

**SRZ (m):** 1.9      **Works priority:** N/A  
**TPZ (m):** 3.0      **Construction Proximity:** 0.1  
**mTPZ (m):**

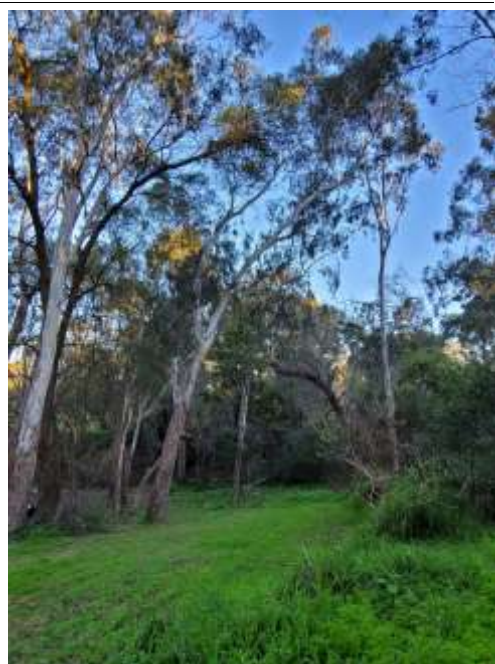
**Tree ID: 165****Genus / species:** *Eucalyptus camaldulensis*

**Retention Value:** Very high**Removal / retention reason:** N/A.**Amenity value:** High**Works Required:** N/A.

**SRZ (m):** 2.8      **Works priority:** N/A  
**TPZ (m):** 7.2      **Construction Proximity:** 0.1  
**mTPZ (m):**

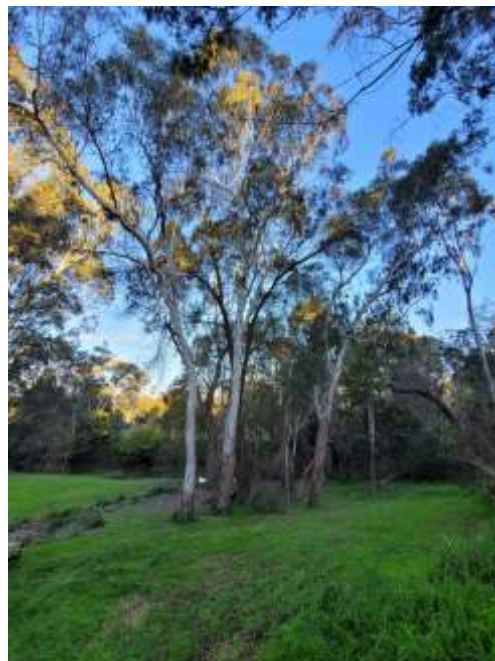
**Tree ID: 166****Genus / species:** *Eucalyptus camaldulensis*

**Retention Value:** Very high**Removal / retention reason:** N/A.**Amenity value:** High**Works Required:** N/A.

**SRZ (m):** 2.8      **Works priority:** N/A  
**TPZ (m):** 7.7      **Construction Proximity:** 0.1  
**mTPZ (m):**

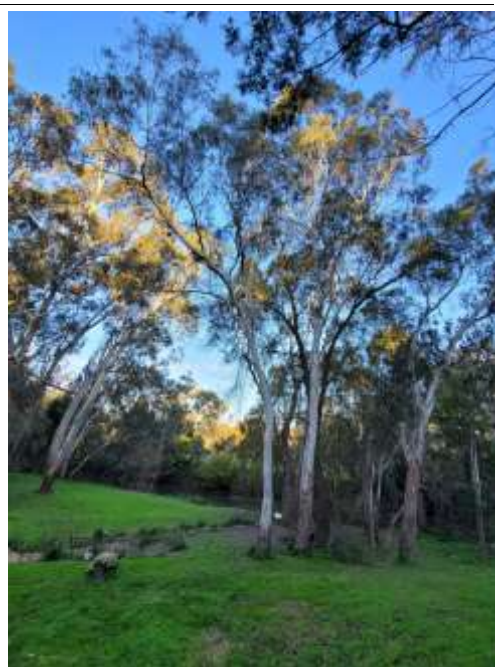
**Tree ID: 167****Genus / species:** *Eucalyptus camaldulensis*

**Retention Value:** High**Removal / retention reason:** N/A.**Amenity value:** High**Works Required:** N/A.

**SRZ (m):** 2.6      **Works priority:** N/A  
**TPZ (m):** 6.1      **Construction Proximity:** 0.1  
**mTPZ (m):**

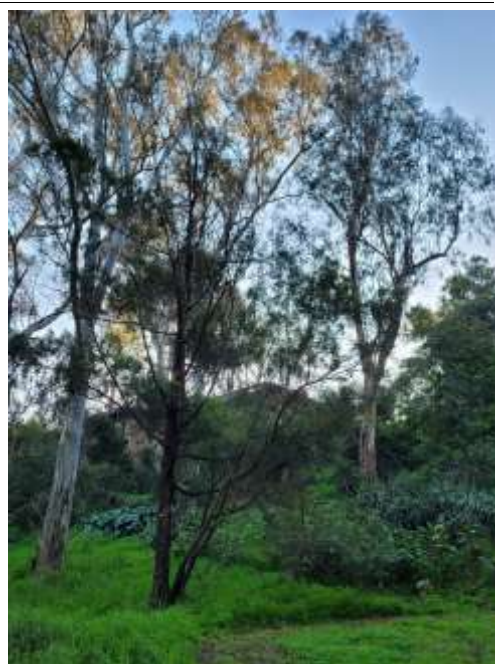
**Tree ID: 168****Genus / species:** *Acacia mearnsii*

**Retention Value:** Remove.**Removal / retention reason:** N/A.**Amenity value:** Very low**Works Required:** N/A.

**SRZ (m):** 2.1      **Works priority:** N/A  
**TPZ (m):** 3.6      **Construction Proximity:** 0.1  
**mTPZ (m):**

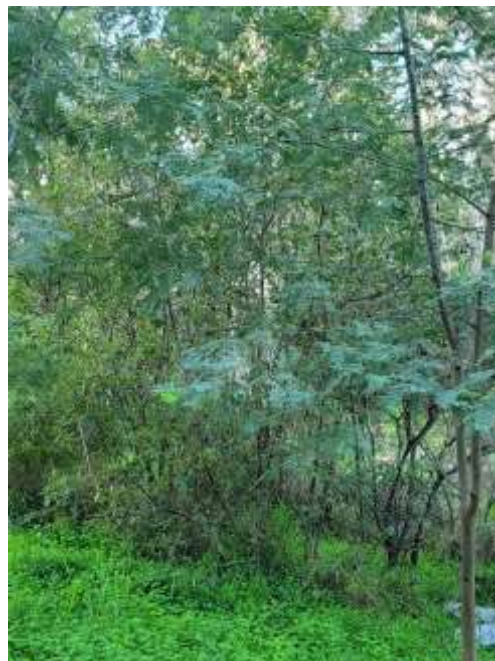
**Tree ID: 169****Genus / species:** *Pomaderris aspera*

**Retention Value:** Low**Removal / retention reason:** N/A.**Amenity value:** Low**Works Required:** N/A.

**SRZ (m):** 1.6      **Works priority:** N/A  
**TPZ (m):** 2.0      **Construction Proximity:** 0.1  
**mTPZ (m):**

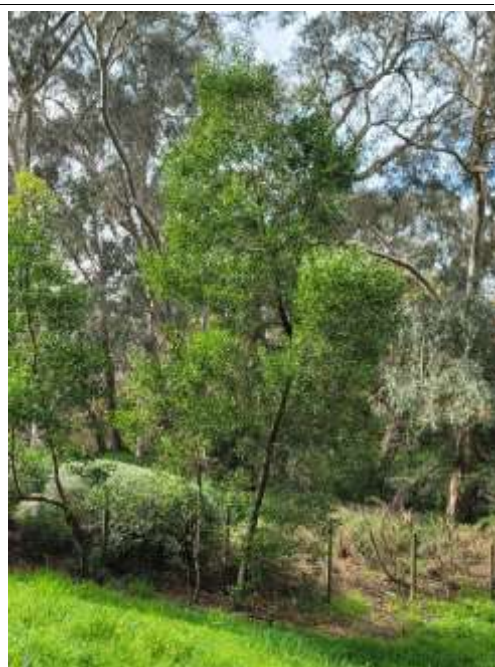
**Tree ID: 170****Genus / species:** *Unknown sp.*

**Retention Value:** Low**Removal / retention reason:** N/A.**Amenity value:** Low**Works Required:** N/A.

**SRZ (m):** 1.6      **Works priority:** N/A  
**TPZ (m):** 2.0      **Construction Proximity:** 0.1  
**mTPZ (m):**

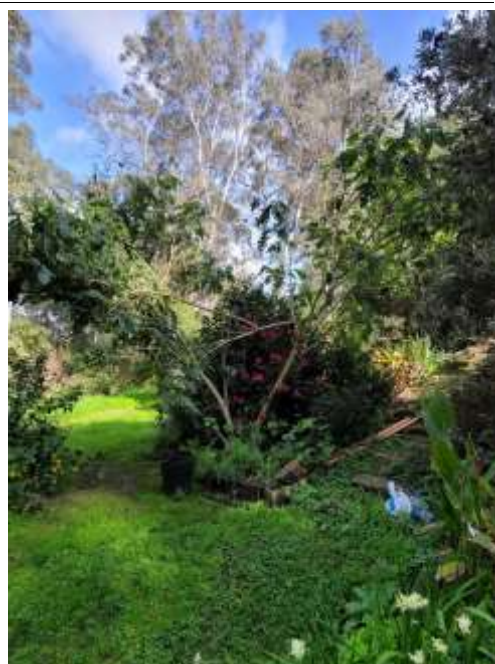
**Tree ID: 171****Genus / species:** *Banksia integrifolia*

**Retention Value:** Low**Removal / retention reason:** N/A.**Amenity value:** Low**Works Required:** N/A.

**SRZ (m):** 1.9      **Works priority:** N/A  
**TPZ (m):** 2.8      **Construction Proximity:** 0.1  
**mTPZ (m):**

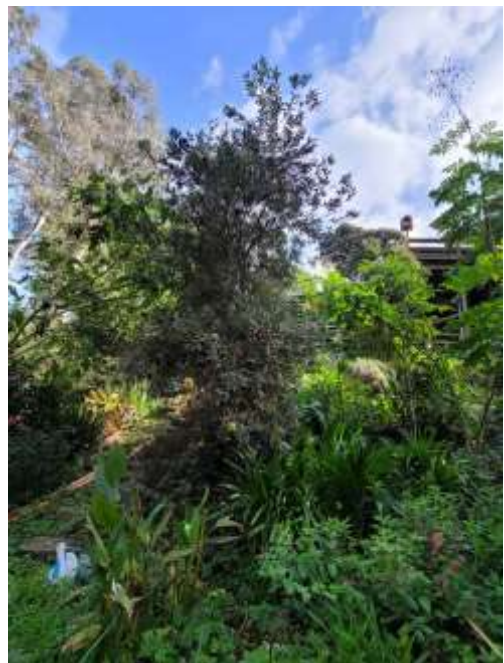
**Tree ID: 172****Genus / species:** *Geijera parvifolia*

**Retention Value:** Low**Removal / retention reason:** N/A.**Amenity value:** Low**Works Required:** N/A.

**SRZ (m):** 2.1      **Works priority:** N/A  
**TPZ (m):** 3.6      **Construction Proximity:** 0.1  
**mTPZ (m):**

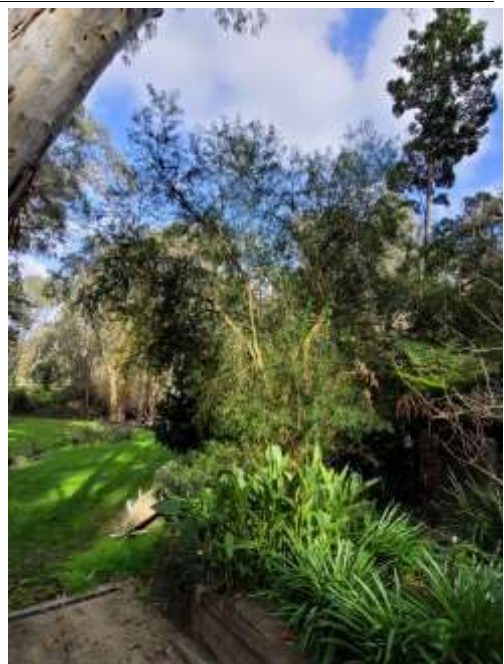
**Tree ID: 173****Genus / species:** *Hymenosporum flavum*

**Retention Value:** High**Removal / retention reason:** N/A.**Amenity value:** Moderate**Works Required:** N/A.

**SRZ (m):** 1.9      **Works priority:** N/A  
**TPZ (m):** 2.8      **Construction Proximity:** 0.1  
**mTPZ (m):**

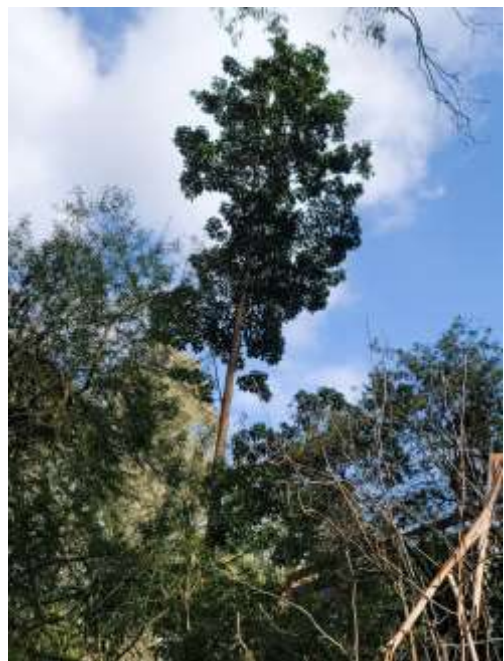
**Tree ID: 174****Genus / species:** *Eucalyptus camaldulensis*

**Retention Value:** High**Removal / retention reason:** N/A.**Amenity value:** High**Works Required:** N/A.

**SRZ (m):** 3.3      **Works priority:** N/A  
**TPZ (m):** 10.4      **Construction Proximity:** 0.1  
**mTPZ (m):**

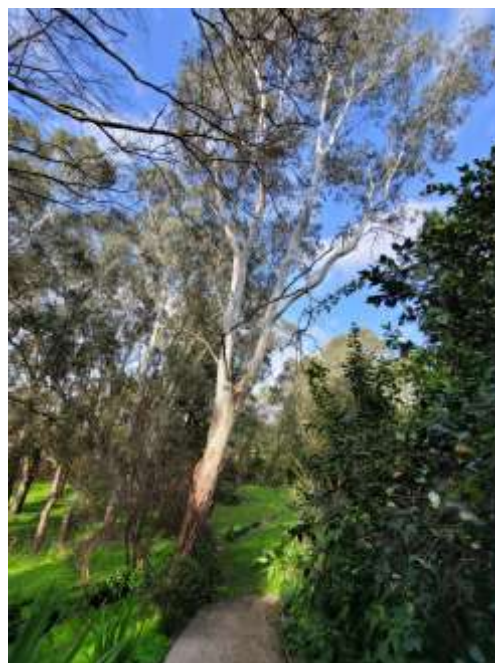
**Tree ID: 175****Genus / species:** *Crataegus monogyna*

**Retention Value:** Low**Removal / retention reason:** N/A.**Amenity value:** Low**Works Required:** N/A.

**SRZ (m):** 2      **Works priority:** N/A  
**TPZ (m):** 3.2      **Construction Proximity:** 0.1  
**mTPZ (m):**

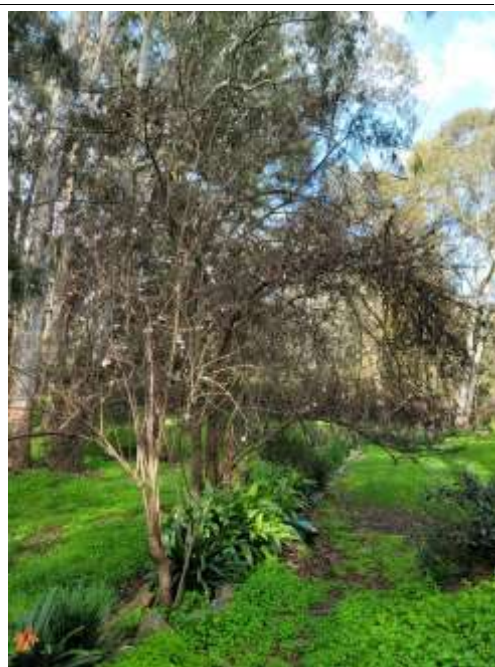
**Tree ID: 176****Genus / species:** *Fraxinus raywoodii*

**Retention Value:** Very high**Removal / retention reason:** N/A.**Amenity value:** High**Works Required:** N/A.

**SRZ (m):** 2.8      **Works priority:** N/A  
**TPZ (m):** 7.4      **Construction Proximity:** 0.1  
**mTPZ (m):**

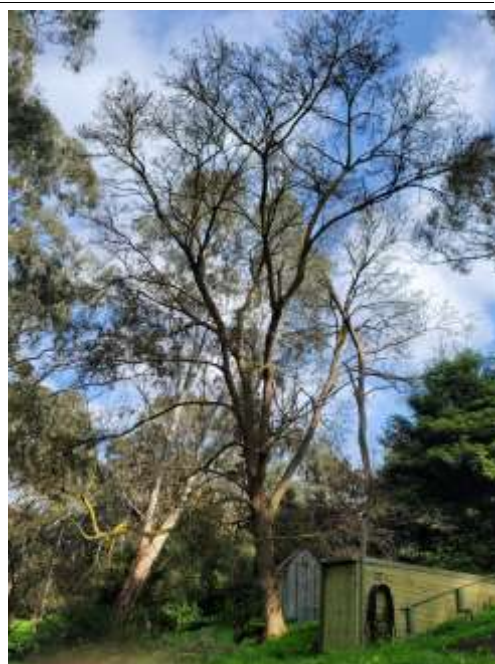
**Tree ID: 177****Genus / species:** *Eucalyptus camaldulensis*

**Retention Value:** Low**Removal / retention reason:** N/A.**Amenity value:** Low**Works Required:** N/A.

**SRZ (m):** 2.9      **Works priority:** N/A  
**TPZ (m):** 8.0      **Construction Proximity:** 0.1  
**mTPZ (m):**

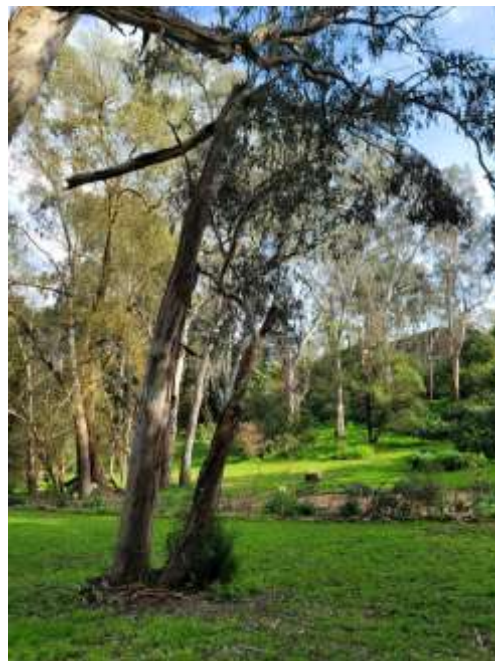
**Tree ID: 178****Genus / species:** *Grevillea robusta*

**Retention Value:** Very high**Removal / retention reason:** N/A.**Amenity value:** High**Works Required:** N/A.

**SRZ (m):** 2.7      **Works priority:** N/A  
**TPZ (m):** 6.8      **Construction Proximity:** 0.1  
**mTPZ (m):**

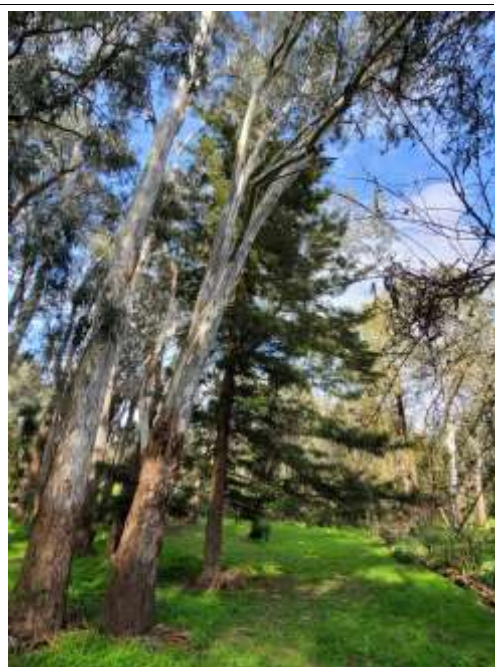
**Tree ID: 179****Genus / species:** *Eucalyptus camaldulensis*

**Retention Value:** High**Removal / retention reason:** N/A.**Amenity value:** High**Works Required:** N/A.

**SRZ (m):** 3.2      **Works priority:** N/A  
**TPZ (m):** 9.5      **Construction Proximity:** 0.1  
**mTPZ (m):**

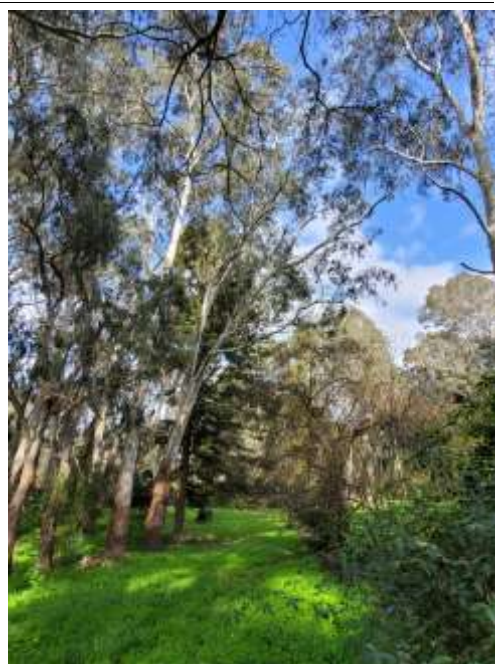
**Tree ID: 180****Genus / species:** *Eucalyptus camaldulensis*

**Retention Value:** Very high**Removal / retention reason:** N/A.**Amenity value:** High**Works Required:** N/A.

**SRZ (m):** 3.2      **Works priority:** N/A  
**TPZ (m):** 9.5      **Construction Proximity:** 0.1  
**mTPZ (m):**

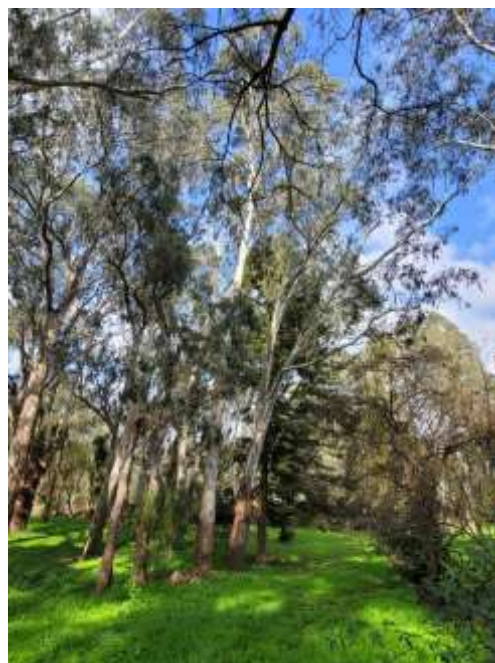
**Tree ID: 181****Genus / species:** *Eucalyptus camaldulensis*

**Retention Value:** Moderate**Removal / retention reason:** N/A.**Amenity value:** High**Works Required:** N/A.

**SRZ (m):** 2.5      **Works priority:** N/A  
**TPZ (m):** 5.6      **Construction Proximity:** 0.1  
**mTPZ (m):**

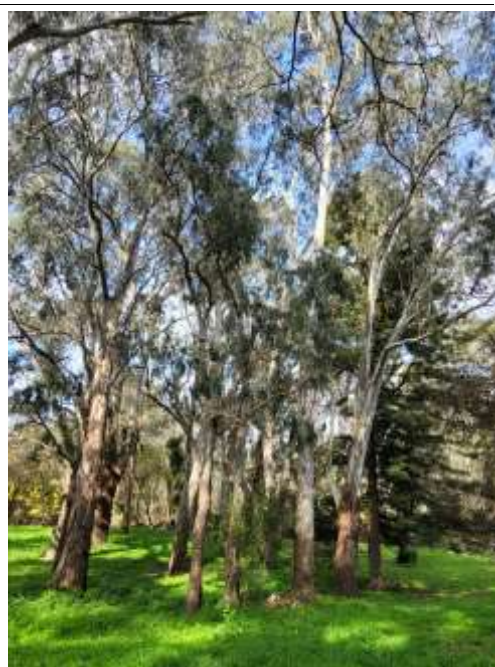
**Tree ID: 182****Genus / species:** *Eucalyptus camaldulensis*

**Retention Value:** Moderate**Removal / retention reason:** N/A.**Amenity value:** Moderate**Works Required:** N/A.

**SRZ (m):** 2.4      **Works priority:** N/A  
**TPZ (m):** 4.8      **Construction Proximity:** 0.1  
**mTPZ (m):**

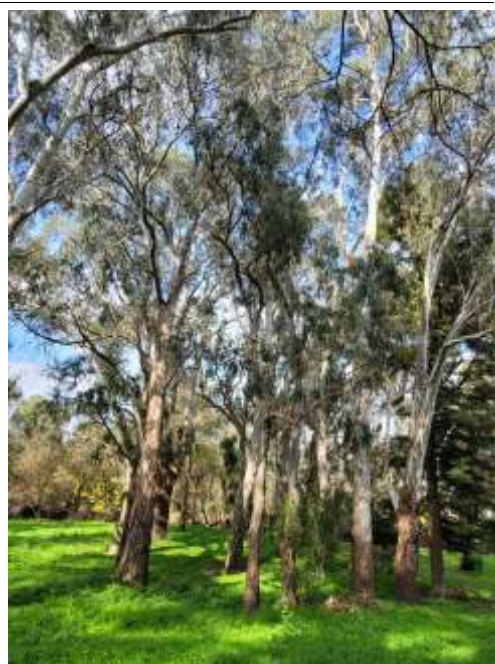
**Tree ID: 183****Genus / species:** *Eucalyptus camaldulensis*

**Retention Value:** Very high**Removal / retention reason:** N/A.**Amenity value:** High**Works Required:** N/A.

**SRZ (m):** 3      **Works priority:** N/A  
**TPZ (m):** 8.9      **Construction Proximity:** 0.1  
**mTPZ (m):**

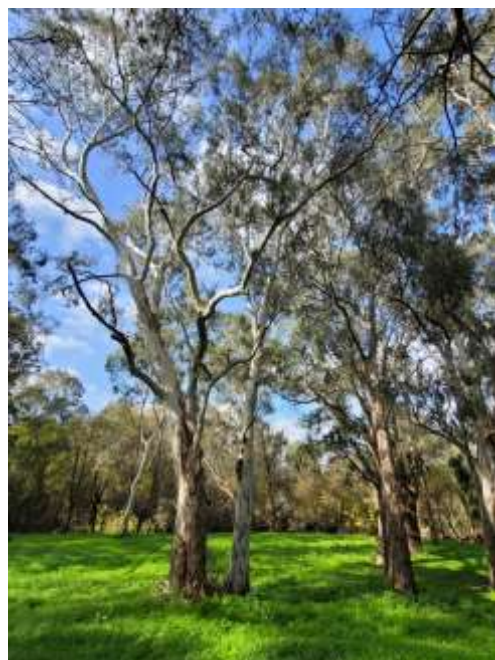
**Tree ID: 184****Genus / species:** *Eucalyptus camaldulensis*

**Retention Value:** High**Removal / retention reason:** N/A.**Amenity value:** High**Works Required:** N/A.

**SRZ (m):** 3.8      **Works priority:** N/A  
**TPZ (m):** 14.5      **Construction Proximity:** 0.1  
**mTPZ (m):**

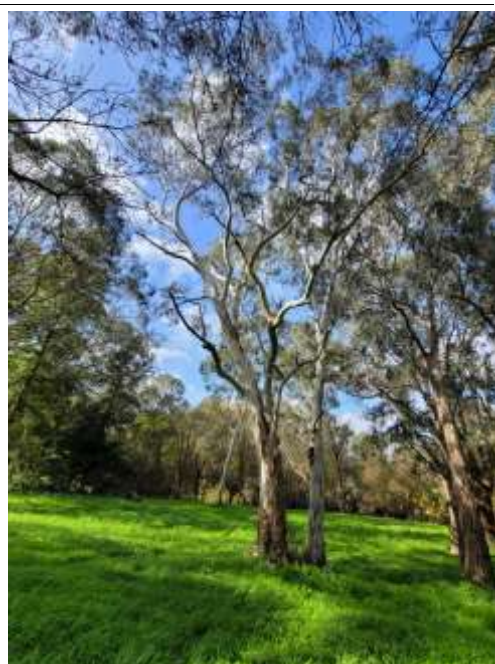
**Tree ID: 185****Genus / species:** *Eucalyptus camaldulensis*

**Retention Value:** High**Removal / retention reason:** N/A.**Amenity value:** High**Works Required:** N/A.

**SRZ (m):** 3      **Works priority:** N/A  
**TPZ (m):** 9.0      **Construction Proximity:** 0.1  
**mTPZ (m):**

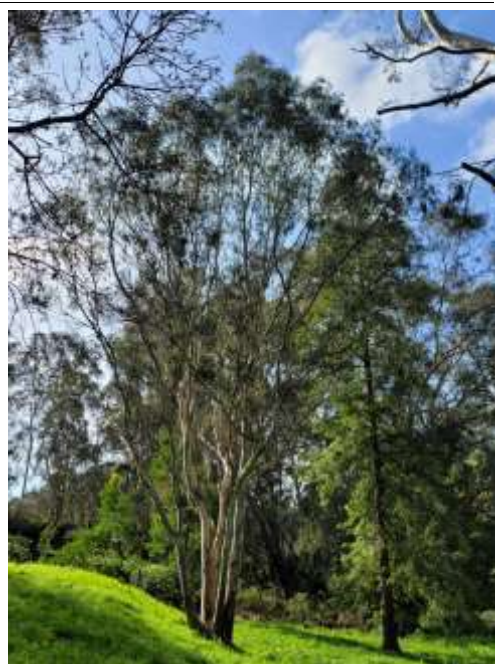
**Tree ID: 187****Genus / species:** *Eucalyptus cladocalyx*

Evergreen Sugar Gum

**Height (m):** 38      **Structure:** Poor  
**Width (m):** 16      **Health:** Fair  
**DBH (cm):** 116 Measured **Maturity:** Over mature  
**Origin:** Australian      **ULE (years):** 15 - 30  
**Retained?:** Retained      **Form:** Good  
**Retention Value:** High  
**Removal / retention reason:** N/A.  
**Amenity value:** High  
**Works Required:** N/A.

**SRZ (m):** 3.7      **Works priority:** N/A  
**TPZ (m):** 13.9      **Construction Proximity:** 0.1  
**mTPZ (m):**

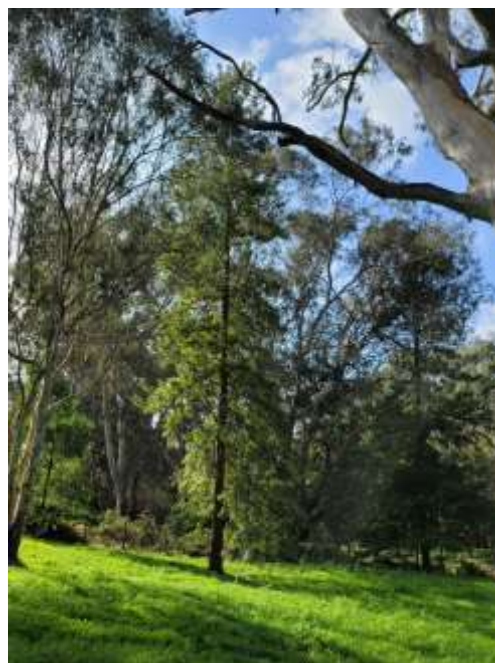
**Tree ID: 188****Genus / species:** *Acacia melanoxylon*

Evergreen Blackwood

**Height (m):** 5      **Structure:** Poor  
**Width (m):** 3      **Health:** Good  
**DBH (cm):** 13 Estimated **Maturity:** Immature  
**Origin:** Melbourne      **ULE (years):** 5 - 15  
**Retained?:** Retained      **Form:** Fair  
**Retention Value:** Low  
**Removal / retention reason:** N/A.  
**Amenity value:** Low  
**Works Required:** N/A.

**SRZ (m):** 1.6      **Works priority:** N/A  
**TPZ (m):** 2.0      **Construction Proximity:** 0.1  
**mTPZ (m):**

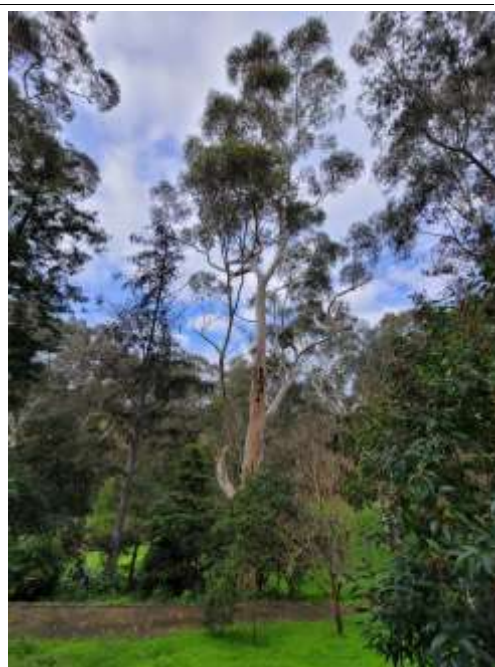
**Tree ID: 189****Genus / species:** *Acacia melanoxylon*

Evergreen Blackwood

**Height (m):** 8      **Structure:** Good  
**Width (m):** 5      **Health:** Good  
**DBH (cm):** 14 Estimated **Maturity:** Immature  
**Origin:** Melbourne      **ULE (years):** 15 - 30  
**Retained?:** Retained      **Form:** Good  
**Retention Value:** Low  
**Removal / retention reason:** N/A.  
**Amenity value:** Low  
**Works Required:** N/A.

**SRZ (m):** 1.6      **Works priority:** N/A  
**TPZ (m):** 2.0      **Construction Proximity:** 0.1  
**mTPZ (m):**

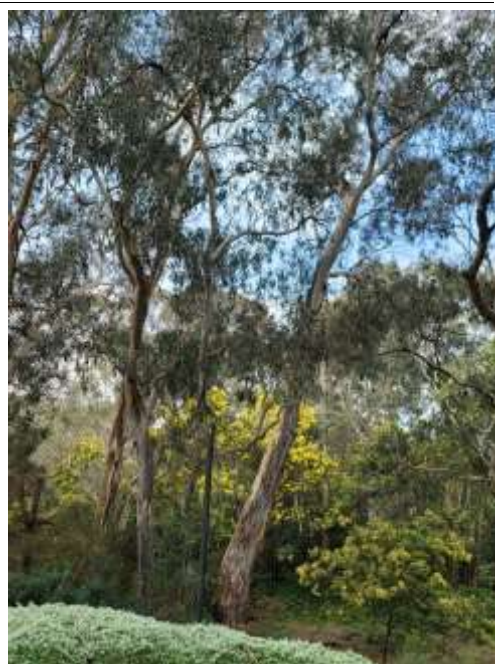
**Tree ID: 202****Genus / species:** *Eucalyptus camaldulensis*

Evergreen River Red Gum

**Height (m):** 17      **Structure:** Good  
**Width (m):** 9      **Health:** Fair  
**DBH (cm):** 44 Measured **Maturity:** Mature  
**Origin:** Melbourne **ULE (years):** 15 - 30  
**Retained?:** Retained **Form:** Fair  
**Retention Value:** High  
**Removal / retention reason:** N/A.  
**Amenity value:** High  
**Works Required:** N/A.

**SRZ (m):** 2.4      **Works priority:** N/A  
**TPZ (m):** 5.3      **Construction Proximity:** 0.1  
**mTPZ (m):**

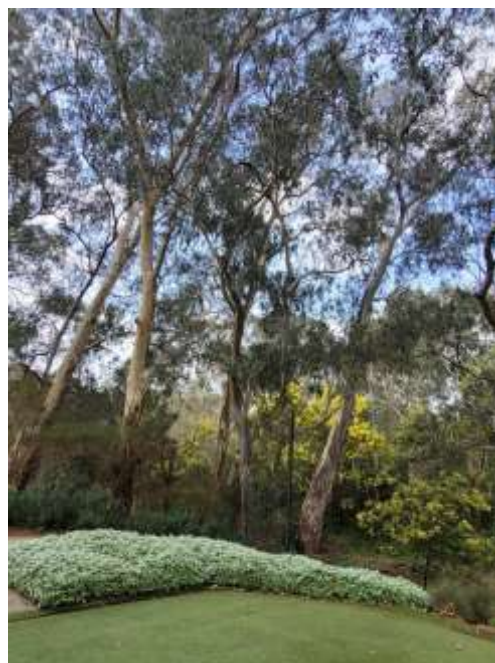
**Tree ID: 203****Genus / species:** *Eucalyptus camaldulensis*

Evergreen River Red Gum

**Height (m):** 30      **Structure:** Good  
**Width (m):** 16      **Health:** Good  
**DBH (cm):** 70 Measured **Maturity:** Mature  
**Origin:** Melbourne **ULE (years):** > 60  
**Retained?:** Retained **Form:** Fair  
**Retention Value:** Very high  
**Removal / retention reason:** N/A.  
**Amenity value:** High  
**Works Required:** N/A.

**SRZ (m):** 2.9      **Works priority:** N/A  
**TPZ (m):** 8.4      **Construction Proximity:** 0.1  
**mTPZ (m):**

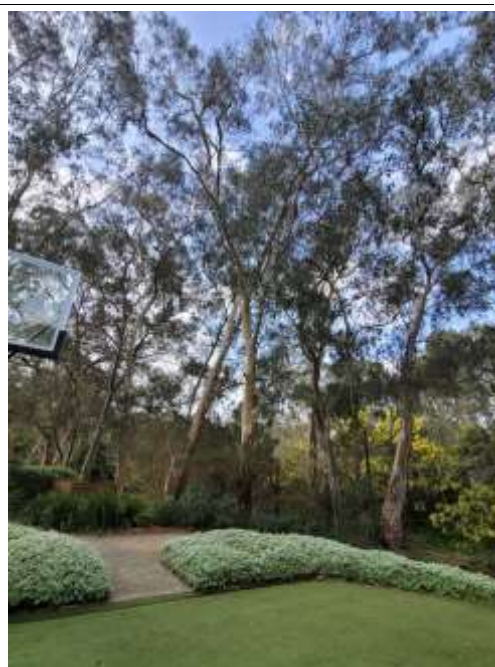
**Tree ID: 204****Genus / species:** *Eucalyptus camaldulensis*

Evergreen River Red Gum

**Height (m):** 37      **Structure:** Good  
**Width (m):** 19      **Health:** Good  
**DBH (cm):** 86 Measured **Maturity:** Mature  
**Origin:** Melbourne **ULE (years):** > 60  
**Retained?:** Retained **Form:** Good  
**Retention Value:** Very high  
**Removal / retention reason:** N/A.  
**Amenity value:** High  
**Works Required:** N/A.

**SRZ (m):** 3.3      **Works priority:** N/A  
**TPZ (m):** 10.3      **Construction Proximity:** 0.1  
**mTPZ (m):**

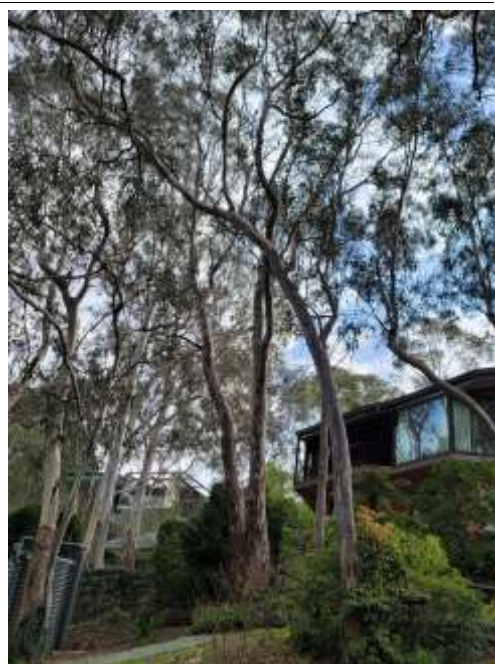
**Tree ID: 208****Genus / species:** *Eucalyptus camaldulensis*

Evergreen River Red Gum

**Height (m):** 14      **Structure:** Good  
**Width (m):** 3      **Health:** Poor  
**DBH (cm):** 18 Measured **Maturity:** Immature  
**Origin:** Melbourne **ULE (years):** 15 - 30  
**Retained?:** Retained **Form:** Fair  
**Retention Value:** Moderate  
**Removal / retention reason:** N/A.  
**Amenity value:** Moderate  
**Works Required:** N/A.

**SRZ (m):** 1.7      **Works priority:** N/A  
**TPZ (m):** 2.2      **Construction Proximity:** 0.1  
**mTPZ (m):**

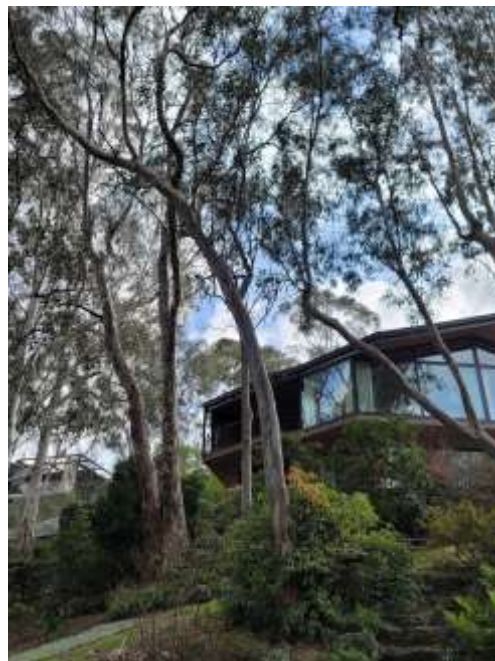
**Tree ID: 209****Genus / species:** *Eucalyptus camaldulensis*

Evergreen River Red Gum

**Height (m):** 21      **Structure:** Good  
**Width (m):** 8      **Health:** Fair  
**DBH (cm):** 30 Measured **Maturity:** Immature  
**Origin:** Melbourne **ULE (years):** 30 - 60  
**Retained?:** Retained **Form:** Fair  
**Retention Value:** High  
**Removal / retention reason:** N/A.  
**Amenity value:** High  
**Works Required:** N/A.

**SRZ (m):** 2.1      **Works priority:** N/A  
**TPZ (m):** 3.6      **Construction Proximity:** 0.1  
**mTPZ (m):**
