## **Nation Partners**

# **Northern Sewers Relining Project Southern Section**

## **Construction Impact Report**

**Wednesday 4<sup>th</sup> December 2024**

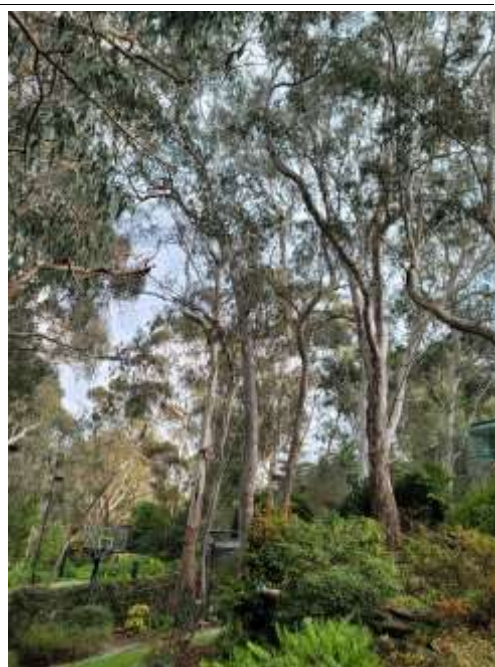
**Tree ID: 210****Genus / species:** *Eucalyptus camaldulensis*

Evergreen River Red Gum

**Height (m):** 24      **Structure:** Fair  
**Width (m):** 6      **Health:** Good  
**DBH (cm):** 47 Measured **Maturity:** Mature  
**Origin:** Melbourne **ULE (years):** > 60  
**Retained?:** Retained **Form:** Good  
**Retention Value:** Very high  
**Removal / retention reason:** N/A.  
**Amenity value:** High  
**Works Required:** N/A.

**SRZ (m):** 2.5      **Works priority:** N/A  
**TPZ (m):** 5.6      **Construction Proximity:** 0.1  
**mTPZ (m):**

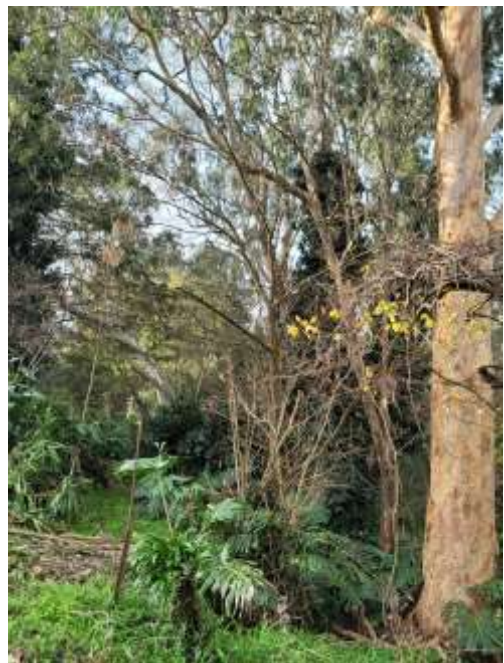
**Tree ID: 224****Genus / species:** *Eucalyptus cladocalyx*

Evergreen Sugar Gum

**Height (m):** 12                      **Structure:** Fair  
**Width (m):** 7                      **Health:** Fair  
**DBH (cm):** 25      Estimated **Maturity:** Immature  
**Origin:** Australian                      **ULE (years):** 15 - 30  
**Retained?:** Retained                      **Form:** Fair  
**Retention Value:** Moderate  
**Removal / retention reason:** N/A.  
**Amenity value:** Moderate  
**Works Required:** N/A.

**SRZ (m):** 1.9              **Works priority:** N/A  
**TPZ (m):** 3.0              **Construction Proximity:** 0.1  
**mTPZ (m):**

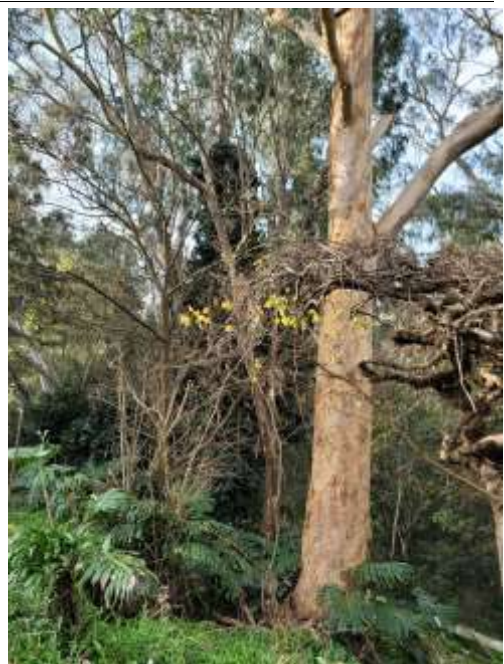
**Tree ID: 225****Genus / species:** *Eucalyptus camaldulensis*

Evergreen River Red Gum

**Height (m):** 19                      **Structure:** Fair  
**Width (m):** 8                      **Health:** Good  
**DBH (cm):** 45      Estimated **Maturity:** Mature  
**Origin:** Melbourne                      **ULE (years):** 30 - 60  
**Retained?:** Retained                      **Form:** Fair  
**Retention Value:** High  
**Removal / retention reason:** N/A.  
**Amenity value:** High  
**Works Required:** N/A.

**SRZ (m):** 2.5              **Works priority:** N/A  
**TPZ (m):** 5.4              **Construction Proximity:** 0.1  
**mTPZ (m):**

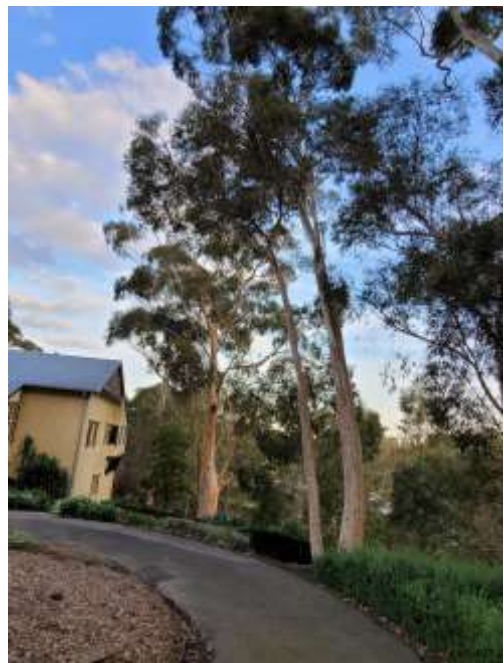
**Tree ID: 240****Genus / species:** *Eucalyptus cladocalyx*

Evergreen Sugar Gum

**Height (m):** 37      **Structure:** Good  
**Width (m):** 11      **Health:** Good  
**DBH (cm):** 65 Measured **Maturity:** Mature  
**Origin:** Australian **ULE (years):** 30 - 60  
**Retained?:** Retained **Form:** Fair  
**Retention Value:** High  
**Removal / retention reason:** N/A.  
**Amenity value:** High  
**Works Required:** N/A.

**SRZ (m):** 2.9      **Works priority:** N/A  
**TPZ (m):** 7.8      **Construction Proximity:** 0.1  
**mTPZ (m):**

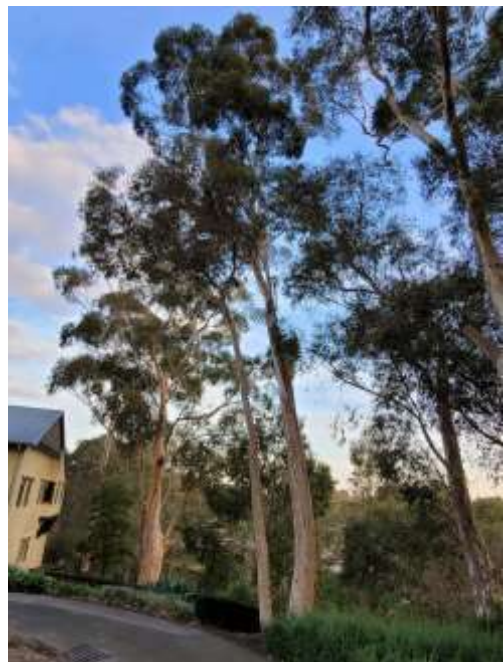
**Tree ID: 241****Genus / species:** *Eucalyptus cladocalyx*

Evergreen Sugar Gum

**Height (m):** 17      **Structure:** Fair  
**Width (m):** 13      **Health:** Fair  
**DBH (cm):** 55 Measured **Maturity:** Mature  
**Origin:** Australian **ULE (years):** 15 - 30  
**Retained?:** Retained **Form:** Fair  
**Retention Value:** High  
**Removal / retention reason:** N/A.  
**Amenity value:** High  
**Works Required:** N/A.

**SRZ (m):** 2.7      **Works priority:** N/A  
**TPZ (m):** 6.6      **Construction Proximity:** 0.1  
**mTPZ (m):**

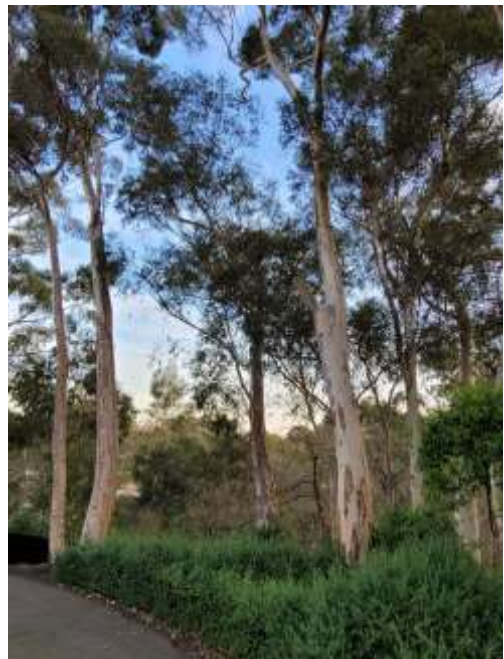
**Tree ID: 242****Genus / species:** *Corymbia maculata*

Evergreen Spotted Gum

**Height (m):** 12      **Structure:** Good  
**Width (m):** 8      **Health:** Good  
**DBH (cm):** 19 Measured **Maturity:** Immature  
**Origin:** Victorian **ULE (years):** > 60  
**Retained?:** Retained **Form:** Good  
**Retention Value:** High  
**Removal / retention reason:** N/A.  
**Amenity value:** Moderate  
**Works Required:** N/A.

**SRZ (m):** 1.7      **Works priority:** N/A  
**TPZ (m):** 2.3      **Construction Proximity:** 0.1  
**mTPZ (m):**

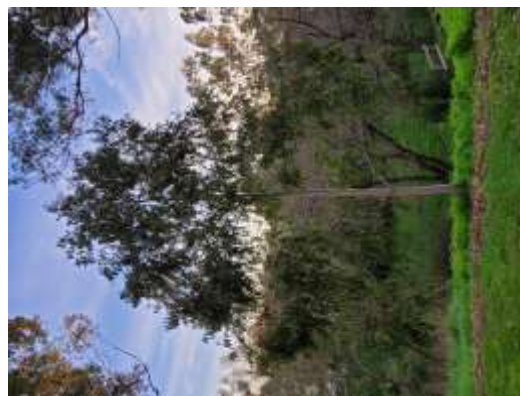
**Tree ID: 243****Genus / species:** *Eucalyptus cladocalyx*

Evergreen Sugar Gum

**Height (m):** 36      **Structure:** Good  
**Width (m):** 15      **Health:** Good  
**DBH (cm):** 96 Measured **Maturity:** Over mature  
**Origin:** Australian **ULE (years):** 30 - 60  
**Retained?:** Retained **Form:** Good  
**Retention Value:** High  
**Removal / retention reason:** N/A.  
**Amenity value:** High  
**Works Required:** N/A.

**SRZ (m):** 3.5      **Works priority:** N/A  
**TPZ (m):** 11.5      **Construction Proximity:** 0.1  
**mTPZ (m):**

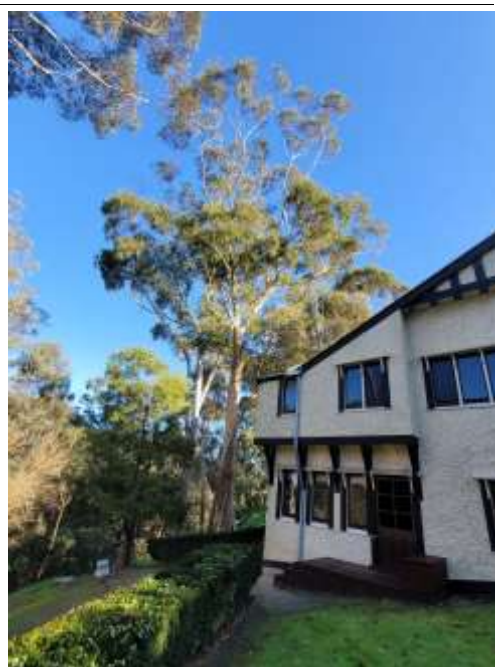
**Tree ID: 244****Genus / species:** *Eucalyptus cladocalyx*

Evergreen Sugar Gum

**Height (m):** 14      **Structure:** Fair  
**Width (m):** 8      **Health:** Good  
**DBH (cm):** 33 Measured **Maturity:** Mature  
**Origin:** Australian **ULE (years):** 30 - 60  
**Retained?:** Retained **Form:** Fair  
**Retention Value:** Moderate  
**Removal / retention reason:** N/A.  
**Amenity value:** Moderate  
**Works Required:** N/A.

**SRZ (m):** 2.2      **Works priority:** N/A  
**TPZ (m):** 4.0      **Construction Proximity:** 0.1  
**mTPZ (m):**

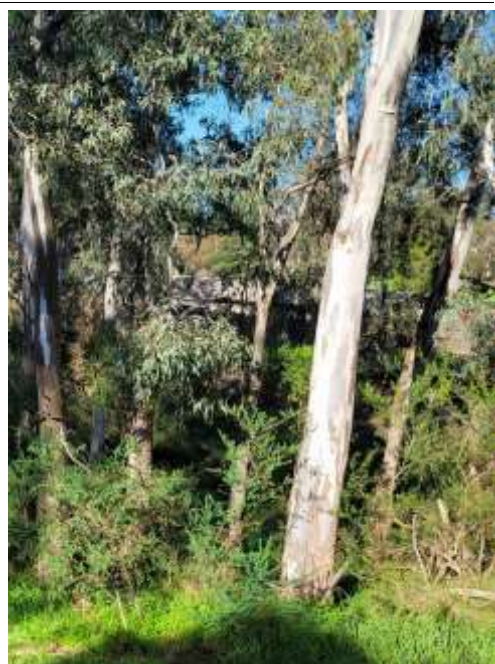
**Tree ID: 257****Genus / species:** *Eucalyptus camaldulensis*

**Height (m):** 19 **Structure:** Good**Width (m):** 8 **Health:** Good**DBH (cm):** 36 Measured **Maturity:** Mature**Origin:** Melbourne **ULE (years):** > 60**Retained?:** Retained **Form:** Fair**Retention Value:** Very high**Removal / retention reason:** N/A.**Amenity value:** High**Works Required:** N/A.**SRZ (m):** 2.3 **Works priority:** N/A**TPZ (m):** 4.3 **Construction Proximity:** 0.1**mTPZ (m):**

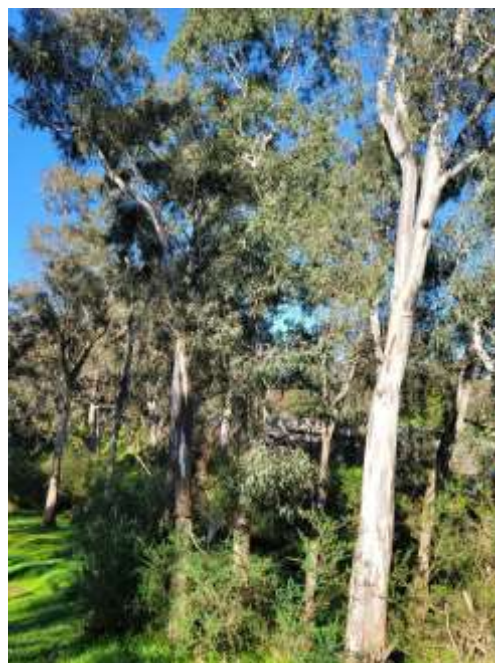
**Tree ID: 258****Genus / species:** *Eucalyptus camaldulensis*

**Height (m):** 18 **Structure:** Good**Width (m):** 8 **Health:** Good**DBH (cm):** 38 Measured **Maturity:** Mature**Origin:** Melbourne **ULE (years):** > 60**Retained?:** Retained **Form:** Fair**Retention Value:** Very high**Removal / retention reason:** N/A.**Amenity value:** High**Works Required:** N/A.**SRZ (m):** 2.3 **Works priority:** N/A**TPZ (m):** 4.6 **Construction Proximity:** 0.1**mTPZ (m):**

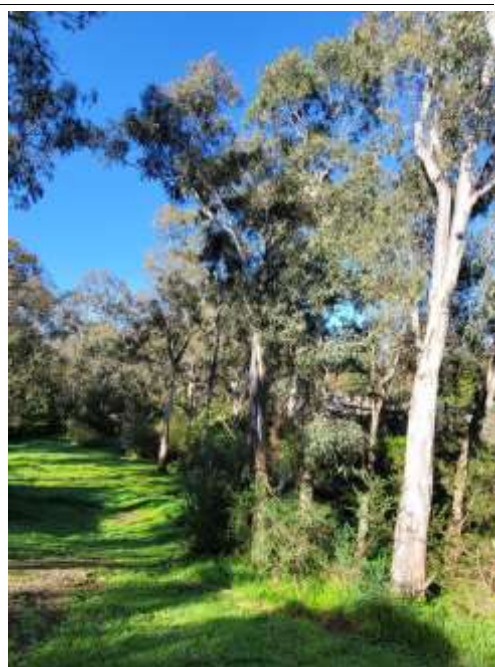
**Tree ID: 259****Genus / species:** *Eucalyptus camaldulensis*

**Height (m):** 21 **Structure:** Good**Width (m):** 8 **Health:** Good**DBH (cm):** 45 Measured **Maturity:** Mature**Origin:** Melbourne **ULE (years):** > 60**Retained?:** Retained **Form:** Good**Retention Value:** Very high**Removal / retention reason:** N/A.**Amenity value:** High**Works Required:** N/A.**SRZ (m):** 2.5 **Works priority:** N/A**TPZ (m):** 5.4 **Construction Proximity:** 0.1**mTPZ (m):**

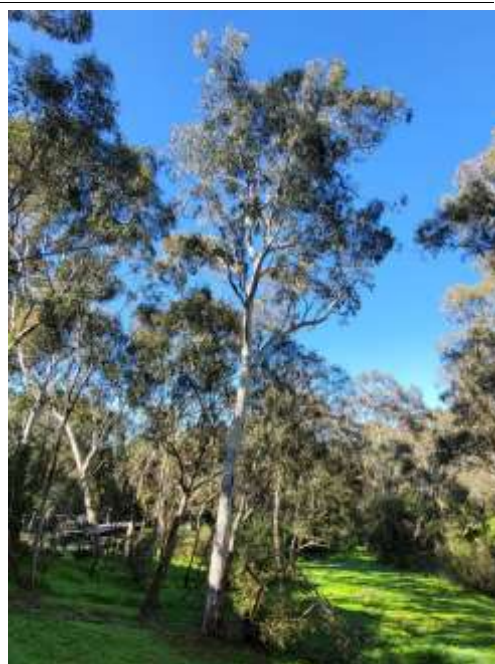
**Tree ID: 260****Genus / species:** *Eucalyptus camaldulensis*

**Height (m):** 10      **Structure:** Good  
**Width (m):** 6      **Health:** Fair  
**DBH (cm):** 26 Measured **Maturity:** Immature  
**Origin:** Melbourne **ULE (years):** 30 - 60  
**Retained?:** Retained **Form:** Good  
**Retention Value:** Low  
**Removal / retention reason:** N/A.  
**Amenity value:** Low  
**Works Required:** N/A.

**SRZ (m):** 2      **Works priority:** N/A  
**TPZ (m):** 3.1      **Construction Proximity:** 0.1  
**mTPZ (m):**

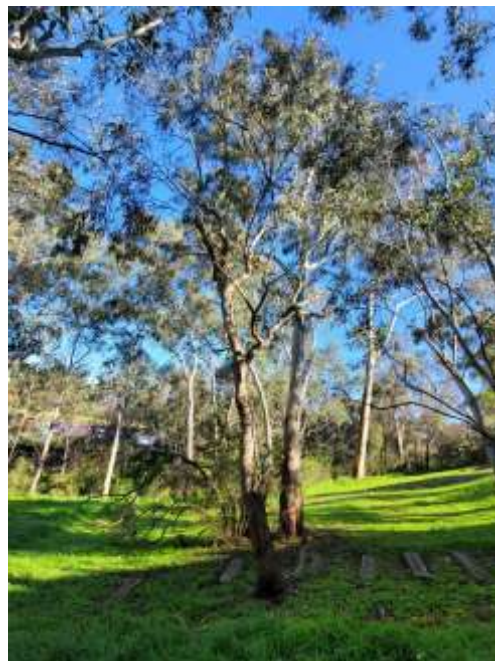
**Tree ID: 261****Genus / species:** *Eucalyptus camaldulensis*

**Height (m):** 5      **Structure:** Poor  
**Width (m):** 2      **Health:** Poor  
**DBH (cm):** 7 Estimated **Maturity:** Immature  
**Origin:** Melbourne **ULE (years):** 5 - 15  
**Retained?:** Retained **Form:** Poor  
**Retention Value:** Very low  
**Removal / retention reason:** N/A.  
**Amenity value:** Very low  
**Works Required:** N/A.

**SRZ (m):** 1.6      **Works priority:** N/A  
**TPZ (m):** 2.0      **Construction Proximity:** 0.1  
**mTPZ (m):**

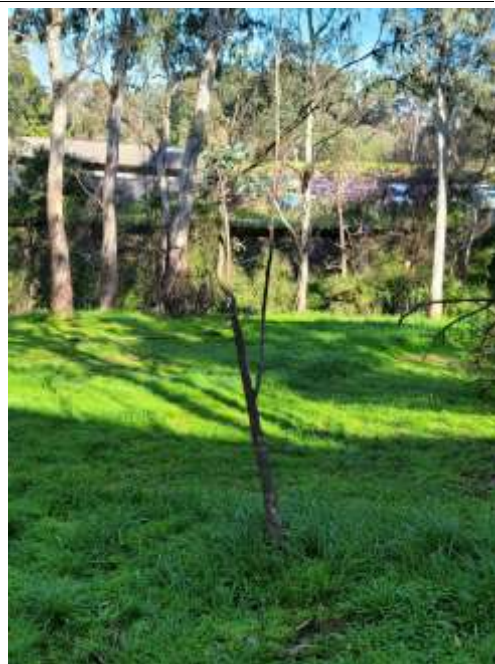
**Tree ID: 262****Genus / species:** *Eucalyptus camaldulensis*

**Height (m):** 12      **Structure:** Good  
**Width (m):** 2      **Health:** Good  
**DBH (cm):** 15 Measured **Maturity:** Immature  
**Origin:** Melbourne **ULE (years):** > 60  
**Retained?:** Retained **Form:** Good  
**Retention Value:** High  
**Removal / retention reason:** N/A.  
**Amenity value:** Moderate  
**Works Required:** N/A.

**SRZ (m):** 1.6      **Works priority:** N/A  
**TPZ (m):** 2.0      **Construction Proximity:** 0.1  
**mTPZ (m):**

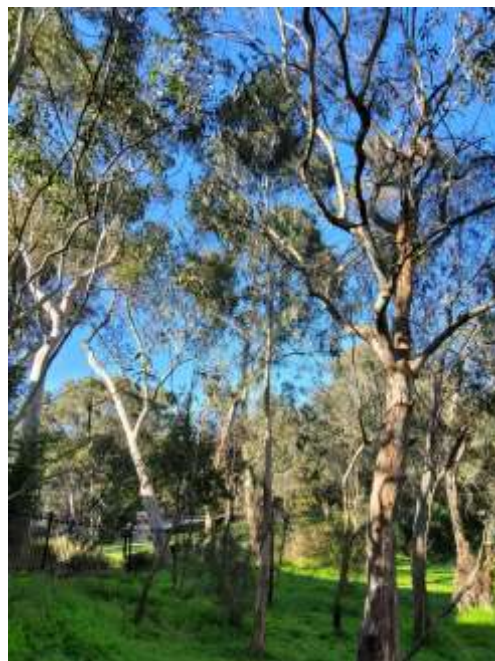
**Tree ID: 263****Genus / species:** *Eucalyptus camaldulensis*

**Height (m):** 8                      **Structure:** Fair  
**Width (m):** 2                      **Health:** Poor  
**DBH (cm):** 10      Estimated **Maturity:** Immature  
**Origin:** Melbourne      **ULE (years):** 15 - 30  
**Retained?:** Retained      **Form:** Fair  
**Retention Value:** Very low  
**Removal / retention reason:** N/A.  
**Amenity value:** Very low  
**Works Required:** N/A.

**SRZ (m):** 1.6              **Works priority:** N/A  
**TPZ (m):** 2.0              **Construction Proximity:** 0.1  
**mTPZ (m):**

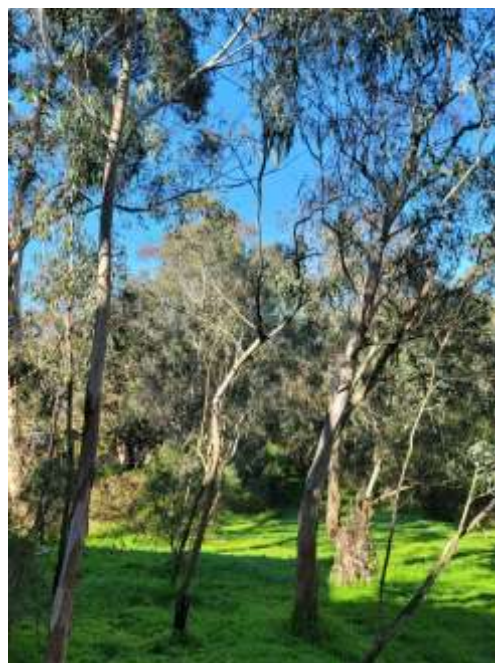
**Tree ID: 264****Genus / species:** *Eucalyptus camaldulensis*

**Height (m):** 12                      **Structure:** Good  
**Width (m):** 5                      **Health:** Good  
**DBH (cm):** 26      Measured **Maturity:** Mature  
**Origin:** Melbourne      **ULE (years):** > 60  
**Retained?:** Retained      **Form:** Good  
**Retention Value:** High  
**Removal / retention reason:** N/A.  
**Amenity value:** Moderate  
**Works Required:** N/A.

**SRZ (m):** 2                      **Works priority:** N/A  
**TPZ (m):** 3.1              **Construction Proximity:** 0.1  
**mTPZ (m):**

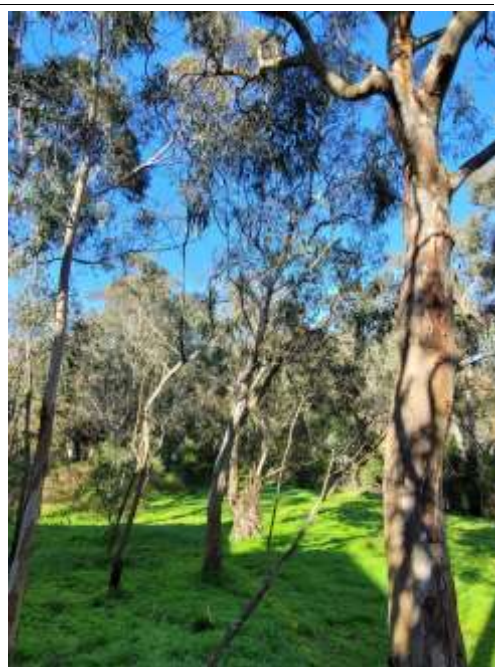
**Tree ID: 265****Genus / species:** *Eucalyptus camaldulensis*

**Height (m):** 13                      **Structure:** Good  
**Width (m):** 7                      **Health:** Poor  
**DBH (cm):** 44      Measured **Maturity:** Mature  
**Origin:** Melbourne      **ULE (years):** 5 - 15  
**Retained?:** Retained      **Form:** Poor  
**Retention Value:** Low  
**Removal / retention reason:** N/A.  
**Amenity value:** Moderate  
**Works Required:** N/A.

**SRZ (m):** 2.4                      **Works priority:** N/A  
**TPZ (m):** 5.3              **Construction Proximity:** 0.1  
**mTPZ (m):**

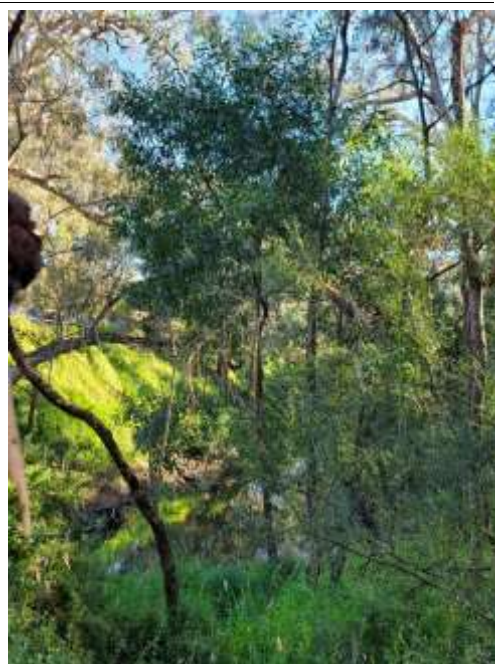
**Tree ID: 281****Genus / species:** *Eucalyptus camaldulensis*

**Height (m):** 12      **Structure:** Good  
**Width (m):** 2      **Health:** Good  
**DBH (cm):** 13      Estimated **Maturity:** Immature  
**Origin:** Melbourne      **ULE (years):** > 60  
**Retained?:** Retained      **Form:** Good  
**Retention Value:** High  
**Removal / retention reason:** N/A.  
**Amenity value:** Moderate  
**Works Required:** N/A.

**SRZ (m):** 1.6      **Works priority:** N/A  
**TPZ (m):** 2.0      **Construction Proximity:** 0.1  
**mTPZ (m):**

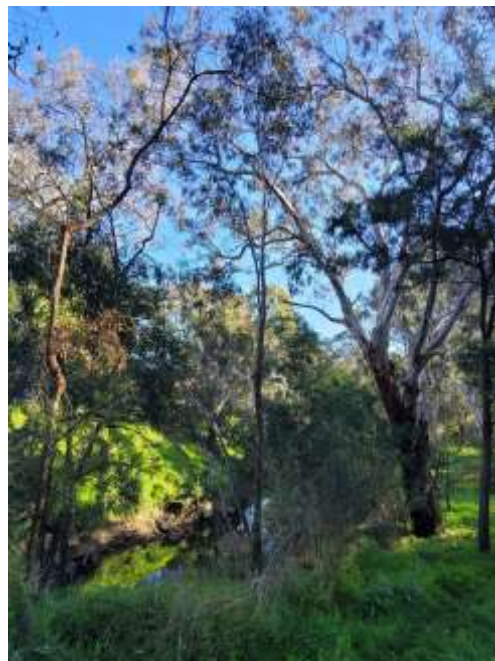
**Tree ID: 282****Genus / species:** *Acacia melanoxylon*

**Height (m):** 9      **Structure:** Good  
**Width (m):** 5      **Health:** Good  
**DBH (cm):** 18      Measured **Maturity:** Immature  
**Origin:** Melbourne      **ULE (years):** 15 - 30  
**Retained?:** Retained      **Form:** Good  
**Retention Value:** Low  
**Removal / retention reason:** N/A.  
**Amenity value:** Low  
**Works Required:** N/A.

**SRZ (m):** 1.7      **Works priority:** N/A  
**TPZ (m):** 2.2      **Construction Proximity:** 0.1  
**mTPZ (m):**

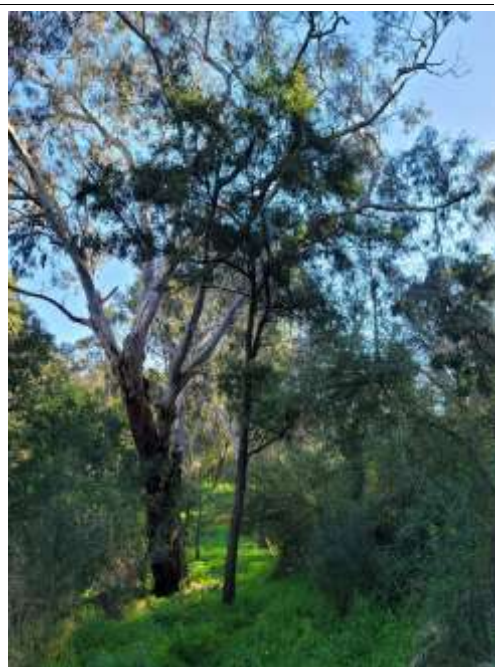
**Tree ID: 283****Genus / species:** *Eucalyptus camaldulensis*

**Height (m):** 10      **Structure:** Poor  
**Width (m):** 8      **Health:** Good  
**DBH (cm):** 32      Estimated **Maturity:** Mature  
**Origin:** Melbourne      **ULE (years):** 5 - 15  
**Retained?:** Retained      **Form:** Good  
**Retention Value:** Low  
**Removal / retention reason:** N/A.  
**Amenity value:** Low  
**Works Required:** N/A.

**SRZ (m):** 2.2      **Works priority:** N/A  
**TPZ (m):** 3.8      **Construction Proximity:** 0.1  
**mTPZ (m):**

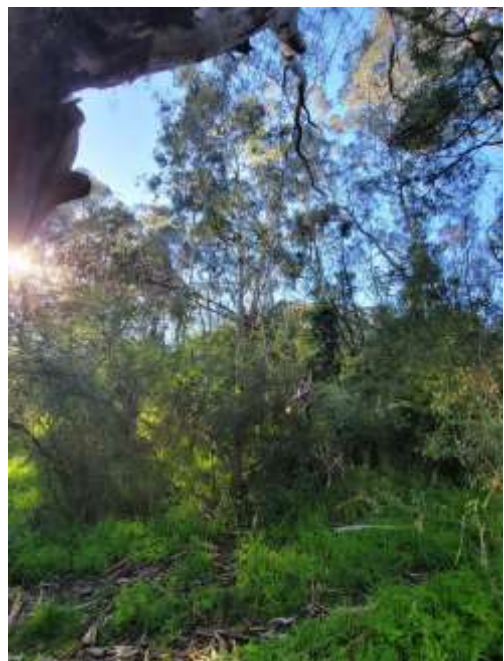
**Tree ID: 287****Genus / species:** *Eucalyptus camaldulensis*

**Height (m):** 7      **Structure:** Fair  
**Width (m):** 2      **Health:** Poor  
**DBH (cm):** 10 Measured **Maturity:** Immature  
**Origin:** Melbourne **ULE (years):** 5 - 15  
**Retained?:** Retained **Form:** Fair  
**Retention Value:** Low  
**Removal / retention reason:** N/A.  
**Amenity value:** Low  
**Works Required:** N/A.

**SRZ (m):** 1.6      **Works priority:** N/A  
**TPZ (m):** 2.0      **Construction Proximity:** 0.1  
**mTPZ (m):**

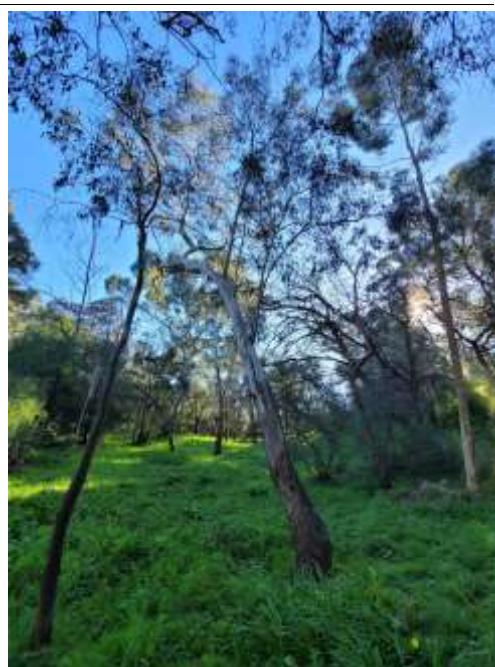
**Tree ID: 289****Genus / species:** *Eucalyptus camaldulensis*

**Height (m):** 13      **Structure:** Fair  
**Width (m):** 5      **Health:** Poor  
**DBH (cm):** 20 Measured **Maturity:** Immature  
**Origin:** Melbourne **ULE (years):** 15 - 30  
**Retained?:** Retained **Form:** Fair  
**Retention Value:** Low  
**Removal / retention reason:** N/A.  
**Amenity value:** Low  
**Works Required:** N/A.

**SRZ (m):** 1.8      **Works priority:** N/A  
**TPZ (m):** 2.4      **Construction Proximity:** 0.1  
**mTPZ (m):**

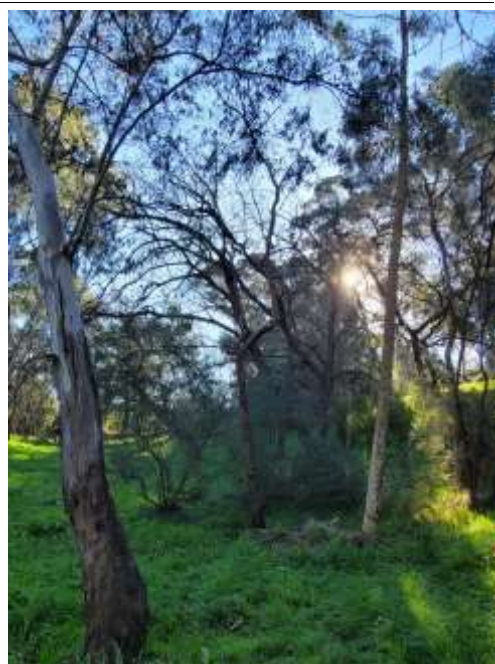
**Tree ID: 290****Genus / species:** *Eucalyptus cladocalyx*

**Retention Value:** Very high**Removal / retention reason:** N/A.**Amenity value:** High**Works Required:** N/A.

**SRZ (m):** 2      **Works priority:** N/A  
**TPZ (m):** 3.1      **Construction Proximity:** 0.1  
**mTPZ (m):**

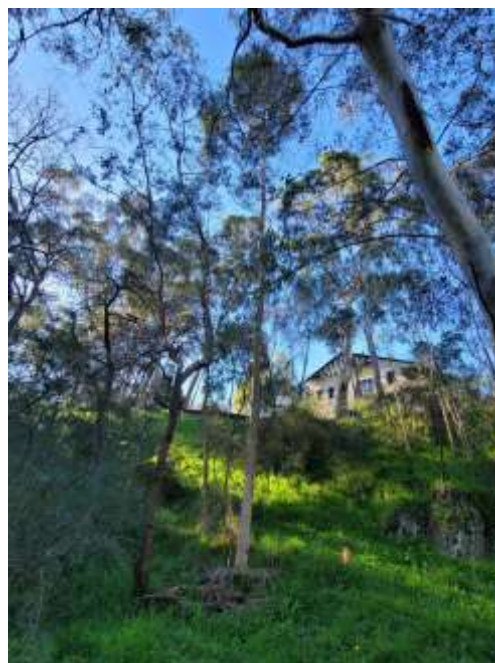
**Tree ID: 291****Genus / species:** *Eucalyptus cladocalyx*

**Retention Value:** Very high**Removal / retention reason:** N/A.**Amenity value:** High**Works Required:** N/A.

**SRZ (m):** 1.9      **Works priority:** N/A  
**TPZ (m):** 2.6      **Construction Proximity:** 0.1  
**mTPZ (m):**

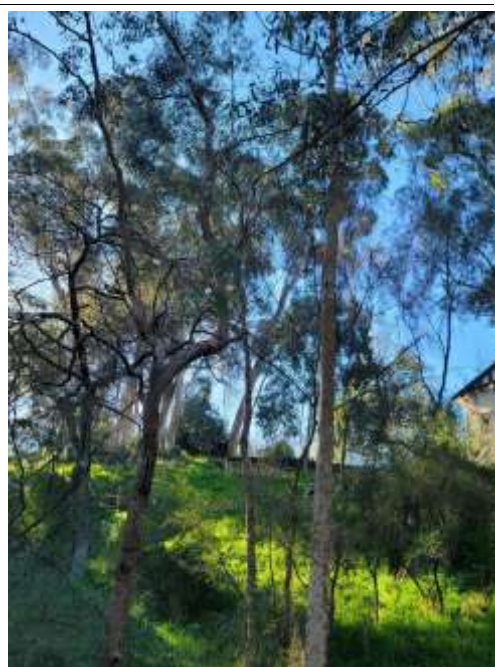
**Tree ID: 292****Genus / species:** *Allocasuarina verticillata*

**Retention Value:** Low**Removal / retention reason:** N/A.**Amenity value:** Low**Works Required:** N/A.

**SRZ (m):** 1.6      **Works priority:** N/A  
**TPZ (m):** 2.0      **Construction Proximity:** 0.1  
**mTPZ (m):**

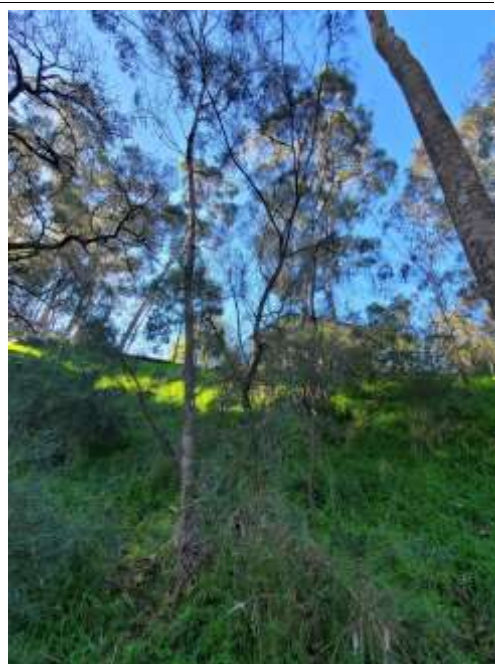
**Tree ID: 293****Genus / species:** *Allocasuarina verticillata*

**Retention Value:** Low**Removal / retention reason:** N/A.**Amenity value:** Low**Works Required:** N/A.

**SRZ (m):** 1.6      **Works priority:** N/A  
**TPZ (m):** 2.0      **Construction Proximity:** 0.1  
**mTPZ (m):**

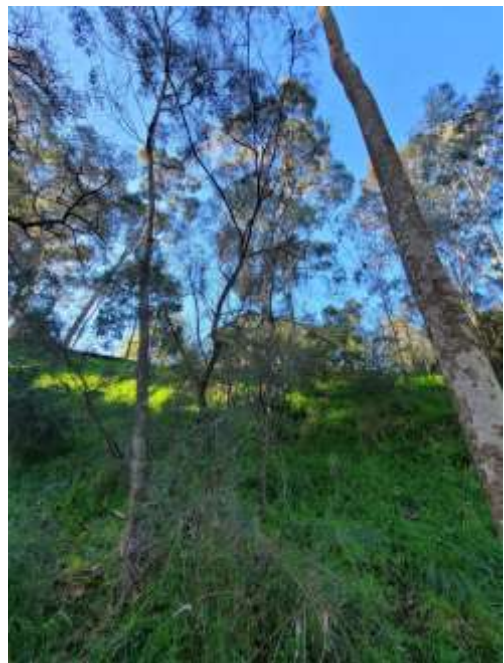
**Tree ID: 294****Genus / species:** *Quercus robur*

**Retention Value:** High**Removal / retention reason:** N/A.**Amenity value:** Moderate**Works Required:** N/A.

**SRZ (m):** 2.6      **Works priority:** N/A  
**TPZ (m):** 5.9      **Construction Proximity:** 0.1  
**mTPZ (m):**

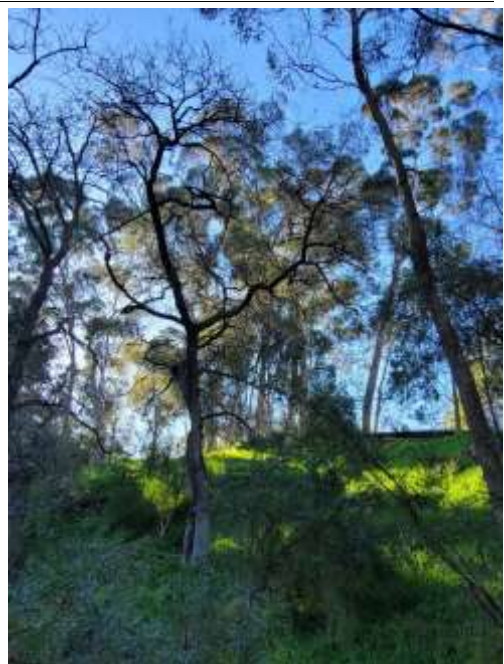
**Tree ID: 295****Genus / species:** *Quercus robur*

**Retention Value:** Very high**Removal / retention reason:** N/A.**Amenity value:** High**Works Required:** N/A.

**SRZ (m):** 3.2      **Works priority:** N/A  
**TPZ (m):** 9.4      **Construction Proximity:** 0.1  
**mTPZ (m):**

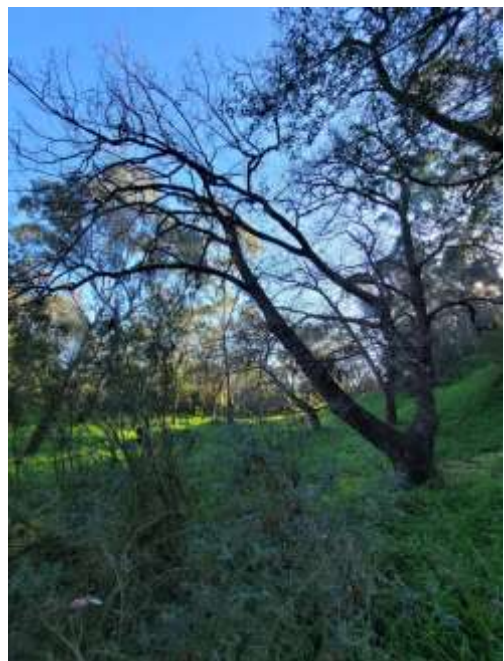
**Tree ID: 296****Genus / species:** *Eucalyptus camaldulensis*

**Retention Value:** Low**Removal / retention reason:** N/A.**Amenity value:** Low**Works Required:** N/A.

**SRZ (m):** 1.6      **Works priority:** N/A  
**TPZ (m):** 2.0      **Construction Proximity:** 0.1  
**mTPZ (m):**

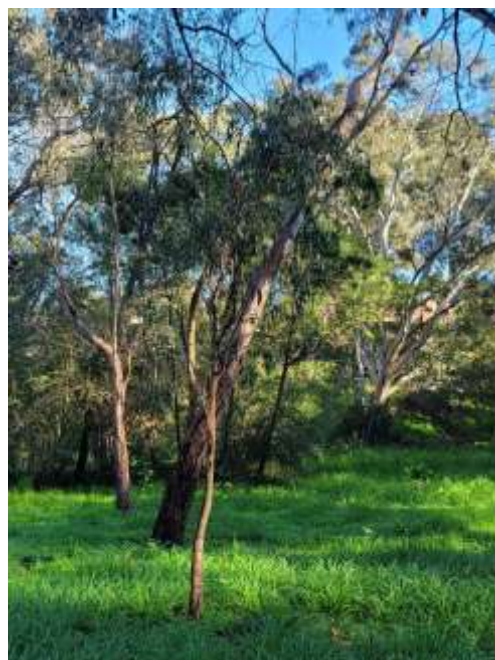
**Tree ID: 297****Genus / species:** *Eucalyptus camaldulensis*

**Retention Value:** Very high**Removal / retention reason:** N/A.**Amenity value:** High**Works Required:** N/A.

**SRZ (m):** 2.3      **Works priority:** N/A  
**TPZ (m):** 4.4      **Construction Proximity:** 0.1  
**mTPZ (m):**

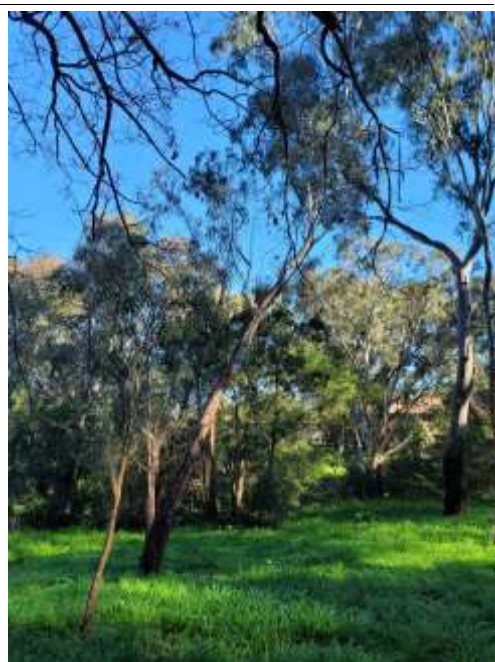
**Tree ID: 298****Genus / species:** *Eucalyptus camaldulensis*

**Retention Value:** Low**Removal / retention reason:** N/A.**Amenity value:** Low**Works Required:** N/A.

**SRZ (m):** 1.9      **Works priority:** N/A  
**TPZ (m):** 2.8      **Construction Proximity:** 0.1  
**mTPZ (m):**

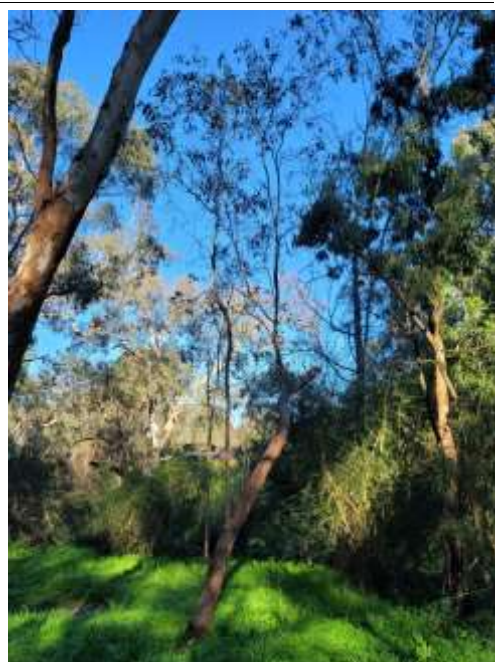
**Tree ID: 301****Genus / species:** *Eucalyptus camaldulensis*

**Retention Value:** Moderate**Removal / retention reason:** N/A.**Amenity value:** Low**Works Required:** N/A.

**SRZ (m):** 1.6              **Works priority:** N/A  
**TPZ (m):** 2.0              **Construction Proximity:** 0.1  
**mTPZ (m):**

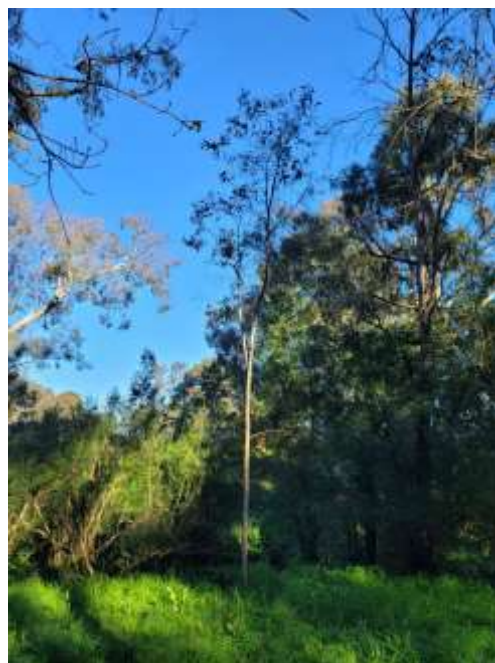
**Tree ID: 302****Genus / species:** *Acacia melanoxylon*

**Retention Value:** Low**Removal / retention reason:** N/A.**Amenity value:** Low**Works Required:** N/A.

**SRZ (m):** 1.6              **Works priority:** N/A  
**TPZ (m):** 2.0              **Construction Proximity:** 0.1  
**mTPZ (m):**

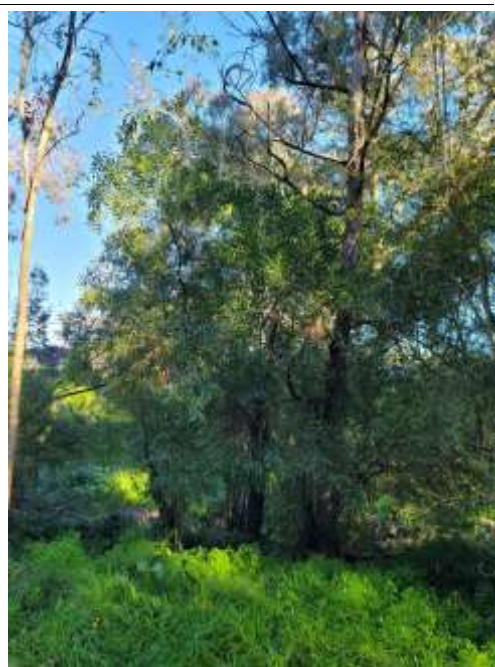
**Tree ID: 303****Genus / species:** *Acacia melanoxylon*

**Retention Value:** Low**Removal / retention reason:** N/A.**Amenity value:** Low**Works Required:** N/A.

**SRZ (m):** 1.6              **Works priority:** N/A  
**TPZ (m):** 2.0              **Construction Proximity:** 0.1  
**mTPZ (m):**

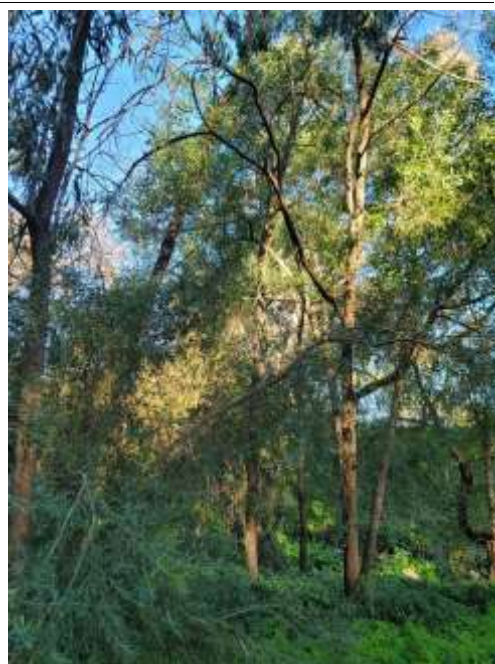
**Tree ID: 304****Genus / species:** *Acacia melanoxylon*

**Retention Value:** Very low**Removal / retention reason:** N/A.**Amenity value:** Low**Works Required:** N/A.

**SRZ (m):** 1.8 **Works priority:** N/A  
**TPZ (m):** 2.4 **Construction Proximity:** 0.1  
**mTPZ (m):**

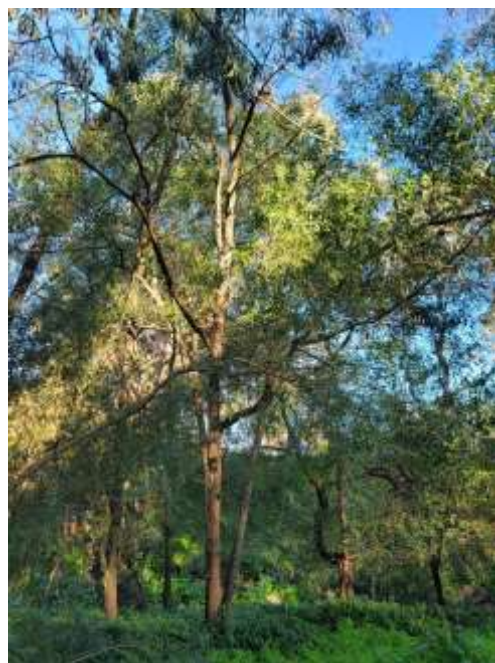
**Tree ID: 305****Genus / species:** *Acacia melanoxylon*

**Retention Value:** Low**Removal / retention reason:** N/A.**Amenity value:** Low**Works Required:** N/A.

**SRZ (m):** 1.8 **Works priority:** N/A  
**TPZ (m):** 2.4 **Construction Proximity:** 0.1  
**mTPZ (m):**

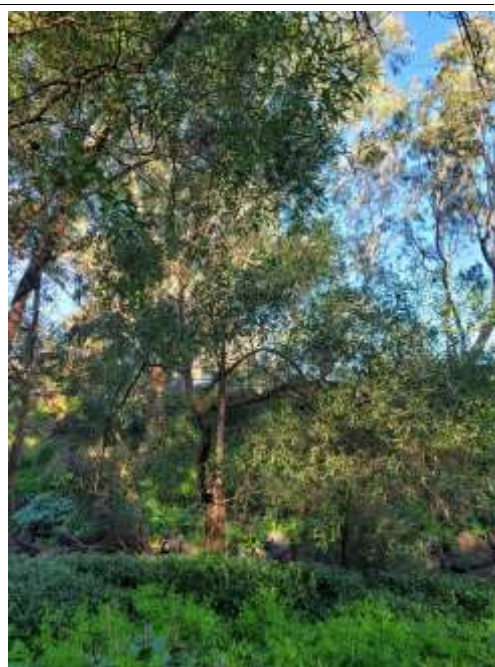
**Tree ID: 306****Genus / species:** *Acacia melanoxylon*

**Retention Value:** Low**Removal / retention reason:** N/A.**Amenity value:** Low**Works Required:** N/A.

**SRZ (m):** 1.6 **Works priority:** N/A  
**TPZ (m):** 2.0 **Construction Proximity:** 0.1  
**mTPZ (m):**

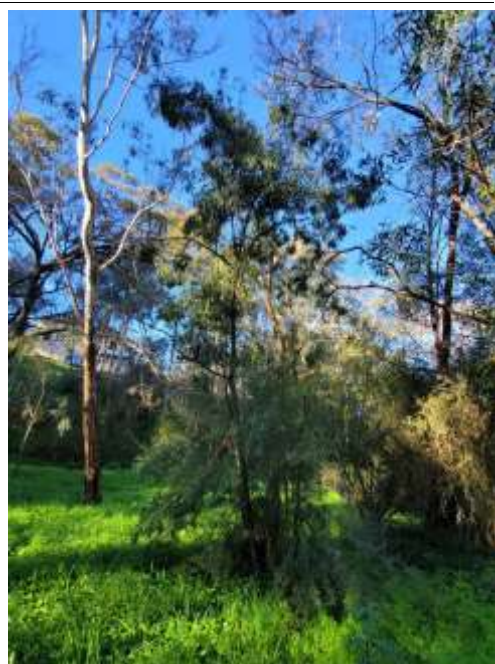
**Tree ID: 307****Genus / species:** *Acacia melanoxylon*

**Height (m):** 7      **Structure:** Good  
**Width (m):** 2      **Health:** Fair  
**DBH (cm):** 7      Estimated **Maturity:** Immature  
**Origin:** Melbourne      **ULE (years):** 5 - 15  
**Retained?:** Retained      **Form:** Fair  
**Retention Value:** Low  
**Removal / retention reason:** N/A.  
**Amenity value:** Low  
**Works Required:** N/A.

**SRZ (m):** 1.6      **Works priority:** N/A  
**TPZ (m):** 2.0      **Construction Proximity:** 0.1  
**mTPZ (m):**

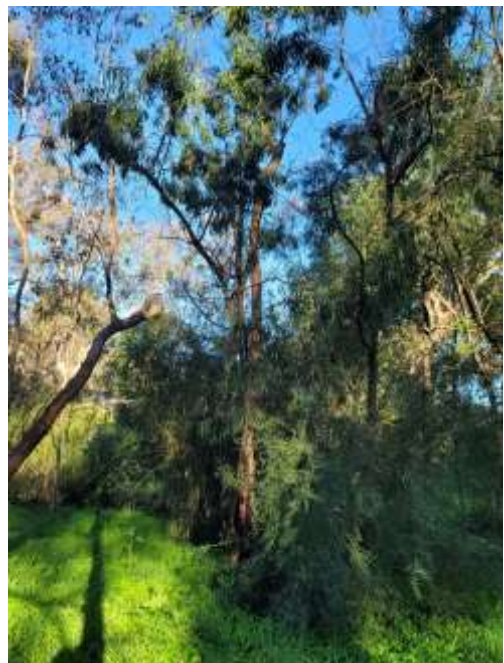
**Tree ID: 308****Genus / species:** *Eucalyptus camaldulensis*

**Height (m):** 11      **Structure:** Poor  
**Width (m):** 3      **Health:** Poor  
**DBH (cm):** 22      Measured **Maturity:** Mature  
**Origin:** Melbourne      **ULE (years):** 5 - 15  
**Retained?:** Retained      **Form:** Fair  
**Retention Value:** Low  
**Removal / retention reason:** N/A.  
**Amenity value:** Low  
**Works Required:** N/A.

**SRZ (m):** 1.9      **Works priority:** N/A  
**TPZ (m):** 2.6      **Construction Proximity:** 0.1  
**mTPZ (m):**

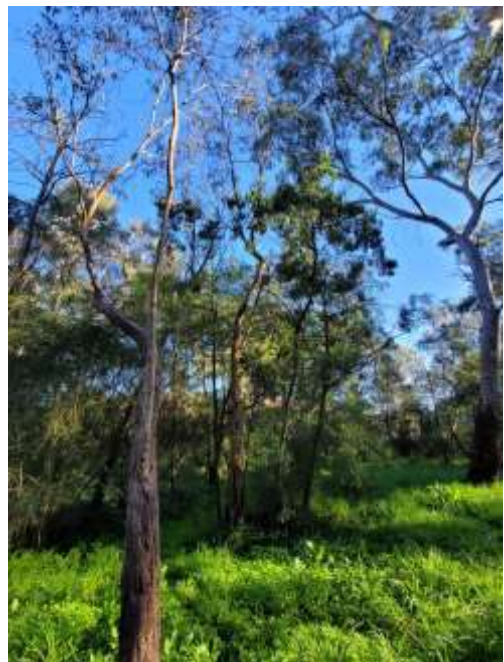
**Tree ID: 309****Genus / species:** *Acacia melanoxylon*

**Height (m):** 7      **Structure:** Poor  
**Width (m):** 2      **Health:** Poor  
**DBH (cm):** 6      Measured **Maturity:** Immature  
**Origin:** Melbourne      **ULE (years):** 5 - 15  
**Retained?:** Retained      **Form:** Fair  
**Retention Value:** Very low  
**Removal / retention reason:** N/A.  
**Amenity value:** Very low  
**Works Required:** N/A.

**SRZ (m):** 1.6      **Works priority:** N/A  
**TPZ (m):** 2.0      **Construction Proximity:** 0.1  
**mTPZ (m):**

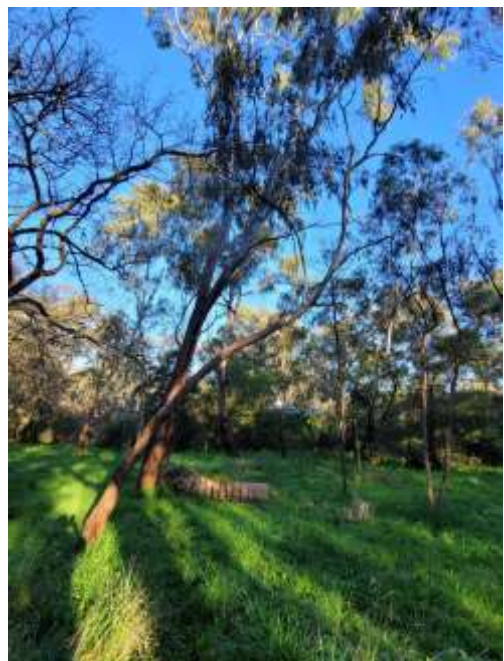
**Tree ID: 322****Genus / species:** *Eucalyptus viminalis*

**Height (m):** 15 **Structure:** Good**Width (m):** 8 **Health:** Fair**DBH (cm):** 38 Measured **Maturity:** Mature**Origin:** Melbourne **ULE (years):** 30 - 60**Retained?:** Retained **Form:** Good**Retention Value:** Moderate**Removal / retention reason:** N/A.**Amenity value:** Moderate**Works Required:** N/A.**SRZ (m):** 2.3 **Works priority:** N/A**TPZ (m):** 4.6 **Construction Proximity:** 0.1**mTPZ (m):**

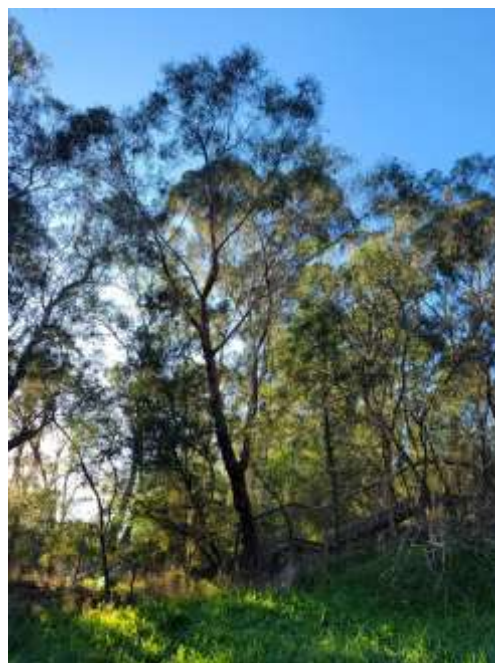
**Tree ID: 323****Genus / species:** *Coprosma quadrifida*

**Height (m):** 5 **Structure:** Good**Width (m):** 6 **Health:** Good**DBH (cm):** 14 Estimated **Maturity:** Mature**Origin:** Melbourne **ULE (years):** 15 - 30**Retained?:** Retained **Form:** Good**Retention Value:** Low**Removal / retention reason:** N/A.**Amenity value:** Low**Works Required:** Canopy lift.**SRZ (m):** 1.6 **Works priority:** Very low**TPZ (m):** 2.0 **Construction Proximity:** 0.1**mTPZ (m):**

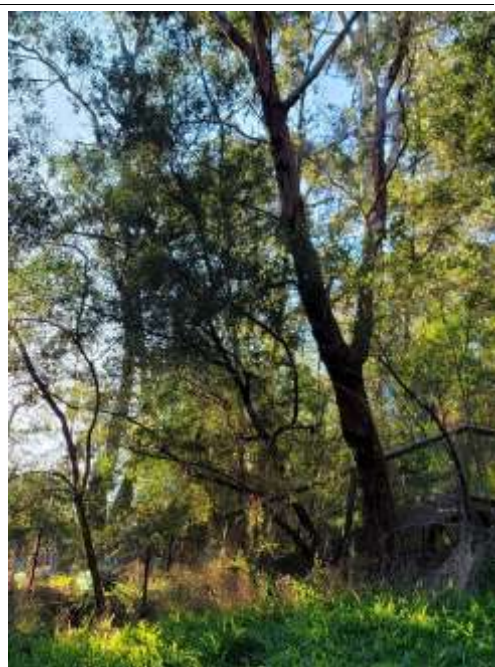
**Tree ID: 324****Genus / species:** *Coprosma quadrifida*

**Height (m):** 6 **Structure:** Good**Width (m):** 3 **Health:** Good**DBH (cm):** 10 Estimated **Maturity:** Mature**Origin:** Melbourne **ULE (years):** 15 - 30**Retained?:** Removed **Form:** Good**Retention Value:** Low**Removal / retention reason:** N/A.**Amenity value:** Low**Works Required:** N/A.**SRZ (m):** 1.6 **Works priority:** N/A**TPZ (m):** 2.0 **Construction Proximity:** 0.1**mTPZ (m):**

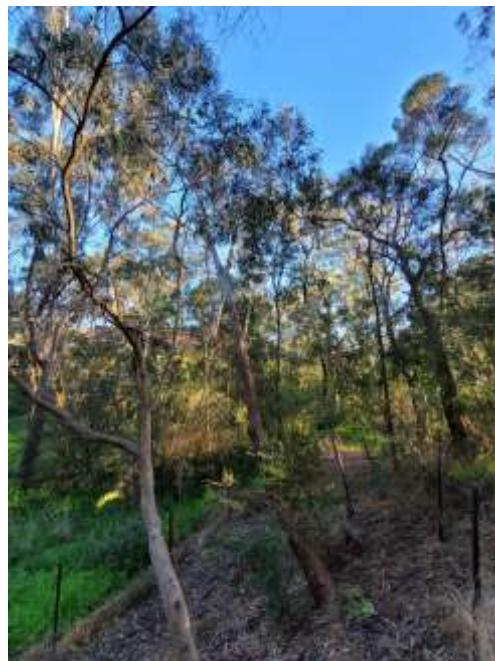
**Tree ID: 329****Genus / species:** *Eucalyptus camaldulensis*

Evergreen River Red Gum

**Height (m):** 8      **Structure:** Good  
**Width (m):** 2      **Health:** Fair  
**DBH (cm):** 9 Estimated **Maturity:** Immature  
**Origin:** Melbourne **ULE (years):** 30 - 60  
**Retained?:** Retained **Form:** Good  
**Retention Value:** Low  
**Removal / retention reason:** N/A.  
**Amenity value:** Low  
**Works Required:** N/A.

**SRZ (m):** 1.6      **Works priority:** N/A  
**TPZ (m):** 2.0      **Construction Proximity:** 0.1  
**mTPZ (m):**

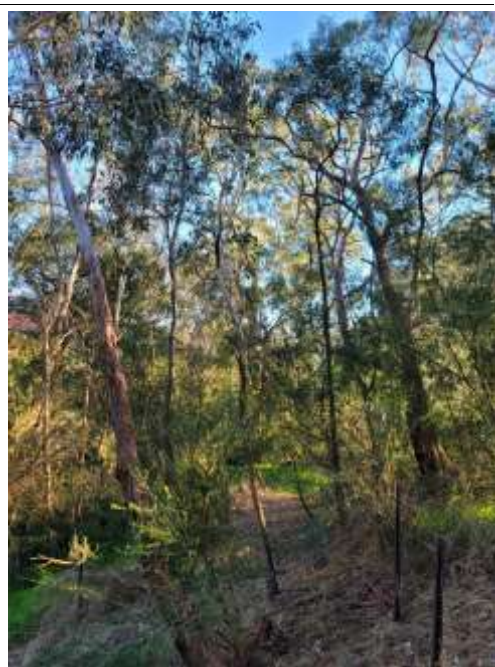
**Tree ID: 330****Genus / species:** *Acacia mearnsii*

Evergreen Black Wattle

**Height (m):** 11      **Structure:** Good  
**Width (m):** 2      **Health:** Good  
**DBH (cm):** 10 Estimated **Maturity:** Immature  
**Origin:** Melbourne **ULE (years):** 15 - 30  
**Retained?:** Removed **Form:** Good  
**Retention Value:** Moderate  
**Removal / retention reason:** N/A.  
**Amenity value:** Moderate  
**Works Required:** N/A.

**SRZ (m):** 1.6      **Works priority:** N/A  
**TPZ (m):** 2.0      **Construction Proximity:** 0.1  
**mTPZ (m):**

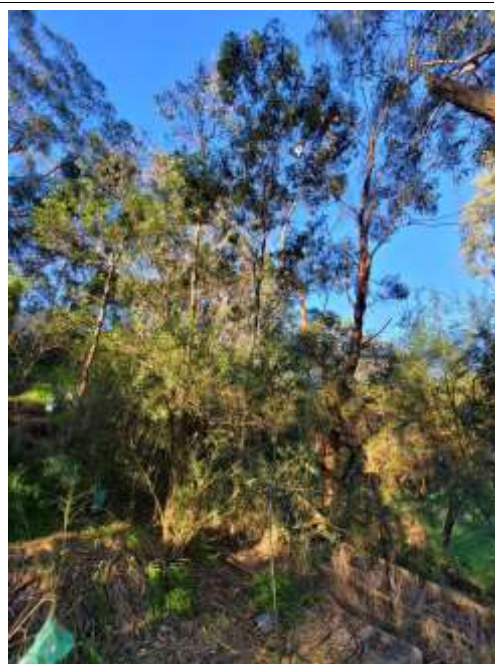
**Tree ID: 331****Genus / species:** *Eucalyptus camaldulensis*

Evergreen River Red Gum

**Height (m):** 12      **Structure:** Good  
**Width (m):** 2      **Health:** Fair  
**DBH (cm):** 15 Measured **Maturity:** Immature  
**Origin:** Melbourne **ULE (years):** > 60  
**Retained?:** Removed **Form:** Good  
**Retention Value:** High  
**Removal / retention reason:** N/A.  
**Amenity value:** Moderate  
**Works Required:** N/A.

**SRZ (m):** 1.6      **Works priority:** N/A  
**TPZ (m):** 2.0      **Construction Proximity:** 0.1  
**mTPZ (m):**

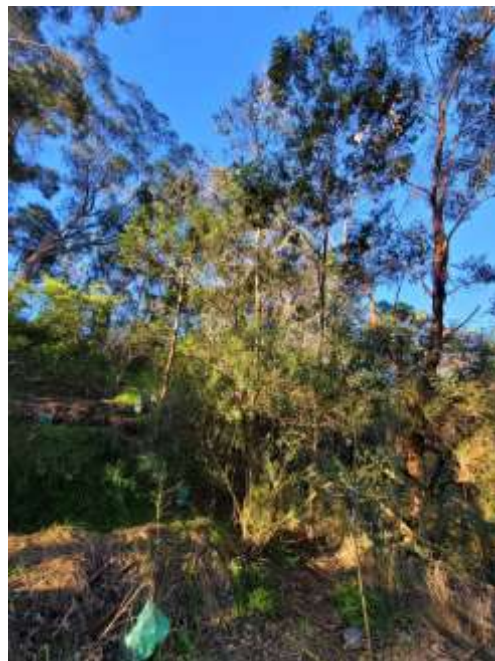
**Tree ID: 332****Genus / species:** *Acacia mearnsii*

Evergreen Black Wattle

**Height (m):** 7      **Structure:** Good  
**Width (m):** 3      **Health:** Good  
**DBH (cm):** 10 Estimated **Maturity:** Immature  
**Origin:** Melbourne **ULE (years):** 15 - 30  
**Retained?:** Retained **Form:** Fair  
**Retention Value:** Low  
**Removal / retention reason:** N/A.  
**Amenity value:** Low  
**Works Required:** N/A.

**SRZ (m):** 1.6      **Works priority:** N/A  
**TPZ (m):** 2.0      **Construction Proximity:** 0.1  
**mTPZ (m):**

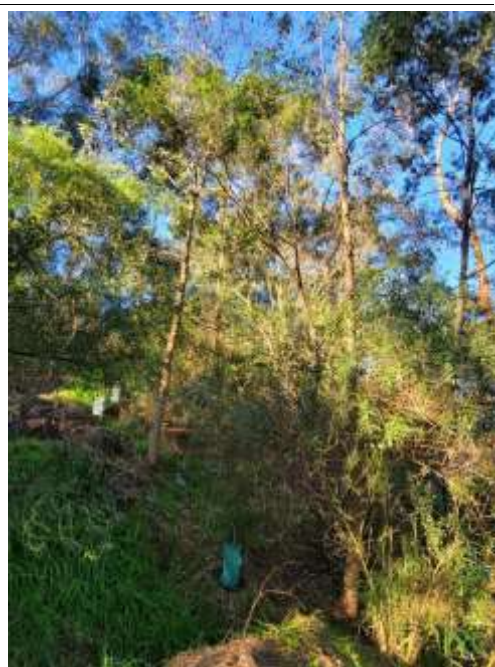
**Tree ID: 333****Genus / species:** *Eucalyptus camaldulensis*

Evergreen River Red Gum

**Height (m):** 11      **Structure:** Good  
**Width (m):** 3      **Health:** Good  
**DBH (cm):** 16 Estimated **Maturity:** Mature  
**Origin:** Melbourne **ULE (years):** 30 - 60  
**Retained?:** Retained **Form:** Good  
**Retention Value:** Moderate  
**Removal / retention reason:** N/A.  
**Amenity value:** Moderate  
**Works Required:** N/A.

**SRZ (m):** 1.6      **Works priority:** N/A  
**TPZ (m):** 2.0      **Construction Proximity:** 0.1  
**mTPZ (m):**

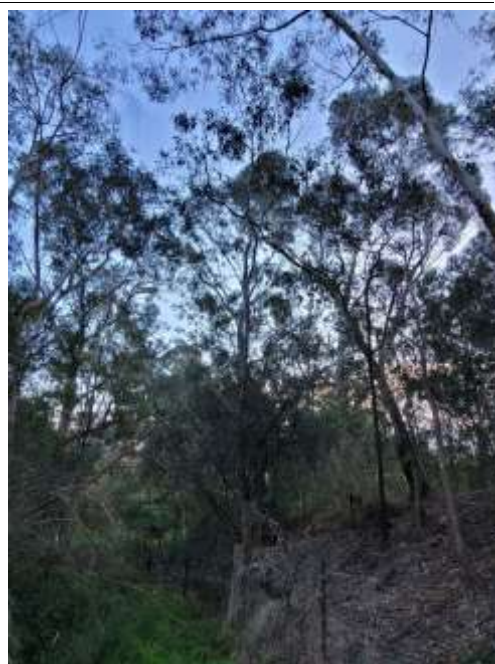
**Tree ID: 334****Genus / species:** *Eucalyptus camaldulensis*

Evergreen River Red Gum

**Height (m):** 14      **Structure:** Poor  
**Width (m):** 2      **Health:** Dead  
**DBH (cm):** 15      Estimated **Maturity:** Immature  
**Origin:** Melbourne      **ULE (years):** 0  
**Retained?:** Retained      **Form:** Very poor  
**Retention Value:** Remove.  
**Removal / retention reason:** N/A.  
**Amenity value:** Very low  
**Works Required:** N/A.

**SRZ (m):** 1.6      **Works priority:** N/A  
**TPZ (m):** 2.0      **Construction Proximity:** 0.1  
**mTPZ (m):**
