## **Nation Partners**

# **Northern Sewers Relining Project Southern Section**

## **Construction Impact Report**

**Wednesday 4<sup>th</sup> December 2024**

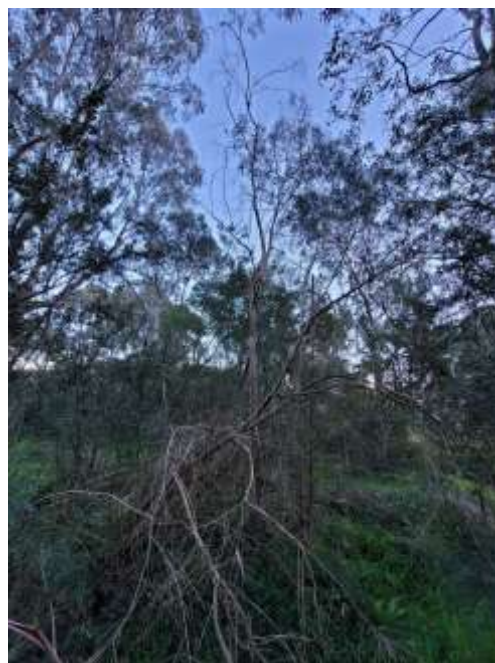
**Tree ID: 335****Genus / species:** *Eucalyptus camaldulensis*

Evergreen River Red Gum

**Height (m):** 14      **Structure:** Good  
**Width (m):** 2      **Health:** Good  
**DBH (cm):** 15      Measured **Maturity:** Immature  
**Origin:** Melbourne      **ULE (years):** 15 - 30  
**Retained?:** Retained      **Form:** Fair  
**Retention Value:** Moderate  
**Removal / retention reason:** N/A.  
**Amenity value:** Moderate  
**Works Required:** N/A.

**SRZ (m):** 1.6      **Works priority:** N/A  
**TPZ (m):** 2.0      **Construction Proximity:** 0.1  
**mTPZ (m):**

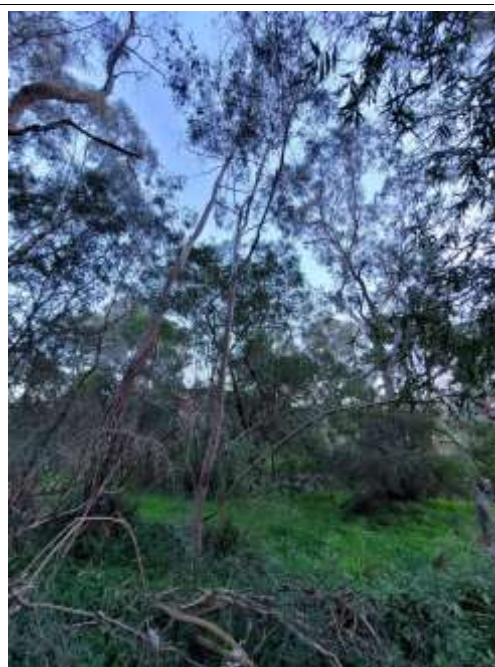
**Tree ID: 336****Genus / species:** *Eucalyptus camaldulensis*

Evergreen River Red Gum

**Height (m):** 17      **Structure:** Good  
**Width (m):** 5      **Health:** Fair  
**DBH (cm):** 25      Measured **Maturity:** Immature  
**Origin:** Melbourne      **ULE (years):** 30 - 60  
**Retained?:** Retained      **Form:** Fair  
**Retention Value:** High  
**Removal / retention reason:** N/A.  
**Amenity value:** High  
**Works Required:** N/A.

**SRZ (m):** 1.9      **Works priority:** N/A  
**TPZ (m):** 3.0      **Construction Proximity:** 0.1  
**mTPZ (m):**

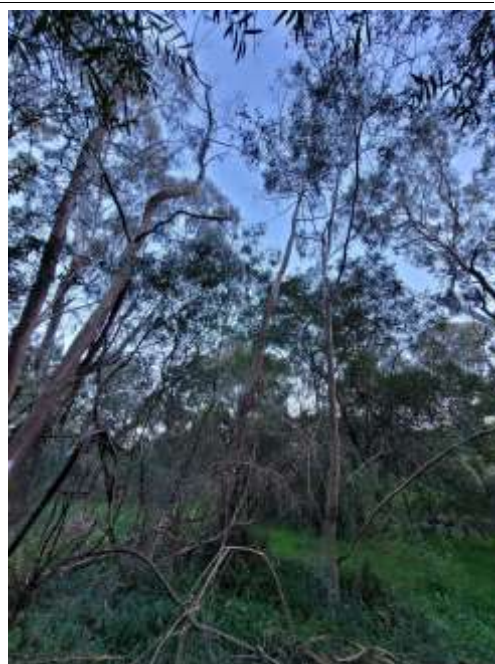
**Tree ID: 337****Genus / species:** *Eucalyptus camaldulensis*

Evergreen River Red Gum

**Retention Value:** Very high**Removal / retention reason:** N/A.**Amenity value:** High**Works Required:** N/A.

**SRZ (m):** 2.2      **Works priority:** N/A  
**TPZ (m):** 4.1      **Construction Proximity:** 0.1  
**mTPZ (m):**

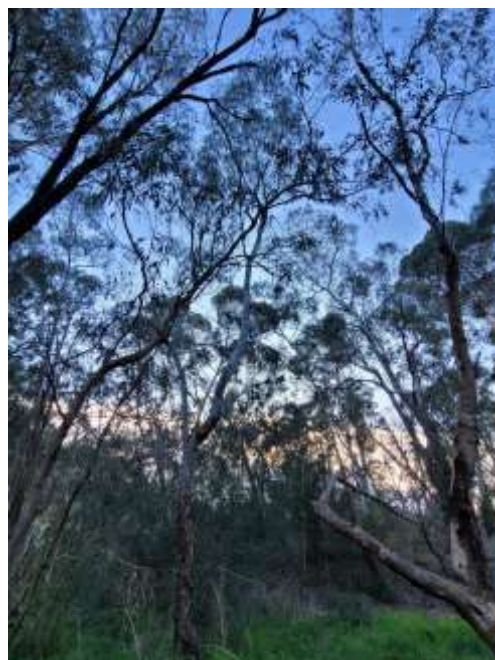
**Tree ID: 338****Genus / species:** *Eucalyptus camaldulensis*

Evergreen River Red Gum

**Retention Value:** Moderate**Removal / retention reason:** N/A.**Amenity value:** High**Works Required:** N/A.

**SRZ (m):** 2      **Works priority:** N/A  
**TPZ (m):** 3.2      **Construction Proximity:** 0.1  
**mTPZ (m):**

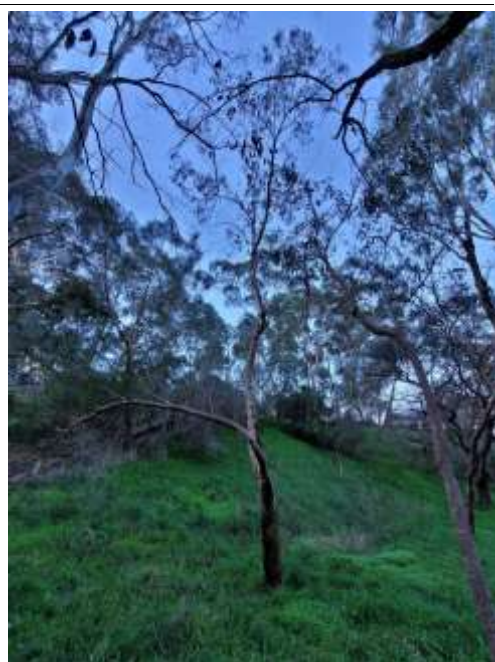
**Tree ID: 339****Genus / species:** *Eucalyptus camaldulensis*

Evergreen River Red Gum

**Retention Value:** Low**Removal / retention reason:** N/A.**Amenity value:** Low**Works Required:** N/A.

**SRZ (m):** 1.6      **Works priority:** N/A  
**TPZ (m):** 2.0      **Construction Proximity:** 0.1  
**mTPZ (m):**

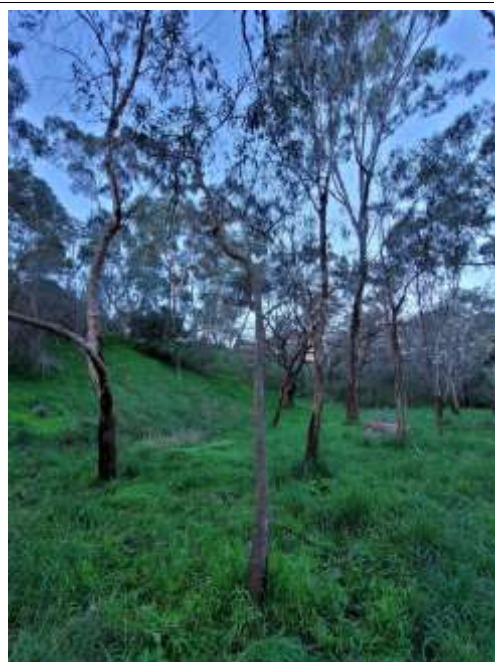
**Tree ID: 340****Genus / species:** *Eucalyptus camaldulensis*

Evergreen River Red Gum

**Height (m):** 15      **Structure:** Fair  
**Width (m):** 7      **Health:** Very poor  
**DBH (cm):** 30      Estimated **Maturity:** Mature  
**Origin:** Melbourne      **ULE (years):** 0  
**Retained?:** Retained      **Form:** Very poor  
**Retention Value:** Very low  
**Removal / retention reason:** N/A.  
**Amenity value:** Very low  
**Works Required:** N/A.

**SRZ (m):** 2.1      **Works priority:** N/A  
**TPZ (m):** 3.6      **Construction Proximity:** 0.1  
**mTPZ (m):**

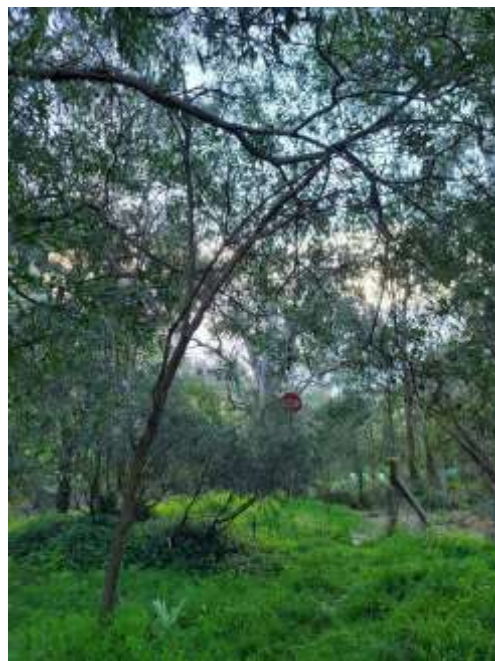
**Tree ID: 343****Genus / species:** *Eucalyptus camaldulensis*

Evergreen River Red Gum

**Height (m):** 12      **Structure:** Fair  
**Width (m):** 3      **Health:** Fair  
**DBH (cm):** 24 Measured **Maturity:** Immature  
**Origin:** Melbourne **ULE (years):** 30 - 60  
**Retained?:** Retained **Form:** Fair  
**Retention Value:** Moderate  
**Removal / retention reason:** N/A.  
**Amenity value:** Moderate  
**Works Required:** N/A.

**SRZ (m):** 1.9      **Works priority:** N/A  
**TPZ (m):** 2.9      **Construction Proximity:** 0.1  
**mTPZ (m):**

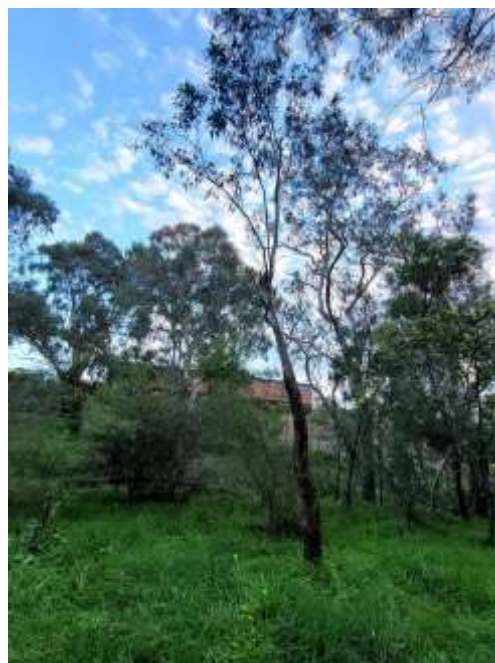
**Tree ID: 344****Genus / species:** *Eucalyptus camaldulensis*

Evergreen River Red Gum

**Height (m):** 22      **Structure:** Poor  
**Width (m):** 3      **Health:** Poor  
**DBH (cm):** 31 Measured **Maturity:** Immature  
**Origin:** Melbourne **ULE (years):** 5 - 15  
**Retained?:** Retained **Form:** Poor  
**Retention Value:** Low  
**Removal / retention reason:** N/A.  
**Amenity value:** Moderate  
**Works Required:** N/A.

**SRZ (m):** 2.1      **Works priority:** N/A  
**TPZ (m):** 3.7      **Construction Proximity:** 0.1  
**mTPZ (m):**

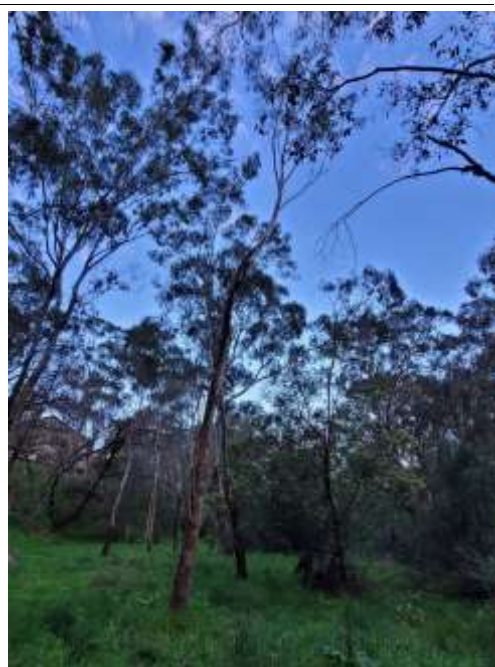
**Tree ID: 345****Genus / species:** *Eucalyptus camaldulensis*

Evergreen River Red Gum

**Height (m):** 11      **Structure:** Poor  
**Width (m):** 2      **Health:** Poor  
**DBH (cm):** 15 Estimated **Maturity:** Immature  
**Origin:** Melbourne **ULE (years):** 5 - 15  
**Retained?:** Retained **Form:** Poor  
**Retention Value:** Low  
**Removal / retention reason:** N/A.  
**Amenity value:** Low  
**Works Required:** N/A.

**SRZ (m):** 1.6      **Works priority:** N/A  
**TPZ (m):** 2.0      **Construction Proximity:** 0.1  
**mTPZ (m):**

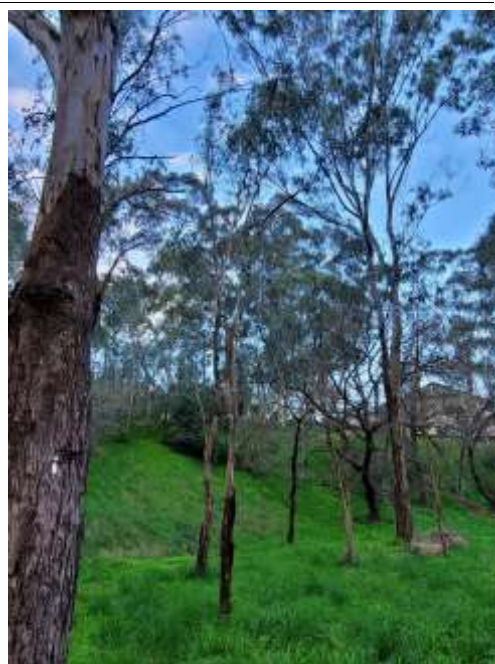
**Tree ID: 346****Genus / species:** *Eucalyptus camaldulensis*

Evergreen River Red Gum

**Height (m):** 16      **Structure:** Fair  
**Width (m):** 3      **Health:** Fair  
**DBH (cm):** 20 Measured **Maturity:** Immature  
**Origin:** Melbourne **ULE (years):** 5 - 15  
**Retained?:** Retained **Form:** Fair  
**Retention Value:** Moderate  
**Removal / retention reason:** N/A.  
**Amenity value:** High  
**Works Required:** N/A.

**SRZ (m):** 1.8      **Works priority:** N/A  
**TPZ (m):** 2.4      **Construction Proximity:** 0.1  
**mTPZ (m):**

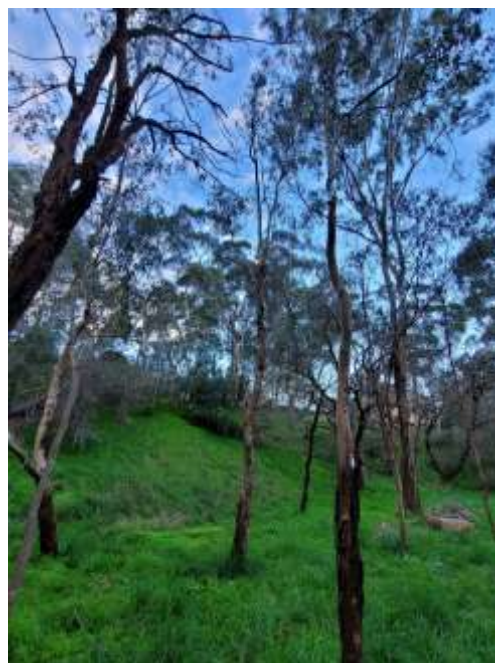
**Tree ID: 347****Genus / species:** *Eucalyptus camaldulensis*

Evergreen River Red Gum

**Height (m):** 8      **Structure:** Fair  
**Width (m):** 4      **Health:** Poor  
**DBH (cm):** 12 Estimated **Maturity:** Immature  
**Origin:** Melbourne **ULE (years):** 5 - 15  
**Retained?:** Retained **Form:** Poor  
**Retention Value:** Very low  
**Removal / retention reason:** N/A.  
**Amenity value:** Very low  
**Works Required:** N/A.

**SRZ (m):** 1.6      **Works priority:** N/A  
**TPZ (m):** 2.0      **Construction Proximity:** 0.1  
**mTPZ (m):**

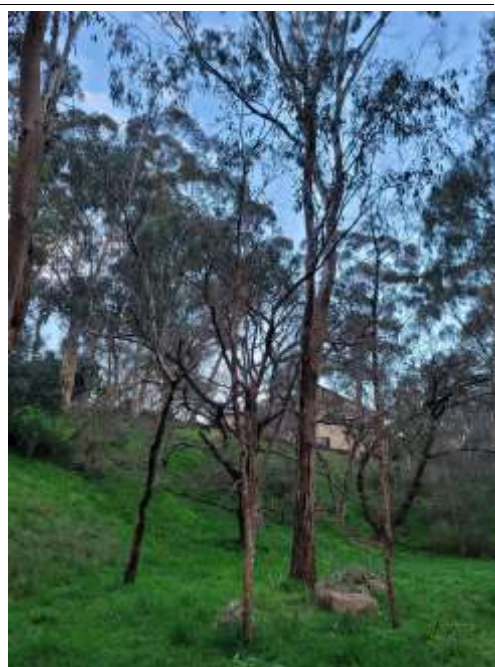
**Tree ID: 348****Genus / species:** *Eucalyptus camaldulensis*

Evergreen River Red Gum

**Height (m):** 9      **Structure:** Fair  
**Width (m):** 2      **Health:** Very poor  
**DBH (cm):** 10 Estimated **Maturity:** Immature  
**Origin:** Melbourne **ULE (years):** 0  
**Retained?:** Retained **Form:** Very poor  
**Retention Value:** Very low  
**Removal / retention reason:** N/A.  
**Amenity value:** Very low  
**Works Required:** N/A.

**SRZ (m):** 1.6      **Works priority:** N/A  
**TPZ (m):** 2.0      **Construction Proximity:** 0.1  
**mTPZ (m):**

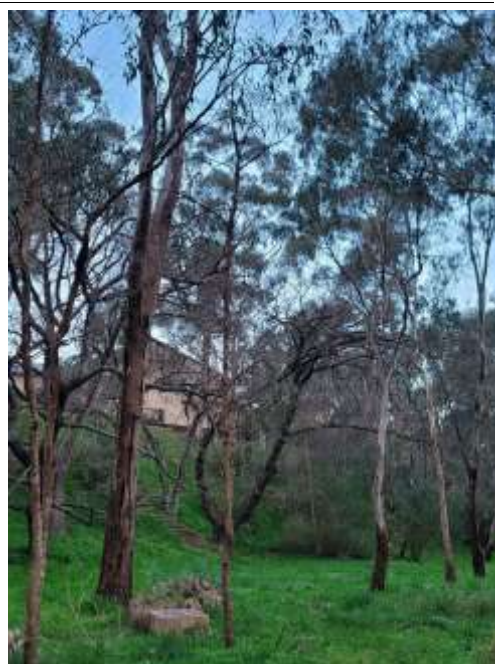
**Tree ID: 349****Genus / species:** *Eucalyptus camaldulensis*

Evergreen River Red Gum

**Retention Value:** High**Removal / retention reason:** N/A.**Amenity value:** High**Works Required:** N/A.

**SRZ (m):** 2.8      **Works priority:** N/A  
**TPZ (m):** 7.3      **Construction Proximity:** 0.1  
**mTPZ (m):**

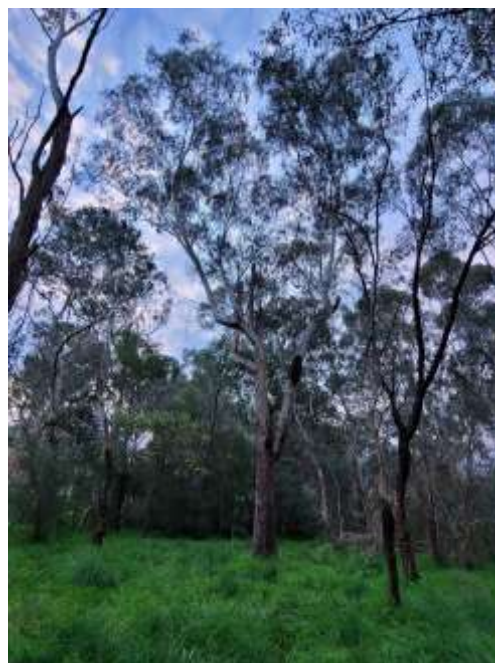
**Tree ID: 350****Genus / species:** *Acacia mearnsii*

Evergreen Black Wattle

**Retention Value:** Low**Removal / retention reason:** N/A.**Amenity value:** Low**Works Required:** N/A.

**SRZ (m):** 1.6      **Works priority:** N/A  
**TPZ (m):** 2.0      **Construction Proximity:** 0.1  
**mTPZ (m):**

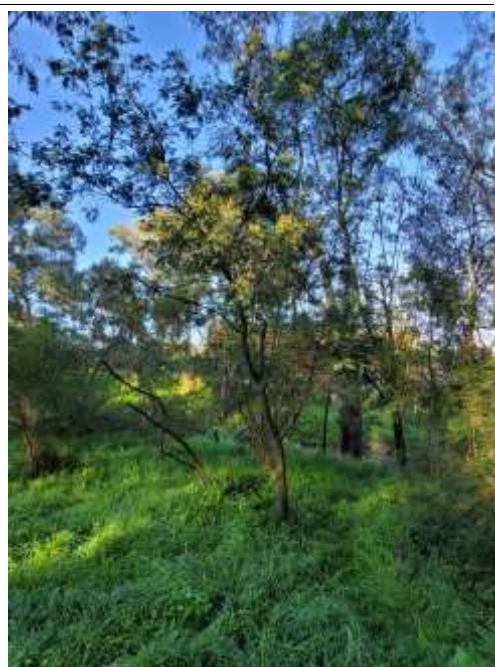
**Tree ID: 351****Genus / species:** *Acacia melanoxylon*

Evergreen Blackwood

**Retention Value:** Very low**Removal / retention reason:** N/A.**Amenity value:** Low**Works Required:** N/A.

**SRZ (m):** 1.7      **Works priority:** N/A  
**TPZ (m):** 2.2      **Construction Proximity:** 0.1  
**mTPZ (m):**

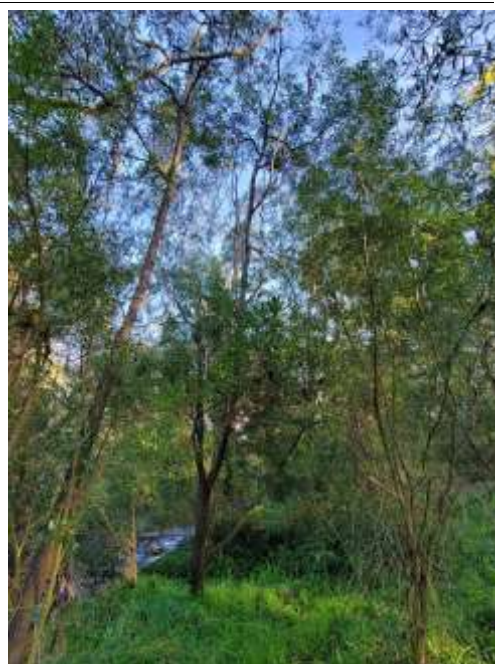
**Tree ID: 352****Genus / species:** *Acacia melanoxylon*

Evergreen Blackwood

**Height (m):** 7      **Structure:** Fair  
**Width (m):** 2      **Health:** Good  
**DBH (cm):** 9      Estimated **Maturity:** Immature  
**Origin:** Melbourne      **ULE (years):** 5 - 15  
**Retained?:** Retained      **Form:** Fair  
**Retention Value:** Low  
**Removal / retention reason:** N/A.  
**Amenity value:** Low  
**Works Required:** N/A.

**SRZ (m):** 1.6      **Works priority:** N/A  
**TPZ (m):** 2.0      **Construction Proximity:** 0.1  
**mTPZ (m):**

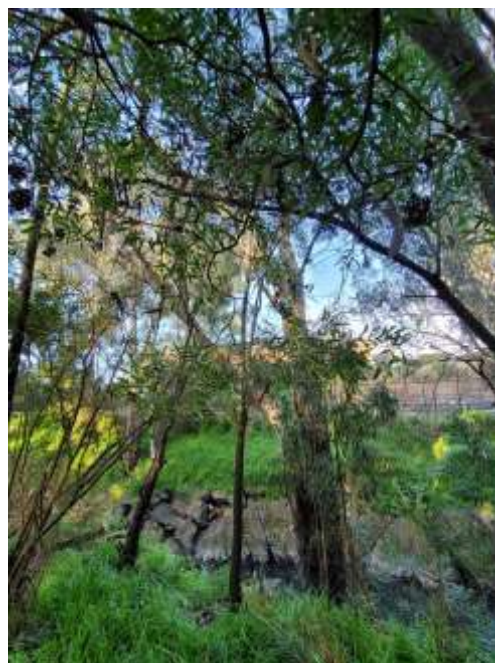
**Tree ID: 353****Genus / species:** *Eucalyptus camaldulensis*

Evergreen River Red Gum

**Height (m):** 18      **Structure:** Fair  
**Width (m):** 14      **Health:** Poor  
**DBH (cm):** 65      Estimated **Maturity:** Mature  
**Origin:** Melbourne      **ULE (years):** 15 - 30  
**Retained?:** Retained      **Form:** Good  
**Retention Value:** High  
**Removal / retention reason:** N/A.  
**Amenity value:** High  
**Works Required:** N/A.

**SRZ (m):** 2.9      **Works priority:** N/A  
**TPZ (m):** 7.8      **Construction Proximity:** 0.1  
**mTPZ (m):**

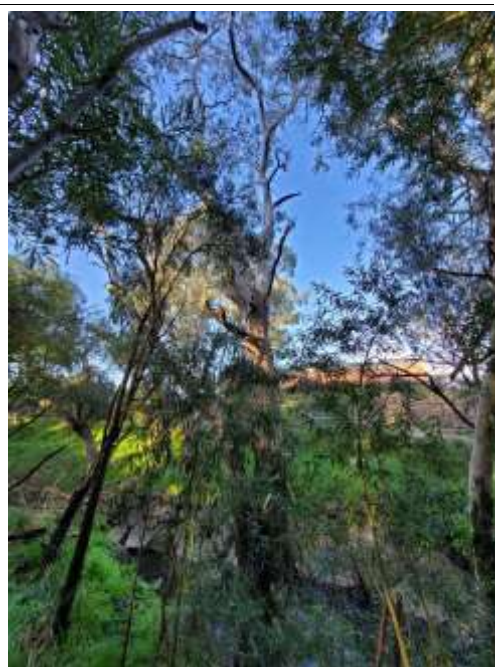
**Tree ID: 354****Genus / species:** *Eucalyptus camaldulensis*

Evergreen River Red Gum

**Height (m):** 19      **Structure:** Good  
**Width (m):** 16      **Health:** Good  
**DBH (cm):** 75      Estimated **Maturity:** Mature  
**Origin:** Melbourne      **ULE (years):** > 60  
**Retained?:** Retained      **Form:** Good  
**Retention Value:** Very high  
**Removal / retention reason:** N/A.  
**Amenity value:** High  
**Works Required:** N/A.

**SRZ (m):** 3      **Works priority:** N/A  
**TPZ (m):** 9.0      **Construction Proximity:** 0.1  
**mTPZ (m):**

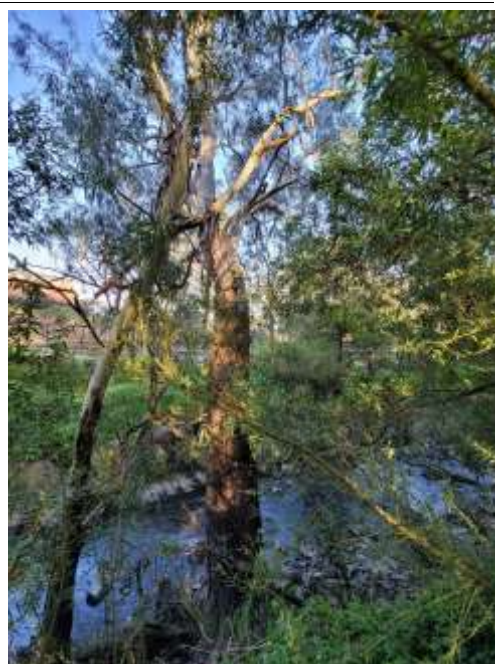
**Tree ID: 355****Genus / species:** *Acacia melanoxylon*

Evergreen Blackwood

**Retention Value:** Low**Removal / retention reason:** N/A.**Amenity value:** Low**Works Required:** N/A.

**SRZ (m):** 1.8      **Works priority:** N/A  
**TPZ (m):** 2.5      **Construction Proximity:** 0.1  
**mTPZ (m):**

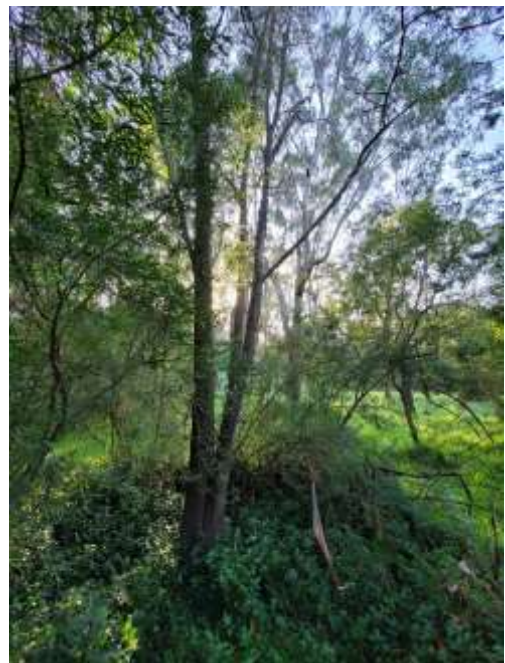
**Tree ID: 356****Genus / species:** *Acacia melanoxylon*

Evergreen Blackwood

**Retention Value:** Low**Removal / retention reason:** N/A.**Amenity value:** Low**Works Required:** N/A.

**SRZ (m):** 1.8      **Works priority:** N/A  
**TPZ (m):** 2.5      **Construction Proximity:** 0.1  
**mTPZ (m):**

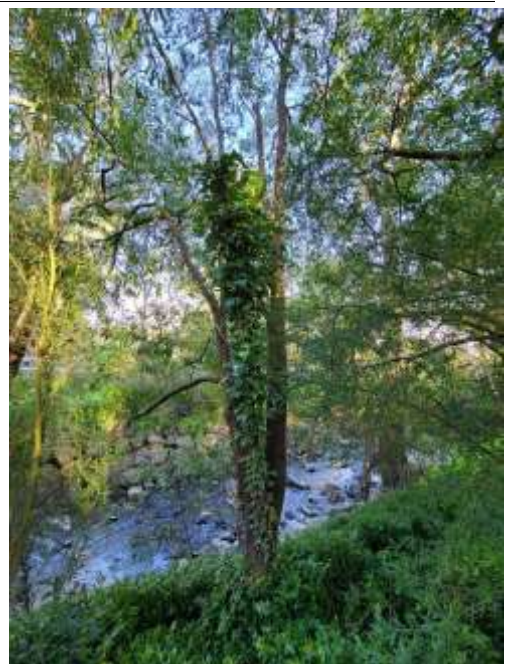
**Tree ID: 357****Genus / species:** *Acacia melanoxylon*

Evergreen Blackwood

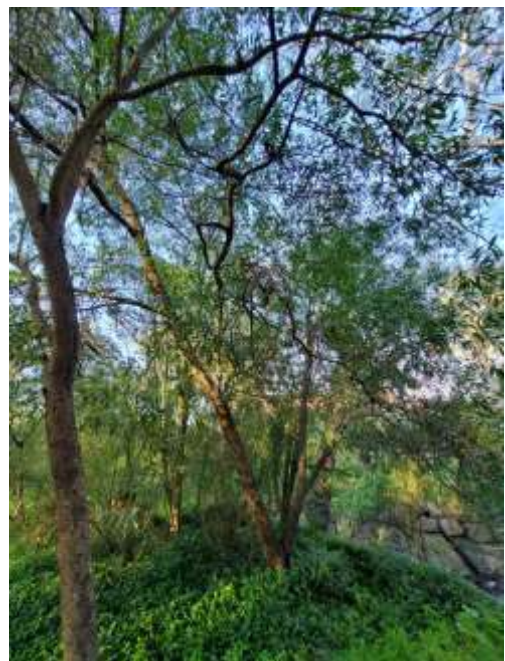
**Tree ID: 358****Genus / species:** *Eucalyptus camaldulensis*

Evergreen River Red Gum

**Height (m):** 10      **Structure:** Good  
**Width (m):** 2      **Health:** Fair  
**DBH (cm):** 9 Measured **Maturity:** Immature  
**Origin:** Melbourne **ULE (years):** > 60  
**Retained?:** Retained **Form:** Fair  
**Retention Value:** Moderate  
**Removal / retention reason:** N/A.  
**Amenity value:** Low  
**Works Required:** N/A.

**SRZ (m):** 1.6      **Works priority:** N/A  
**TPZ (m):** 2.0      **Construction Proximity:** 0.1  
**mTPZ (m):**

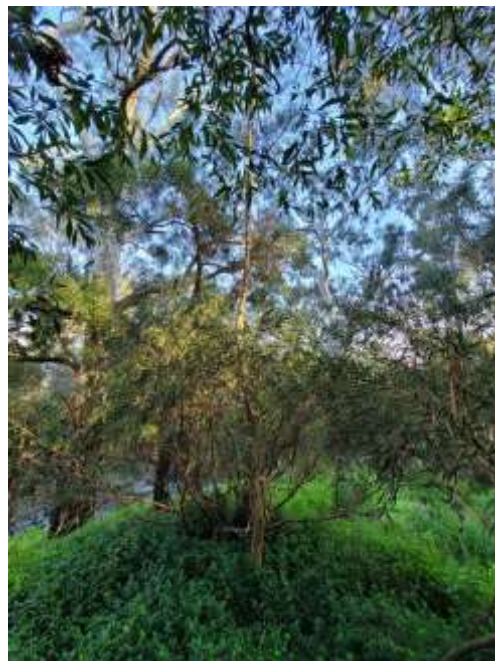
**Tree ID: 359****Genus / species:** *Acacia melanoxylon*

Evergreen Blackwood

**Height (m):** 9      **Structure:** Poor  
**Width (m):** 7      **Health:** Poor  
**DBH (cm):** 20 Measured **Maturity:** Mature  
**Origin:** Melbourne **ULE (years):** 5 - 15  
**Retained?:** Retained **Form:** Poor  
**Retention Value:** Low  
**Removal / retention reason:** N/A.  
**Amenity value:** Low  
**Works Required:** Canopy lift.

**SRZ (m):** 1.8      **Works priority:** Very low  
**TPZ (m):** 2.4      **Construction Proximity:** 0.1  
**mTPZ (m):**

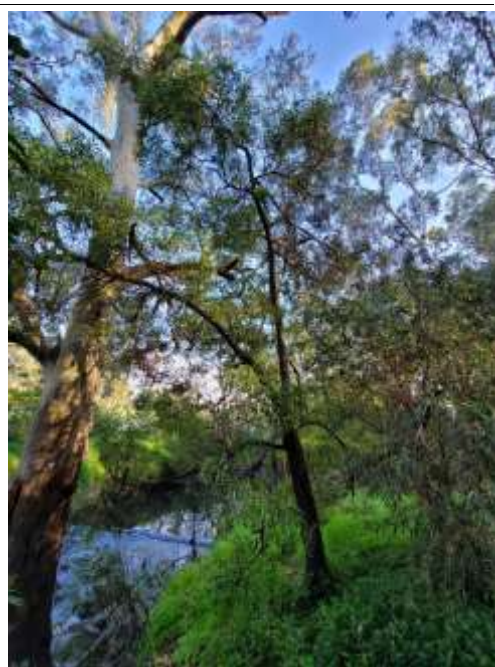
**Tree ID: 360****Genus / species:** *Eucalyptus camaldulensis*

Evergreen River Red Gum

**Height (m):** 22      **Structure:** Good  
**Width (m):** 18      **Health:** Good  
**DBH (cm):** 75 Estimated **Maturity:** Mature  
**Origin:** Melbourne **ULE (years):** 30 - 60  
**Retained?:** Retained **Form:** Good  
**Retention Value:** High  
**Removal / retention reason:** N/A.  
**Amenity value:** High  
**Works Required:** N/A.

**SRZ (m):** 3      **Works priority:** N/A  
**TPZ (m):** 9.0      **Construction Proximity:** 0.1  
**mTPZ (m):**

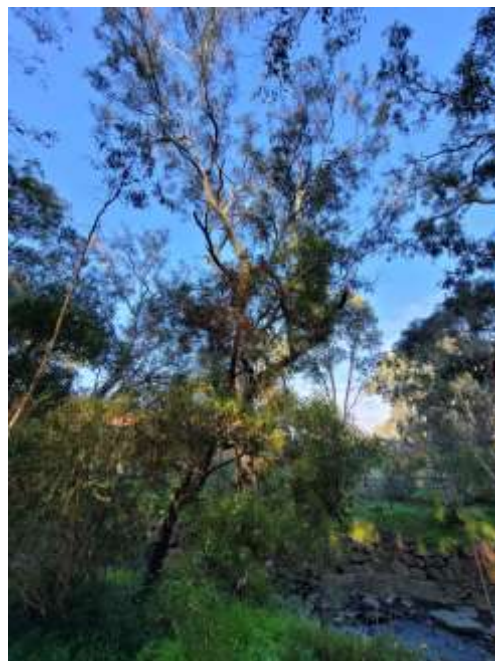
**Tree ID: 361****Genus / species:** *Eucalyptus camaldulensis*

Evergreen River Red Gum

**Retention Value:** High**Removal / retention reason:** N/A.**Amenity value:** High**Works Required:** N/A.

**SRZ (m):** 3.4      **Works priority:** N/A  
**TPZ (m):** 11.4      **Construction Proximity:** 0.1  
**mTPZ (m):**

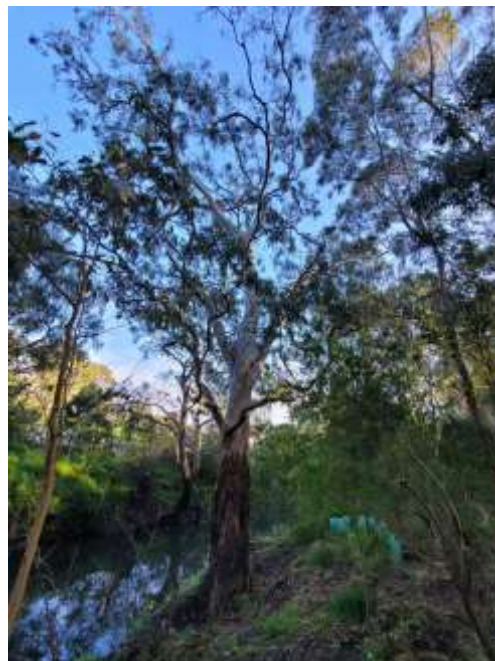
**Tree ID: 362****Genus / species:** *Eucalyptus camaldulensis*

Evergreen River Red Gum

**Retention Value:** High**Removal / retention reason:** N/A.**Amenity value:** High**Works Required:** N/A.

**SRZ (m):** 1.9      **Works priority:** N/A  
**TPZ (m):** 2.8      **Construction Proximity:** 0.1  
**mTPZ (m):**

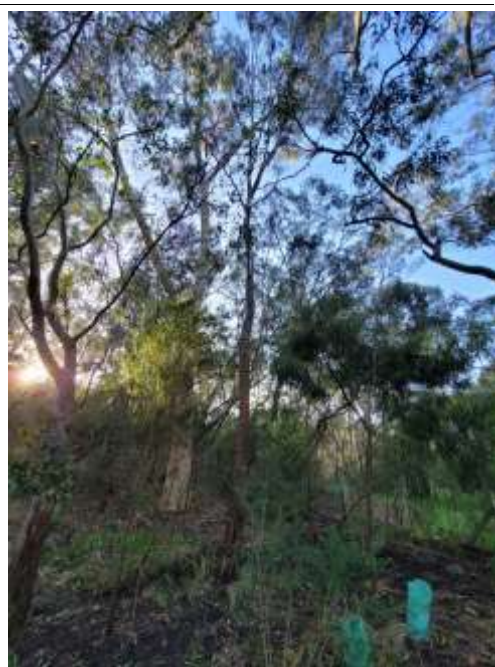
**Tree ID: 363****Genus / species:** *Eucalyptus camaldulensis*

Evergreen River Red Gum

**Retention Value:** Low**Removal / retention reason:** N/A.**Amenity value:** Low**Works Required:** N/A.

**SRZ (m):** 1.8      **Works priority:** N/A  
**TPZ (m):** 2.4      **Construction Proximity:** 0.1  
**mTPZ (m):**

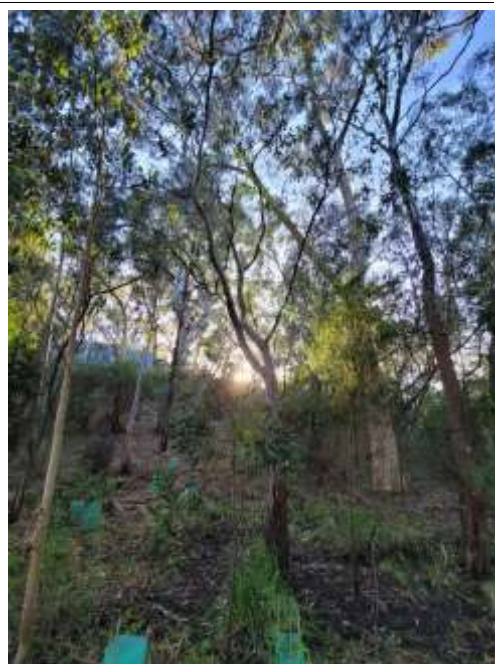
**Tree ID: 364****Genus / species:** *Eucalyptus cladocalyx*

Evergreen Sugar Gum

**Retention Value:** High**Removal / retention reason:** N/A.**Amenity value:** High**Works Required:** N/A.

**SRZ (m):** 2.9      **Works priority:** N/A  
**TPZ (m):** 8.2      **Construction Proximity:** 0.1  
**mTPZ (m):**

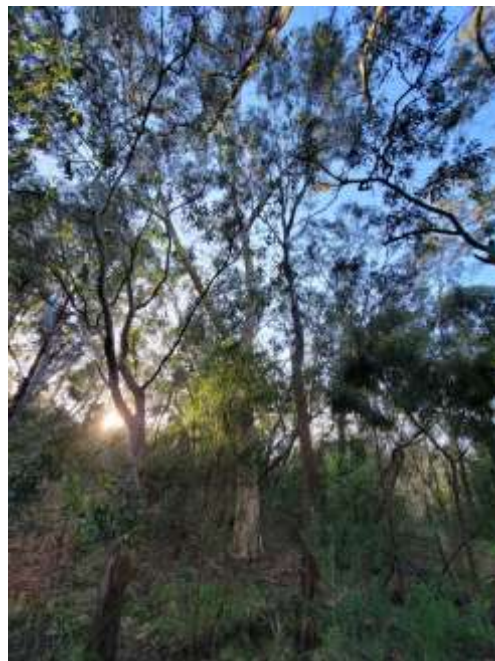
**Tree ID: 365****Genus / species:** *Eucalyptus camaldulensis*

Evergreen River Red Gum

**Retention Value:** Low**Removal / retention reason:** N/A.**Amenity value:** Low**Works Required:** N/A.

**SRZ (m):** 1.6      **Works priority:** N/A  
**TPZ (m):** 2.0      **Construction Proximity:** 0.1  
**mTPZ (m):**

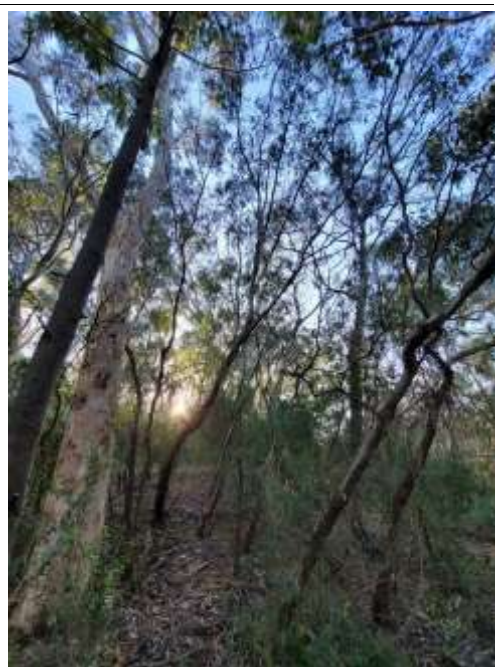
**Tree ID: 366****Genus / species:** *Eucalyptus camaldulensis*

Evergreen River Red Gum

**Retention Value:** Low**Removal / retention reason:** N/A.**Amenity value:** Low**Works Required:** N/A.

**SRZ (m):** 1.7      **Works priority:** N/A  
**TPZ (m):** 2.0      **Construction Proximity:** 0.1  
**mTPZ (m):**

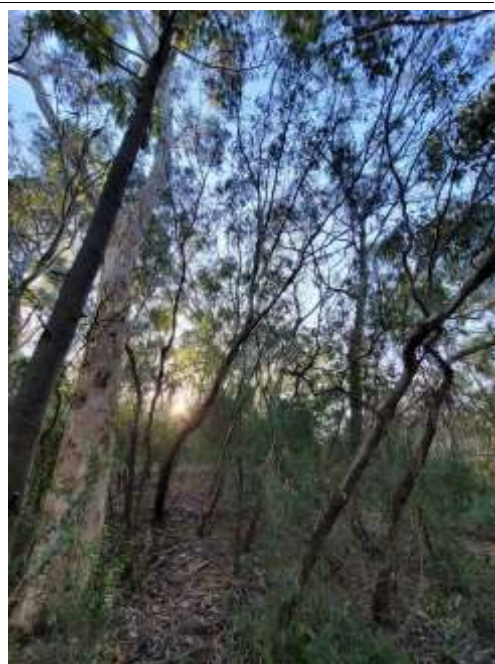
**Tree ID: 367****Genus / species:** *Eucalyptus camaldulensis*

Evergreen River Red Gum

**Height (m):** 9      **Structure:** Good  
**Width (m):** 5      **Health:** Fair  
**DBH (cm):** 20 Measured **Maturity:** Immature  
**Origin:** Melbourne **ULE (years):** 30 - 60  
**Retained?:** Retained **Form:** Good  
**Retention Value:** Low  
**Removal / retention reason:** N/A.  
**Amenity value:** Low  
**Works Required:** N/A.

**SRZ (m):** 1.8      **Works priority:** N/A  
**TPZ (m):** 2.4      **Construction Proximity:** 0.1  
**mTPZ (m):**

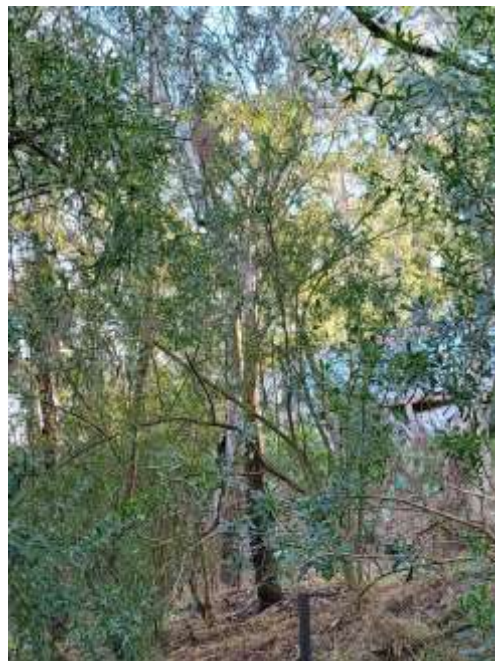
**Tree ID: 368****Genus / species:** *Eucalyptus camaldulensis*

Evergreen River Red Gum

**Height (m):** 17      **Structure:** Good  
**Width (m):** 8      **Health:** Good  
**DBH (cm):** 36 Measured **Maturity:** Mature  
**Origin:** Melbourne **ULE (years):** > 60  
**Retained?:** Retained **Form:** Good  
**Retention Value:** Very high  
**Removal / retention reason:** N/A.  
**Amenity value:** High  
**Works Required:** N/A.

**SRZ (m):** 2.3      **Works priority:** N/A  
**TPZ (m):** 4.3      **Construction Proximity:** 0.1  
**mTPZ (m):**

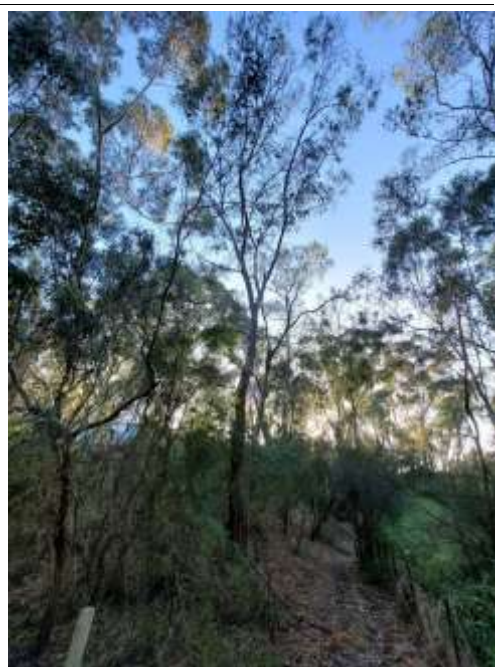
**Tree ID: 369****Genus / species:** *Eucalyptus* sp.

Evergreen Gum

**Height (m):** 13      **Structure:** Poor  
**Width (m):** 7      **Health:** Dead  
**DBH (cm):** 36 Estimated **Maturity:** Mature  
**Origin:** Australian **ULE (years):** 0  
**Retained?:** Retained **Form:** Very poor  
**Retention Value:** Remove.  
**Removal / retention reason:** N/A.  
**Amenity value:** Very low  
**Works Required:** N/A.

**SRZ (m):** 2.3      **Works priority:** N/A  
**TPZ (m):** 4.3      **Construction Proximity:** 0.1  
**mTPZ (m):**

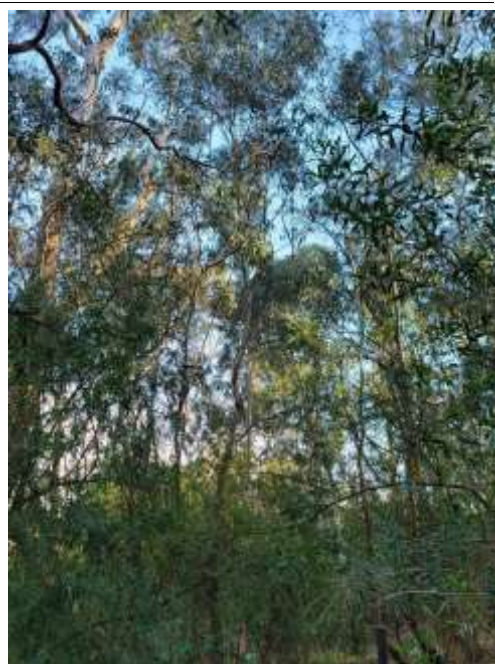
**Tree ID: 370****Genus / species:** *Eucalyptus camaldulensis*

Evergreen River Red Gum

**Height (m):** 14      **Structure:** Good  
**Width (m):** 6      **Health:** Fair  
**DBH (cm):** 19 Measured **Maturity:** Immature  
**Origin:** Melbourne **ULE (years):** > 60  
**Retained?:** Retained **Form:** Good  
**Retention Value:** High  
**Removal / retention reason:** N/A.  
**Amenity value:** Moderate  
**Works Required:** N/A.

**SRZ (m):** 1.7      **Works priority:** N/A  
**TPZ (m):** 2.3      **Construction Proximity:** 0.1  
**mTPZ (m):**

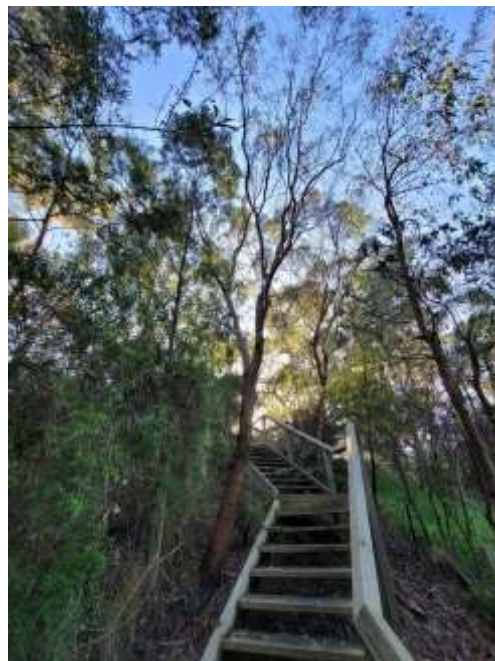
**Tree ID: 371****Genus / species:** *Eucalyptus camaldulensis*

Evergreen River Red Gum

**Height (m):** 9      **Structure:** Good  
**Width (m):** 2      **Health:** Fair  
**DBH (cm):** 12 Measured **Maturity:** Immature  
**Origin:** Melbourne **ULE (years):** 30 - 60  
**Retained?:** Retained **Form:** Good  
**Retention Value:** Low  
**Removal / retention reason:** N/A.  
**Amenity value:** Low  
**Works Required:** N/A.

**SRZ (m):** 1.6      **Works priority:** N/A  
**TPZ (m):** 2.0      **Construction Proximity:** 0.1  
**mTPZ (m):**

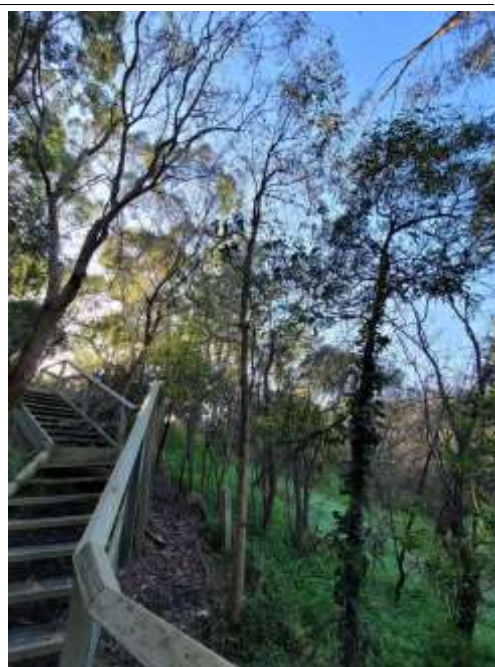
**Tree ID: 372****Genus / species:** *Ulmus procera*

Deciduous English Elm

**Height (m):** 6      **Structure:** Good  
**Width (m):** 4      **Health:** Good  
**DBH (cm):** 29 Measured **Maturity:** Mature  
**Origin:** Exotic **ULE (years):** 30 - 60  
**Retained?:** Retained **Form:** Fair  
**Retention Value:** Low  
**Removal / retention reason:** N/A.  
**Amenity value:** Low  
**Works Required:** N/A.

**SRZ (m):** 2.1      **Works priority:** N/A  
**TPZ (m):** 3.5      **Construction Proximity:** 0.1  
**mTPZ (m):**

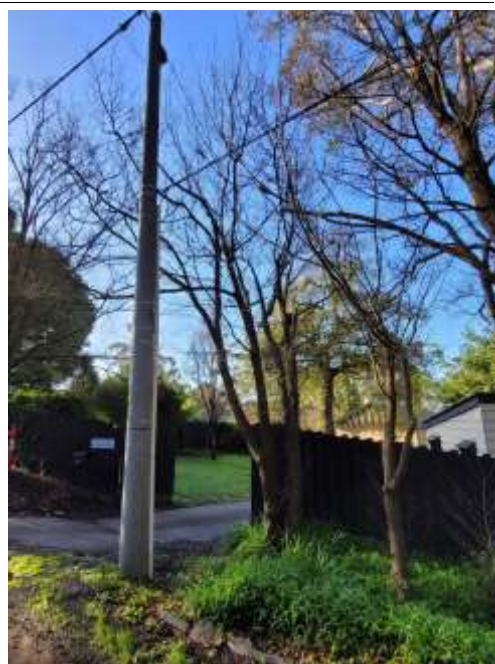
**Tree ID: 373****Genus / species:** *Ulmus procera*

Deciduous English Elm

**Height (m):** 11      **Structure:** Good  
**Width (m):** 8      **Health:** Poor  
**DBH (cm):** 28 Measured **Maturity:** Mature  
**Origin:** Exotic      **ULE (years):** 5 - 15  
**Retained?:** Retained      **Form:** Fair

**Retention Value:** Low**Removal / retention reason:** N/A.**Amenity value:** Low**Works Required:** Canopy lift.**SRZ (m):** 2      **Works priority:** Very low**TPZ (m):** 3.4      **Construction Proximity:** 0.1**mTPZ (m):**

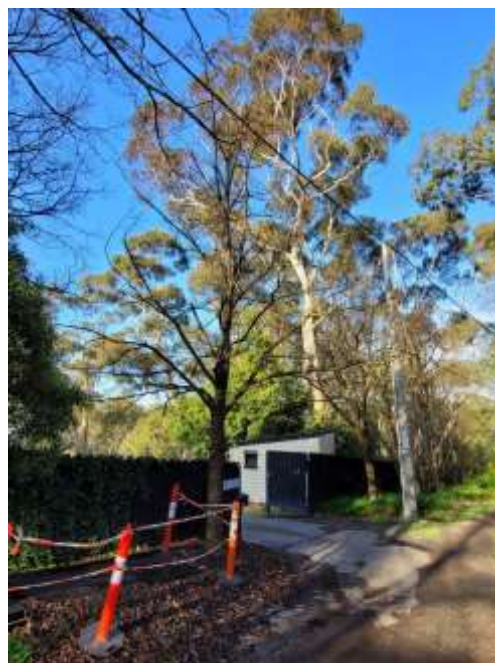
**Tree ID: 374****Genus / species:** *Ulmus procera*

Deciduous English Elm

**Height (m):** 16      **Structure:** Fair  
**Width (m):** 14      **Health:** Good  
**DBH (cm):** 55 Measured **Maturity:** Mature  
**Origin:** Exotic      **ULE (years):** 30 - 60  
**Retained?:** Retained      **Form:** Good

**Retention Value:** High**Removal / retention reason:** N/A.**Amenity value:** High**Works Required:** Canopy lift.**SRZ (m):** 2.7      **Works priority:** Very low**TPZ (m):** 6.6      **Construction Proximity:** 0.1**mTPZ (m):**

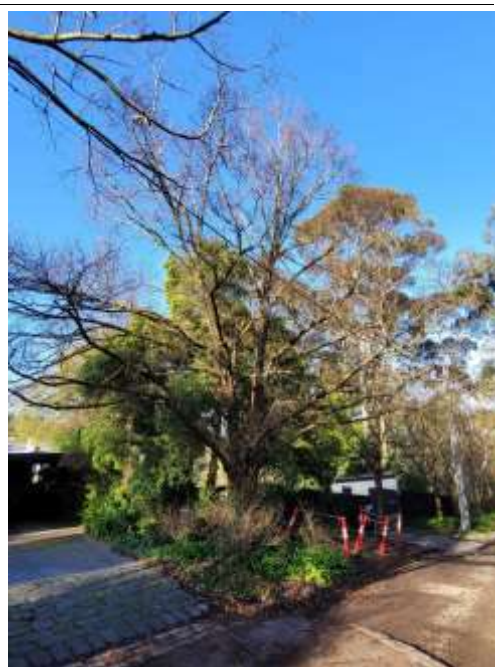
**Tree ID: 375****Genus / species:** *Ulmus procera*

Deciduous English Elm

**Height (m):** 14      **Structure:** Fair  
**Width (m):** 14      **Health:** Good  
**DBH (cm):** 66 Measured **Maturity:** Mature  
**Origin:** Exotic      **ULE (years):** 30 - 60  
**Retained?:** Retained      **Form:** Good

**Retention Value:** Moderate**Removal / retention reason:** N/A.**Amenity value:** Moderate**Works Required:** N/A.**SRZ (m):** 2.9      **Works priority:** N/A**TPZ (m):** 7.9      **Construction Proximity:** 0.1**mTPZ (m):**

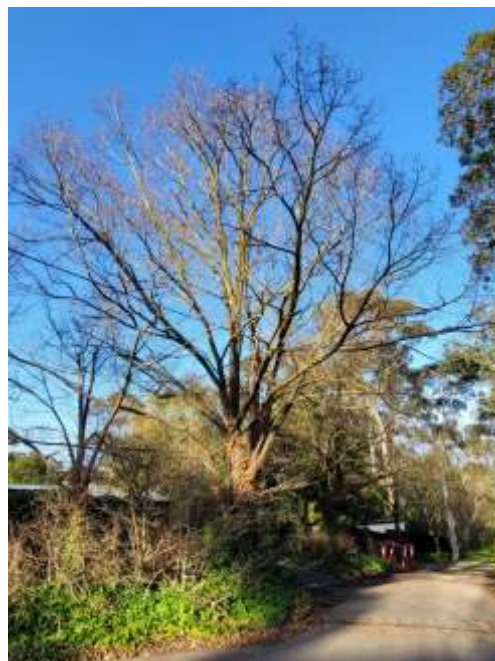
**Tree ID: 376****Genus / species:** *Melaleuca armillaris*

Evergreen Giant Honey Myrtle

**Height (m):** 14      **Structure:** Fair  
**Width (m):** 12      **Health:** Good  
**DBH (cm):** 65      Estimated **Maturity:** Over mature  
**Origin:** Victorian      **ULE (years):** 15 - 30  
**Retained?:** Retained      **Form:** Fair  
**Retention Value:** Moderate  
**Removal / retention reason:** N/A.  
**Amenity value:** Moderate  
**Works Required:** N/A.

**SRZ (m):** 2.9      **Works priority:** N/A  
**TPZ (m):** 7.8      **Construction Proximity:** 0.1  
**mTPZ (m):**

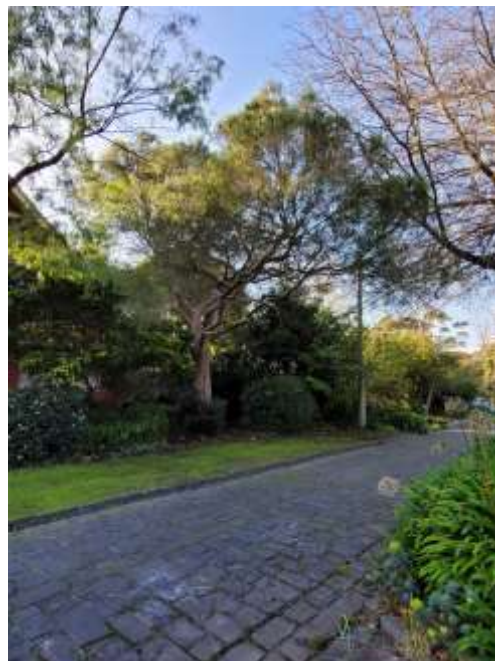
**Tree ID: 377****Genus / species:** *Melaleuca armillaris*

Evergreen Giant Honey Myrtle

**Height (m):** 17      **Structure:** Fair  
**Width (m):** 14      **Health:** Good  
**DBH (cm):** 150      Estimated **Maturity:** Over mature  
**Origin:** Victorian      **ULE (years):** 15 - 30  
**Retained?:** Retained      **Form:** Fair  
**Retention Value:** High  
**Removal / retention reason:** N/A.  
**Amenity value:** High  
**Works Required:** N/A.

**SRZ (m):** 4.1      **Works priority:** N/A  
**TPZ (m):** 15.0      **Construction Proximity:** 0.1  
**mTPZ (m):**

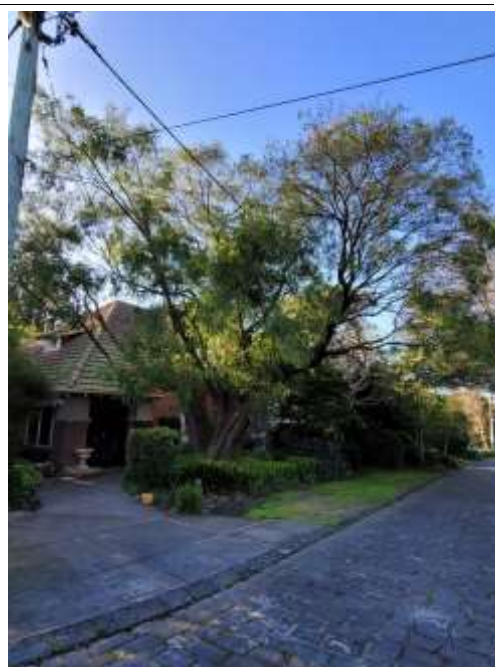
**Tree ID: 378****Genus / species:** *Grevillea robusta*

Evergreen Silky Oak

**Height (m):** 25      **Structure:** Fair  
**Width (m):** 9      **Health:** Good  
**DBH (cm):** 50      Measured **Maturity:** Mature  
**Origin:** Australian      **ULE (years):** 30 - 60  
**Retained?:** Retained      **Form:** Good  
**Retention Value:** High  
**Removal / retention reason:** N/A.  
**Amenity value:** High  
**Works Required:** N/A.

**SRZ (m):** 2.6      **Works priority:** N/A  
**TPZ (m):** 6.0      **Construction Proximity:** 0.1  
**mTPZ (m):**

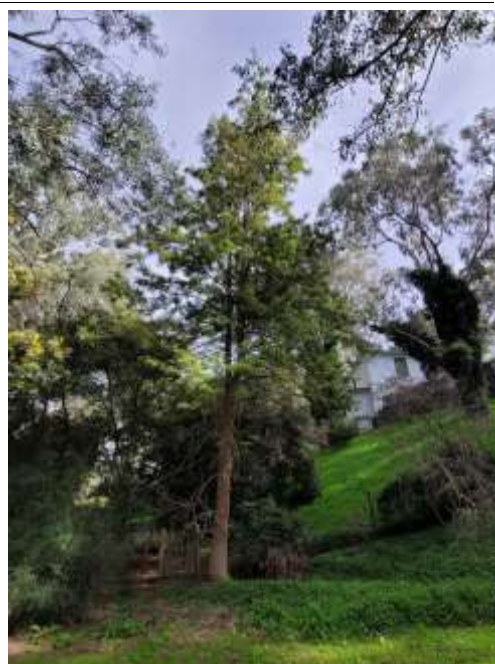
**Tree ID: 379****Genus / species:** *Acacia dealbata*

Evergreen Silver Wattle

**Retention Value:** Low**Removal / retention reason:** N/A.**Amenity value:** Moderate**Works Required:** N/A.

**SRZ (m):** 1.7      **Works priority:** N/A  
**TPZ (m):** 2.3      **Construction Proximity:** 0.1  
**mTPZ (m):**

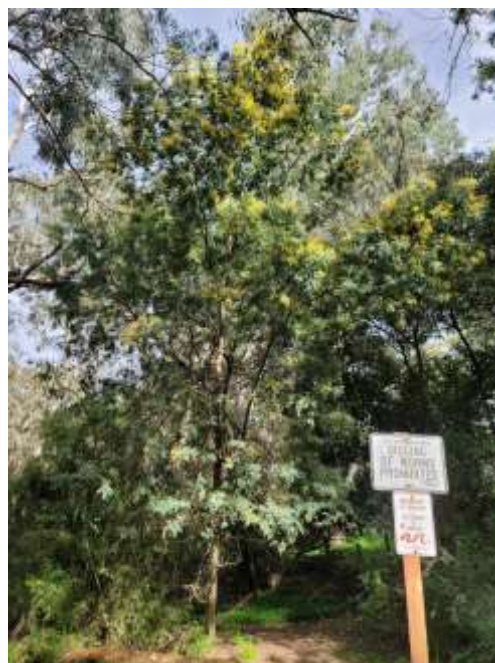
**Tree ID: 380****Genus / species:** *Acacia dealbata*

Evergreen Silver Wattle

**Retention Value:** Low**Removal / retention reason:** N/A.**Amenity value:** Moderate**Works Required:** N/A.

**SRZ (m):** 1.8      **Works priority:** N/A  
**TPZ (m):** 2.5      **Construction Proximity:** 0.1  
**mTPZ (m):**

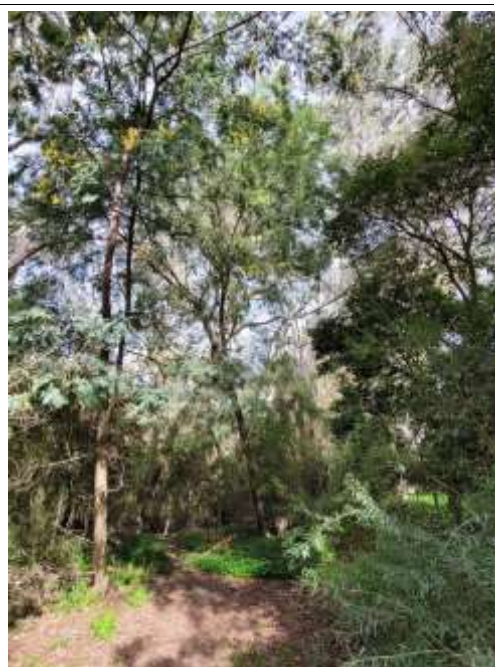
**Tree ID: 381****Genus / species:** *Laurus nobilis*

Evergreen Bay Tree

**Retention Value:** Moderate**Removal / retention reason:** N/A.**Amenity value:** Low**Works Required:** N/A.

**SRZ (m):** 2.2      **Works priority:** N/A  
**TPZ (m):** 4.2      **Construction Proximity:** 0.1  
**mTPZ (m):**

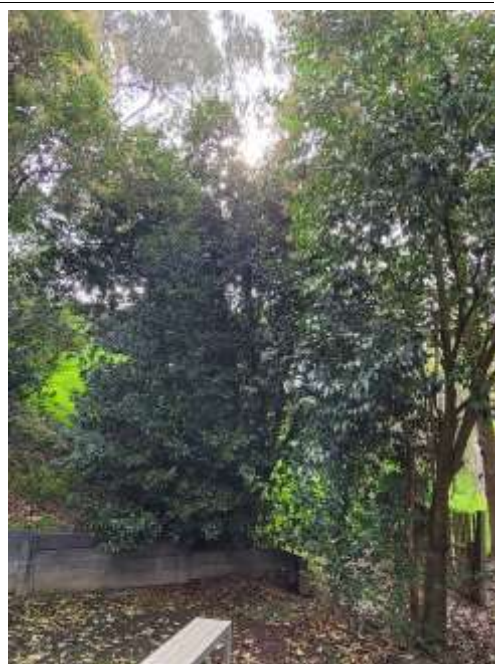
**Tree ID: 382****Genus / species:** *Melaleuca linariifolia*

Evergreen Flax Leaf Paperbark

**Height (m):** 9      **Structure:** Fair  
**Width (m):** 3      **Health:** Very poor  
**DBH (cm):** 15      **Estimated Maturity:** Mature  
**Origin:** Australian      **ULE (years):** 1 - 5  
**Retained?:** Removed      **Form:** Very poor  
**Retention Value:** Very low  
**Removal / retention reason:** N/A.  
**Amenity value:** Very low  
**Works Required:** N/A.

**SRZ (m):** 1.6      **Works priority:** N/A  
**TPZ (m):** 2.0      **Construction Proximity:** 0.1  
**mTPZ (m):**

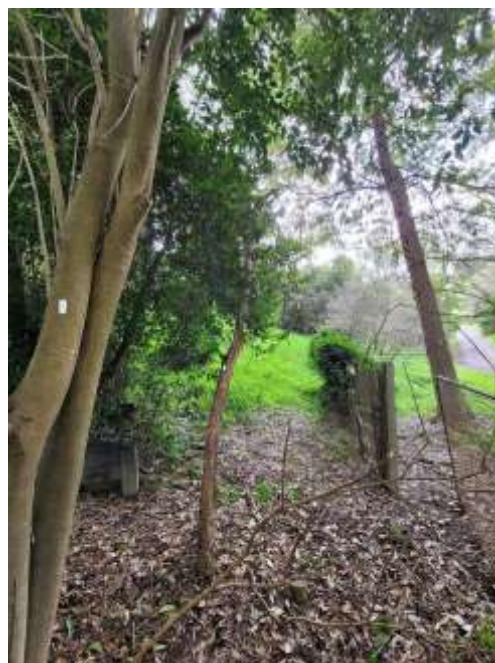
**Tree ID: 383****Genus / species:** *Ligustrum lucidum*

Evergreen Privet

**Height (m):** 12      **Structure:** Fair  
**Width (m):** 7      **Health:** Good  
**DBH (cm):** 26      **Measured Maturity:** Mature  
**Origin:** Exotic      **ULE (years):** 15 - 30  
**Retained?:** Removed      **Form:** Good  
**Retention Value:** Moderate  
**Removal / retention reason:** N/A.  
**Amenity value:** Moderate  
**Works Required:** N/A.

**SRZ (m):** 2      **Works priority:** N/A  
**TPZ (m):** 3.1      **Construction Proximity:** 0.1  
**mTPZ (m):**

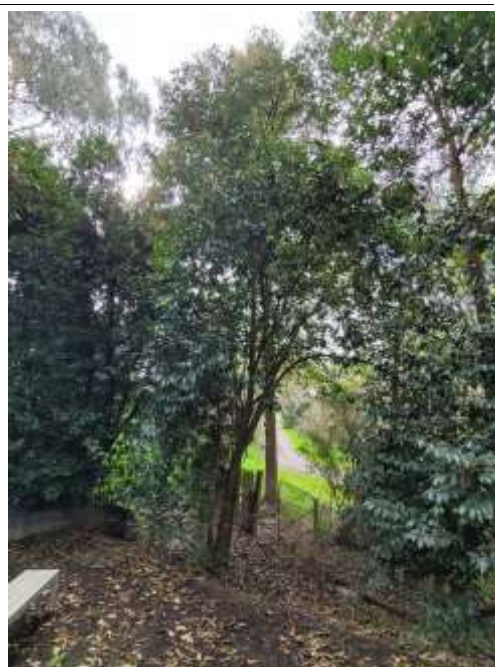
**Tree ID: 384****Genus / species:** *Ligustrum lucidum*

Evergreen Privet

**Height (m):** 11      **Structure:** Good  
**Width (m):** 6      **Health:** Good  
**DBH (cm):** 24      **Measured Maturity:** Mature  
**Origin:** Exotic      **ULE (years):** 15 - 30  
**Retained?:** Retained      **Form:** Good  
**Retention Value:** Moderate  
**Removal / retention reason:** N/A.  
**Amenity value:** Moderate  
**Works Required:** N/A.

**SRZ (m):** 1.9      **Works priority:** N/A  
**TPZ (m):** 2.9      **Construction Proximity:** 0.1  
**mTPZ (m):**

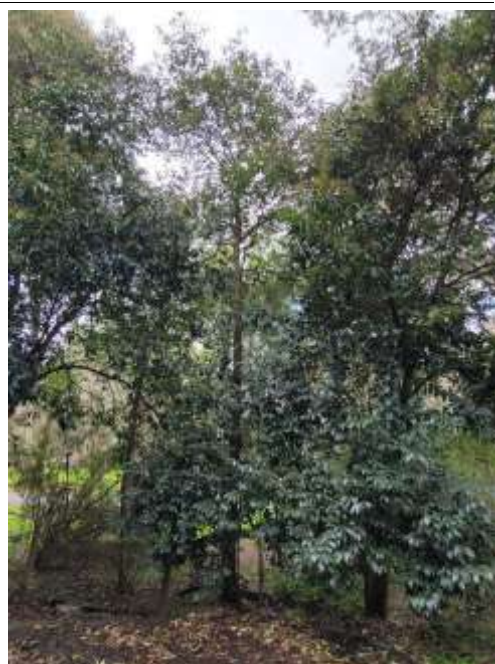
**Tree ID: 385****Genus / species:** *Eucalyptus sp.*

Evergreen Gum

**Height (m):** 10      **Structure:** Fair  
**Width (m):** 3      **Health:** Good  
**DBH (cm):** 12      Estimated **Maturity:** Immature  
**Origin:** Australian      **ULE (years):** 15 - 30  
**Retained?:** Removed      **Form:** Poor  
**Retention Value:** Low  
**Removal / retention reason:** N/A.  
**Amenity value:** Low  
**Works Required:** N/A.

**SRZ (m):** 1.6      **Works priority:** N/A  
**TPZ (m):** 2.0      **Construction Proximity:** 0.1  
**mTPZ (m):**
