## **Nation Partners**

# **Northern Sewers Relining Project Southern Section**

## **Construction Impact Report**

**Wednesday 4<sup>th</sup> December 2024**

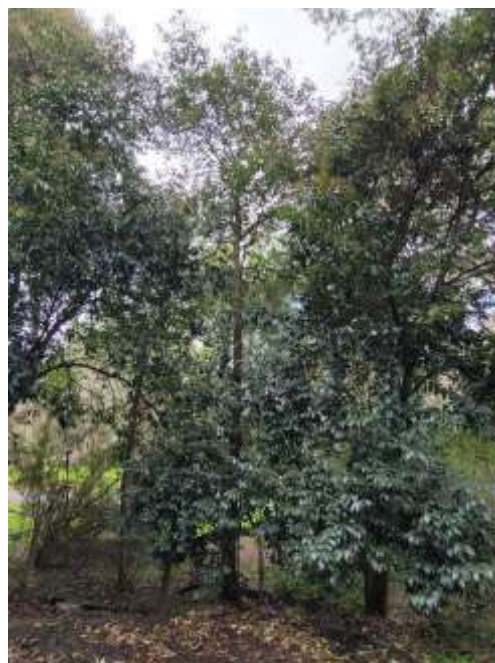
**Tree ID: 386****Genus / species:** *Ligustrum lucidum*

Evergreen Privet

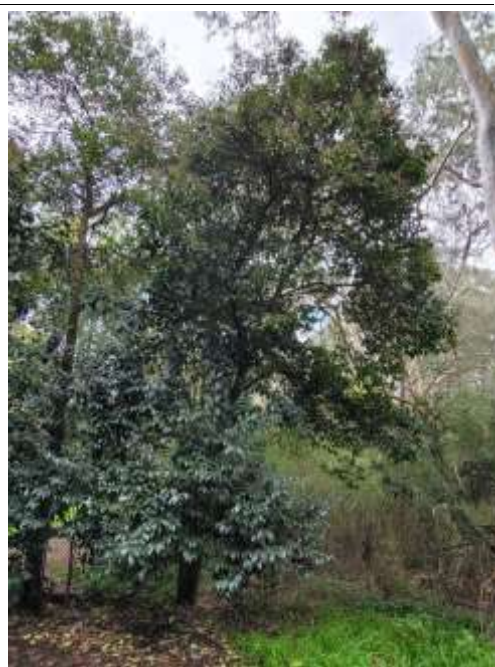
**Tree ID: 387****Genus / species:** *Eucalyptus camaldulensis*

Evergreen River Red Gum

**Height (m):** 28      **Structure:** Good  
**Width (m):** 9      **Health:** Good  
**DBH (cm):** 71      Measured **Maturity:** Mature  
**Origin:** Melbourne      **ULE (years):** > 60  
**Retained?:** Retained      **Form:** Good  
**Retention Value:** Very high  
**Removal / retention reason:** N/A.  
**Amenity value:** High  
**Works Required:** N/A.

**SRZ (m):** 3      **Works priority:** N/A  
**TPZ (m):** 8.5      **Construction Proximity:** 0.1  
**mTPZ (m):**

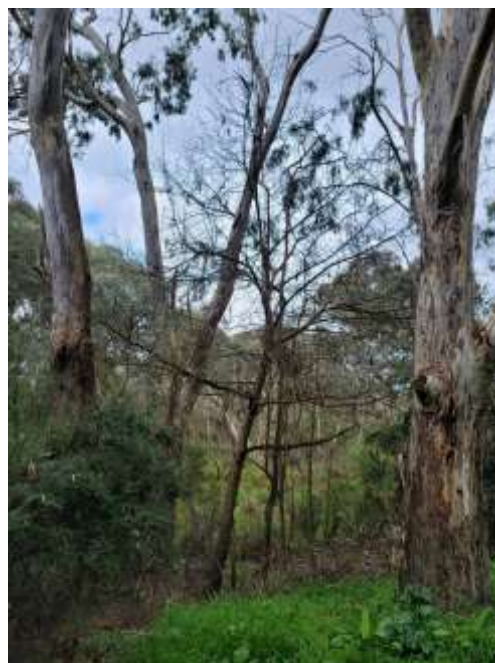
**Tree ID: 389****Genus / species:** *Eucalyptus camaldulensis*

Evergreen      River Red Gum

**Retention Value:** Very high**Removal / retention reason:** N/A.**Amenity value:** High**Works Required:** N/A.

**SRZ (m):** 3.4      **Works priority:** N/A  
**TPZ (m):** 10.8      **Construction Proximity:** 0.1  
**mTPZ (m):**

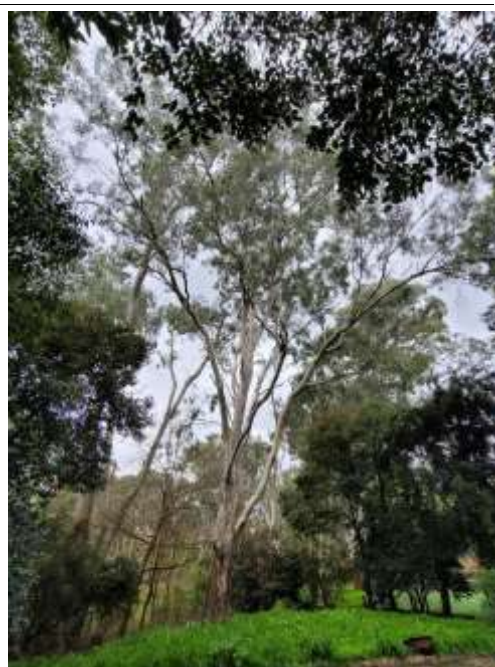
**Tree ID: 390****Genus / species:** *Ligustrum lucidum*

Evergreen      Privet

**Retention Value:** Low**Removal / retention reason:** N/A.**Amenity value:** Low**Works Required:** N/A.

**SRZ (m):** 2      **Works priority:** N/A  
**TPZ (m):** 3.4      **Construction Proximity:** 0.1  
**mTPZ (m):**

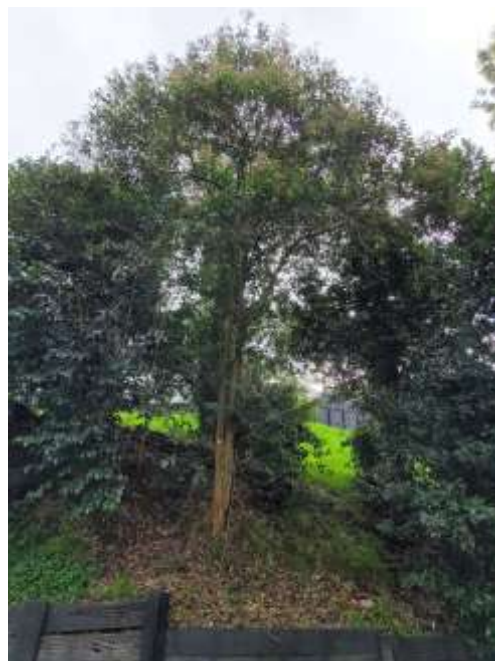
**Tree ID: 391****Genus / species:** *Laurus nobilis*

Evergreen Bay Tree

**Retention Value:** Moderate**Removal / retention reason:** N/A.**Amenity value:** Low**Works Required:** N/A.

**SRZ (m):** 1.6      **Works priority:** N/A  
**TPZ (m):** 2.0      **Construction Proximity:** 0.1  
**mTPZ (m):**

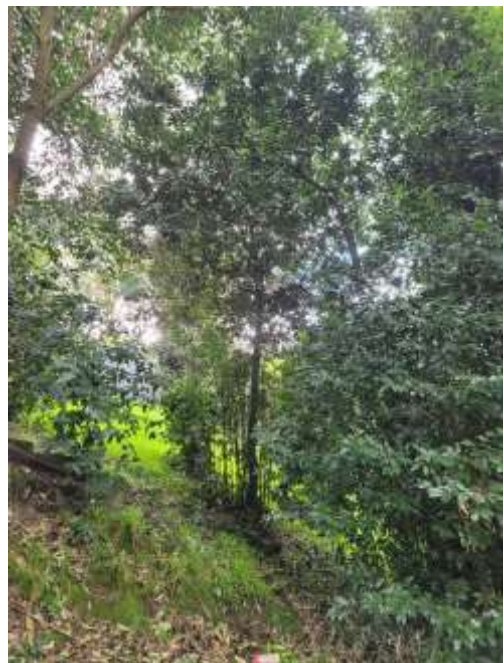
**Tree ID: 392****Genus / species:** *Laurus nobilis*

Evergreen Bay Tree

**Retention Value:** High**Removal / retention reason:** N/A.**Amenity value:** Moderate**Works Required:** N/A.

**SRZ (m):** 2.1      **Works priority:** N/A  
**TPZ (m):** 3.6      **Construction Proximity:** 0.1  
**mTPZ (m):**

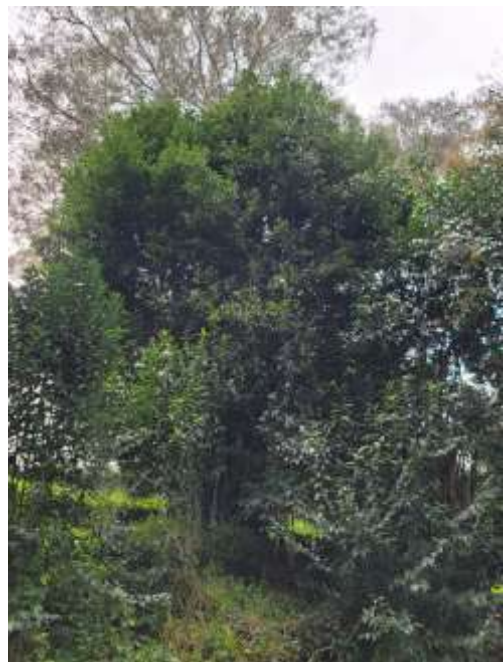
**Tree ID: 393****Genus / species:** *Eucalyptus ovata*

Evergreen Swamp Gum

**Retention Value:** High**Removal / retention reason:** N/A.**Amenity value:** High**Works Required:** N/A.

**SRZ (m):** 2.6      **Works priority:** N/A  
**TPZ (m):** 6.0      **Construction Proximity:** 0.1  
**mTPZ (m):**

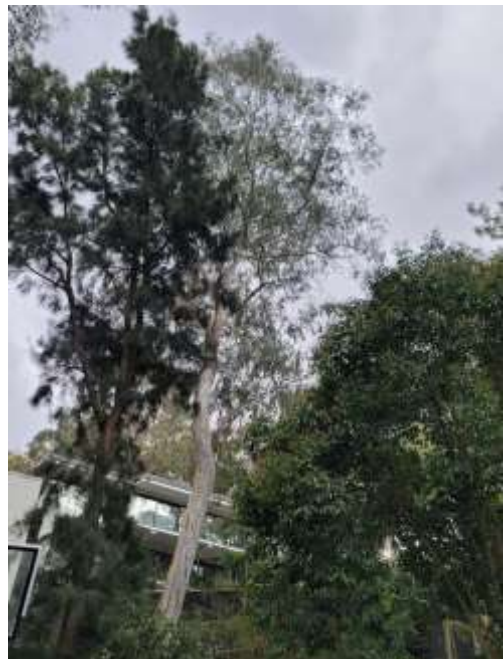
**Tree ID: 394****Genus / species:** *Casuarina cunninghamiana*

Evergreen River She - Oak

**Retention Value:** High**Removal / retention reason:** N/A.**Amenity value:** High**Works Required:** N/A.

**SRZ (m):** 2.5      **Works priority:** N/A  
**TPZ (m):** 5.4      **Construction Proximity:** 0.1  
**mTPZ (m):**

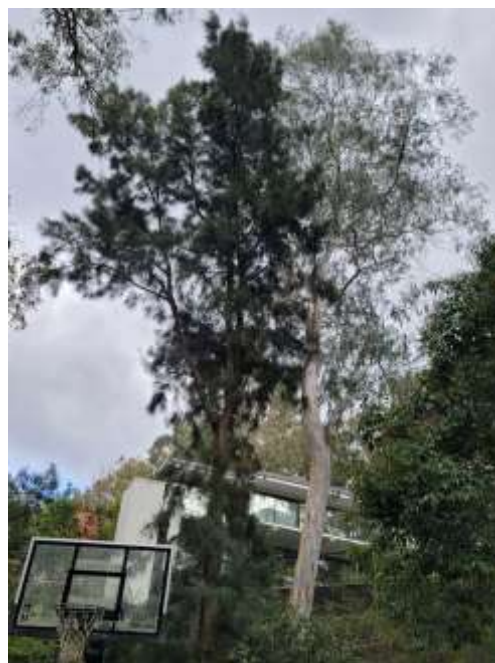
**Tree ID: 395****Genus / species:** *Corymbia maculata*

Evergreen Spotted Gum

**Retention Value:** Moderate**Removal / retention reason:** N/A.**Amenity value:** Moderate**Works Required:** N/A.

**SRZ (m):** 1.8      **Works priority:** N/A  
**TPZ (m):** 2.4      **Construction Proximity:** 0.1  
**mTPZ (m):**

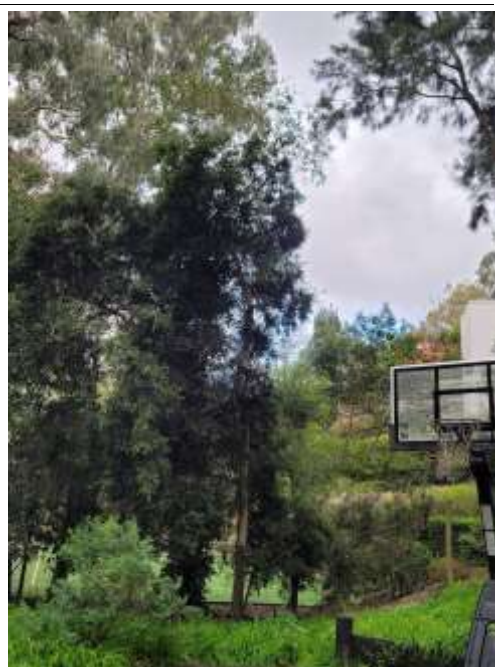
**Tree ID: 396****Genus / species:** *Ligustrum lucidum*

Evergreen Privet

**Retention Value:** Low**Removal / retention reason:** N/A.**Amenity value:** Low**Works Required:** N/A.

**SRZ (m):** 1.7      **Works priority:** N/A  
**TPZ (m):** 2.3      **Construction Proximity:** 0.1  
**mTPZ (m):**

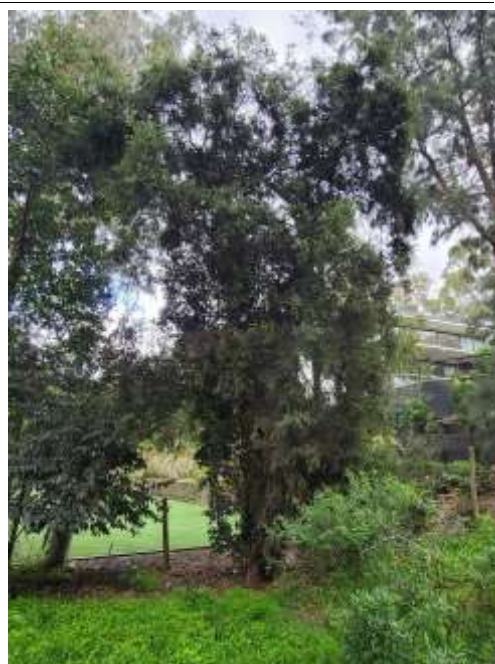
**Tree ID: 397****Genus / species:** *Ligustrum lucidum*

Evergreen Privet

**Retention Value:** Low**Removal / retention reason:** N/A.**Amenity value:** Low**Works Required:** N/A.

**SRZ (m):** 1.7      **Works priority:** N/A  
**TPZ (m):** 2.3      **Construction Proximity:** 0.1  
**mTPZ (m):**

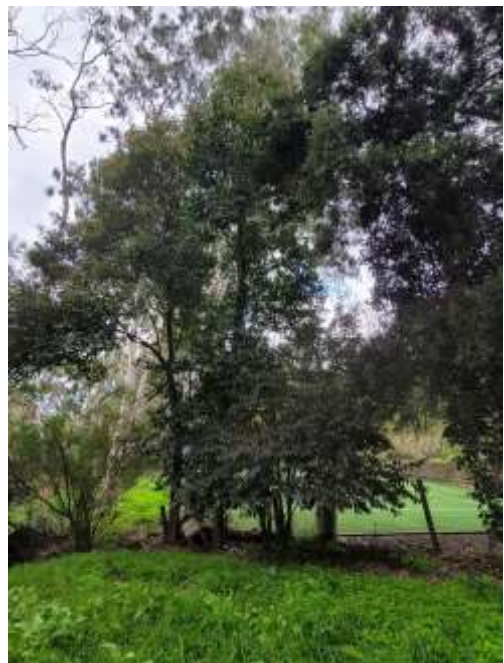
**Tree ID: 398****Genus / species:** *Ligustrum lucidum*

Evergreen Privet

**Retention Value:** Moderate**Removal / retention reason:** N/A.**Amenity value:** Moderate**Works Required:** N/A.

**SRZ (m):** 1.9      **Works priority:** N/A  
**TPZ (m):** 2.6      **Construction Proximity:** 0.1  
**mTPZ (m):**

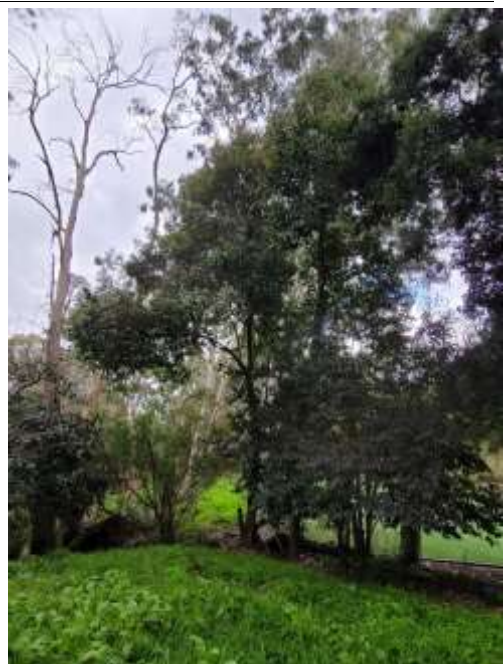
**Tree ID: 399****Genus / species:** *Acacia pycnantha*

Evergreen Golden Wattle

**Retention Value:** Low**Removal / retention reason:** N/A.**Amenity value:** Low**Works Required:** N/A.

**SRZ (m):** 1.6      **Works priority:** N/A  
**TPZ (m):** 2.0      **Construction Proximity:** 0.1  
**mTPZ (m):**

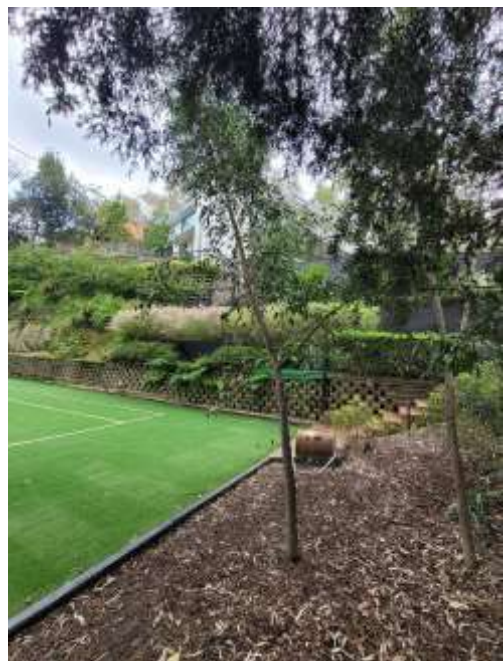
**Tree ID: 400****Genus / species:** *Acacia pycnantha*

Evergreen Golden Wattle

**Height (m):** 5      **Structure:** Good  
**Width (m):** 2      **Health:** Good  
**DBH (cm):** 7 Measured **Maturity:** Immature  
**Origin:** Melbourne **ULE (years):** 15 - 30  
**Retained?:** Retained **Form:** Good  
**Retention Value:** Low  
**Removal / retention reason:** N/A.  
**Amenity value:** Low  
**Works Required:** N/A.

**SRZ (m):** 1.6      **Works priority:** N/A  
**TPZ (m):** 2.0      **Construction Proximity:** 0.1  
**mTPZ (m):**

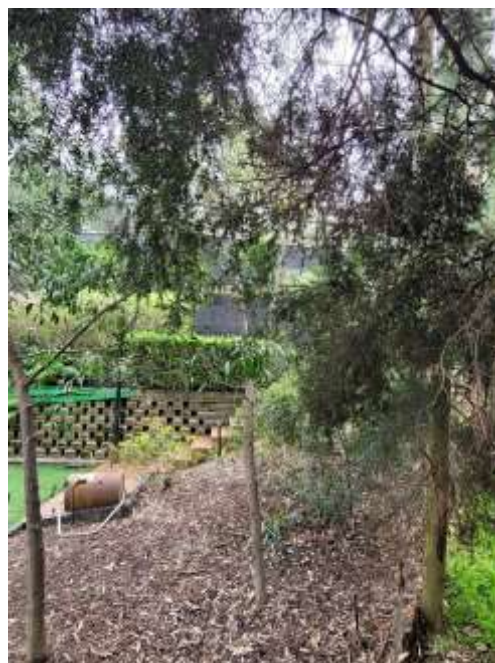
**Tree ID: 401****Genus / species:** *Eucalyptus camaldulensis*

Evergreen River Red Gum

**Height (m):** 19      **Structure:** Good  
**Width (m):** 8      **Health:** Fair  
**DBH (cm):** 44 Measured **Maturity:** Mature  
**Origin:** Melbourne **ULE (years):** 30 - 60  
**Retained?:** Retained **Form:** Fair  
**Retention Value:** High  
**Removal / retention reason:** N/A.  
**Amenity value:** High  
**Works Required:** N/A.

**SRZ (m):** 2.4      **Works priority:** N/A  
**TPZ (m):** 5.3      **Construction Proximity:** 0.1  
**mTPZ (m):**

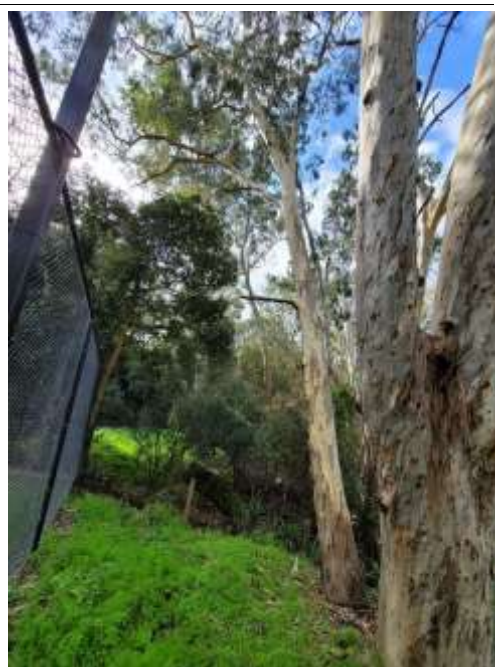
**Tree ID: 402****Genus / species:** *Eucalyptus camaldulensis*

Evergreen River Red Gum

**Height (m):** 21      **Structure:** Fair  
**Width (m):** 12      **Health:** Good  
**DBH (cm):** 75 Measured **Maturity:** Mature  
**Origin:** Melbourne **ULE (years):** 30 - 60  
**Retained?:** Retained **Form:** Fair  
**Retention Value:** High  
**Removal / retention reason:** N/A.  
**Amenity value:** High  
**Works Required:** N/A.

**SRZ (m):** 3      **Works priority:** N/A  
**TPZ (m):** 9.0      **Construction Proximity:** 0.1  
**mTPZ (m):**

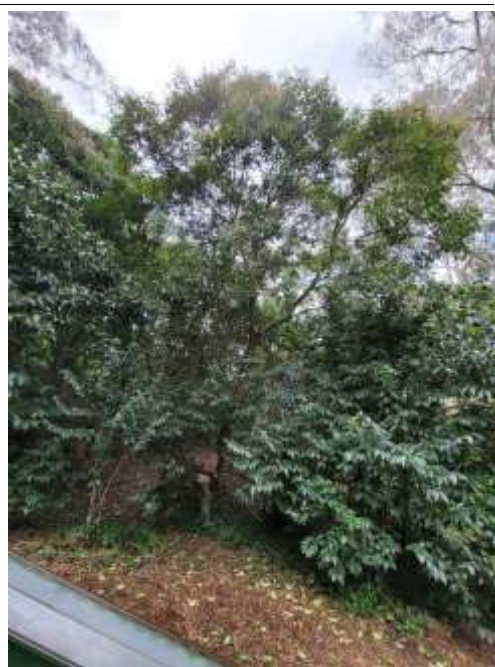
**Tree ID: 405****Genus / species:** *Ligustrum lucidum*

Evergreen Privet

**Retention Value:** Moderate**Removal / retention reason:** N/A.**Amenity value:** Moderate**Works Required:** N/A.

**SRZ (m):** 1.9      **Works priority:** N/A  
**TPZ (m):** 2.6      **Construction Proximity:** 0.1  
**mTPZ (m):**

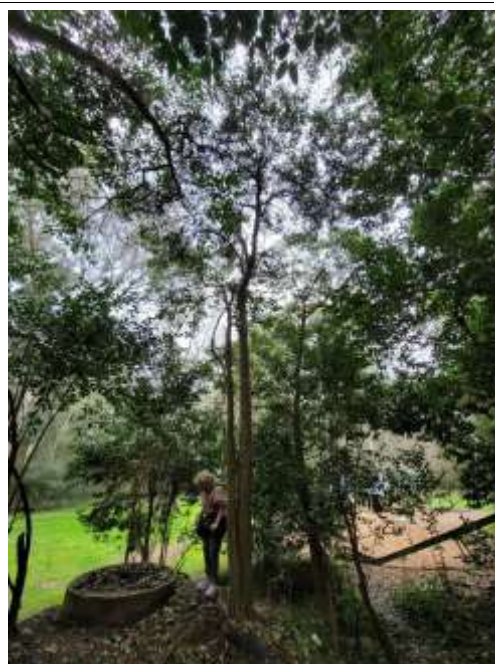
**Tree ID: 406****Genus / species:** *Ligustrum lucidum*

Evergreen Privet

**Retention Value:** Low**Removal / retention reason:** N/A.**Amenity value:** Low**Works Required:** N/A.

**SRZ (m):** 2      **Works priority:** N/A  
**TPZ (m):** 3.1      **Construction Proximity:** 0.1  
**mTPZ (m):**

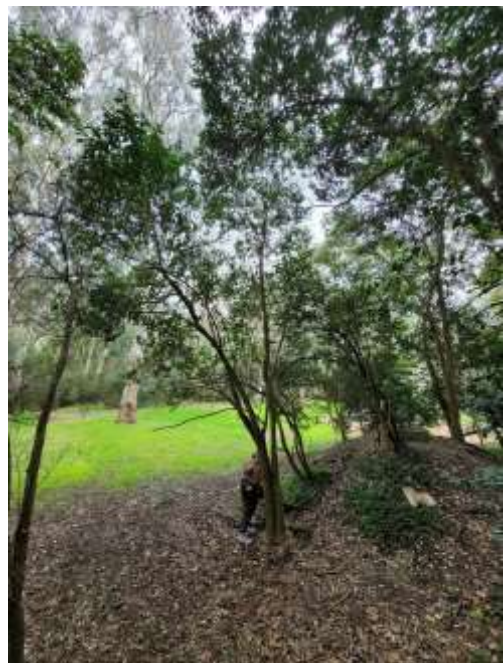
**Tree ID: 407****Genus / species:** *Ligustrum lucidum*

Evergreen Privet

**Retention Value:** Low**Removal / retention reason:** N/A.**Amenity value:** Low**Works Required:** N/A.

**SRZ (m):** 1.9      **Works priority:** N/A  
**TPZ (m):** 2.8      **Construction Proximity:** 0.1  
**mTPZ (m):**

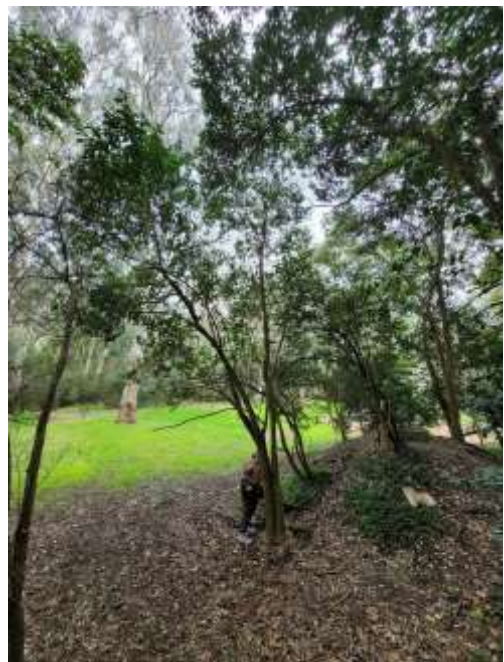
**Tree ID: 408****Genus / species:** *Eucalyptus camaldulensis*

Evergreen River Red Gum

**Retention Value:** Very high**Removal / retention reason:** N/A.**Amenity value:** High**Works Required:** N/A.

**SRZ (m):** 2.6      **Works priority:** N/A  
**TPZ (m):** 5.9      **Construction Proximity:** 0.1  
**mTPZ (m):**

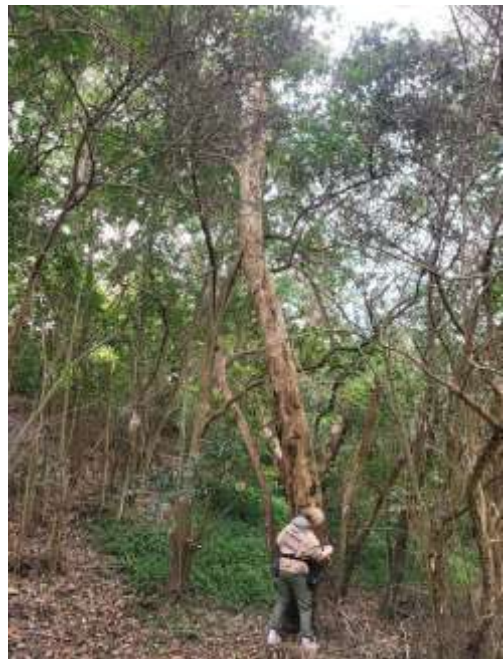
**Tree ID: 409****Genus / species:** *Eucalyptus camaldulensis*

Evergreen River Red Gum

**Height (m):** 14 **Structure:** Good**Width (m):** 7 **Health:** Fair**DBH (cm):** 30 Measured **Maturity:** Mature**Origin:** Melbourne **ULE (years):** 15 - 30**Retained?:** Retained **Form:** Fair**Retention Value:** Moderate**Removal / retention reason:** N/A.**Amenity value:** Moderate**Works Required:** N/A.**SRZ (m):** 2.1 **Works priority:** N/A**TPZ (m):** 3.6 **Construction Proximity:** 0.1**mTPZ (m):**

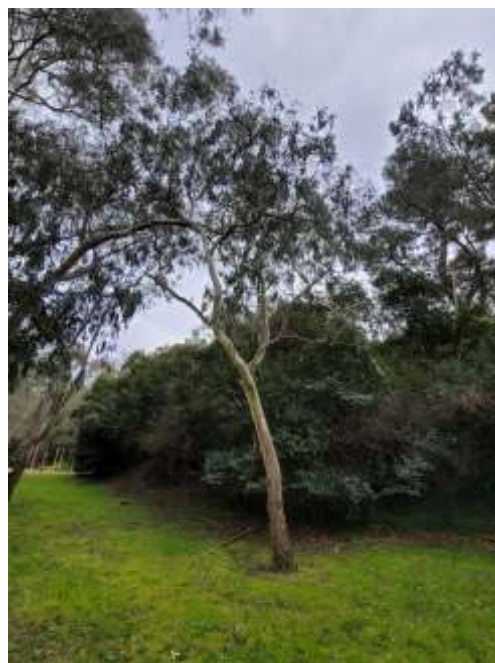
**Tree ID: 410****Genus / species:** *Eucalyptus camaldulensis*

Evergreen River Red Gum

**Height (m):** 22 **Structure:** Poor**Width (m):** 7 **Health:** Good**DBH (cm):** 36 Measured **Maturity:** Mature**Origin:** Melbourne **ULE (years):** 15 - 30**Retained?:** Retained **Form:** Fair**Retention Value:** High**Removal / retention reason:** N/A.**Amenity value:** High**Works Required:** N/A.**SRZ (m):** 2.3 **Works priority:** N/A**TPZ (m):** 4.3 **Construction Proximity:** 0.1**mTPZ (m):**

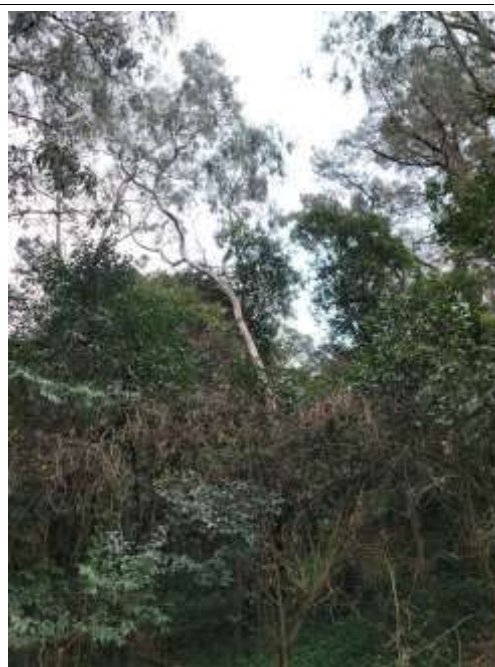
**Tree ID: 411****Genus / species:** *Eucalyptus camaldulensis*

Evergreen River Red Gum

**Height (m):** 17 **Structure:** Good**Width (m):** 6 **Health:** Fair**DBH (cm):** 34 Measured **Maturity:** Mature**Origin:** Melbourne **ULE (years):** 30 - 60**Retained?:** Retained **Form:** Fair**Retention Value:** High**Removal / retention reason:** N/A.**Amenity value:** High**Works Required:** N/A.**SRZ (m):** 2.2 **Works priority:** N/A**TPZ (m):** 4.1 **Construction Proximity:** 0.1**mTPZ (m):**

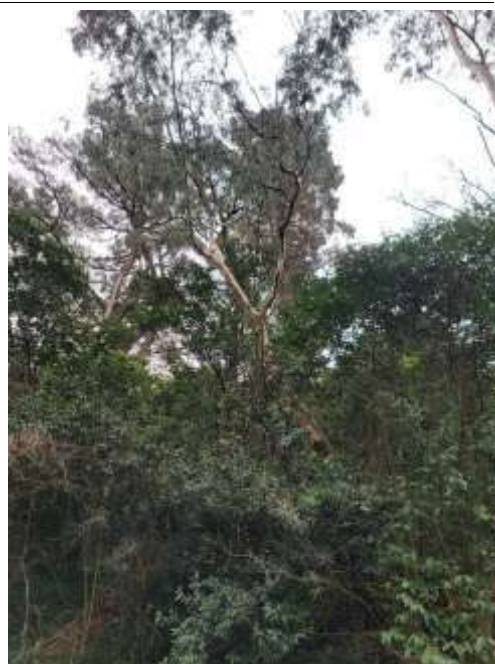
**Tree ID: 412****Genus / species:** *Eucalyptus camaldulensis*

Evergreen River Red Gum

**Retention Value:** Very high**Removal / retention reason:** N/A.**Amenity value:** High**Works Required:** N/A.

**SRZ (m):** 2.5      **Works priority:** N/A  
**TPZ (m):** 5.6      **Construction Proximity:** 0.1  
**mTPZ (m):**

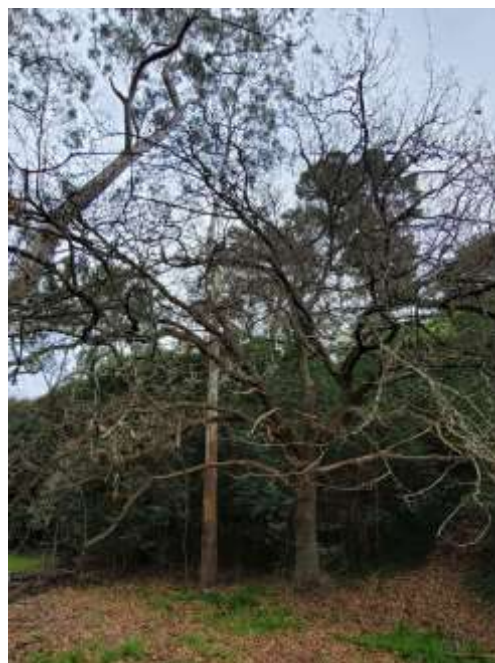
**Tree ID: 413****Genus / species:** *Quercus robur*

Deciduous English Oak

**Retention Value:** High**Removal / retention reason:** N/A.**Amenity value:** Moderate**Works Required:** N/A.

**SRZ (m):** 2.8      **Works priority:** N/A  
**TPZ (m):** 7.4      **Construction Proximity:** 0.1  
**mTPZ (m):**

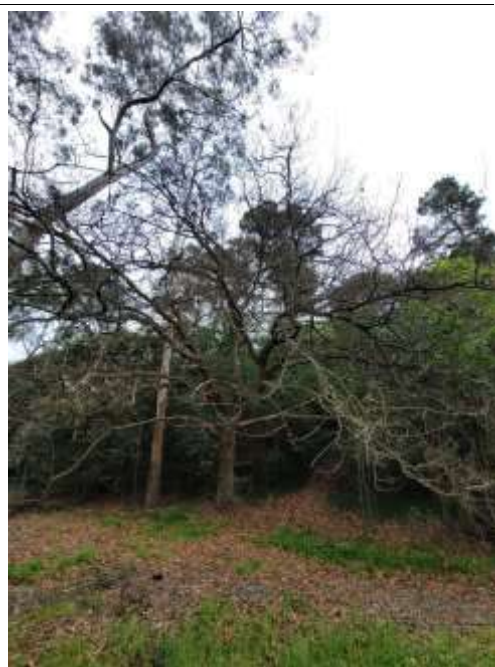
**Tree ID: 414****Genus / species:** *Eucalyptus camaldulensis*

Evergreen River Red Gum

**Retention Value:** Very high**Removal / retention reason:** N/A.**Amenity value:** High**Works Required:** N/A.

**SRZ (m):** 2.8      **Works priority:** N/A  
**TPZ (m):** 7.1      **Construction Proximity:** 0.1  
**mTPZ (m):**

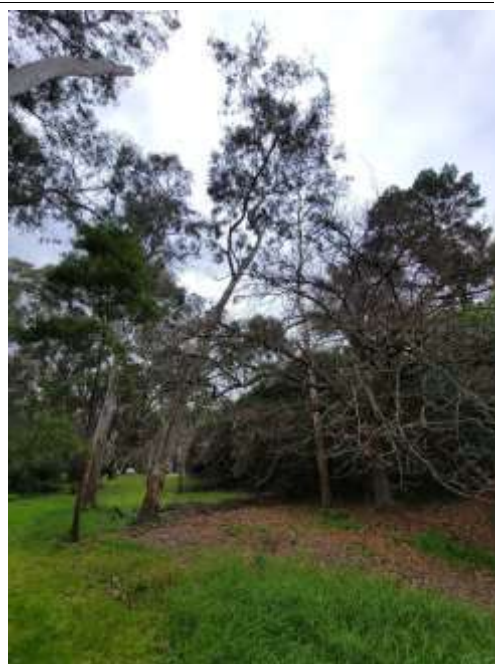
**Tree ID: 415****Genus / species:** *Eucalyptus camaldulensis*

Evergreen River Red Gum

**Removal / retention reason:** N/A.**Amenity value:** High**Works Required:** N/A.

**SRZ (m):** 2.9      **Works priority:** N/A  
**TPZ (m):** 7.8      **Construction Proximity:** 0.1  
**mTPZ (m):**

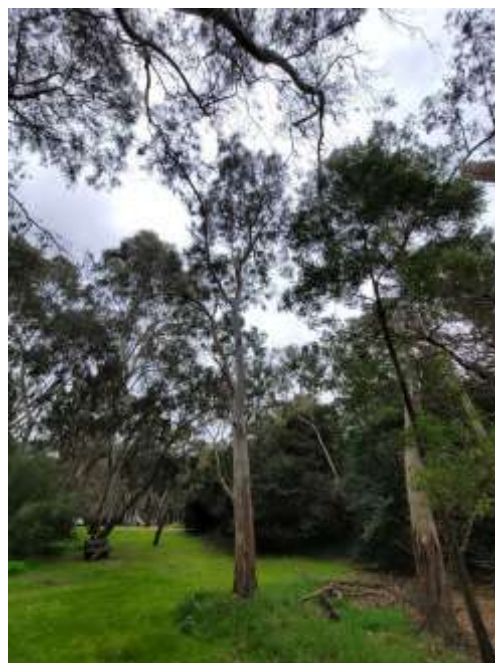
**Tree ID: 416****Genus / species:** *Eucalyptus camaldulensis*

Evergreen River Red Gum

**Removal / retention reason:** N/A.**Amenity value:** High**Works Required:** N/A.

**SRZ (m):** 3.7      **Works priority:** N/A  
**TPZ (m):** 13.7      **Construction Proximity:** 0.1  
**mTPZ (m):**

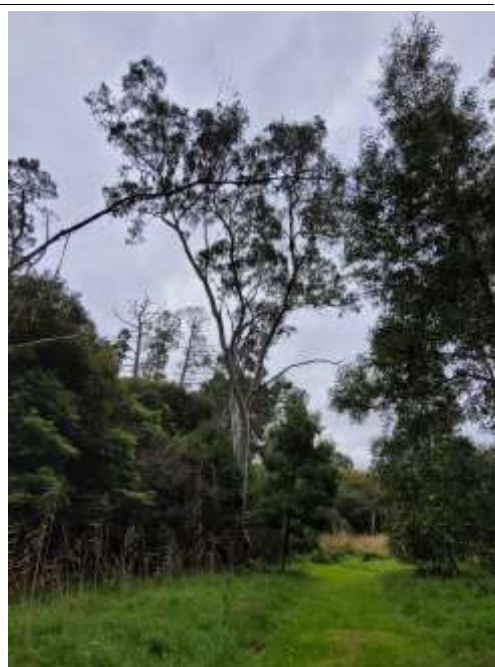
**Tree ID: 417****Genus / species:** *Acacia melanoxylon*

Evergreen Blackwood

**Removal / retention reason:** N/A.**Amenity value:** Low**Works Required:** N/A.

**SRZ (m):** 1.6      **Works priority:** N/A  
**TPZ (m):** 2.0      **Construction Proximity:** 0.1  
**mTPZ (m):**

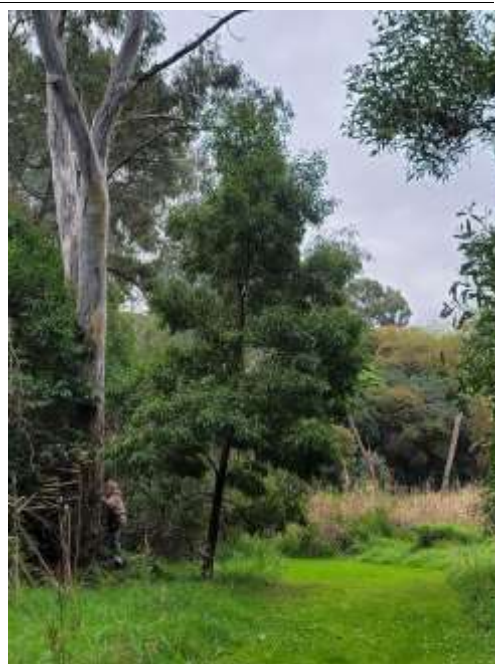
**Tree ID: 418****Genus / species:** *Acacia melanoxylon*

Evergreen Blackwood

**Retention Value:** Low**Removal / retention reason:** N/A.**Amenity value:** Low**Works Required:** N/A.

**SRZ (m):** 1.7      **Works priority:** N/A  
**TPZ (m):** 2.2      **Construction Proximity:** 0.1  
**mTPZ (m):**

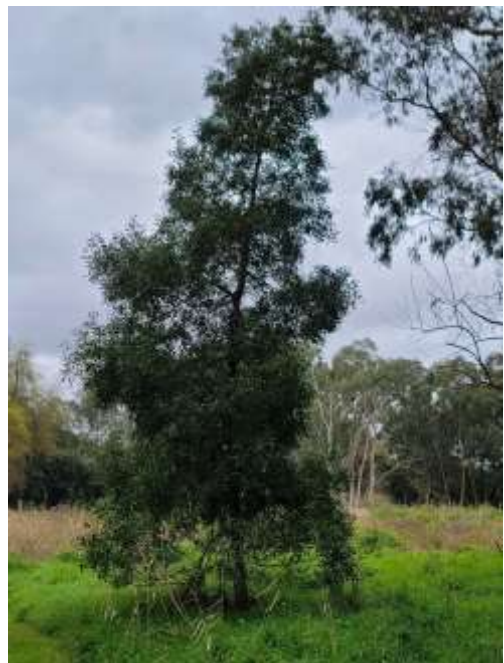
**Tree ID: 419****Genus / species:** *Eucalyptus camaldulensis*

Evergreen River Red Gum

**Retention Value:** Very high**Removal / retention reason:** N/A.**Amenity value:** High**Works Required:** N/A.

**SRZ (m):** 2.4      **Works priority:** N/A  
**TPZ (m):** 5.2      **Construction Proximity:** 0.1  
**mTPZ (m):**

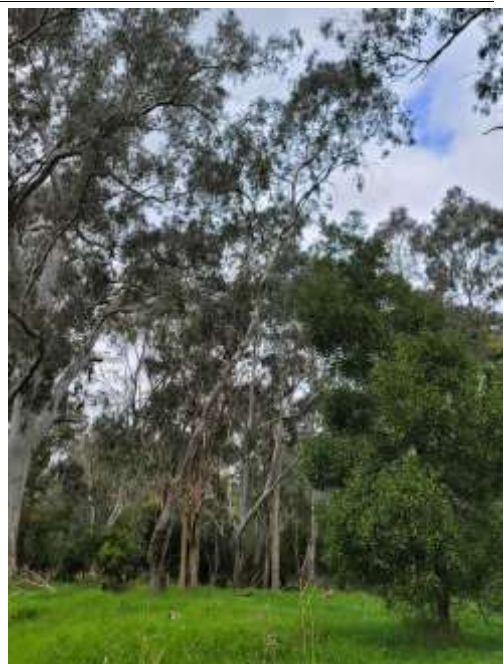
**Tree ID: 420****Genus / species:** *Eucalyptus camaldulensis*

Evergreen River Red Gum

**Retention Value:** Very high**Removal / retention reason:** N/A.**Amenity value:** High**Works Required:** N/A.

**SRZ (m):** 3.7      **Works priority:** N/A  
**TPZ (m):** 13.9      **Construction Proximity:** 0.1  
**mTPZ (m):**

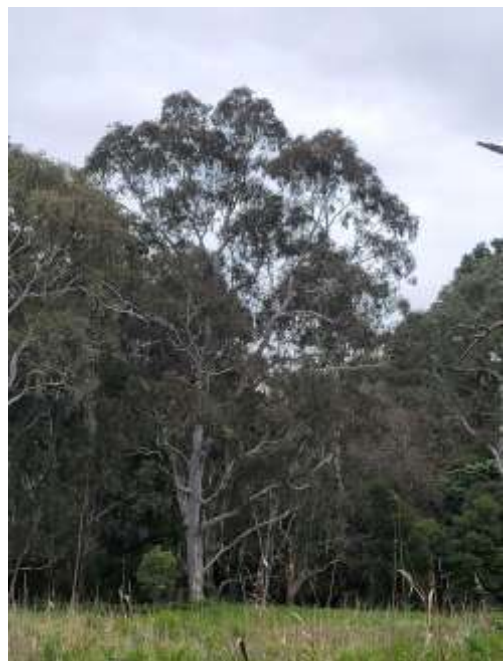
**Tree ID: 421****Genus / species:** *Eucalyptus camaldulensis*

Evergreen River Red Gum

**Retention Value:** High**Removal / retention reason:** N/A.**Amenity value:** High**Works Required:** N/A.

**SRZ (m):** 3.8      **Works priority:** N/A  
**TPZ (m):** 14.5      **Construction Proximity:** 0.1  
**mTPZ (m):**

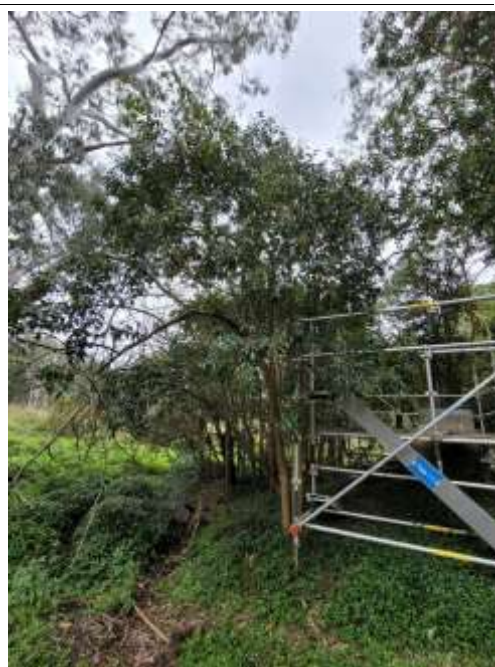
**Tree ID: 423****Genus / species:** *Ligustrum lucidum*

Evergreen Privet

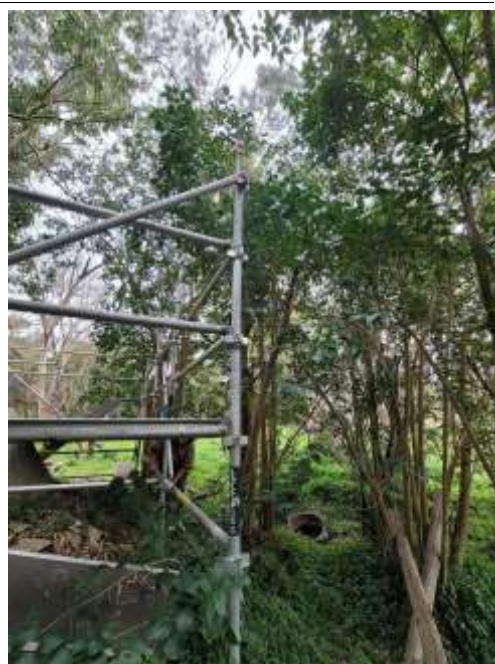
**Tree ID: 424****Genus / species:** *Ligustrum lucidum*

Evergreen Privet

**Retention Value:** Low**Removal / retention reason:** N/A.**Amenity value:** Low**Works Required:** N/A.

<b>SRZ (m):</b>	1.9	<b>Works priority:</b>	N/A
<b>TPZ (m):</b>	3.0	<b>Construction Proximity:</b>	0.1
<b>mTPZ (m):</b>

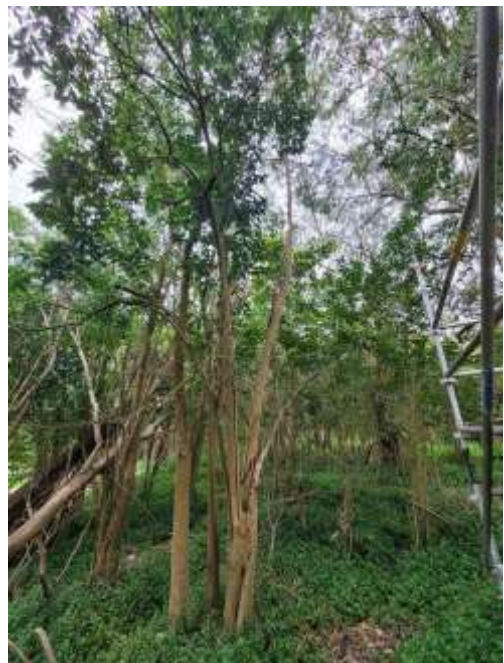
**Tree ID: 425****Genus / species:** *Ligustrum lucidum*

Evergreen Privet

**Retention Value:** Low**Removal / retention reason:** N/A.**Amenity value:** Low**Works Required:** N/A.

<b>SRZ (m):</b>	1.9	<b>Works priority:</b>	N/A
<b>TPZ (m):</b>	3.0	<b>Construction Proximity:</b>	0.1
<b>mTPZ (m):</b>

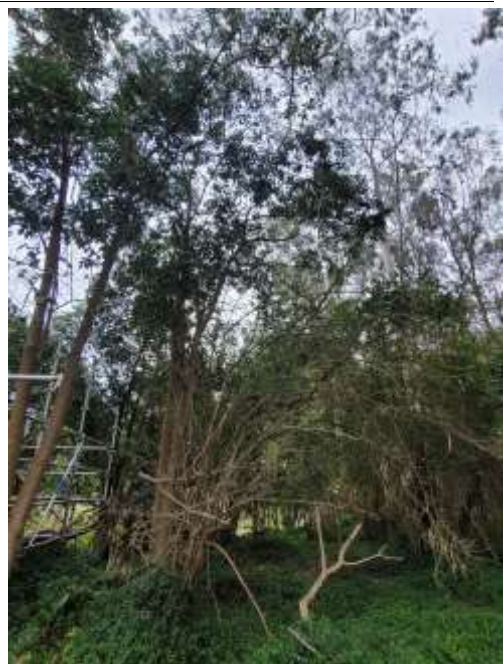
**Tree ID: 426****Genus / species:** *Ligustrum lucidum*

Evergreen Privet

**Retention Value:** Low**Removal / retention reason:** N/A.**Amenity value:** Low**Works Required:** N/A.

<b>SRZ (m):</b>	1.9	<b>Works priority:</b>	N/A
<b>TPZ (m):</b>	2.6	<b>Construction Proximity:</b>	0.1
<b>mTPZ (m):</b>

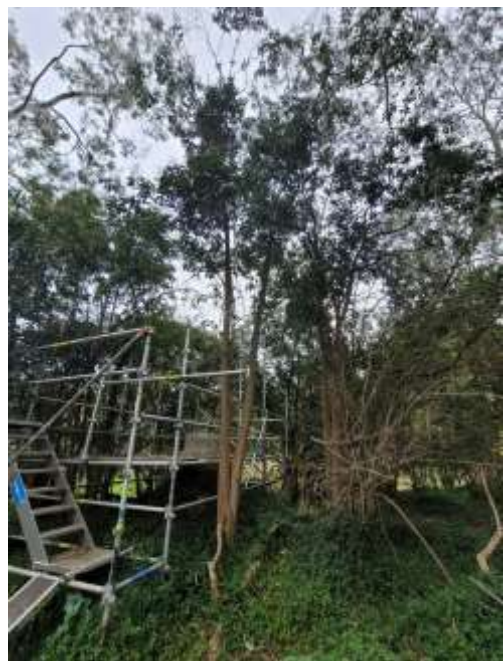
**Tree ID: 427****Genus / species:** *Eucalyptus camaldulensis*

Evergreen River Red Gum

**Retention Value:** Very high**Removal / retention reason:** N/A.**Amenity value:** High**Works Required:** N/A.

**SRZ (m):** 3.8      **Works priority:** N/A  
**TPZ (m):** 14.8      **Construction Proximity:** 0.1  
**mTPZ (m):**

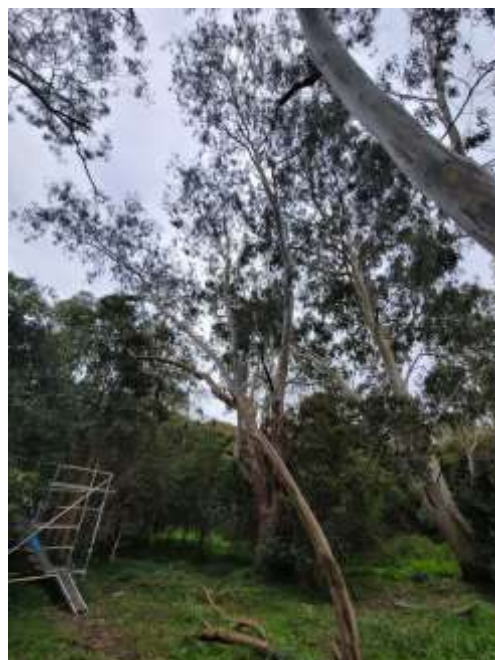
**Tree ID: 428****Genus / species:** *Eucalyptus camaldulensis*

Evergreen River Red Gum

**Retention Value:** Very high**Removal / retention reason:** N/A.**Amenity value:** High**Works Required:** N/A.

**SRZ (m):** 4.1      **Works priority:** N/A  
**TPZ (m):** 15.0      **Construction Proximity:** 0.1  
**mTPZ (m):**

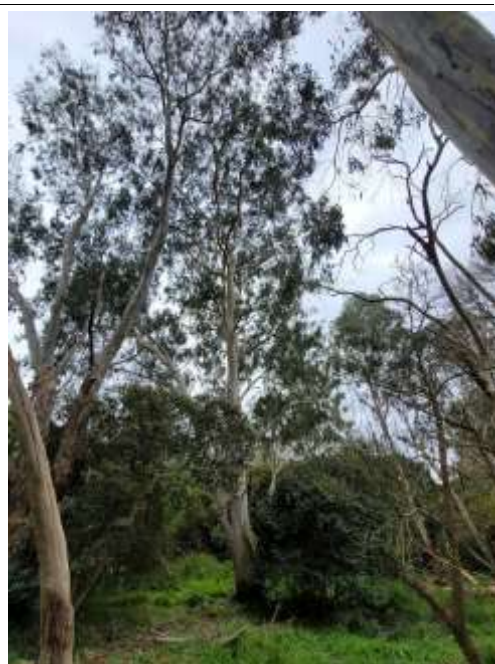
**Tree ID: 429****Genus / species:** *Eucalyptus camaldulensis*

Evergreen River Red Gum

**Retention Value:** Very high**Removal / retention reason:** N/A.**Amenity value:** High**Works Required:** N/A.

**SRZ (m):** 3      **Works priority:** N/A  
**TPZ (m):** 9.1      **Construction Proximity:** 0.1  
**mTPZ (m):**

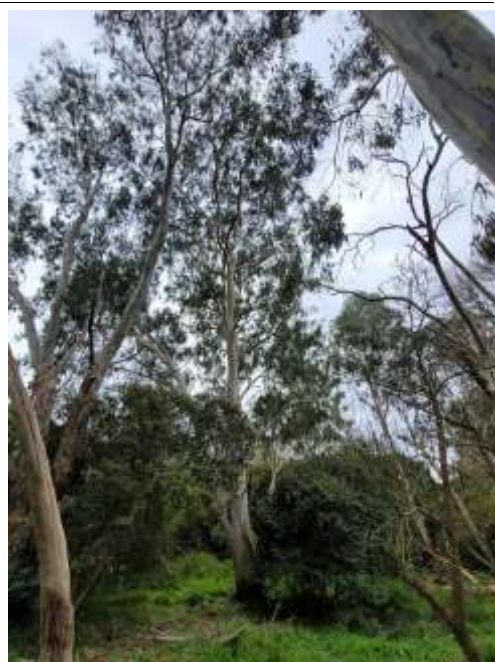
**Tree ID: 430****Genus / species:** *Eucalyptus camaldulensis*

Evergreen River Red Gum

**Height (m):** 30      **Structure:** Poor  
**Width (m):** 16      **Health:** Dead  
**DBH (cm):** 85      Estimated **Maturity:** Mature  
**Origin:** Melbourne      **ULE (years):** 0  
**Retained?:** Retained      **Form:** Very poor  
**Retention Value:** Remove.  
**Removal / retention reason:** N/A.  
**Amenity value:** Very low  
**Works Required:** N/A.

**SRZ (m):** 3.3      **Works priority:** N/A  
**TPZ (m):** 10.2      **Construction Proximity:** 0.1  
**mTPZ (m):**

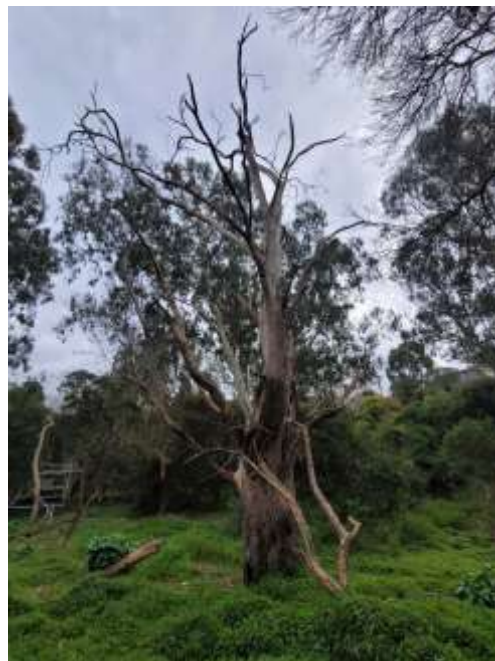
**Tree ID: 431****Genus / species:** *Fraxinus angustifolia*

Deciduous Narrow Leaf Ash

**Height (m):** 17      **Structure:** Good  
**Width (m):** 8      **Health:** Fair  
**DBH (cm):** 40      Measured **Maturity:** Mature  
**Origin:** Exotic      **ULE (years):** 15 - 30  
**Retained?:** Retained      **Form:** Fair  
**Retention Value:** High  
**Removal / retention reason:** N/A.  
**Amenity value:** High  
**Works Required:** N/A.

**SRZ (m):** 2.4      **Works priority:** N/A  
**TPZ (m):** 4.8      **Construction Proximity:** 0.1  
**mTPZ (m):**

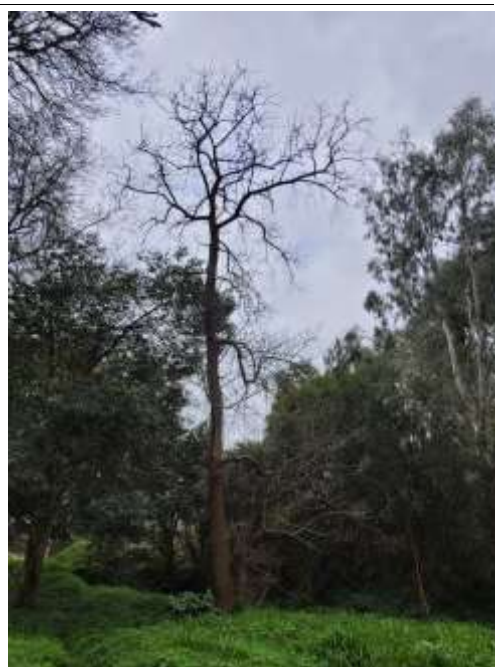
**Tree ID: 432****Genus / species:** *Fraxinus angustifolia*

Deciduous Narrow Leaf Ash

**Height (m):** 27      **Structure:** Good  
**Width (m):** 11      **Health:** Good  
**DBH (cm):** 53      Measured **Maturity:** Mature  
**Origin:** Exotic      **ULE (years):** > 60  
**Retained?:** Retained      **Form:** Good  
**Retention Value:** Very high  
**Removal / retention reason:** N/A.  
**Amenity value:** High  
**Works Required:** N/A.

**SRZ (m):** 2.6      **Works priority:** N/A  
**TPZ (m):** 6.4      **Construction Proximity:** 0.1  
**mTPZ (m):**

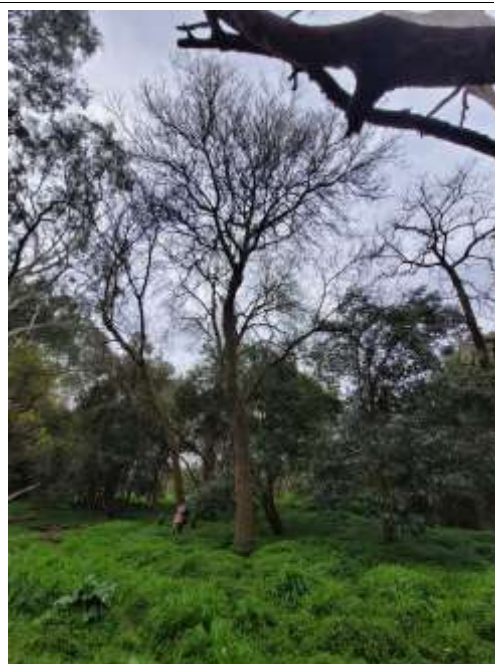
**Tree ID: 433****Genus / species:** *Fraxinus angustifolia*

Deciduous      Narrow Leaf Ash

**Retention Value:** Very high**Removal / retention reason:** N/A.**Amenity value:** High**Works Required:** N/A.

**SRZ (m):** 2.5      **Works priority:** N/A  
**TPZ (m):** 5.5      **Construction Proximity:** 0.1  
**mTPZ (m):**

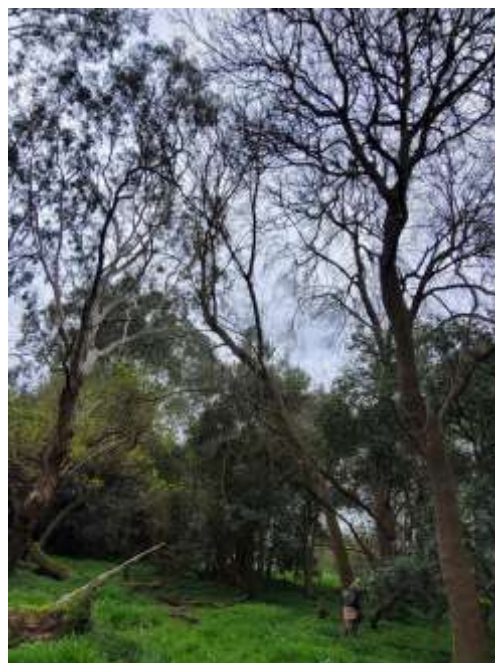
**Tree ID: 434****Genus / species:** *Fraxinus angustifolia*

Deciduous      Narrow Leaf Ash

**Retention Value:** Very high**Removal / retention reason:** N/A.**Amenity value:** High**Works Required:** N/A.

**SRZ (m):** 2.8      **Works priority:** N/A  
**TPZ (m):** 7.6      **Construction Proximity:** 0.1  
**mTPZ (m):**

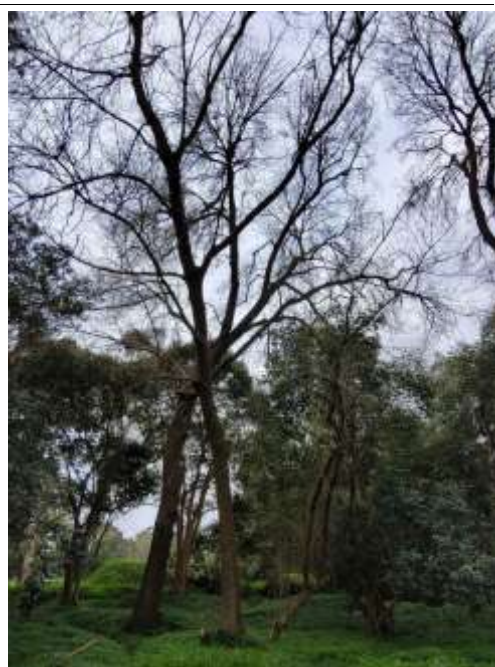
**Tree ID: 435****Genus / species:** *Eucalyptus camaldulensis*

Evergreen      River Red Gum

**Retention Value:** High**Removal / retention reason:** N/A.**Amenity value:** High**Works Required:** N/A.

**SRZ (m):** 3.2      **Works priority:** N/A  
**TPZ (m):** 9.8      **Construction Proximity:** 0.1  
**mTPZ (m):**

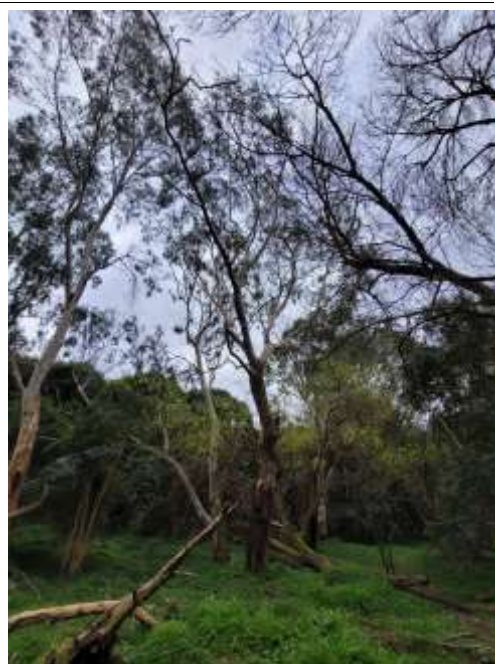
**Tree ID: 436****Genus / species:** *Eucalyptus camaldulensis*

Evergreen River Red Gum

**Retention Value:** Very high**Removal / retention reason:** N/A.**Amenity value:** High**Works Required:** N/A.

**SRZ (m):** 2.8      **Works priority:** N/A  
**TPZ (m):** 7.1      **Construction Proximity:** 0.1  
**mTPZ (m):**

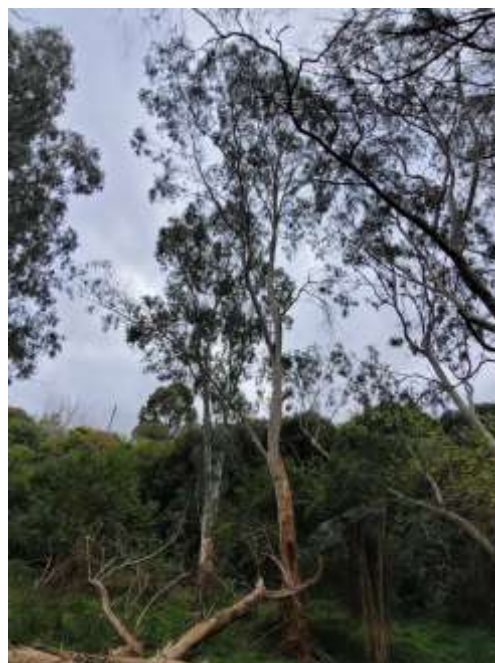
**Tree ID: 437****Genus / species:** *Eucalyptus camaldulensis*

Evergreen River Red Gum

**Retention Value:** Very high**Removal / retention reason:** N/A.**Amenity value:** High**Works Required:** N/A.

**SRZ (m):** 2.9      **Works priority:** N/A  
**TPZ (m):** 7.8      **Construction Proximity:** 0.1  
**mTPZ (m):**

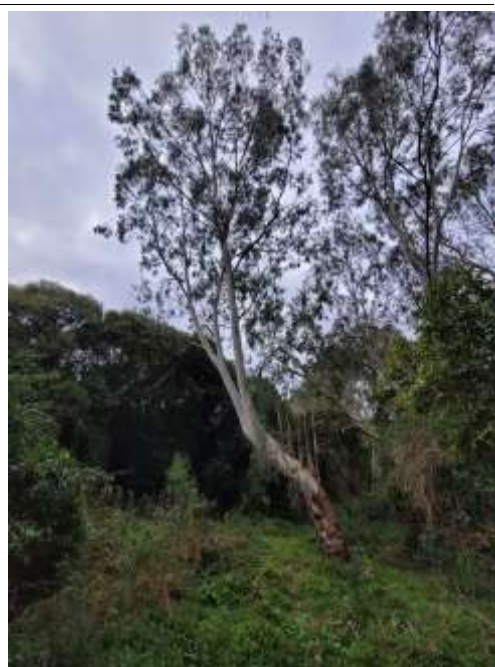
**Tree ID: 438****Genus / species:** *Eucalyptus camaldulensis*

Evergreen River Red Gum

**Retention Value:** Very high**Removal / retention reason:** N/A.**Amenity value:** High**Works Required:** N/A.

**SRZ (m):** 2.8      **Works priority:** N/A  
**TPZ (m):** 7.6      **Construction Proximity:** 0.1  
**mTPZ (m):**

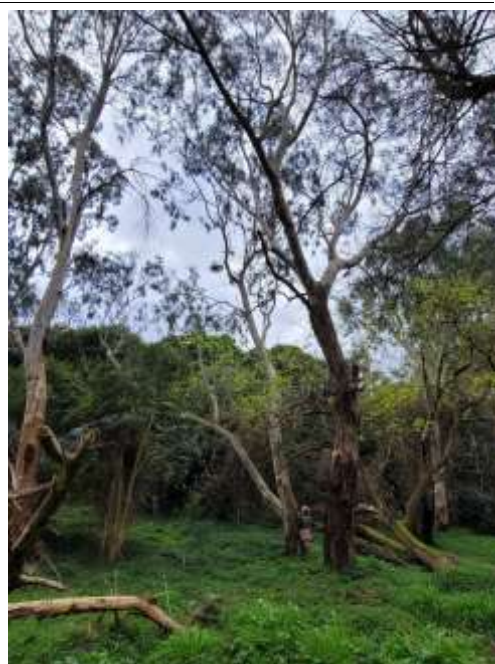
**Tree ID: 439****Genus / species:** *Fraxinus angustifolia*

Deciduous      Narrow Leaf Ash

<b>Height (m):</b>	12	<b>Structure:</b>	Fair
<b>Width (m):</b>	10	<b>Health:</b>	Good
<b>DBH (cm):</b>	42    Measured	<b>Maturity:</b>	Mature
<b>Origin:</b>	Exotic	<b>ULE (years):</b>	15 - 30
<b>Retained?:</b>	Removed	<b>Form:</b>	Fair
<b>Retention Value:</b>	Moderate		
<b>Removal / retention reason:</b>	N/A.		
<b>Amenity value:</b>	Moderate		
<b>Works Required:</b>	N/A.

<b>SRZ (m):</b>	2.4	<b>Works priority:</b>	N/A
<b>TPZ (m):</b>	5.0	<b>Construction Proximity:</b>	0.1
<b>mTPZ (m):</b>

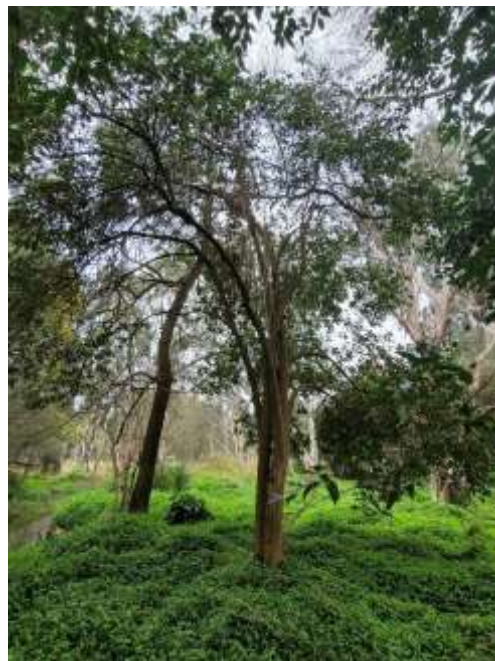
**Tree ID: 440****Genus / species:** *Ligustrum lucidum*

Evergreen      Privet

<b>Height (m):</b>	11	<b>Structure:</b>	Fair
<b>Width (m):</b>	7	<b>Health:</b>	Good
<b>DBH (cm):</b>	45    Measured	<b>Maturity:</b>	Mature
<b>Origin:</b>	Exotic	<b>ULE (years):</b>	15 - 30
<b>Retained?:</b>	Retained	<b>Form:</b>	Fair
<b>Retention Value:</b>	Moderate		
<b>Removal / retention reason:</b>	N/A.		
<b>Amenity value:</b>	Moderate		
<b>Works Required:</b>	N/A.

<b>SRZ (m):</b>	2.5	<b>Works priority:</b>	N/A
<b>TPZ (m):</b>	5.4	<b>Construction Proximity:</b>	0.1
<b>mTPZ (m):</b>

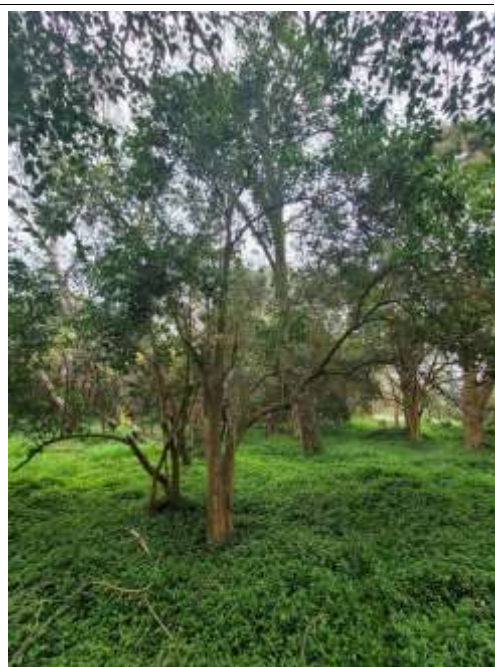
**Tree ID: 441****Genus / species:** *Ligustrum lucidum*

Evergreen      Privet

<b>Height (m):</b>	9	<b>Structure:</b>	Fair
<b>Width (m):</b>	6	<b>Health:</b>	Good
<b>DBH (cm):</b>	34    Measured	<b>Maturity:</b>	Mature
<b>Origin:</b>	Exotic	<b>ULE (years):</b>	15 - 30
<b>Retained?:</b>	Retained	<b>Form:</b>	Fair
<b>Retention Value:</b>	Low		
<b>Removal / retention reason:</b>	N/A.		
<b>Amenity value:</b>	Low		
<b>Works Required:</b>	N/A.

<b>SRZ (m):</b>	2.2	<b>Works priority:</b>	N/A
<b>TPZ (m):</b>	4.1	<b>Construction Proximity:</b>	0.1
<b>mTPZ (m):</b>
