## **Nation Partners**

# **Northern Sewers Relining Project Southern Section**

## **Construction Impact Report**

**Wednesday 4<sup>th</sup> December 2024**

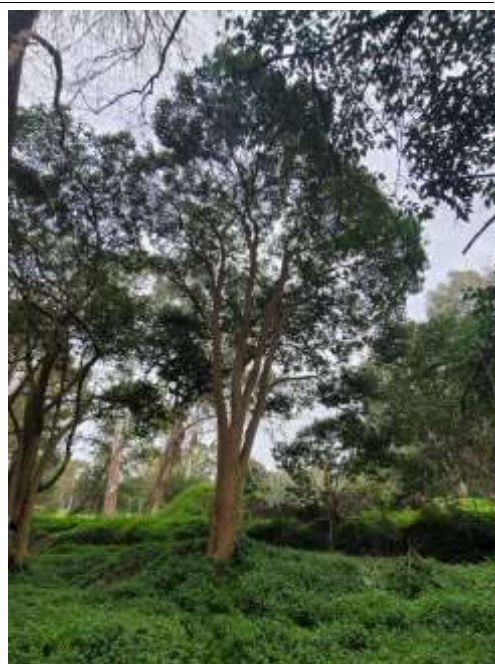
**Tree ID: 442****Genus / species:** *Ligustrum lucidum*

Evergreen Privet

**Retention Value:** Moderate**Removal / retention reason:** N/A.**Amenity value:** Moderate**Works Required:** N/A.

**SRZ (m):** 2.6      **Works priority:** N/A  
**TPZ (m):** 6.4      **Construction Proximity:** 0.1  
**mTPZ (m):**

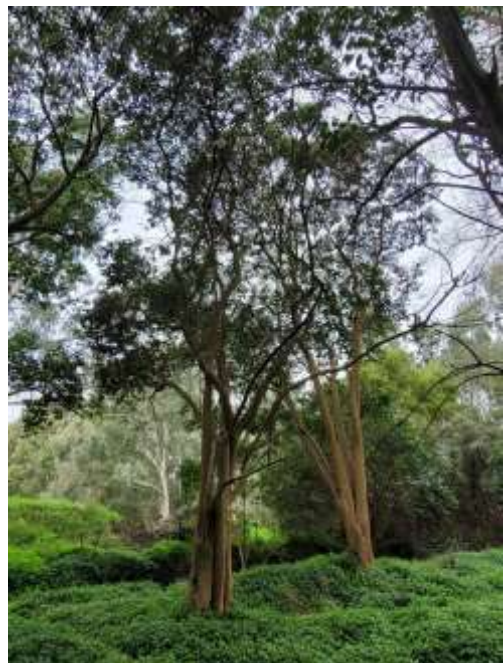
**Tree ID: 443****Genus / species:** *Ligustrum lucidum*

Evergreen Privet

**Retention Value:** Moderate**Removal / retention reason:** N/A.**Amenity value:** Moderate**Works Required:** N/A.

**SRZ (m):** 2.5      **Works priority:** N/A  
**TPZ (m):** 5.5      **Construction Proximity:** 0.1  
**mTPZ (m):**

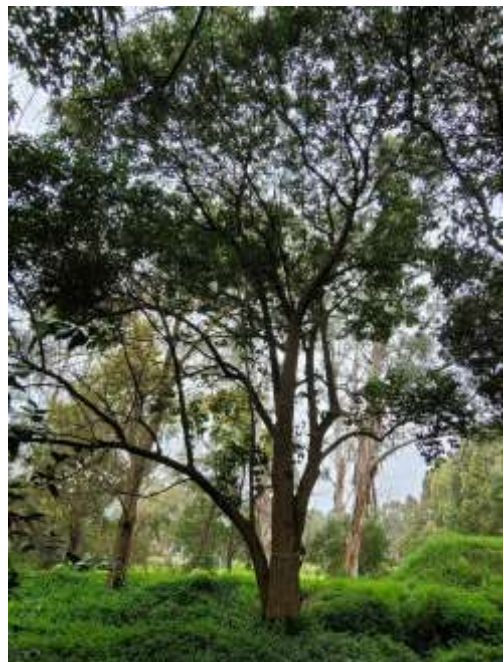
**Tree ID: 444****Genus / species:** *Ligustrum lucidum*

Evergreen Privet

**Retention Value:** Moderate**Removal / retention reason:** N/A.**Amenity value:** Moderate**Works Required:** N/A.

**SRZ (m):** 2.7      **Works priority:** N/A  
**TPZ (m):** 7.0      **Construction Proximity:** 0.1  
**mTPZ (m):**

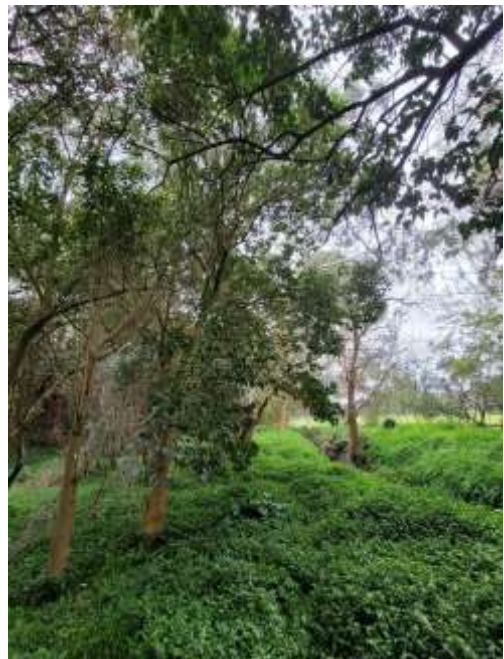
**Tree ID: 445****Genus / species:** *Ligustrum lucidum*

Evergreen Privet

**Retention Value:** Low**Removal / retention reason:** N/A.**Amenity value:** Low**Works Required:** N/A.

<b>SRZ (m):</b>	2.1	<b>Works priority:</b>	N/A
<b>TPZ (m):</b>	3.5	<b>Construction Proximity:</b>	0.1
<b>mTPZ (m):</b>

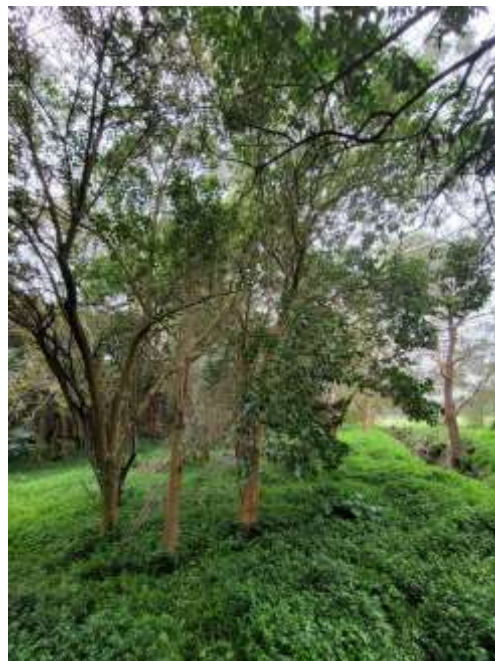
**Tree ID: 446****Genus / species:** *Ligustrum lucidum*

Evergreen Privet

**Retention Value:** Low**Removal / retention reason:** N/A.**Amenity value:** Low**Works Required:** N/A.

<b>SRZ (m):</b>	1.6	<b>Works priority:</b>	N/A
<b>TPZ (m):</b>	2.0	<b>Construction Proximity:</b>	0.1
<b>mTPZ (m):</b>

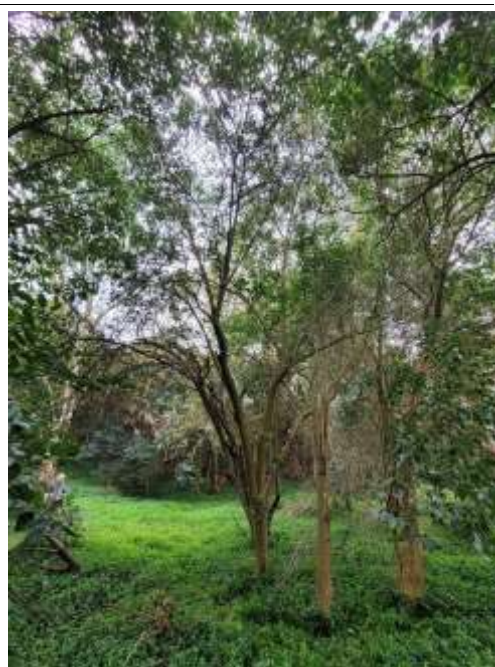
**Tree ID: 447****Genus / species:** *Ligustrum lucidum*

Evergreen Privet

**Retention Value:** Low**Removal / retention reason:** N/A.**Amenity value:** Low**Works Required:** N/A.

<b>SRZ (m):</b>	1.9	<b>Works priority:</b>	N/A
<b>TPZ (m):</b>	3.0	<b>Construction Proximity:</b>	0.1
<b>mTPZ (m):</b>

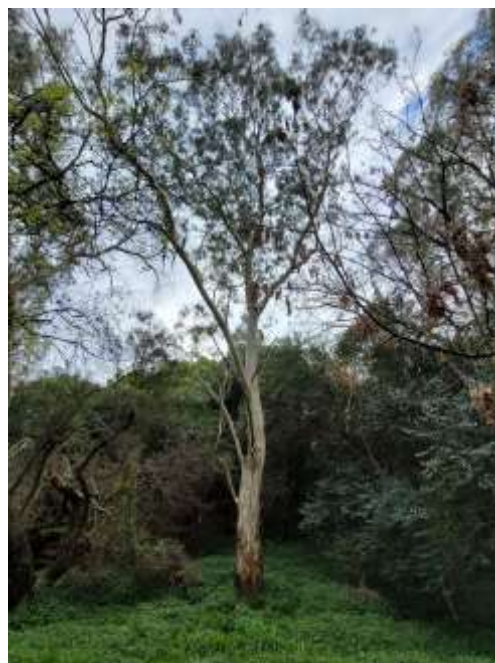
**Tree ID: 449****Genus / species:** *Ligustrum lucidum*

Evergreen Privet

**Retention Value:** Moderate**Removal / retention reason:** N/A.**Amenity value:** Moderate**Works Required:** N/A.

**SRZ (m):** 1.8      **Works priority:** N/A  
**TPZ (m):** 2.5      **Construction Proximity:** 0.1  
**mTPZ (m):**

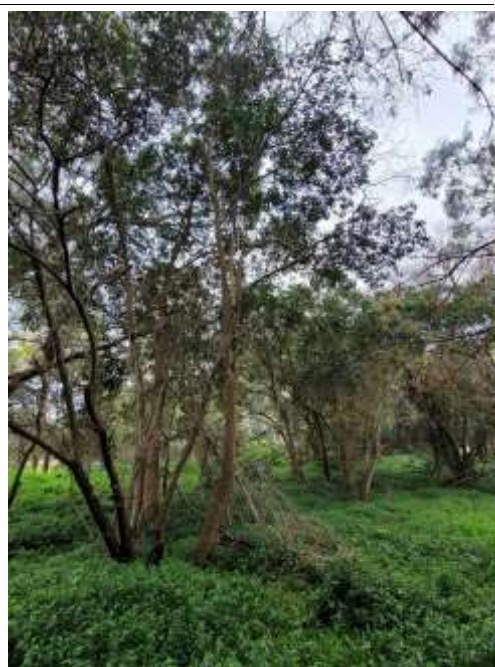
**Tree ID: 450****Genus / species:** *Ligustrum lucidum*

Evergreen Privet

**Retention Value:** Moderate**Removal / retention reason:** N/A.**Amenity value:** Moderate**Works Required:** N/A.

**SRZ (m):** 2.1      **Works priority:** N/A  
**TPZ (m):** 3.6      **Construction Proximity:** 0.1  
**mTPZ (m):**

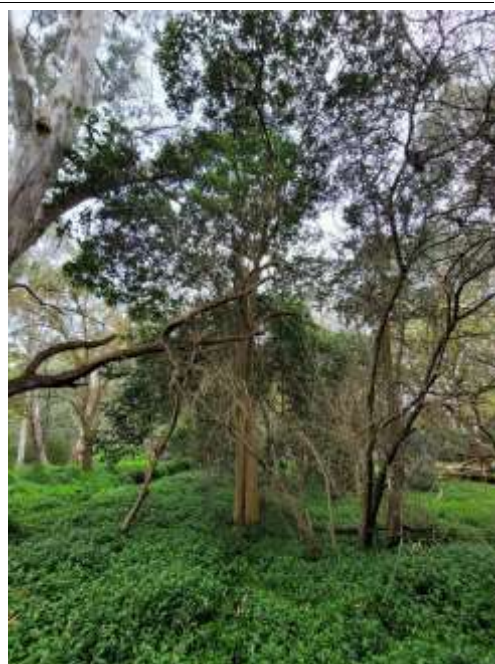
**Tree ID: 451****Genus / species:** *Eucalyptus camaldulensis*

Evergreen River Red Gum

**Retention Value:** Very high**Removal / retention reason:** N/A.**Amenity value:** High**Works Required:** N/A.

**SRZ (m):** 3.5      **Works priority:** N/A  
**TPZ (m):** 12.1      **Construction Proximity:** 0.1  
**mTPZ (m):**

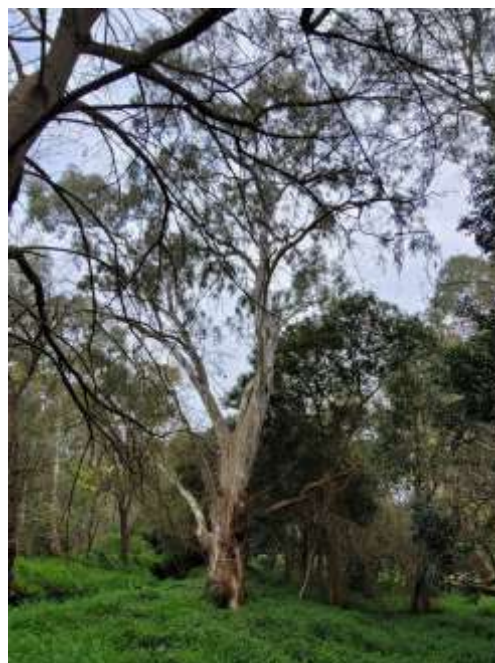
**Tree ID: 452****Genus / species:** *Acer negundo*

Deciduous Box Elder

**Retention Value:** High**Removal / retention reason:** N/A.**Amenity value:** High**Works Required:** Canopy lift.

**SRZ (m):** 2.7      **Works priority:** Very low  
**TPZ (m):** 6.8      **Construction Proximity:** 0.1  
**mTPZ (m):**

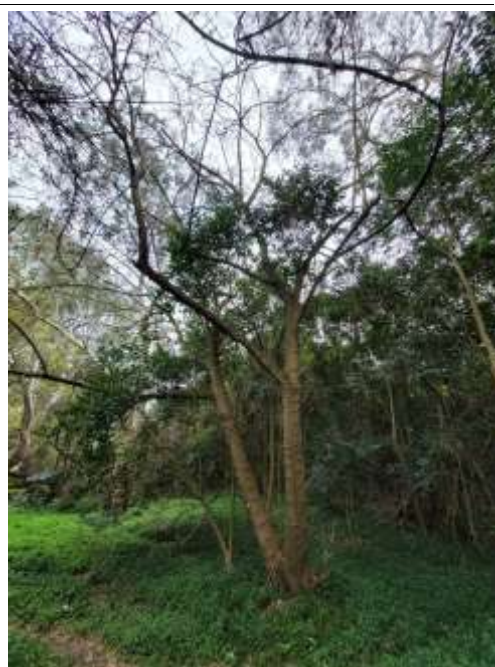
**Tree ID: 453****Genus / species:** *Eucalyptus camaldulensis*

Evergreen River Red Gum

**Retention Value:** High**Removal / retention reason:** N/A.**Amenity value:** High**Works Required:** N/A.

**SRZ (m):** 4.1      **Works priority:** N/A  
**TPZ (m):** 15.0      **Construction Proximity:** 0.1  
**mTPZ (m):**

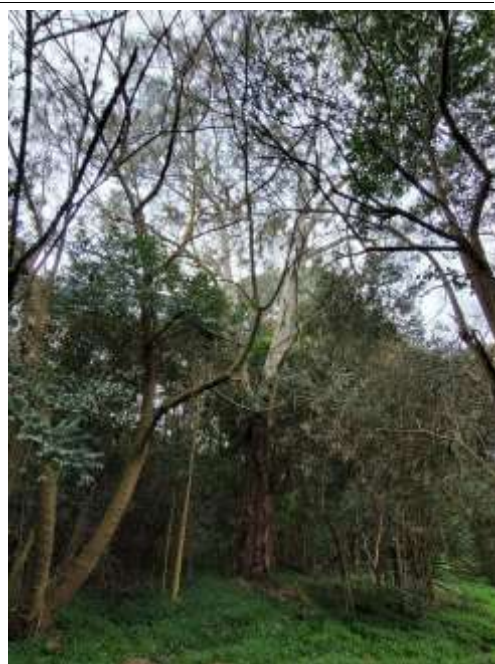
**Tree ID: 454****Genus / species:** *Ligustrum lucidum*

Evergreen Privet

**Retention Value:** Moderate**Removal / retention reason:** N/A.**Amenity value:** Moderate**Works Required:** N/A.

**SRZ (m):** 2      **Works priority:** N/A  
**TPZ (m):** 3.2      **Construction Proximity:** 0.1  
**mTPZ (m):**

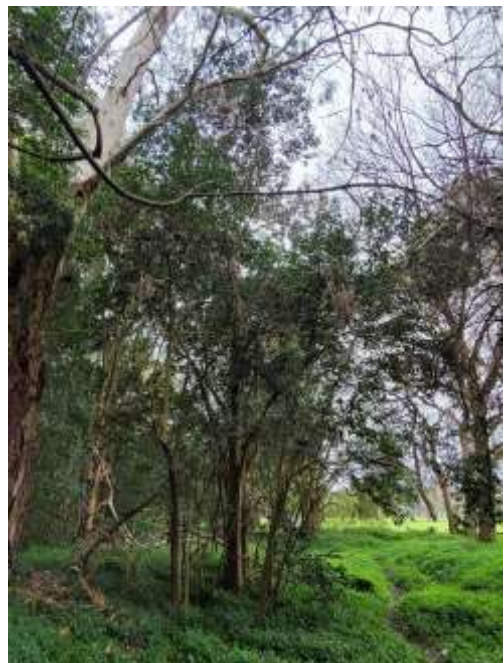
**Tree ID: 455****Genus / species:** *Acer negundo*

Deciduous Box Elder

**Retention Value:** High**Removal / retention reason:** N/A.**Amenity value:** High**Works Required:** N/A.

**SRZ (m):** 2.6      **Works priority:** N/A  
**TPZ (m):** 6.0      **Construction Proximity:** 0.1  
**mTPZ (m):**

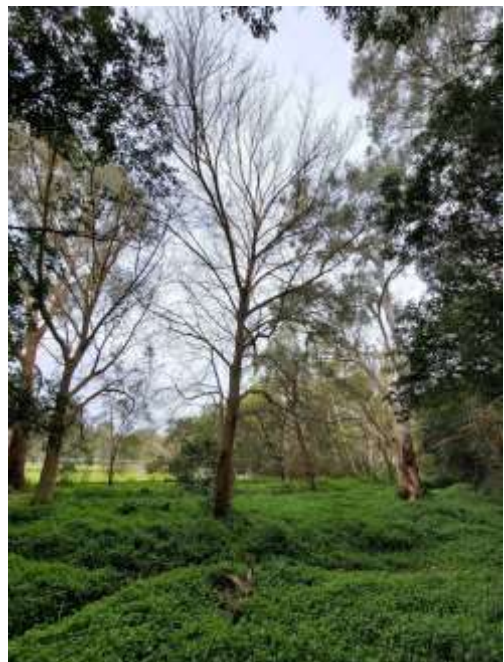
**Tree ID: 456****Genus / species:** *Acer negundo*

Deciduous Box Elder

**Retention Value:** High**Removal / retention reason:** N/A.**Amenity value:** High**Works Required:** N/A.

**SRZ (m):** 2.4      **Works priority:** N/A  
**TPZ (m):** 5.3      **Construction Proximity:** 0.1  
**mTPZ (m):**

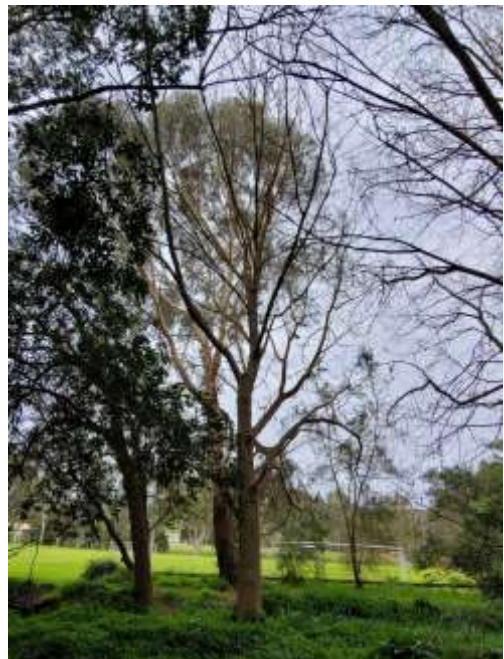
**Tree ID: 457****Genus / species:** *Acer negundo*

Deciduous Box Elder

**Retention Value:** Moderate**Removal / retention reason:** N/A.**Amenity value:** Moderate**Works Required:** N/A.

**SRZ (m):** 2.1      **Works priority:** N/A  
**TPZ (m):** 3.7      **Construction Proximity:** 0.1  
**mTPZ (m):**

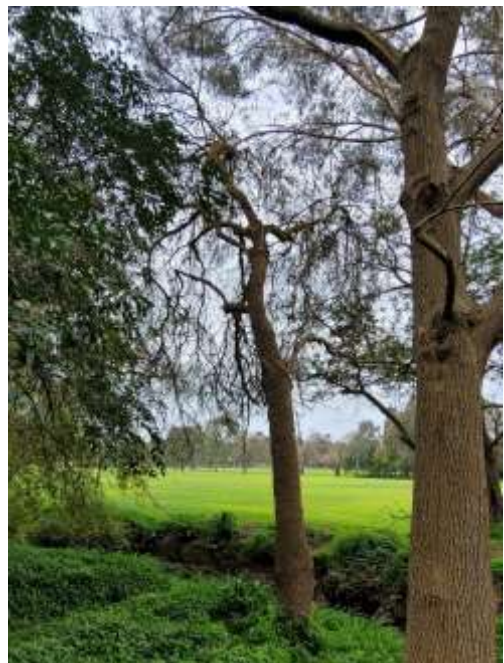
**Tree ID: 458****Genus / species:** *Ligustrum lucidum*

Evergreen Privet

**Retention Value:** High**Removal / retention reason:** N/A.**Amenity value:** High**Works Required:** N/A.

**SRZ (m):** 2.6      **Works priority:** N/A  
**TPZ (m):** 6.0      **Construction Proximity:** 0.1  
**mTPZ (m):**

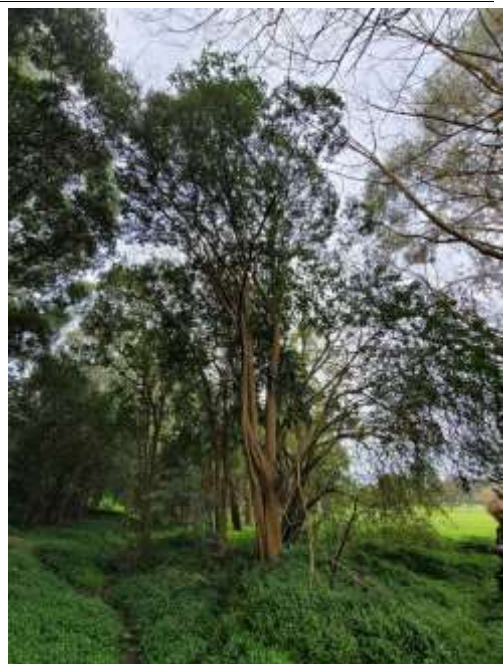
**Tree ID: 459****Genus / species:** *Ligustrum lucidum*

Evergreen Privet

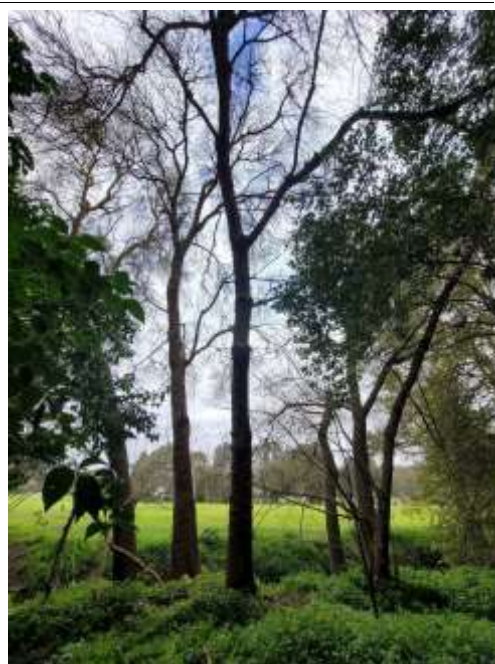
**Tree ID: 466****Genus / species:** *Fraxinus angustifolia*

Deciduous Narrow Leaf Ash

**Height (m):** 18      **Structure:** Good  
**Width (m):** 7      **Health:** Good  
**DBH (cm):** 46 Measured **Maturity:** Mature  
**Origin:** Exotic      **ULE (years):** 15 - 30  
**Retained?:** Retained      **Form:** Fair  
**Retention Value:** High  
**Removal / retention reason:** N/A.  
**Amenity value:** High  
**Works Required:** N/A.

**SRZ (m):** 2.5      **Works priority:** N/A  
**TPZ (m):** 5.5      **Construction Proximity:** 0.1  
**mTPZ (m):**

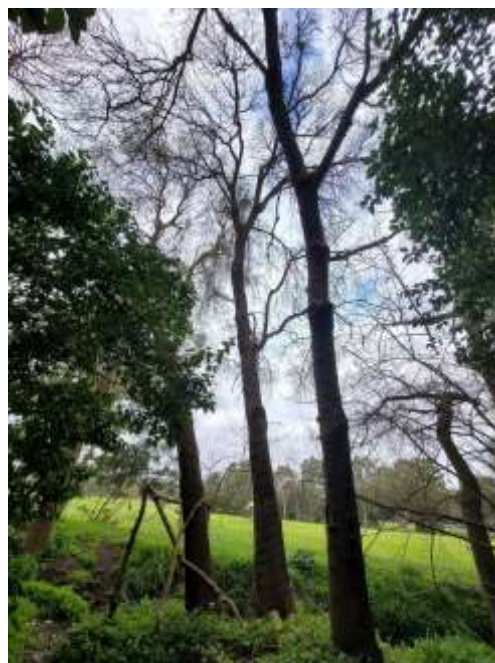
**Tree ID: 467****Genus / species:** *Fraxinus angustifolia*

Deciduous Narrow Leaf Ash

**Height (m):** 14      **Structure:** Good  
**Width (m):** 9      **Health:** Good  
**DBH (cm):** 39 Measured **Maturity:** Mature  
**Origin:** Exotic      **ULE (years):** 15 - 30  
**Retained?:** Retained      **Form:** Poor  
**Retention Value:** Moderate  
**Removal / retention reason:** N/A.  
**Amenity value:** Moderate  
**Works Required:** N/A.

**SRZ (m):** 2.3      **Works priority:** N/A  
**TPZ (m):** 4.7      **Construction Proximity:** 0.1  
**mTPZ (m):**

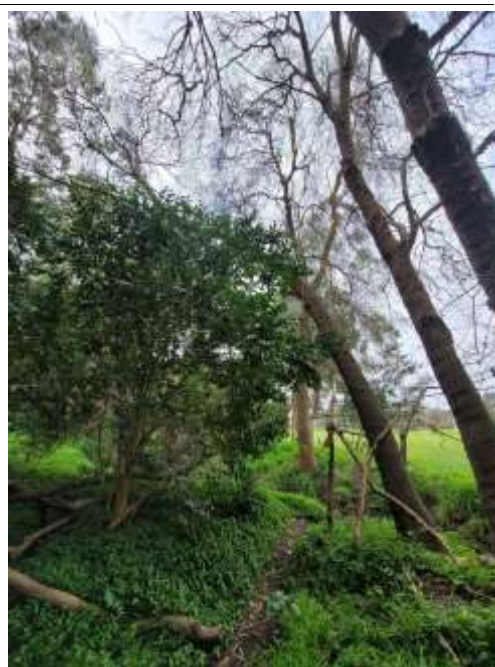
**Tree ID: 468****Genus / species:** *Fraxinus angustifolia*

Deciduous Narrow Leaf Ash

**Height (m):** 28      **Structure:** Good  
**Width (m):** 9      **Health:** Good  
**DBH (cm):** 52 Measured **Maturity:** Mature  
**Origin:** Exotic      **ULE (years):** 30 - 60  
**Retained?:** Retained      **Form:** Good  
**Retention Value:** High  
**Removal / retention reason:** N/A.  
**Amenity value:** High  
**Works Required:** N/A.

**SRZ (m):** 2.6      **Works priority:** N/A  
**TPZ (m):** 6.2      **Construction Proximity:** 0.1  
**mTPZ (m):**

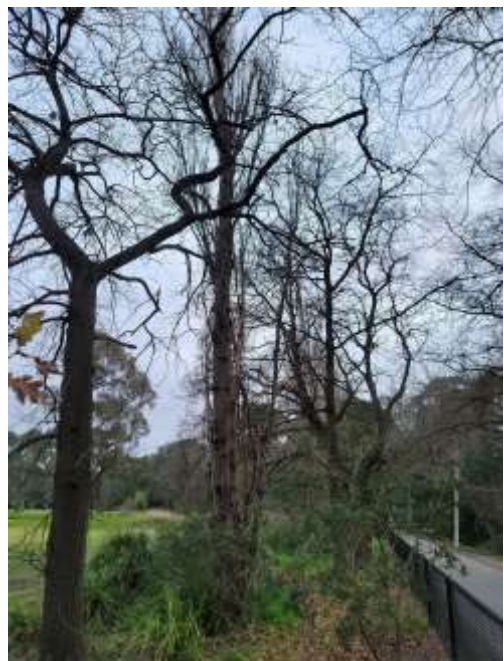
**Tree ID: 484****Genus / species:** *Acacia implexa*

Evergreen Lightwood

**Height (m):** 12      **Structure:** Poor  
**Width (m):** 8      **Health:** Very poor  
**DBH (cm):** 45      Estimated **Maturity:** Over mature  
**Origin:** Melbourne      **ULE (years):** 0  
**Retained?:** Retained      **Form:** Very poor  
**Retention Value:** Very low  
**Removal / retention reason:** N/A.  
**Amenity value:** Very low  
**Works Required:** N/A.

**SRZ (m):** 2.5      **Works priority:** N/A  
**TPZ (m):** 5.4      **Construction Proximity:** 0.1  
**mTPZ (m):**

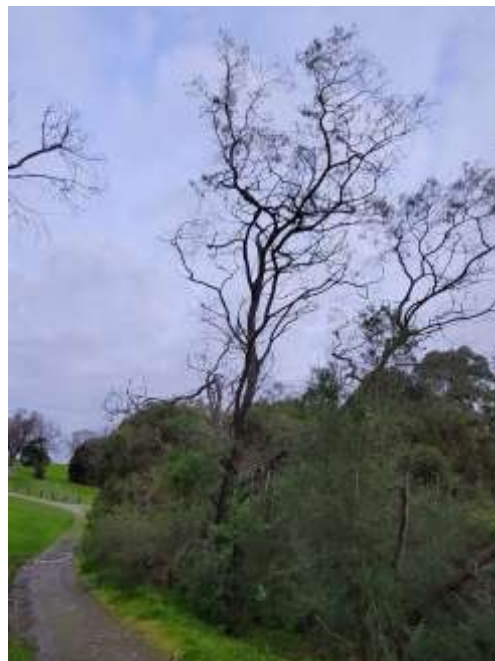
**Tree ID: 485****Genus / species:** *Acacia implexa*

Evergreen Lightwood

**Height (m):** 8      **Structure:** Poor  
**Width (m):** 5      **Health:** Very poor  
**DBH (cm):** 25      Estimated **Maturity:** Over mature  
**Origin:** Melbourne      **ULE (years):** 0  
**Retained?:** Retained      **Form:** Very poor  
**Retention Value:** Very low  
**Removal / retention reason:** N/A.  
**Amenity value:** Very low  
**Works Required:** N/A.

**SRZ (m):** 1.9      **Works priority:** N/A  
**TPZ (m):** 3.0      **Construction Proximity:** 0.1  
**mTPZ (m):**

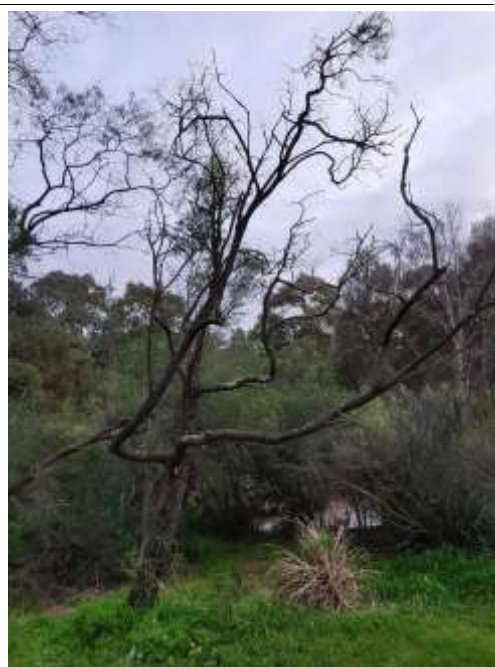
**Tree ID: 486****Genus / species:** *Prunus serrulata*

Deciduous Japanese Flowering Cherry

**Height (m):** 5      **Structure:** Fair  
**Width (m):** 7      **Health:** Good  
**DBH (cm):** 22      Estimated **Maturity:** Mature  
**Origin:** Exotic      **ULE (years):** 15 - 30  
**Retained?:** Retained      **Form:** Fair  
**Retention Value:** Low  
**Removal / retention reason:** N/A.  
**Amenity value:** Low  
**Works Required:** N/A.

**SRZ (m):** 1.9      **Works priority:** N/A  
**TPZ (m):** 2.6      **Construction Proximity:** 0.1  
**mTPZ (m):**

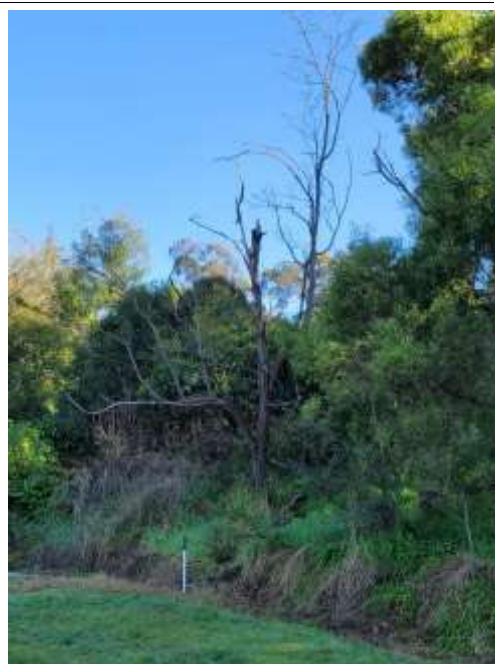
**Tree ID: 490****Genus / species:** *Eucalyptus camaldulensis*

Evergreen River Red Gum

**Height (m):** 22      **Structure:** Good  
**Width (m):** 15      **Health:** Good  
**DBH (cm):** 61 Measured **Maturity:** Mature  
**Origin:** Melbourne      **ULE (years):** > 60  
**Retained?:** Retained      **Form:** Good

**Retention Value:** Very high**Removal / retention reason:** N/A.**Amenity value:** High**Works Required:** Canopy lift.**SRZ (m):** 2.8      **Works priority:** Very low**TPZ (m):** 7.3      **Construction Proximity:** 0.1**mTPZ (m):**

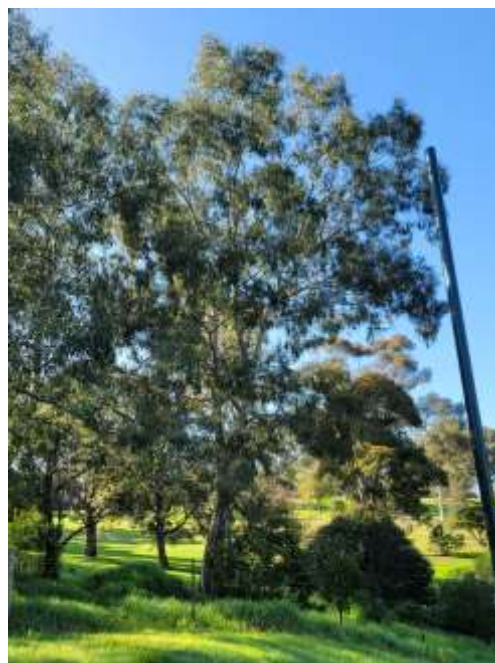
**Tree ID: 491****Genus / species:** *Corymbia maculata*

Evergreen Spotted Gum

**Height (m):** 18      **Structure:** Good  
**Width (m):** 18      **Health:** Good  
**DBH (cm):** 60 Measured **Maturity:** Mature  
**Origin:** Victorian      **ULE (years):** > 60  
**Retained?:** Retained      **Form:** Good

**Retention Value:** Very high**Removal / retention reason:** N/A.**Amenity value:** High**Works Required:** N/A.**SRZ (m):** 2.8      **Works priority:** N/A**TPZ (m):** 7.2      **Construction Proximity:** 0.1**mTPZ (m):**

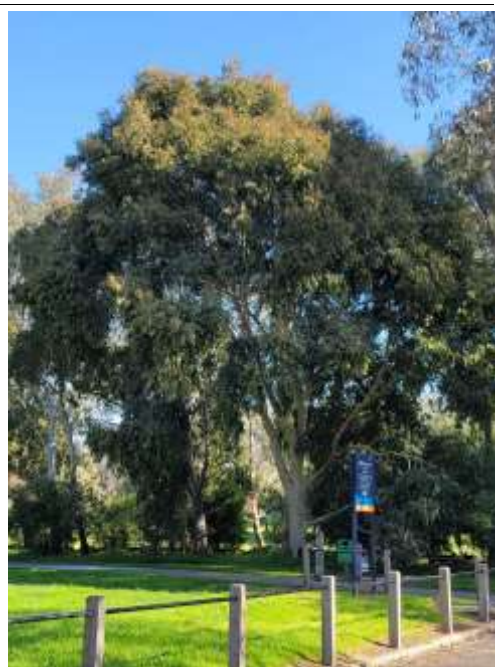
**Tree ID: 492****Genus / species:** *Fraxinus oxycarpa*

Deciduous Desert Ash

**Height (m):** 11      **Structure:** Good  
**Width (m):** 12      **Health:** Good  
**DBH (cm):** 56 Measured **Maturity:** Mature  
**Origin:** Exotic      **ULE (years):** 30 - 60  
**Retained?:** Retained      **Form:** Good

**Retention Value:** Moderate**Removal / retention reason:** N/A.**Amenity value:** Moderate**Works Required:** Canopy lift.**SRZ (m):** 2.7      **Works priority:** Very low**TPZ (m):** 6.7      **Construction Proximity:** 0.1**mTPZ (m):**

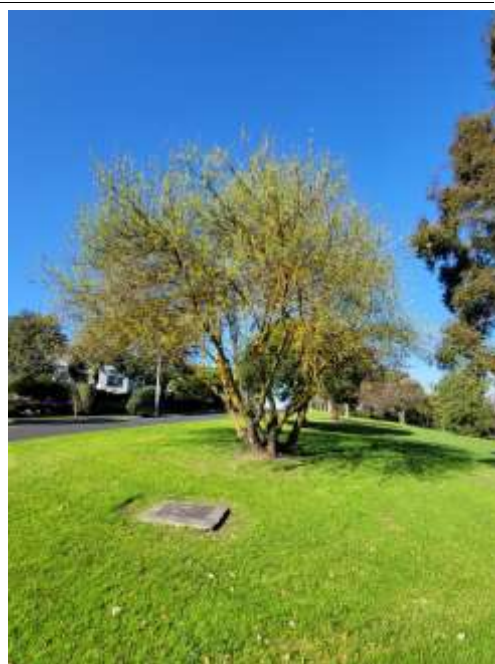
**Tree ID: 493****Genus / species:** *Corymbia maculata*

Evergreen Spotted Gum

**Height (m):** 22      **Structure:** Good  
**Width (m):** 19      **Health:** Good  
**DBH (cm):** 80 Measured **Maturity:** Mature  
**Origin:** Victorian      **ULE (years):** > 60  
**Retained?:** Retained      **Form:** Good

**Retention Value:** Very high**Removal / retention reason:** N/A.**Amenity value:** High**Works Required:** Canopy lift.**SRZ (m):** 3.2      **Works priority:** Very low**TPZ (m):** 9.6      **Construction Proximity:** 0.1**mTPZ (m):**

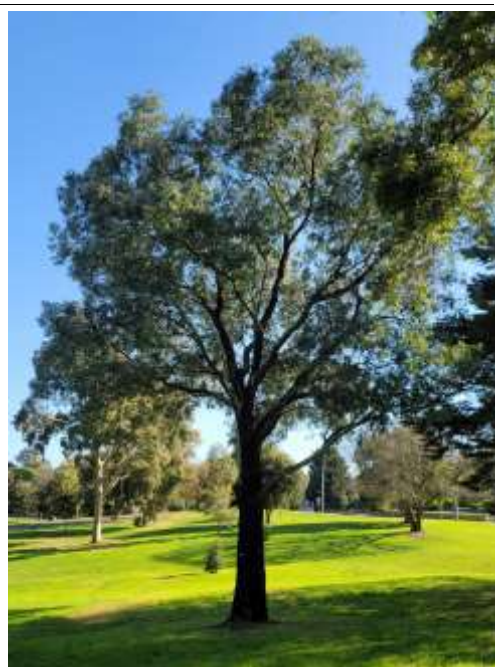
**Tree ID: 495****Genus / species:** *Acacia implexa*

Evergreen Lightwood

**Height (m):** 14      **Structure:** Good  
**Width (m):** 7      **Health:** Good  
**DBH (cm):** 29 Measured **Maturity:** Mature  
**Origin:** Melbourne      **ULE (years):** 15 - 30  
**Retained?:** Retained      **Form:** Good

**Retention Value:** Moderate**Removal / retention reason:** N/A.**Amenity value:** Moderate**Works Required:** N/A.**SRZ (m):** 2.1      **Works priority:** N/A**TPZ (m):** 3.5      **Construction Proximity:** 0.1**mTPZ (m):**

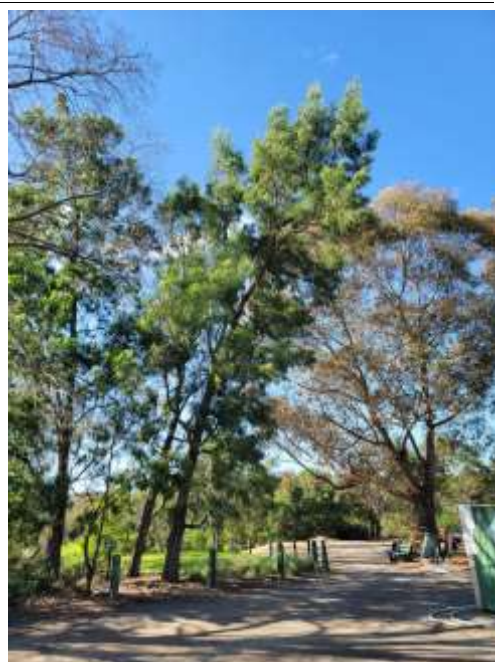
**Tree ID: 496****Genus / species:** *Eucalyptus saligna*

Evergreen Sydney Blue Gum

**Retention Value:** Very high**Removal / retention reason:** N/A.**Amenity value:** High**Works Required:** N/A.

**SRZ (m):** 2.5      **Works priority:** N/A  
**TPZ (m):** 5.6      **Construction Proximity:** 0.1  
**mTPZ (m):**

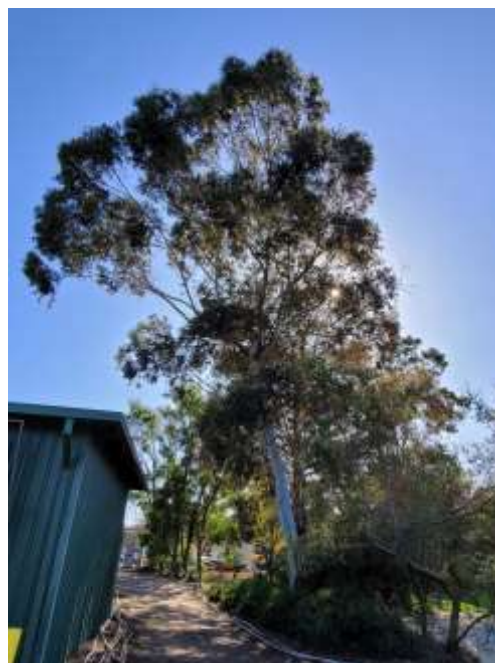
**Tree ID: 497****Genus / species:** *Acacia mearnsii*

Evergreen Black Wattle

**Retention Value:** Very low**Removal / retention reason:** N/A.**Amenity value:** Low**Works Required:** Canopy lift.

**SRZ (m):** 2.8      **Works priority:** Very low  
**TPZ (m):** 7.2      **Construction Proximity:** 0.1  
**mTPZ (m):**

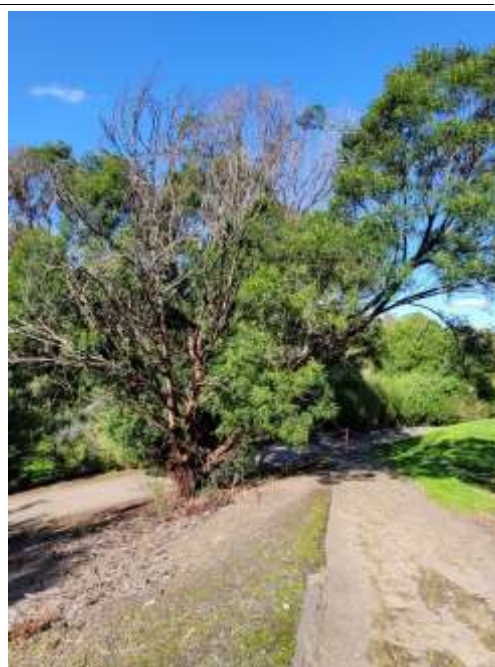
**Tree ID: 498****Genus / species:** *Myoporum insulare*

Evergreen Boobialla

**Retention Value:** Low**Removal / retention reason:** N/A.**Amenity value:** Low**Works Required:** N/A.

**SRZ (m):** 1.6      **Works priority:** N/A  
**TPZ (m):** 2.0      **Construction Proximity:** 0.1  
**mTPZ (m):**

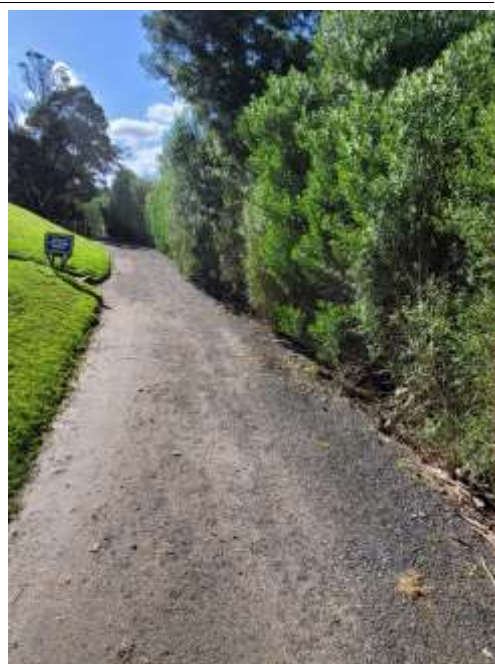
**Tree ID: 499****Genus / species:** *Eucalyptus camaldulensis*

Evergreen River Red Gum

**Retention Value:** Very high**Removal / retention reason:** N/A.**Amenity value:** High**Works Required:** N/A.

**SRZ (m):** 2.5      **Works priority:** N/A  
**TPZ (m):** 5.4      **Construction Proximity:** 0.1  
**mTPZ (m):**

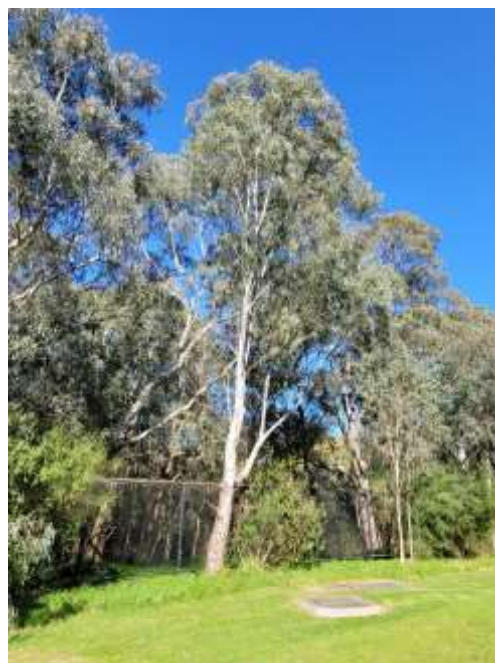
**Tree ID: 500****Genus / species:** *Eucalyptus camaldulensis*

Evergreen River Red Gum

**Retention Value:** Moderate**Removal / retention reason:** N/A.**Amenity value:** Low**Works Required:** N/A.

**SRZ (m):** 1.6      **Works priority:** N/A  
**TPZ (m):** 2.0      **Construction Proximity:** 0.1  
**mTPZ (m):**

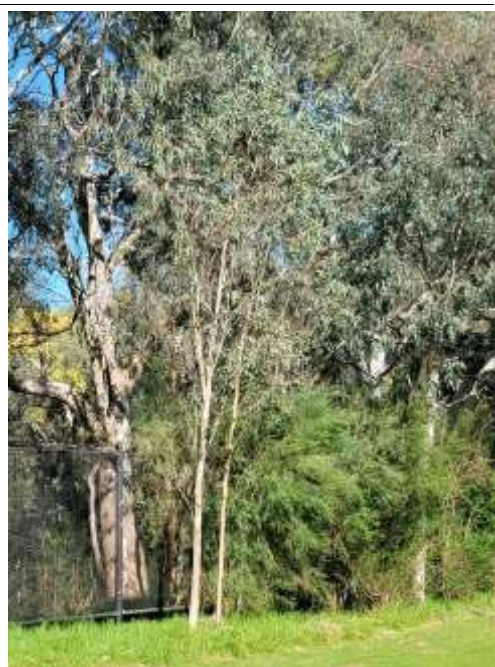
**Tree ID: 501****Genus / species:** *Eucalyptus camaldulensis*

Evergreen River Red Gum

**Retention Value:** Low**Removal / retention reason:** N/A.**Amenity value:** Low**Works Required:** N/A.

**SRZ (m):** 1.6      **Works priority:** N/A  
**TPZ (m):** 2.0      **Construction Proximity:** 0.1  
**mTPZ (m):**

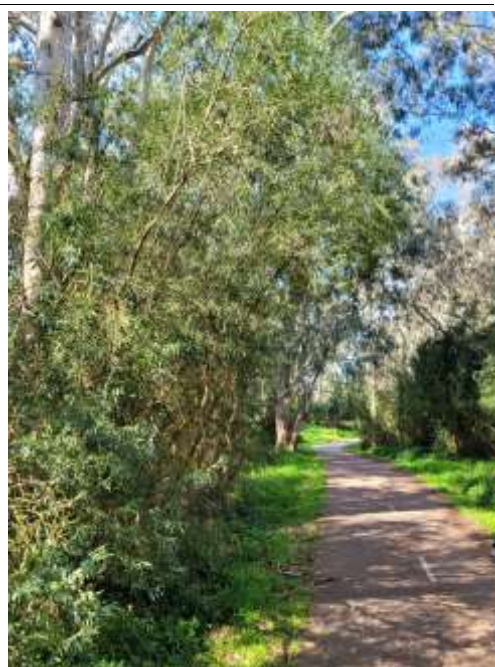
**Tree ID: 504****Genus / species:** *Eucalyptus camaldulensis*

Evergreen River Red Gum

**Retention Value:** Very high**Removal / retention reason:** N/A.**Amenity value:** High**Works Required:** N/A.

**SRZ (m):** 2.2      **Works priority:** N/A  
**TPZ (m):** 4.2      **Construction Proximity:** 0.1  
**mTPZ (m):**

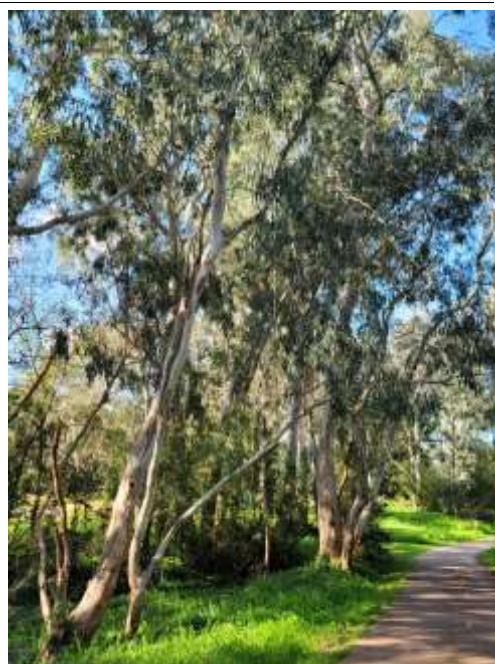
**Tree ID: 505****Genus / species:** *Eucalyptus camaldulensis*

Evergreen River Red Gum

**Retention Value:** Very high**Removal / retention reason:** N/A.**Amenity value:** High**Works Required:** N/A.

**SRZ (m):** 2.7      **Works priority:** N/A  
**TPZ (m):** 6.6      **Construction Proximity:** 0.1  
**mTPZ (m):**

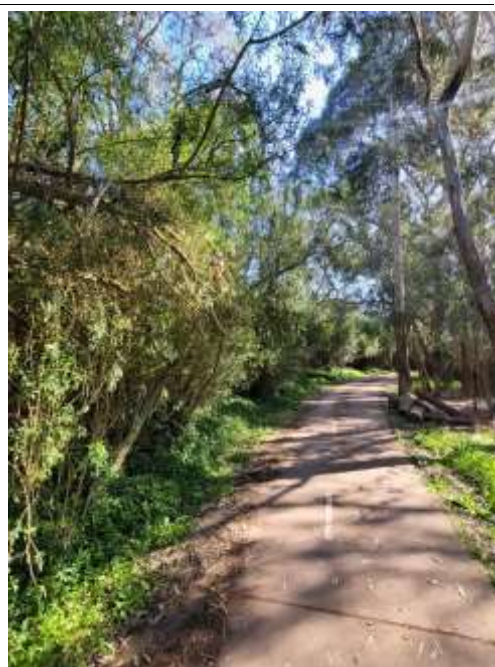
**Tree ID: 510****Genus / species:** *Eucalyptus camaldulensis*

Evergreen River Red Gum

**Height (m):** 13      **Structure:** Poor  
**Width (m):** 3      **Health:** Good  
**DBH (cm):** 18      Estimated **Maturity:** Immature  
**Origin:** Melbourne      **ULE (years):** 15 - 30  
**Retained?:** Retained      **Form:** Good  
**Retention Value:** Moderate  
**Removal / retention reason:** N/A.  
**Amenity value:** Moderate  
**Works Required:** N/A.

**SRZ (m):** 1.7      **Works priority:** N/A  
**TPZ (m):** 2.2      **Construction Proximity:** 0.1  
**mTPZ (m):**

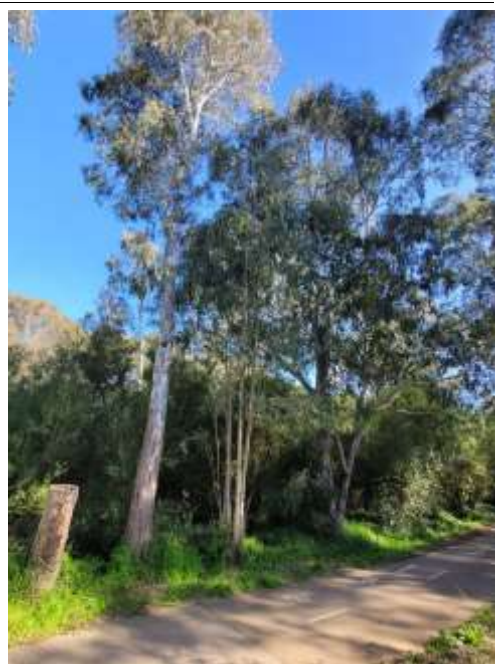
**Tree ID: 511****Genus / species:** *Eucalyptus camaldulensis*

Evergreen River Red Gum

**Retention Value:** Very high**Removal / retention reason:** N/A.**Amenity value:** High**Works Required:** N/A.

**SRZ (m):** 2.1      **Works priority:** N/A  
**TPZ (m):** 3.6      **Construction Proximity:** 0.1  
**mTPZ (m):**

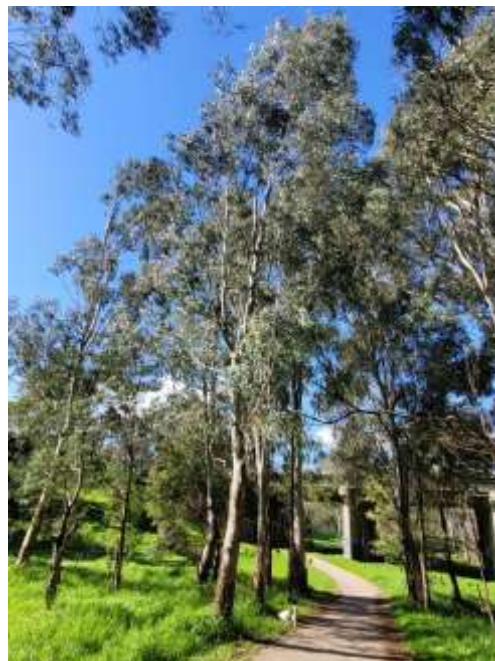
**Tree ID: 512****Genus / species:** *Eucalyptus camaldulensis*

Evergreen River Red Gum

**Retention Value:** High**Removal / retention reason:** N/A.**Amenity value:** High**Works Required:** N/A.

**SRZ (m):** 2.1      **Works priority:** N/A  
**TPZ (m):** 3.7      **Construction Proximity:** 0.1  
**mTPZ (m):**

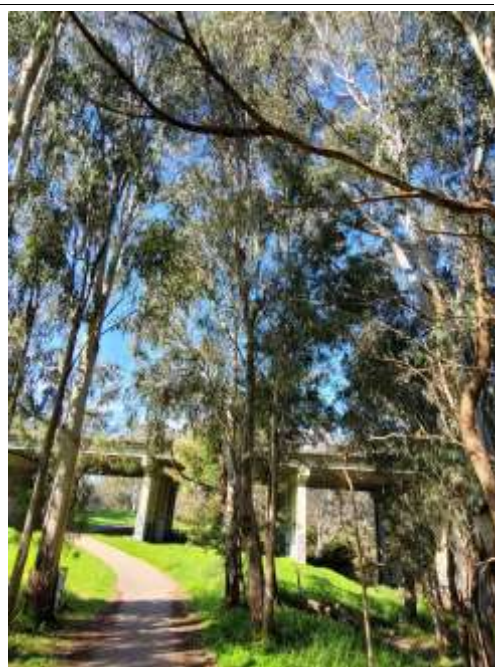
**Tree ID: 513****Genus / species:** *Acacia melanoxylon*

Evergreen Blackwood

**Retention Value:** Remove.**Removal / retention reason:** N/A.**Amenity value:** Very low**Works Required:** N/A.

**SRZ (m):** 1.9      **Works priority:** N/A  
**TPZ (m):** 3.0      **Construction Proximity:** 0.1  
**mTPZ (m):**

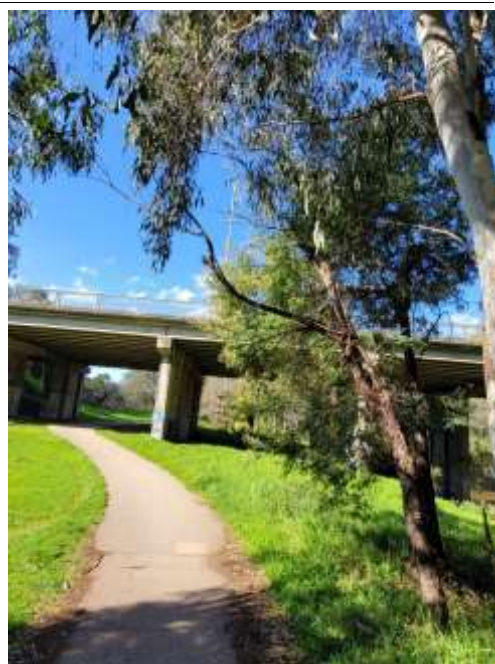
**Tree ID: 514****Genus / species:** *Eucalyptus camaldulensis*

Evergreen River Red Gum

**Height (m):** 23      **Structure:** Good  
**Width (m):** 11      **Health:** Good  
**DBH (cm):** 45      Estimated **Maturity:** Mature  
**Origin:** Melbourne      **ULE (years):** 0  
**Retained?:** Retained      **Form:** Fair

**Retention Value:** Very low**Removal / retention reason:** N/A.**Amenity value:** High**Works Required:** Canopy lift.**SRZ (m):** 2.5      **Works priority:** Very low**TPZ (m):** 5.4      **Construction Proximity:** 0.1**mTPZ (m):**

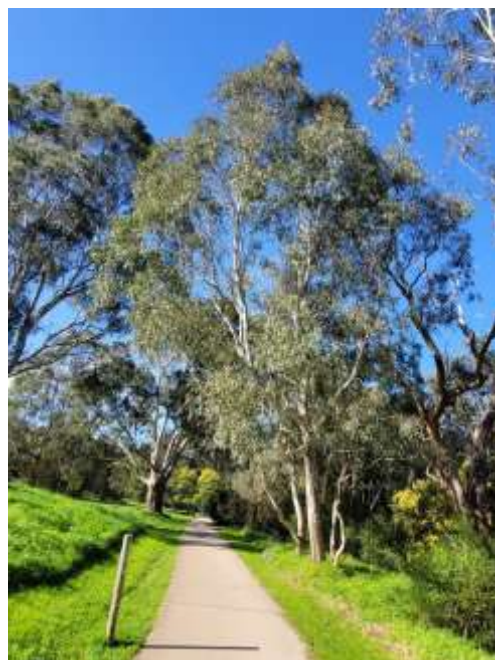
**Tree ID: 515****Genus / species:** *Eucalyptus camaldulensis*

Evergreen River Red Gum

**Height (m):** 17      **Structure:** Good  
**Width (m):** 9      **Health:** Good  
**DBH (cm):** 30      Estimated **Maturity:** Mature  
**Origin:** Melbourne      **ULE (years):** > 60  
**Retained?:** Retained      **Form:** Good

**Retention Value:** Very high**Removal / retention reason:** N/A.**Amenity value:** High**Works Required:** N/A.**SRZ (m):** 2.1      **Works priority:** N/A**TPZ (m):** 3.6      **Construction Proximity:** 0.1**mTPZ (m):**

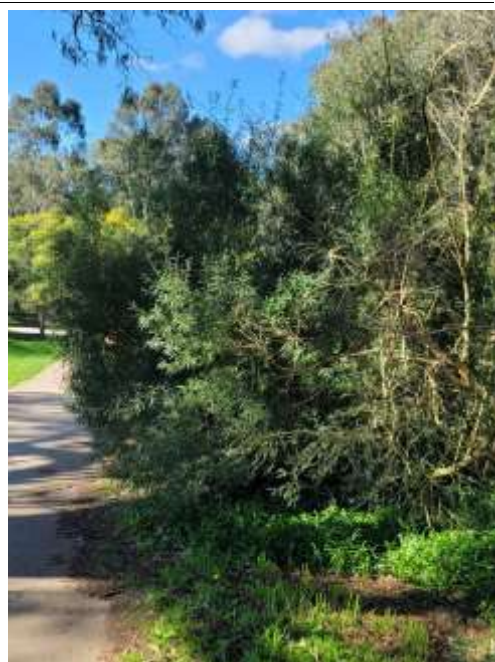
**Tree ID: 517****Genus / species:** *Acacia mearnsii*

Evergreen Black Wattle

**Height (m):** 7      **Structure:** Poor  
**Width (m):** 8      **Health:** Poor  
**DBH (cm):** 35      **Estimated Maturity:** Over mature  
**Origin:** Melbourne      **ULE (years):** 1 - 5  
**Retained?:** Removed      **Form:** Poor  
**Retention Value:** Very low  
**Removal / retention reason:** N/A.  
**Amenity value:** Very low  
**Works Required:** N/A.

**SRZ (m):** 2.2      **Works priority:** N/A  
**TPZ (m):** 4.2      **Construction Proximity:** 0.1  
**mTPZ (m):**

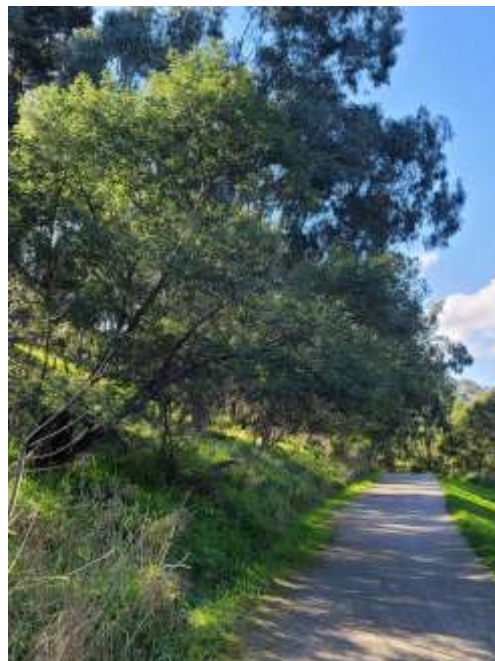
**Tree ID: 518****Genus / species:** *Eucalyptus camaldulensis*

Evergreen River Red Gum

**Height (m):** 14      **Structure:** Good  
**Width (m):** 5      **Health:** Good  
**DBH (cm):** 30      **Estimated Maturity:** Mature  
**Origin:** Melbourne      **ULE (years):** > 60  
**Retained?:** Retained      **Form:** Fair  
**Retention Value:** High  
**Removal / retention reason:** N/A.  
**Amenity value:** Moderate  
**Works Required:** N/A.

**SRZ (m):** 2.1      **Works priority:** N/A  
**TPZ (m):** 3.6      **Construction Proximity:** 0.1  
**mTPZ (m):**

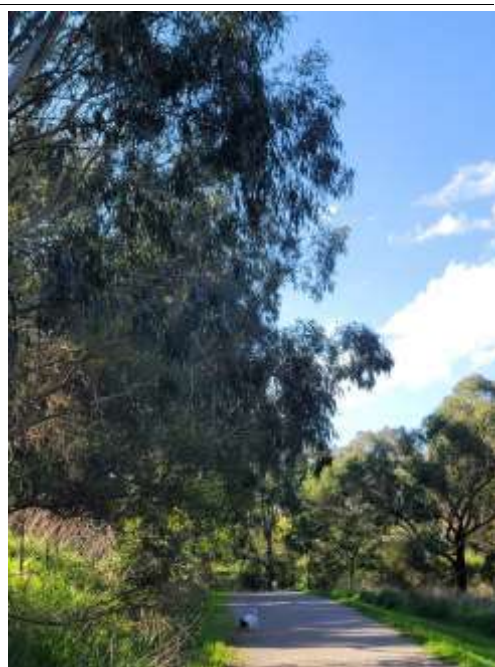
**Tree ID: 519****Genus / species:** *Eucalyptus camaldulensis*

Evergreen River Red Gum

**Height (m):** 7      **Structure:** Good  
**Width (m):** 2      **Health:** Good  
**DBH (cm):** 10      **Estimated Maturity:** Immature  
**Origin:** Melbourne      **ULE (years):** > 60  
**Retained?:** Retained      **Form:** Fair  
**Retention Value:** Moderate  
**Removal / retention reason:** N/A.  
**Amenity value:** Low  
**Works Required:** N/A.

**SRZ (m):** 1.6      **Works priority:** N/A  
**TPZ (m):** 2.0      **Construction Proximity:** 0.1  
**mTPZ (m):**

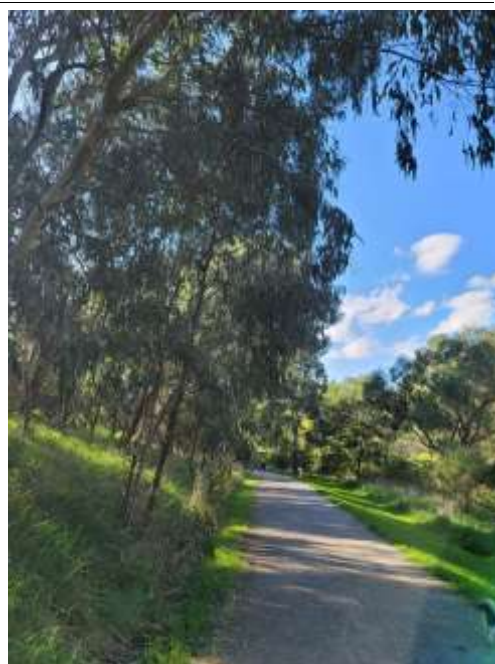
**Tree ID: 520****Genus / species:** *Eucalyptus camaldulensis*

Evergreen River Red Gum

**Height (m):** 14      **Structure:** Fair  
**Width (m):** 13      **Health:** Good  
**DBH (cm):** 45      Estimated **Maturity:** Mature  
**Origin:** Melbourne      **ULE (years):** 30 - 60  
**Retained?:** Retained      **Form:** Fair

**Retention Value:** Moderate**Removal / retention reason:** N/A.**Amenity value:** Moderate**Works Required:** Canopy lift.**SRZ (m):** 2.5      **Works priority:** Very low**TPZ (m):** 5.4      **Construction Proximity:** 0.1**mTPZ (m):**

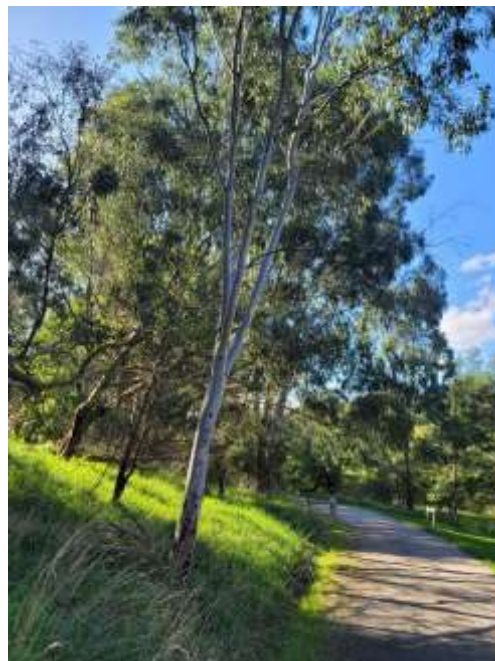
**Tree ID: 521****Genus / species:** *Acacia melanoxylon*

Evergreen Blackwood

**Height (m):** 6      **Structure:** Fair  
**Width (m):** 3      **Health:** Good  
**DBH (cm):** 12      Estimated **Maturity:** Mature  
**Origin:** Melbourne      **ULE (years):** 15 - 30  
**Retained?:** Removed      **Form:** Fair

**Retention Value:** Low**Removal / retention reason:** N/A.**Amenity value:** Low**Works Required:** N/A.**SRZ (m):** 1.6      **Works priority:** N/A.**TPZ (m):** 2.0      **Construction Proximity:** 0.1**mTPZ (m):**

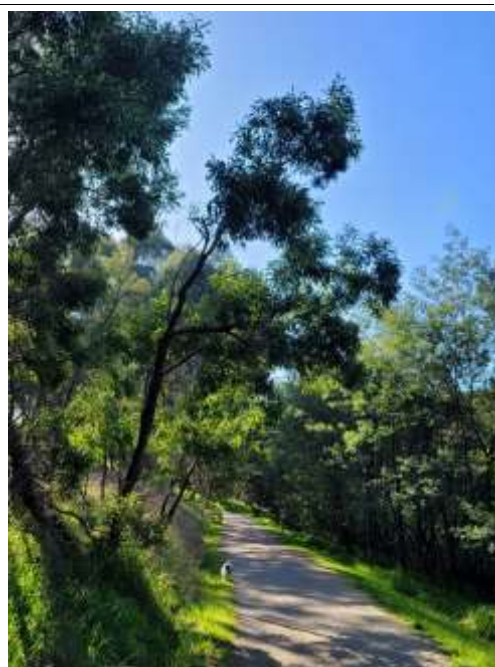
**Tree ID: 522****Genus / species:** *Acacia melanoxylon*

Evergreen Blackwood

**Height (m):** 5      **Structure:** Fair  
**Width (m):** 2      **Health:** Good  
**DBH (cm):** 10      Estimated **Maturity:** Immature  
**Origin:** Melbourne      **ULE (years):** 5 - 15  
**Retained?:** Removed      **Form:** Fair

**Retention Value:** Low**Removal / retention reason:** N/A.**Amenity value:** Low**Works Required:** N/A.**SRZ (m):** 1.6      **Works priority:** N/A.**TPZ (m):** 2.0      **Construction Proximity:** 0.1**mTPZ (m):**

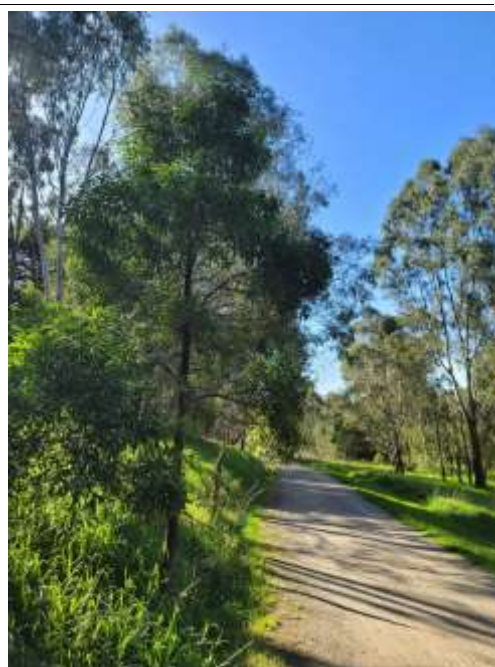
**Tree ID: 525****Genus / species:** *Eucalyptus camaldulensis*

Evergreen River Red Gum

**Height (m):** 17      **Structure:** Poor  
**Width (m):** 11      **Health:** Good  
**DBH (cm):** 40      Estimated **Maturity:** Mature  
**Origin:** Melbourne      **ULE (years):** 15 - 30  
**Retained?:** Retained      **Form:** Fair  
**Retention Value:** High  
**Removal / retention reason:** N/A.  
**Amenity value:** High  
**Works Required:** Canopy lift.

**SRZ (m):** 2.4      **Works priority:** Very low  
**TPZ (m):** 4.8      **Construction Proximity:** 0.1  
**mTPZ (m):**

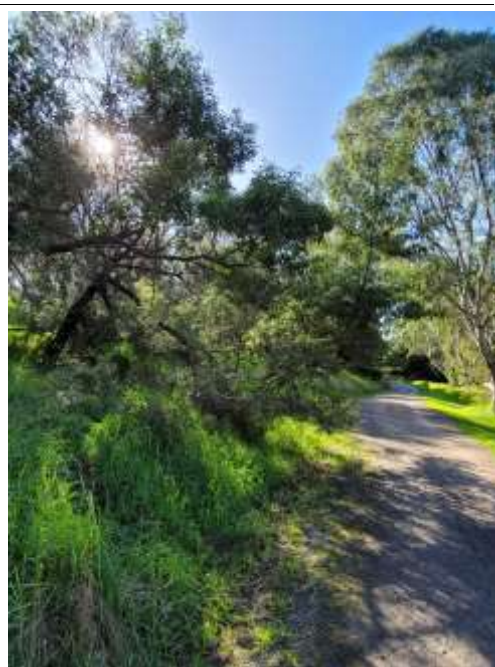
**Tree ID: 528****Genus / species:** *Acacia mearnsii*

Evergreen Black Wattle

**Height (m):** 7      **Structure:** Fair  
**Width (m):** 6      **Health:** Good  
**DBH (cm):** 10      Estimated **Maturity:** Immature  
**Origin:** Melbourne      **ULE (years):** 15 - 30  
**Retained?:** Removed      **Form:** Fair

**Retention Value:** Low**Removal / retention reason:** N/A.**Amenity value:** Low**Works Required:** N/A.**SRZ (m):** 1.6      **Works priority:** N/A.**TPZ (m):** 2.0      **Construction Proximity:** 0.1**mTPZ (m):**
