## **Nation Partners**

# **Northern Sewers Relining Project Southern Section**

## **Construction Impact Report**

**Wednesday 4<sup>th</sup> December 2024**

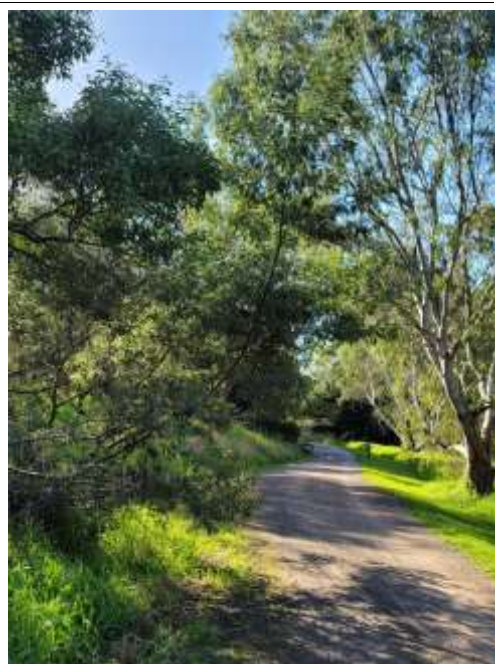
**Tree ID: 529****Genus / species:** *Eucalyptus camaldulensis*

Evergreen River Red Gum

**Height (m):** 8                      **Structure:** Poor  
**Width (m):** 10                    **Health:** Good  
**DBH (cm):** 35      Estimated **Maturity:** Mature  
**Origin:** Melbourne      **ULE (years):** 15 - 30  
**Retained?:** Removed      **Form:** Very poor  
**Retention Value:** Low  
**Removal / retention reason:** N/A.  
**Amenity value:** Low  
**Works Required:** N/A.

**SRZ (m):** 2.2              **Works priority:** N/A  
**TPZ (m):** 4.2              **Construction Proximity:** 0.1  
**mTPZ (m):**

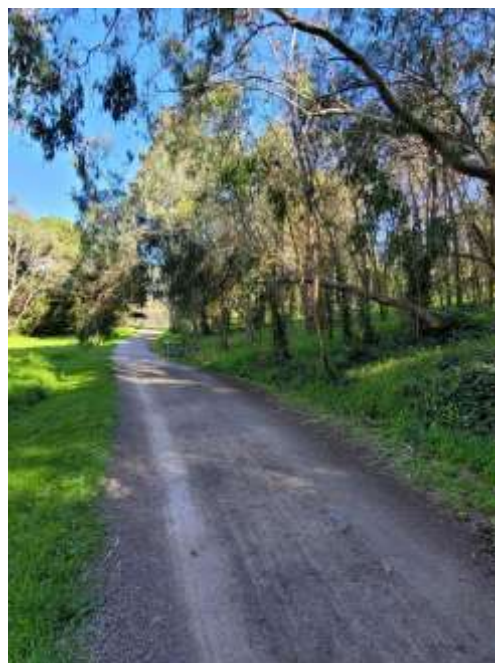
**Tree ID: 530****Genus / species:** *Eucalyptus camaldulensis*

Evergreen River Red Gum

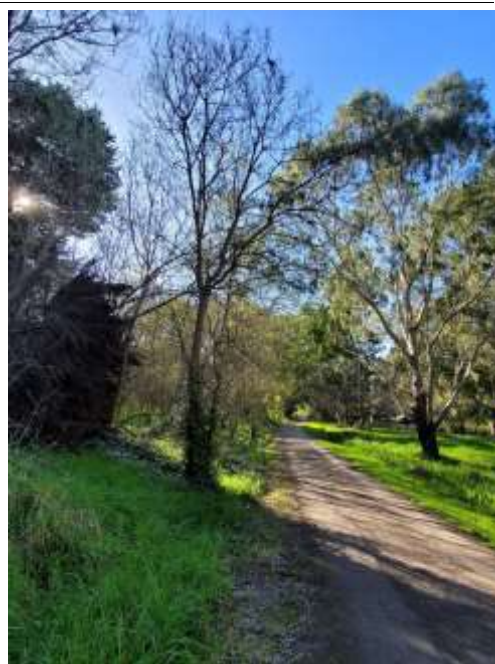
**Tree ID: 532****Genus / species:** *Eucalyptus camaldulensis*

Evergreen River Red Gum

**Retention Value:** Low**Removal / retention reason:** N/A.**Amenity value:** Low**Works Required:** N/A.

**SRZ (m):** 1.6      **Works priority:** N/A  
**TPZ (m):** 2.0      **Construction Proximity:** 0.1  
**mTPZ (m):**

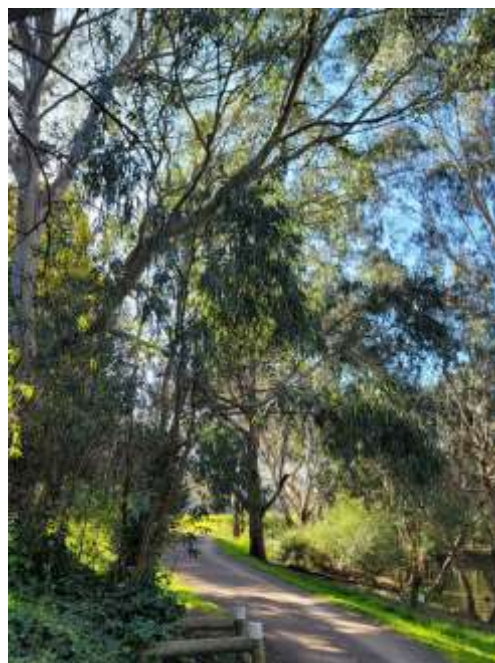
**Tree ID: 533****Genus / species:** *Eucalyptus camaldulensis*

Evergreen River Red Gum

**Retention Value:** Very high**Removal / retention reason:** N/A.**Amenity value:** High**Works Required:** N/A.

**SRZ (m):** 2.6      **Works priority:** N/A  
**TPZ (m):** 6.0      **Construction Proximity:** 0.1  
**mTPZ (m):**

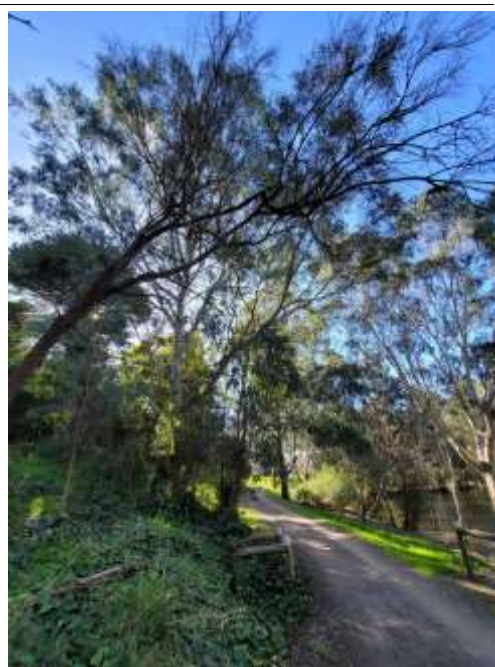
**Tree ID: 534****Genus / species:** *Eucalyptus camaldulensis*

Evergreen River Red Gum

**Retention Value:** Very high**Removal / retention reason:** N/A.**Amenity value:** High**Works Required:** N/A.

**SRZ (m):** 2.7      **Works priority:** N/A  
**TPZ (m):** 6.6      **Construction Proximity:** 0.1  
**mTPZ (m):**

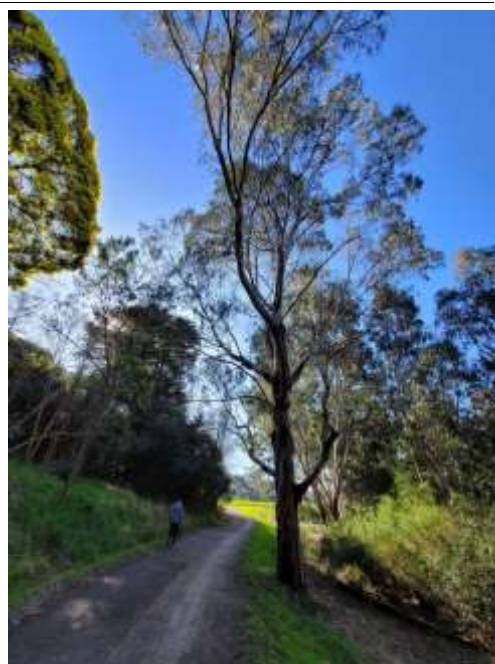
**Tree ID: 535****Genus / species:** *Eucalyptus camaldulensis*

Evergreen River Red Gum

**Height (m):** 21      **Structure:** Fair  
**Width (m):** 16      **Health:** Good  
**DBH (cm):** 65      Estimated **Maturity:** Mature  
**Origin:** Melbourne      **ULE (years):** > 60  
**Retained?:** Retained      **Form:** Good  
**Retention Value:** Very high

**Removal / retention reason:** N/A.**Amenity value:** High**Works Required:** Canopy lift.**SRZ (m):** 2.9      **Works priority:** Very low**TPZ (m):** 7.8      **Construction Proximity:** 0.1**mTPZ (m):**

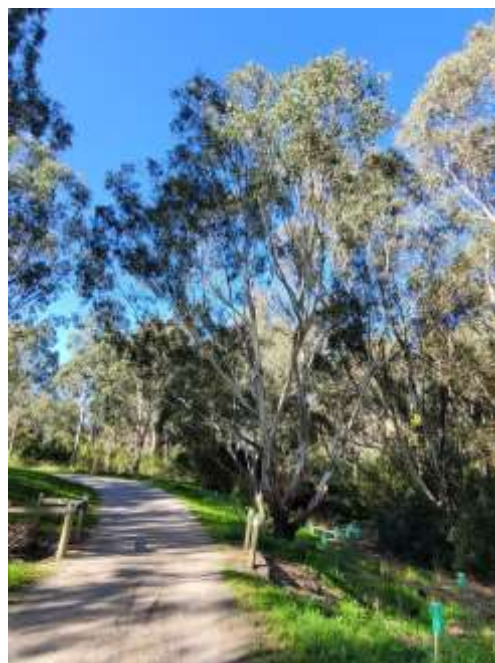
**Tree ID: 536****Genus / species:** *Eucalyptus camaldulensis*

Evergreen River Red Gum

**Height (m):** 30      **Structure:** Good  
**Width (m):** 18      **Health:** Good  
**DBH (cm):** 90      Estimated **Maturity:** Mature  
**Origin:** Melbourne      **ULE (years):** > 60  
**Retained?:** Retained      **Form:** Good  
**Retention Value:** Very high

**Removal / retention reason:** N/A.**Amenity value:** High**Works Required:** N/A.**SRZ (m):** 3.4      **Works priority:** N/A**TPZ (m):** 10.8      **Construction Proximity:** 0.1**mTPZ (m):**

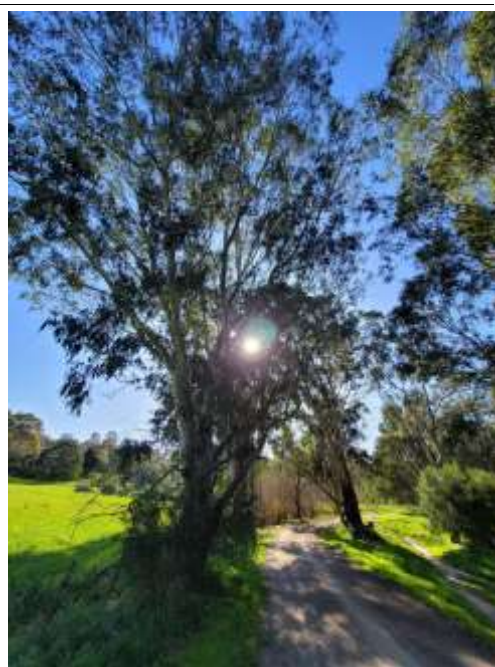
**Tree ID: 537****Genus / species:** *Eucalyptus camaldulensis*

Evergreen River Red Gum

**Height (m):** 31      **Structure:** Good  
**Width (m):** 23      **Health:** Good  
**DBH (cm):** 105      Estimated **Maturity:** Mature  
**Origin:** Melbourne      **ULE (years):** 30 - 60  
**Retained?:** Retained      **Form:** Good  
**Retention Value:** High

**Removal / retention reason:** N/A.**Amenity value:** High**Works Required:** Canopy lift.**SRZ (m):** 3.6      **Works priority:** Very low**TPZ (m):** 12.6      **Construction Proximity:** 0.1**mTPZ (m):**

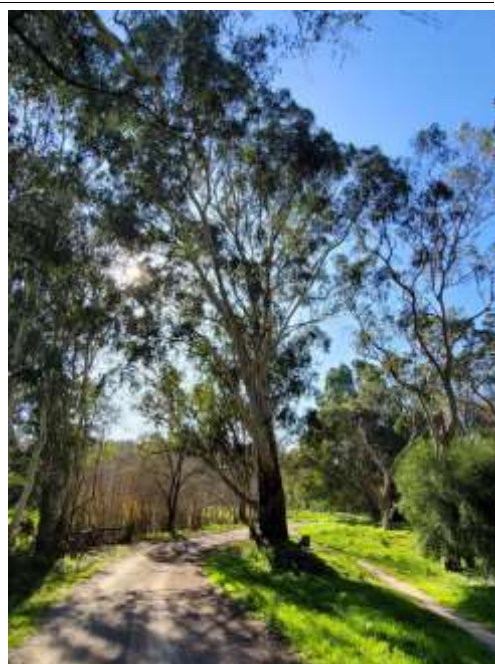
**Tree ID: 538****Genus / species:** *Eucalyptus camaldulensis*

Evergreen River Red Gum

**Height (m):** 17      **Structure:** Good  
**Width (m):** 16      **Health:** Good  
**DBH (cm):** 85      Estimated **Maturity:** Mature  
**Origin:** Melbourne      **ULE (years):** 30 - 60  
**Retained?:** Retained      **Form:** Fair

**Retention Value:** High**Removal / retention reason:** N/A.**Amenity value:** High**Works Required:** Canopy lift.**SRZ (m):** 3.3      **Works priority:** Very low**TPZ (m):** 10.2      **Construction Proximity:** 0.1**mTPZ (m):**

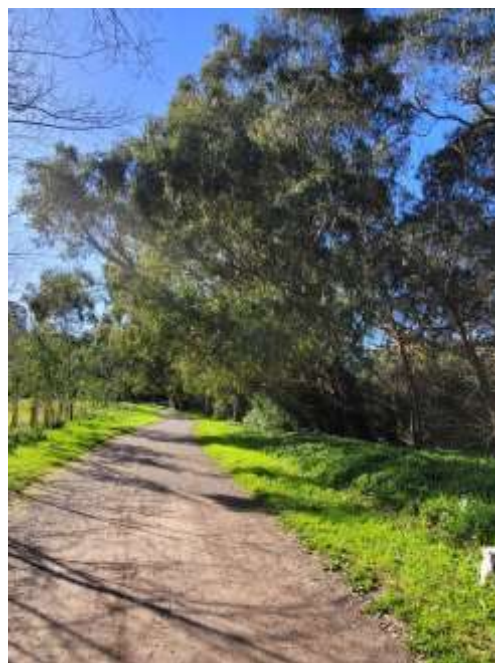
**Tree ID: 539****Genus / species:** *Eucalyptus camaldulensis*

Evergreen River Red Gum

**Height (m):** 10      **Structure:** Good  
**Width (m):** 13      **Health:** Good  
**DBH (cm):** 35      Estimated **Maturity:** Mature  
**Origin:** Melbourne      **ULE (years):** 30 - 60  
**Retained?:** Retained      **Form:** Poor

**Retention Value:** Low**Removal / retention reason:** N/A.**Amenity value:** Low**Works Required:** Canopy lift.**SRZ (m):** 2.2      **Works priority:** Very low**TPZ (m):** 4.2      **Construction Proximity:** 0.1**mTPZ (m):**

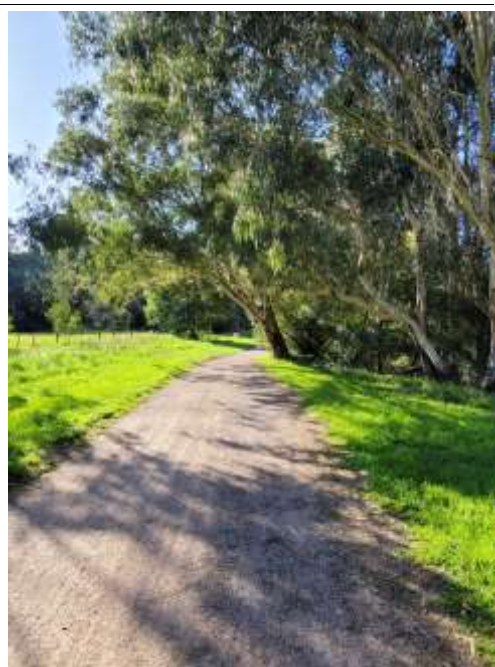
**Tree ID: 540****Genus / species:** *Eucalyptus camaldulensis*

Evergreen River Red Gum

**Height (m):** 27      **Structure:** Good  
**Width (m):** 18      **Health:** Good  
**DBH (cm):** 75      Estimated **Maturity:** Mature  
**Origin:** Melbourne      **ULE (years):** > 60  
**Retained?:** Retained      **Form:** Good

**Retention Value:** Very high**Removal / retention reason:** N/A.**Amenity value:** High**Works Required:** Canopy lift.**SRZ (m):** 3      **Works priority:** Very low**TPZ (m):** 9.0      **Construction Proximity:** 0.1**mTPZ (m):**

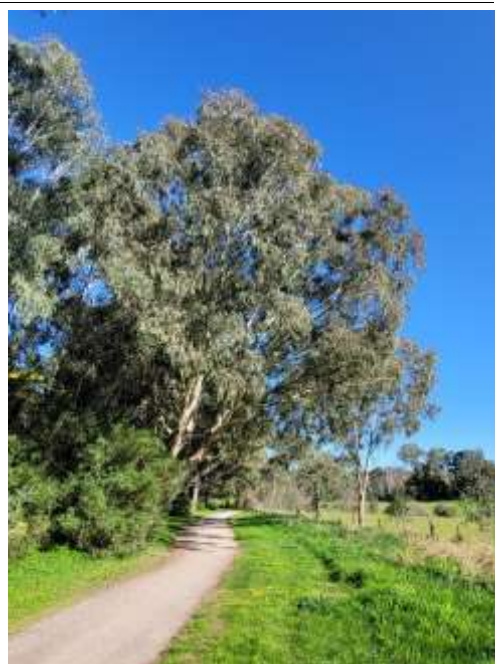
**Tree ID: 541****Genus / species:** *Eucalyptus camaldulensis*

Evergreen River Red Gum

**Height (m):** 25      **Structure:** Good  
**Width (m):** 16      **Health:** Good  
**DBH (cm):** 80      Estimated **Maturity:** Mature  
**Origin:** Melbourne      **ULE (years):** > 60  
**Retained?:** Retained      **Form:** Good

**Retention Value:** Very high**Removal / retention reason:** N/A.**Amenity value:** High**Works Required:** Canopy lift.**SRZ (m):** 3.2      **Works priority:** Very low**TPZ (m):** 9.6      **Construction Proximity:** 0.1**mTPZ (m):**

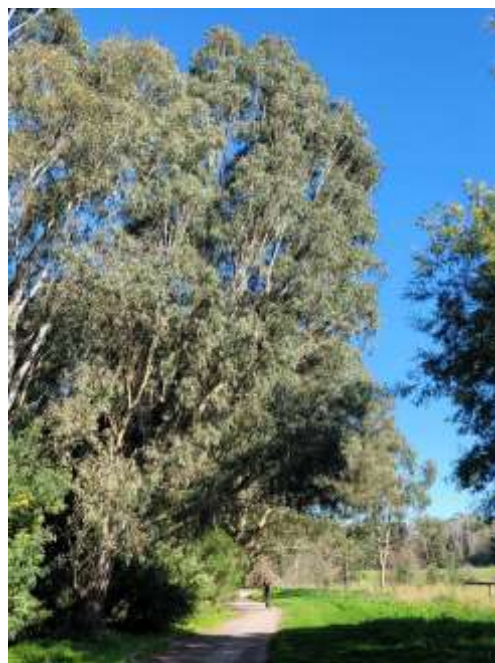
**Tree ID: 542****Genus / species:** *Eucalyptus camaldulensis*

Evergreen River Red Gum

**Height (m):** 18      **Structure:** Good  
**Width (m):** 14      **Health:** Good  
**DBH (cm):** 65      Estimated **Maturity:** Mature  
**Origin:** Melbourne      **ULE (years):** > 60  
**Retained?:** Retained      **Form:** Fair

**Retention Value:** Very high**Removal / retention reason:** N/A.**Amenity value:** High**Works Required:** Canopy lift.**SRZ (m):** 2.9      **Works priority:** Very low**TPZ (m):** 7.8      **Construction Proximity:** 0.1**mTPZ (m):**

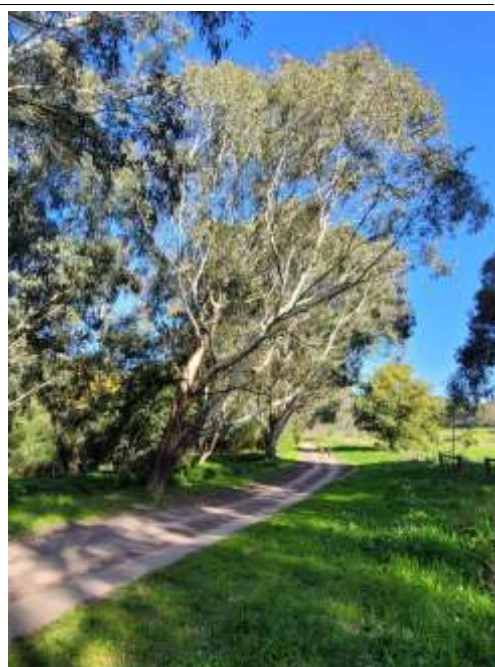
**Tree ID: 543****Genus / species:** *Eucalyptus camaldulensis*

Evergreen River Red Gum

**Height (m):** 26      **Structure:** Good  
**Width (m):** 19      **Health:** Good  
**DBH (cm):** 90      Estimated **Maturity:** Mature  
**Origin:** Melbourne      **ULE (years):** > 60  
**Retained?:** Retained      **Form:** Good

**Retention Value:** Very high**Removal / retention reason:** N/A.**Amenity value:** High**Works Required:** Canopy lift.**SRZ (m):** 3.4      **Works priority:** Very low**TPZ (m):** 10.8      **Construction Proximity:** 0.1**mTPZ (m):**

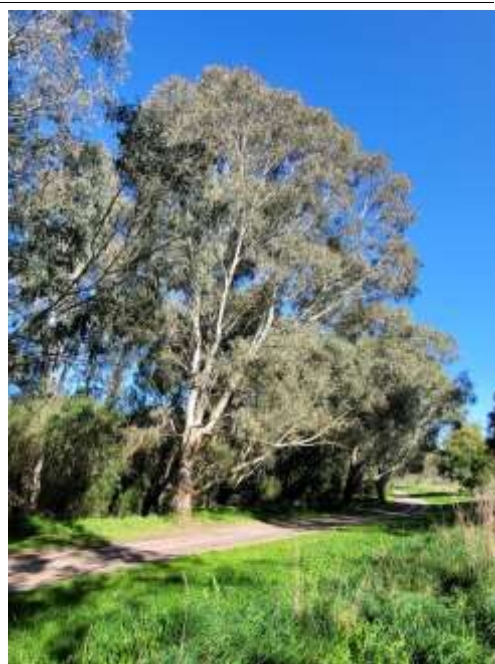
**Tree ID: 544****Genus / species:** *Eucalyptus camaldulensis*

Evergreen River Red Gum

**Height (m):** 26      **Structure:** Good  
**Width (m):** 16      **Health:** Good  
**DBH (cm):** 85      Estimated **Maturity:** Mature  
**Origin:** Melbourne      **ULE (years):** > 60  
**Retained?:** Retained      **Form:** Good

**Retention Value:** Very high**Removal / retention reason:** N/A.**Amenity value:** High**Works Required:** Canopy lift.**SRZ (m):** 3.3      **Works priority:** Very low**TPZ (m):** 10.2      **Construction Proximity:** 0.1**mTPZ (m):**

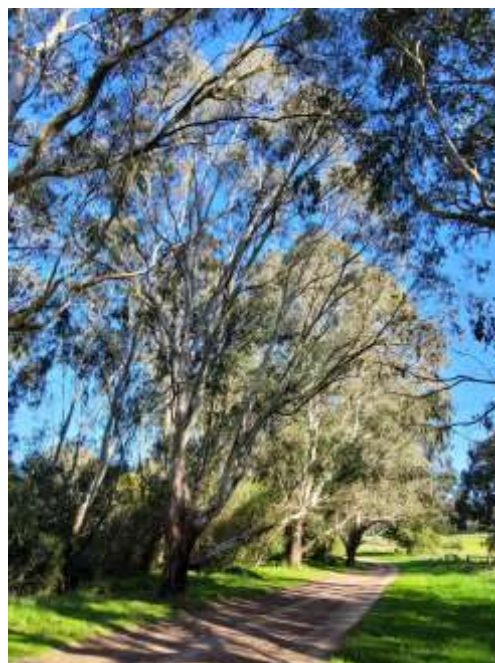
**Tree ID: 545****Genus / species:** *Eucalyptus camaldulensis*

Evergreen River Red Gum

**Height (m):** 21      **Structure:** Good  
**Width (m):** 13      **Health:** Good  
**DBH (cm):** 55      Estimated **Maturity:** Mature  
**Origin:** Melbourne      **ULE (years):** > 60  
**Retained?:** Retained      **Form:** Fair

**Retention Value:** Very high**Removal / retention reason:** N/A.**Amenity value:** High**Works Required:** Canopy lift.**SRZ (m):** 2.7      **Works priority:** Very low**TPZ (m):** 6.6      **Construction Proximity:** 0.1**mTPZ (m):**

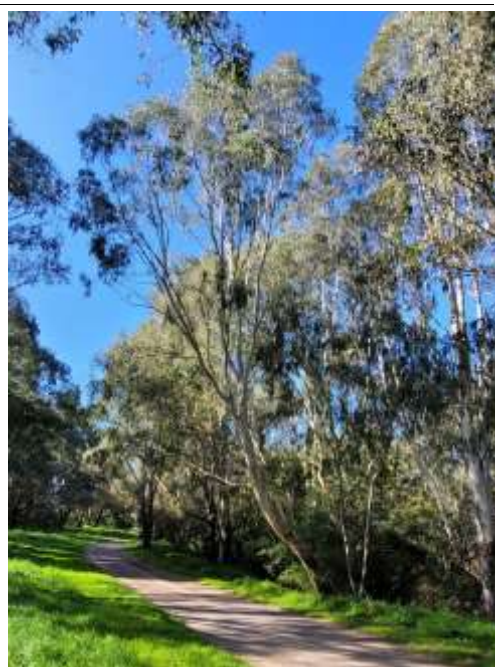
**Tree ID: 546****Genus / species:** *Eucalyptus camaldulensis*

Evergreen River Red Gum

**Height (m):** 19      **Structure:** Good  
**Width (m):** 10      **Health:** Good  
**DBH (cm):** 40      Estimated **Maturity:** Mature  
**Origin:** Melbourne      **ULE (years):** > 60  
**Retained?:** Retained      **Form:** Fair

**Retention Value:** Very high**Removal / retention reason:** N/A.**Amenity value:** High**Works Required:** N/A.**SRZ (m):** 2.4      **Works priority:** N/A**TPZ (m):** 4.8      **Construction Proximity:** 0.1**mTPZ (m):**

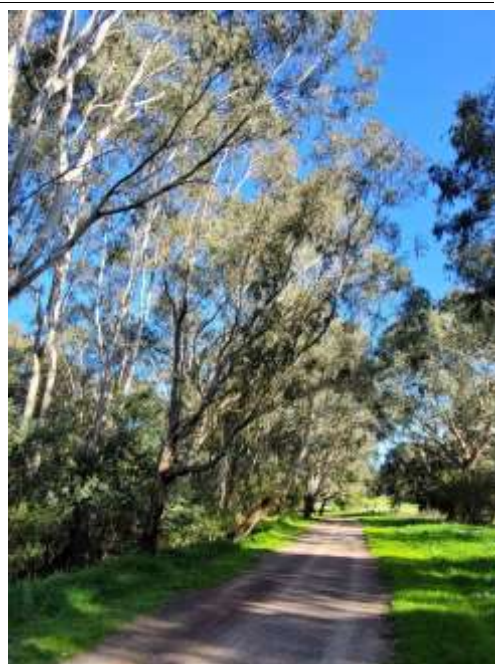
**Tree ID: 547****Genus / species:** *Eucalyptus camaldulensis*

Evergreen River Red Gum

**Height (m):** 20      **Structure:** Good  
**Width (m):** 18      **Health:** Good  
**DBH (cm):** 60      Estimated **Maturity:** Mature  
**Origin:** Melbourne      **ULE (years):** > 60  
**Retained?:** Retained      **Form:** Good

**Retention Value:** Very high**Removal / retention reason:** N/A.**Amenity value:** High**Works Required:** Canopy lift.**SRZ (m):** 2.8      **Works priority:** Very low**TPZ (m):** 7.2      **Construction Proximity:** 0.1**mTPZ (m):**

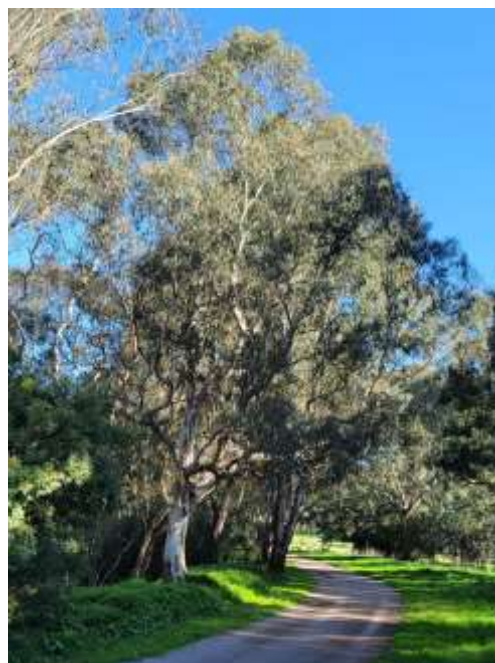
**Tree ID: 548****Genus / species:** *Eucalyptus camaldulensis*

Evergreen River Red Gum

**Height (m):** 18      **Structure:** Good  
**Width (m):** 16      **Health:** Good  
**DBH (cm):** 55      Estimated **Maturity:** Mature  
**Origin:** Melbourne      **ULE (years):** > 60  
**Retained?:** Retained      **Form:** Fair

**Retention Value:** Very high**Removal / retention reason:** N/A.**Amenity value:** High**Works Required:** Canopy lift.**SRZ (m):** 2.7      **Works priority:** Very low**TPZ (m):** 6.6      **Construction Proximity:** 0.1**mTPZ (m):**

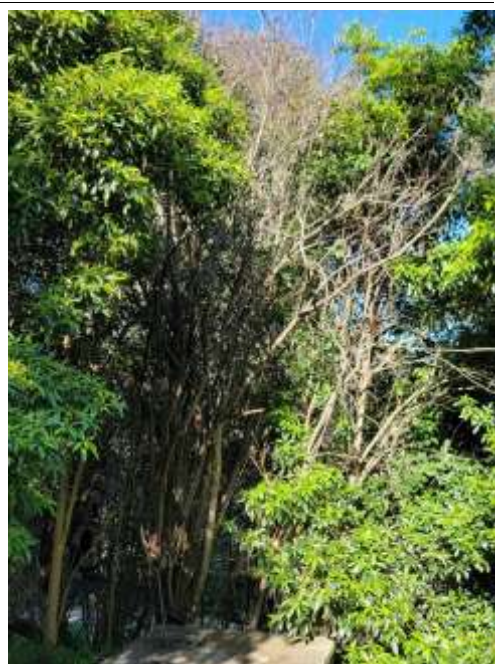
**Tree ID: 550****Genus / species:** *Pittosporum undulatum*

Evergreen Sweet Pittosporum

**Height (m):** 8                      **Structure:** Good  
**Width (m):** 9                      **Health:** Good  
**DBH (cm):** 40      Estimated **Maturity:** Mature  
**Origin:** Victorian              **ULE (years):** 5 - 15  
**Retained?:** Retained              **Form:** Good

**Retention Value:** Low**Removal / retention reason:** N/A.**Amenity value:** Low**Works Required:** Canopy lift.**SRZ (m):** 2.4              **Works priority:** Very low**TPZ (m):** 4.8              **Construction Proximity:** 0.1**mTPZ (m):**

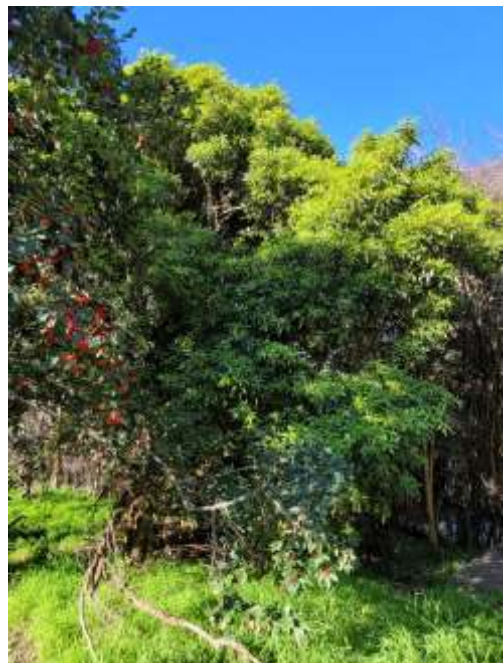
**Tree ID: 551****Genus / species:** *Acacia implexa*

Evergreen Lightwood

**Height (m):** 9                      **Structure:** Fair  
**Width (m):** 3                      **Health:** Poor  
**DBH (cm):** 25      Estimated **Maturity:** Mature  
**Origin:** Melbourne              **ULE (years):** 5 - 15  
**Retained?:** Retained              **Form:** Fair

**Retention Value:** Low**Removal / retention reason:** N/A.**Amenity value:** Low**Works Required:** Canopy lift.**SRZ (m):** 1.9              **Works priority:** Very low**TPZ (m):** 3.0              **Construction Proximity:** 0.1**mTPZ (m):**

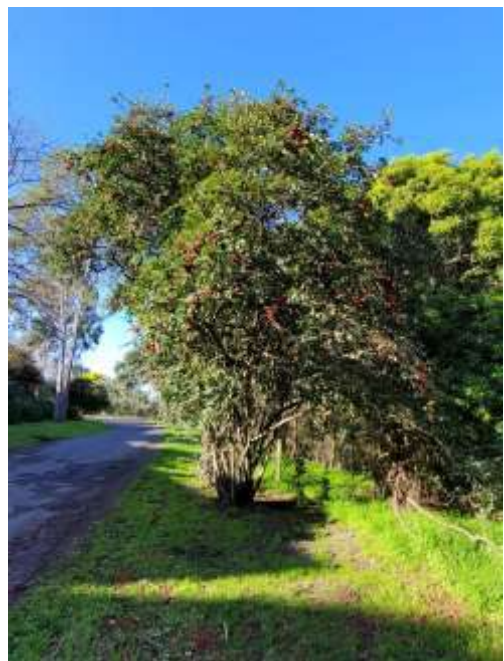
**Tree ID: 553****Genus / species:** *Ligustrum lucidum*

Evergreen Privet

**Retention Value:** Low**Removal / retention reason:** N/A.**Amenity value:** Low**Works Required:** N/A.

**SRZ (m):** 2.2              **Works priority:** N/A  
**TPZ (m):** 4.0              **Construction Proximity:** 0.1  
**mTPZ (m):**

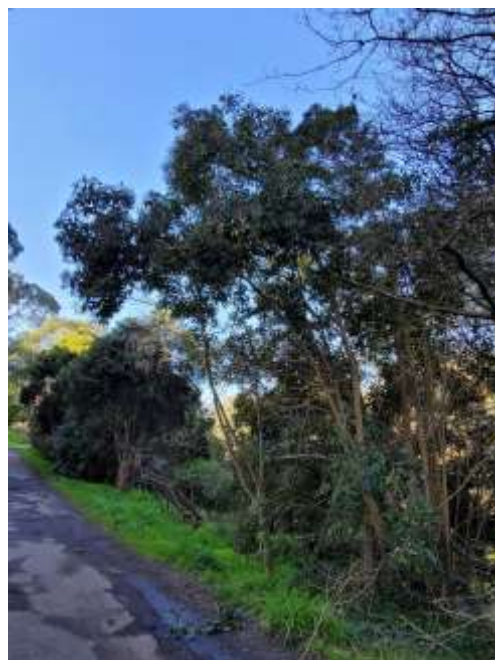
**Tree ID: 554****Genus / species:** *Betula pendula*

Deciduous Silver Birch

**Retention Value:** Very low**Removal / retention reason:** N/A.**Amenity value:** Very low**Works Required:** N/A.

**SRZ (m):** 1.6              **Works priority:** N/A  
**TPZ (m):** 2.0              **Construction Proximity:** 0.1  
**mTPZ (m):**

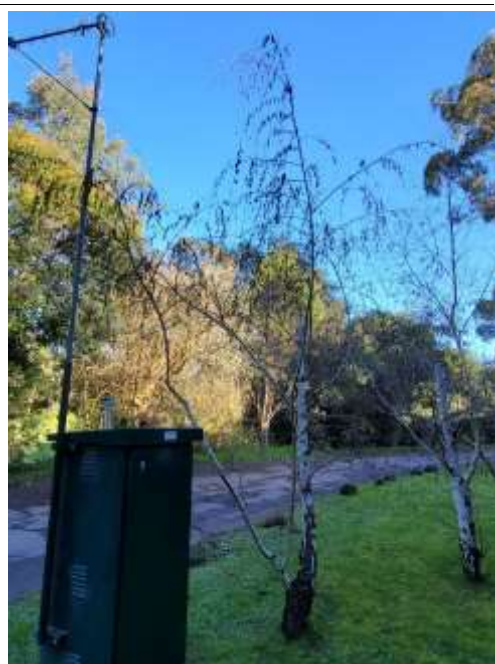
**Tree ID: 555****Genus / species:** *Betula pendula*

Deciduous Silver Birch

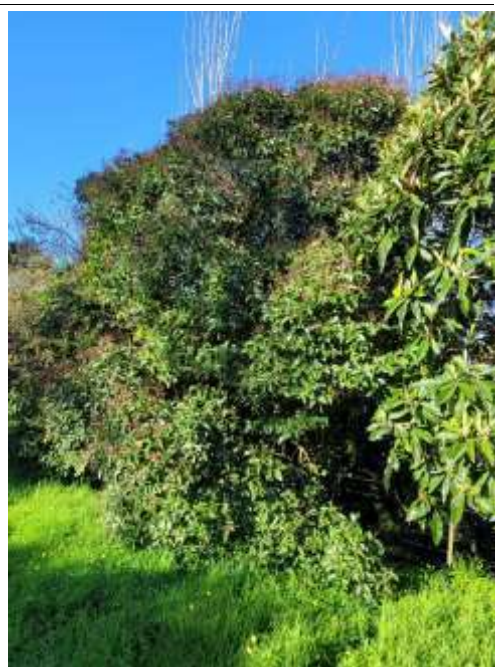
**Tree ID: 558****Genus / species:** *Euonymus japonica*

Evergreen Japanese Spindle Tree

**Height (m):** 7      **Structure:** Good  
**Width (m):** 8      **Health:** Good  
**DBH (cm):** 30      Estimated **Maturity:** Mature  
**Origin:** Exotic      **ULE (years):** 15 - 30  
**Retained?:** Retained      **Form:** Good  
**Retention Value:** Low  
**Removal / retention reason:** N/A.  
**Amenity value:** Low  
**Works Required:** N/A.

**SRZ (m):** 2.1      **Works priority:** N/A  
**TPZ (m):** 3.6      **Construction Proximity:** 0.1  
**mTPZ (m):**

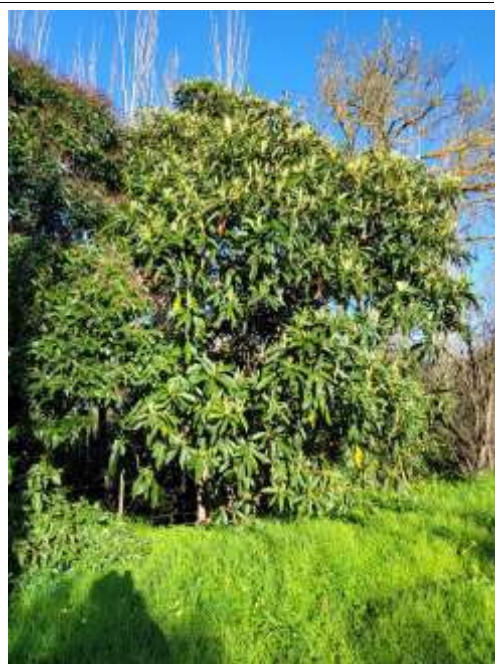
**Tree ID: 559****Genus / species:** *Fraxinus angustifolia*

Deciduous      Narrow Leaf Ash

<b>Height (m):</b>	14	<b>Structure:</b>	Good
<b>Width (m):</b>	12	<b>Health:</b>	Good
<b>DBH (cm):</b>	40      Estimated	<b>Maturity:</b>	Over mature
<b>Origin:</b>	Exotic	<b>ULE (years):</b>	15 - 30
<b>Retained?:</b>	Retained	<b>Form:</b>	Good
<b>Retention Value:</b>	Moderate		
<b>Removal / retention reason:</b>	N/A.		
<b>Amenity value:</b>	Moderate		
<b>Works Required:</b>	N/A.

<b>SRZ (m):</b>	2.4	<b>Works priority:</b>	N/A
<b>TPZ (m):</b>	4.8	<b>Construction Proximity:</b>	0.1
<b>mTPZ (m):</b>

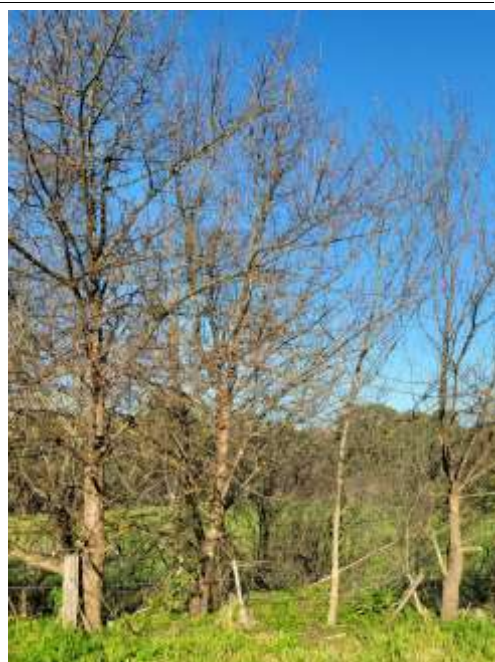
**Tree ID: 565****Genus / species:** *Fraxinus angustifolia*

Deciduous Narrow Leaf Ash

**Height (m):** 8                      **Structure:** Good  
**Width (m):** 2                      **Health:** Good  
**DBH (cm):** 8      Estimated **Maturity:** Immature  
**Origin:** Exotic                      **ULE (years):** > 60  
**Retained?:** Retained                      **Form:** Good

**Retention Value:** Moderate**Removal / retention reason:** N/A.**Amenity value:** Low**Works Required:** Canopy lift.**SRZ (m):** 1.6                      **Works priority:** Very low**TPZ (m):** 2.0                      **Construction Proximity:** 0.1**mTPZ (m):**

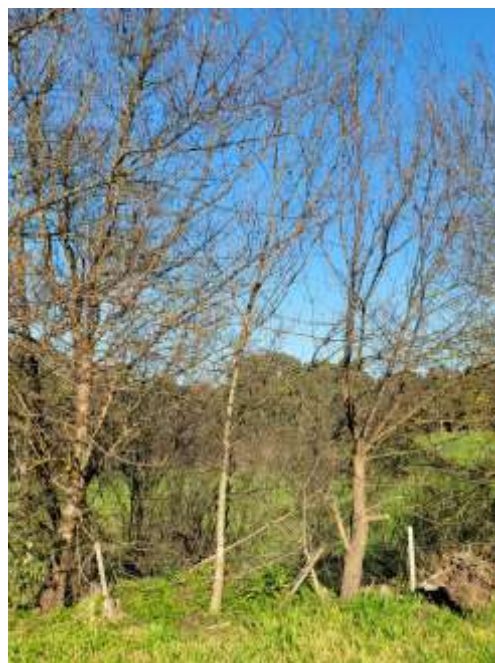
**Tree ID: 566****Genus / species:** *Fraxinus angustifolia*

Deciduous Narrow Leaf Ash

**Height (m):** 8                      **Structure:** Good  
**Width (m):** 4                      **Health:** Good  
**DBH (cm):** 20      Estimated **Maturity:** Immature  
**Origin:** Exotic                      **ULE (years):** > 60  
**Retained?:** Retained                      **Form:** Good

**Retention Value:** Moderate**Removal / retention reason:** N/A.**Amenity value:** Low**Works Required:** Canopy lift.**SRZ (m):** 1.8                      **Works priority:** Very low**TPZ (m):** 2.4                      **Construction Proximity:** 0.1**mTPZ (m):**

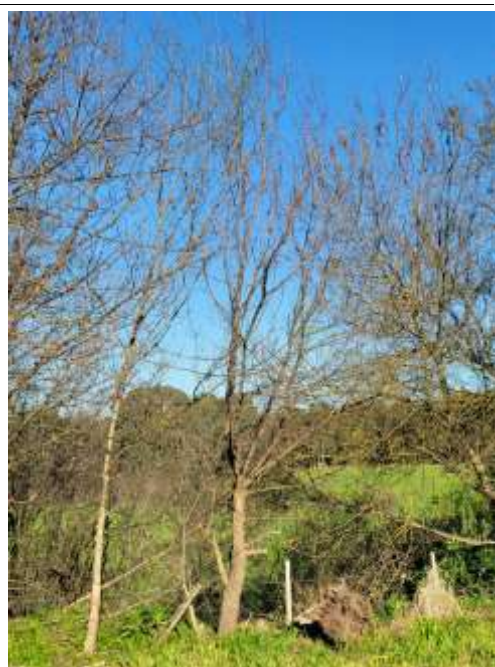
**Tree ID: 567****Genus / species:** *Fraxinus angustifolia*

Deciduous Narrow Leaf Ash

**Height (m):** 13                      **Structure:** Good  
**Width (m):** 12                      **Health:** Good  
**DBH (cm):** 45      Estimated **Maturity:** Mature  
**Origin:** Exotic                      **ULE (years):** > 60  
**Retained?:** Retained                      **Form:** Good

**Retention Value:** High**Removal / retention reason:** N/A.**Amenity value:** Moderate**Works Required:** N/A.**SRZ (m):** 2.5                      **Works priority:** N/A**TPZ (m):** 5.4                      **Construction Proximity:** 0.1**mTPZ (m):**

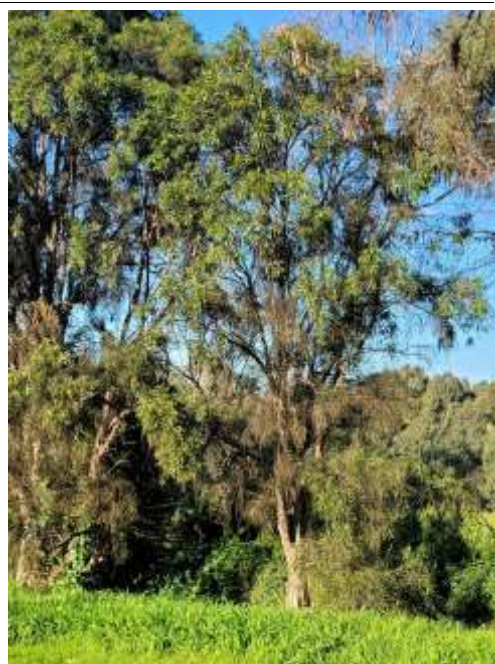
**Tree ID: 571****Genus / species:** *Eucalyptus viminalis*

Evergreen Manna Gum

**Height (m):** 21      **Structure:** Fair  
**Width (m):** 20      **Health:** Good  
**DBH (cm):** 105      **Maturity:** Over mature  
**Origin:** Melbourne      **ULE (years):** 30 - 60  
**Retained?:** Retained      **Form:** Good  
**Retention Value:** High  
**Removal / retention reason:** N/A.  
**Amenity value:** High  
**Works Required:** N/A.

**SRZ (m):** 3.6      **Works priority:** N/A  
**TPZ (m):** 12.6      **Construction Proximity:** 0.1  
**mTPZ (m):**

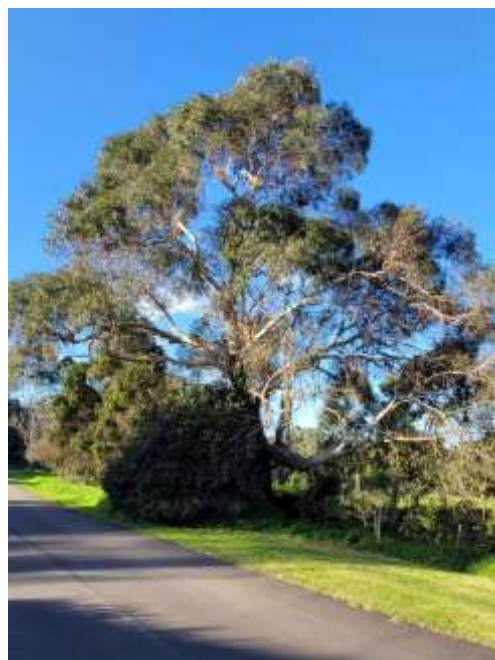
**Tree ID: 572****Genus / species:** *Eucalyptus camaldulensis*

Evergreen River Red Gum

**Height (m):** 15      **Structure:** Good  
**Width (m):** 14      **Health:** Good  
**DBH (cm):** 51      **Maturity:** Mature  
**Origin:** Melbourne      **ULE (years):** > 60  
**Retained?:** Retained      **Form:** Good  
**Retention Value:** High  
**Removal / retention reason:** N/A.  
**Amenity value:** Moderate  
**Works Required:** N/A.

**SRZ (m):** 2.6      **Works priority:** N/A  
**TPZ (m):** 6.1      **Construction Proximity:** 0.1  
**mTPZ (m):**

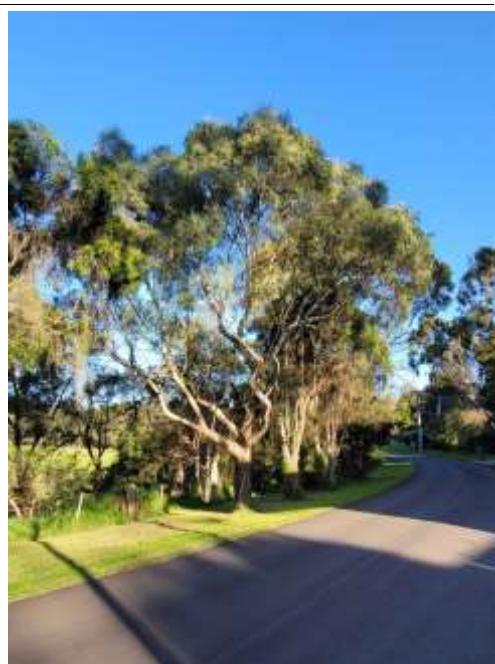
**Tree ID: 573****Genus / species:** *Callistemon salignus*

Evergreen Willow Bottle Brush

**Height (m):** 6      **Structure:** Fair  
**Width (m):** 4      **Health:** Poor  
**DBH (cm):** 25      **Maturity:** Mature  
**Origin:** Australian      **ULE (years):** 5 - 15  
**Retained?:** Retained      **Form:** Poor  
**Retention Value:** Low  
**Removal / retention reason:** N/A.  
**Amenity value:** Low  
**Works Required:** N/A.

**SRZ (m):** 1.9      **Works priority:** N/A  
**TPZ (m):** 3.0      **Construction Proximity:** 0.1  
**mTPZ (m):**

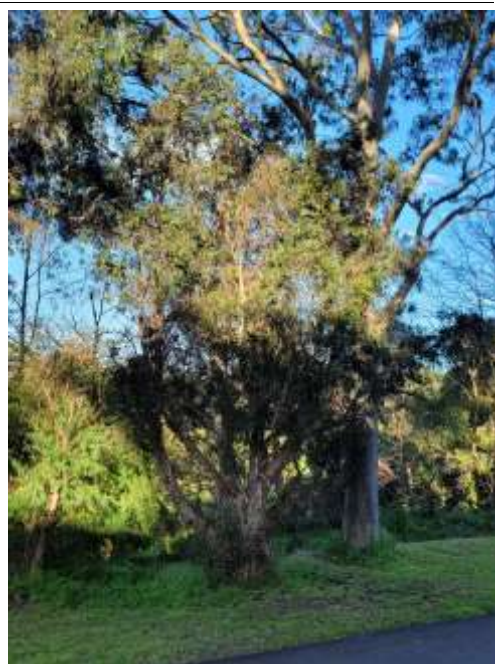
**Tree ID: 577****Genus / species:** *Corymbia maculata*

Evergreen Spotted Gum

**Height (m):** 14      **Structure:** Poor  
**Width (m):** 2      **Health:** Dead  
**DBH (cm):** 15      **Maturity:** Immature  
**Origin:** Victorian      **ULE (years):** 0  
**Retained?:** Removed      **Form:** Very poor  
**Retention Value:** Remove.  
**Removal / retention reason:** N/A.  
**Amenity value:** Very low  
**Works Required:** N/A.

**SRZ (m):** 1.6      **Works priority:** N/A  
**TPZ (m):** 2.0      **Construction Proximity:** 0.1  
**mTPZ (m):**

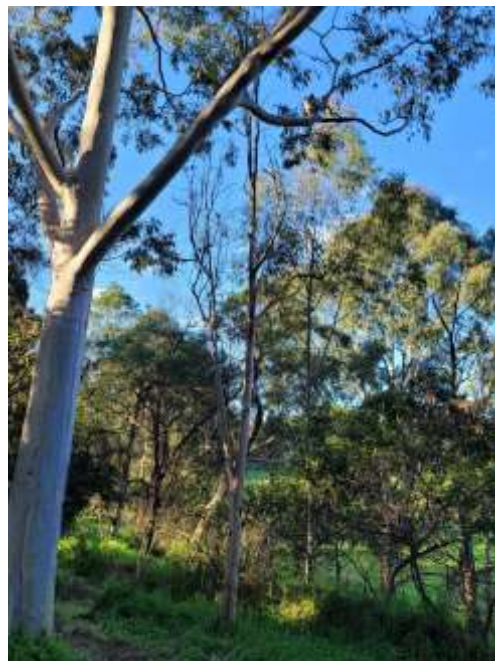
**Tree ID: 578****Genus / species:** *Corymbia maculata*

Evergreen Spotted Gum

**Height (m):** 21      **Structure:** Good  
**Width (m):** 18      **Health:** Good  
**DBH (cm):** 48      **Maturity:** Mature  
**Origin:** Victorian      **ULE (years):** > 60  
**Retained?:** Retained      **Form:** Good  
**Retention Value:** Very high  
**Removal / retention reason:** N/A.  
**Amenity value:** High  
**Works Required:** N/A.

**SRZ (m):** 2.5      **Works priority:** N/A  
**TPZ (m):** 5.8      **Construction Proximity:** 0.1  
**mTPZ (m):**

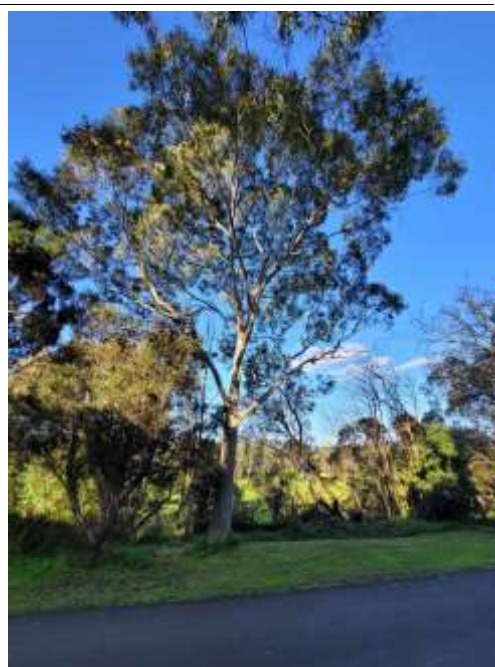
**Tree ID: 579****Genus / species:** *Laurus nobilis*

Evergreen Bay Tree

**Height (m):** 5      **Structure:** Good  
**Width (m):** 6      **Health:** Good  
**DBH (cm):** 15      **Maturity:** Mature  
**Origin:** Exotic      **ULE (years):** > 60  
**Retained?:** Retained      **Form:** Fair  
**Retention Value:** Moderate  
**Removal / retention reason:** N/A.  
**Amenity value:** Low  
**Works Required:** N/A.

**SRZ (m):** 1.6      **Works priority:** N/A  
**TPZ (m):** 2.0      **Construction Proximity:** 0.1  
**mTPZ (m):**

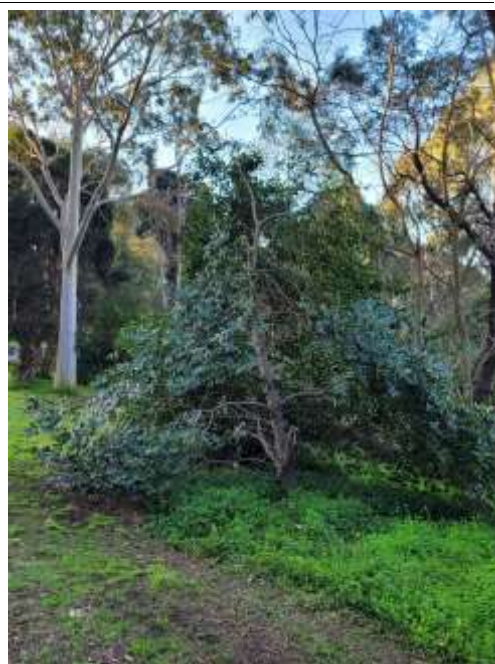
**Tree ID: 580****Genus / species:** *Robinia pseudoacacia*

Deciduous Black Locust

**Height (m):** 19      **Structure:** Very poor  
**Width (m):** 13      **Health:** Good  
**DBH (cm):** 63 Measured **Maturity:** Over mature  
**Origin:** Exotic      **ULE (years):** 1 - 5  
**Retained?:** Retained      **Form:** Fair  
**Retention Value:** Low  
**Removal / retention reason:** N/A.  
**Amenity value:** High  
**Works Required:** N/A.

**SRZ (m):** 2.8      **Works priority:** N/A  
**TPZ (m):** 7.6      **Construction Proximity:** 0.1  
**mTPZ (m):**

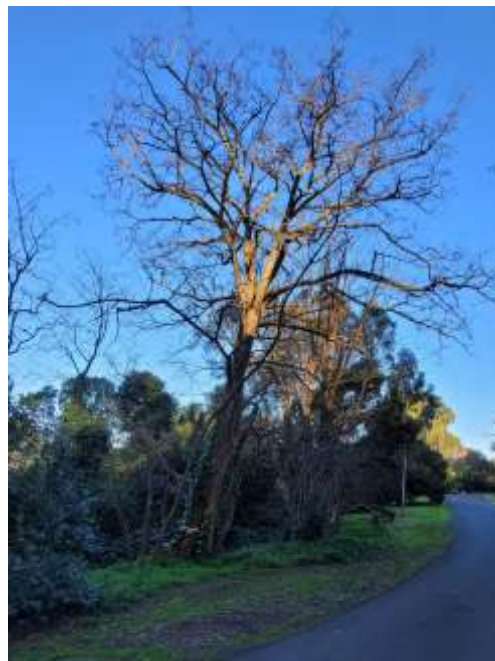
**Tree ID: 601****Genus / species:** *Eucalyptus botryoides*

Evergreen Southern Mahogany

**Height (m):** 7      **Structure:** Good  
**Width (m):** 4      **Health:** Good  
**DBH (cm):** 15 Estimated **Maturity:** Immature  
**Origin:** Victorian      **ULE (years):** 30 - 60  
**Retained?:** Removed      **Form:** Good  
**Retention Value:** Low  
**Removal / retention reason:** N/A.  
**Amenity value:** Low  
**Works Required:** N/A.

**SRZ (m):** 1.6      **Works priority:** N/A  
**TPZ (m):** 2.0      **Construction Proximity:** 0.1  
**mTPZ (m):**

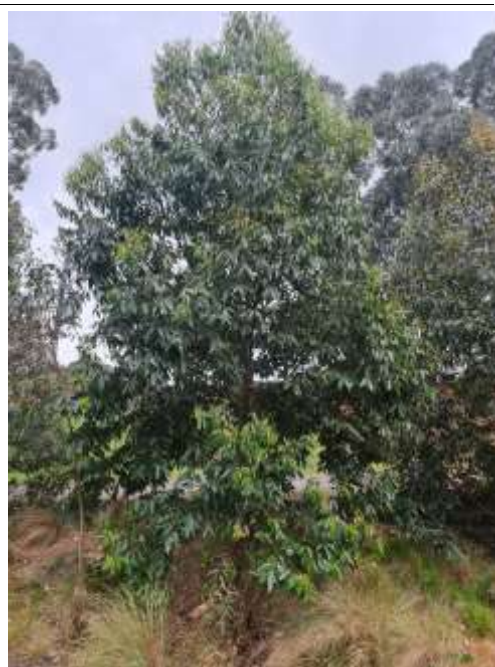
**Tree ID: 602****Genus / species:** *Eucalyptus botryoides*

Evergreen Southern Mahogany

**Height (m):** 5      **Structure:** Good  
**Width (m):** 3      **Health:** Good  
**DBH (cm):** 12 Estimated **Maturity:** Immature  
**Origin:** Victorian      **ULE (years):** 30 - 60  
**Retained?:** Removed      **Form:** Good  
**Retention Value:** Low  
**Removal / retention reason:** N/A.  
**Amenity value:** Low  
**Works Required:** N/A.

**SRZ (m):** 1.6      **Works priority:** N/A  
**TPZ (m):** 2.0      **Construction Proximity:** 0.1  
**mTPZ (m):**

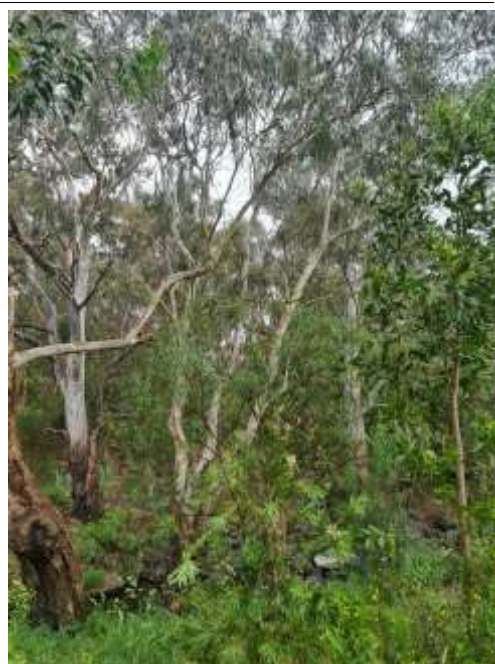
**Tree ID: 606****Genus / species:** *Quercus robur*

Deciduous English Oak

**Height (m):** 12      **Structure:** Fair  
**Width (m):** 6      **Health:** Poor  
**DBH (cm):** 40 Measured **Maturity:** Over mature  
**Origin:** Exotic      **ULE (years):** 5 - 15  
**Retained?:** Retained      **Form:** Fair  
**Retention Value:** Low  
**Removal / retention reason:** N/A.  
**Amenity value:** Low  
**Works Required:** Canopy lift.

**SRZ (m):** 2.4      **Works priority:** Very low  
**TPZ (m):** 4.8      **Construction Proximity:** 0.1  
**mTPZ (m):**

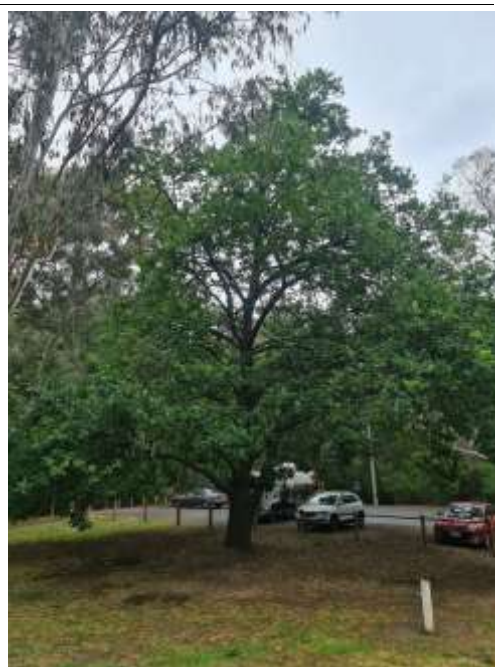
**Tree ID: 608****Genus / species:** *Ligustrum lucidum*

**Height (m):** 7      **Structure:** Fair  
**Width (m):** 3      **Health:** Fair  
**DBH (cm):** 15 Estimated **Maturity:** Mature  
**Origin:** Exotic      **ULE (years):** 15 - 30  
**Retained?:** Removed      **Form:** Fair  
**Retention Value:** Low  
**Removal / retention reason:** N/A.  
**Amenity value:** Low  
**Works Required:** N/A.

**SRZ (m):** 1.6      **Works priority:** N/A  
**TPZ (m):** 2.0      **Construction Proximity:** 0.1  
**mTPZ (m):**

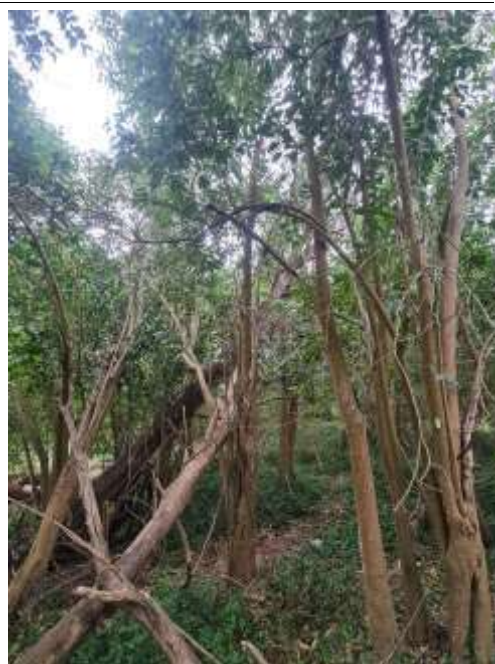
**Tree ID: 609****Genus / species:** *Unknown sp.*

**Height (m):** 12      **Structure:** Very poor  
**Width (m):** 3      **Health:** Dead  
**DBH (cm):** 20      Estimated **Maturity:** Over mature  
**Origin:** Unknown      **ULE (years):** 0  
**Retained?:** Removed      **Form:** Poor  
**Retention Value:** Remove.  
**Removal / retention reason:** N/A.  
**Amenity value:** Very low  
**Works Required:** N/A.

**SRZ (m):** 1.8      **Works priority:** N/A  
**TPZ (m):** 2.4      **Construction Proximity:** 0.1  
**mTPZ (m):**

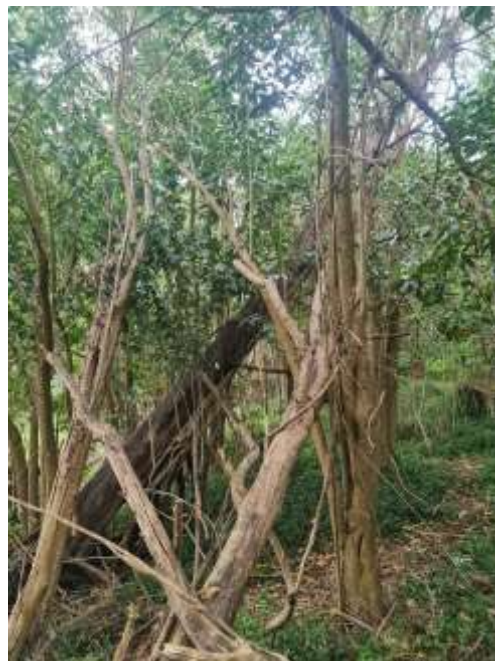
**Tree ID: 610****Genus / species:** *Unknown sp.*

**Height (m):** 12      **Structure:** Very poor  
**Width (m):** 3      **Health:** Dead  
**DBH (cm):** 22      Estimated **Maturity:** Over mature  
**Origin:** Unknown      **ULE (years):** 0  
**Retained?:** Removed      **Form:** Poor  
**Retention Value:** Remove.  
**Removal / retention reason:** N/A.  
**Amenity value:** Very low  
**Works Required:** N/A.

**SRZ (m):** 1.9      **Works priority:** N/A  
**TPZ (m):** 2.6      **Construction Proximity:** 0.1  
**mTPZ (m):**

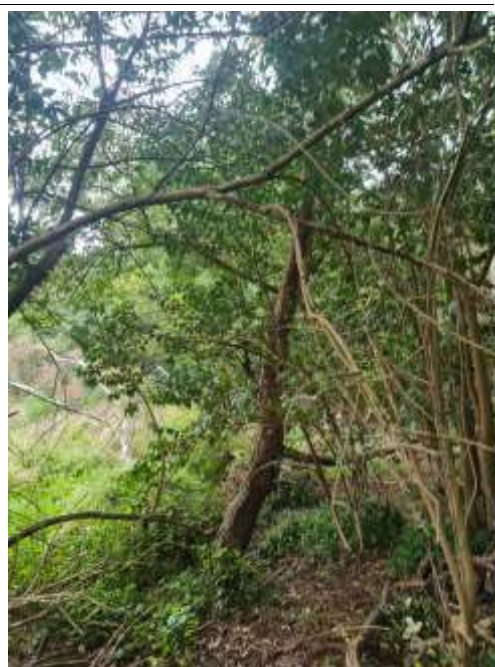
**Tree ID: 611****Genus / species:** *Unknown sp.*

**Height (m):** 5      **Structure:** Very poor  
**Width (m):** 4      **Health:** Dead  
**DBH (cm):** 18      Estimated **Maturity:** Over mature  
**Origin:** Unknown      **ULE (years):** 0  
**Retained?:** Removed      **Form:** Poor  
**Retention Value:** Remove.  
**Removal / retention reason:** N/A.  
**Amenity value:** Very low  
**Works Required:** N/A.

**SRZ (m):** 1.7      **Works priority:** N/A  
**TPZ (m):** 2.2      **Construction Proximity:** 0.1  
**mTPZ (m):**

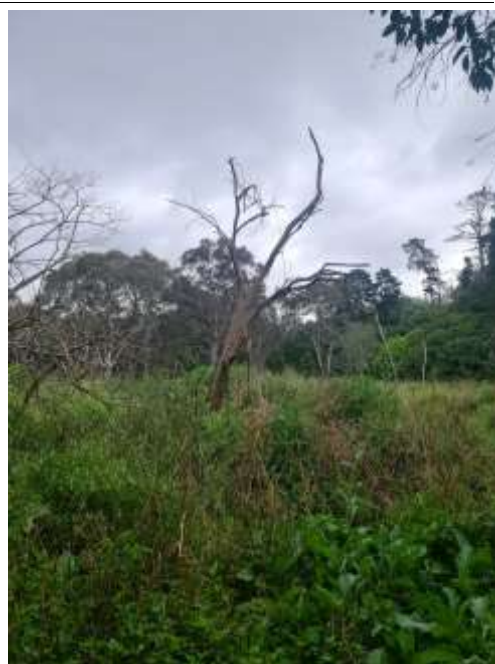
**Tree ID: 612****Genus / species:** *Unknown sp.*

**Height (m):** 5      **Structure:** Very poor  
**Width (m):** 5      **Health:** Dead  
**DBH (cm):** 18      **Estimated Maturity:** Over mature  
**Origin:** Unknown      **ULE (years):** 0  
**Retained?:** Removed      **Form:** Poor  
**Retention Value:** Remove.  
**Removal / retention reason:** N/A.  
**Amenity value:** Very low  
**Works Required:** N/A.

**SRZ (m):** 1.7      **Works priority:** N/A  
**TPZ (m):** 2.2      **Construction Proximity:** 0.1  
**mTPZ (m):**

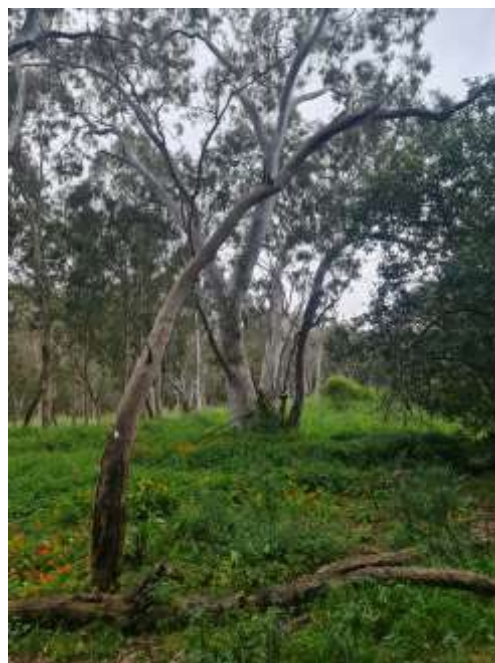
**Tree ID: 613****Genus / species:** *Eucalyptus sp.*

**Height (m):** 14      **Structure:** Good  
**Width (m):** 8      **Health:** Poor  
**DBH (cm):** 47      **Measured Maturity:** Mature  
**Origin:** Australian      **ULE (years):** 5 - 15  
**Retained?:** Removed      **Form:** Good  
**Retention Value:** Low  
**Removal / retention reason:** N/A.  
**Amenity value:** Moderate  
**Works Required:** N/A.

**SRZ (m):** 2.5      **Works priority:** N/A  
**TPZ (m):** 5.6      **Construction Proximity:** 0.1  
**mTPZ (m):**

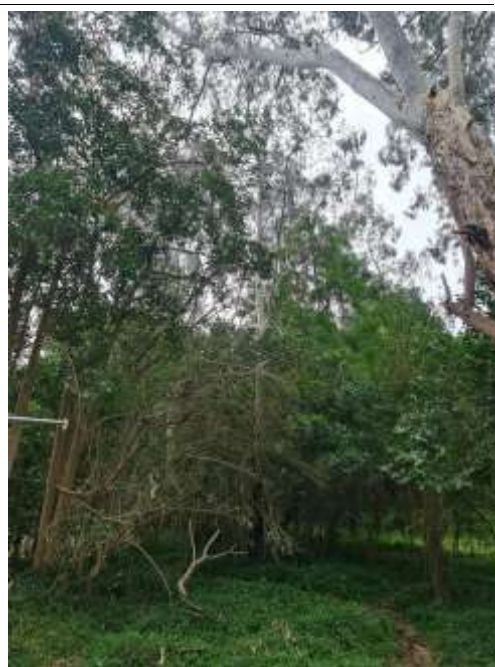
**Tree ID: 614****Genus / species:** *Eucalyptus sp.*

**Height (m):** 10      **Structure:** Fair  
**Width (m):** 6      **Health:** Poor  
**DBH (cm):** 12      **Estimated Maturity:** Mature  
**Origin:** Australian      **ULE (years):** 5 - 15  
**Retained?:** Removed      **Form:** Good  
**Retention Value:** Low  
**Removal / retention reason:** N/A.  
**Amenity value:** Low  
**Works Required:** N/A.

**SRZ (m):** 1.6      **Works priority:** N/A  
**TPZ (m):** 2.0      **Construction Proximity:** 0.1  
**mTPZ (m):**

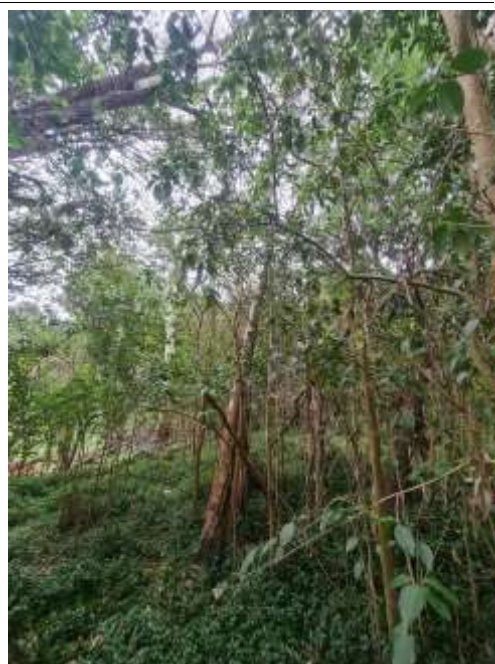
**Tree ID: 615****Genus / species:** *Ligustrum lucidum*

**Retention Value:** Low**Removal / retention reason:** N/A.**Amenity value:** Low**Works Required:** N/A.

**SRZ (m):** 1.9      **Works priority:** N/A  
**TPZ (m):** 3.0      **Construction Proximity:** 0.1  
**mTPZ (m):**
