## **Nation Partners**

# **Northern Sewers Relining Project Southern Section**

## **Construction Impact Report**

**Wednesday 4<sup>th</sup> December 2024**

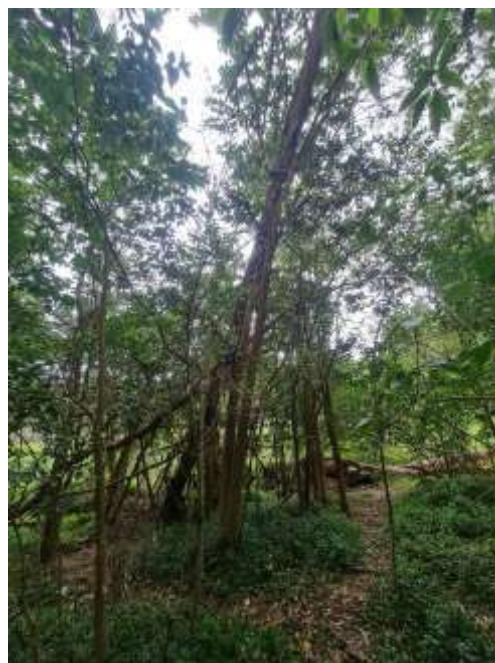
**Tree ID: 616****Genus / species:** *Quercus robur*

**Retention Value:** Moderate**Removal / retention reason:** N/A.**Amenity value:** Moderate**Works Required:** Canopy lift.

**SRZ (m):** 2.6      **Works priority:** Very low  
**TPZ (m):** 6.2      **Construction Proximity:** 0.1  
**mTPZ (m):**

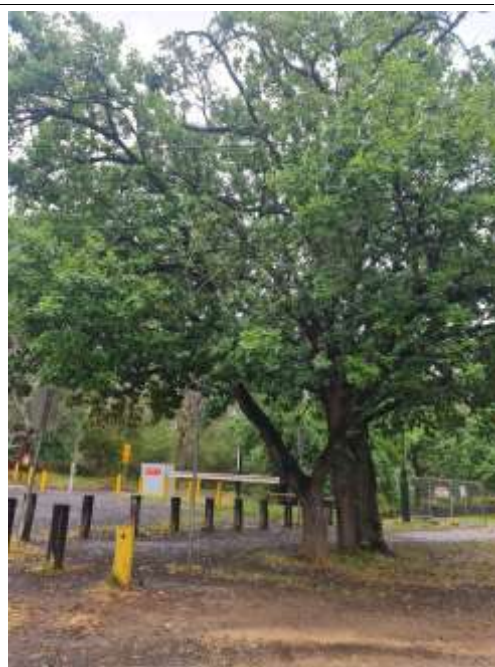
**Tree ID: 617****Genus / species:** *Eucalyptus sp.*

**Retention Value:** High**Removal / retention reason:** N/A.**Amenity value:** High**Works Required:** Canopy lift.

**SRZ (m):** 2.9      **Works priority:** Very low  
**TPZ (m):** 8.4      **Construction Proximity:** 0.1  
**mTPZ (m):**

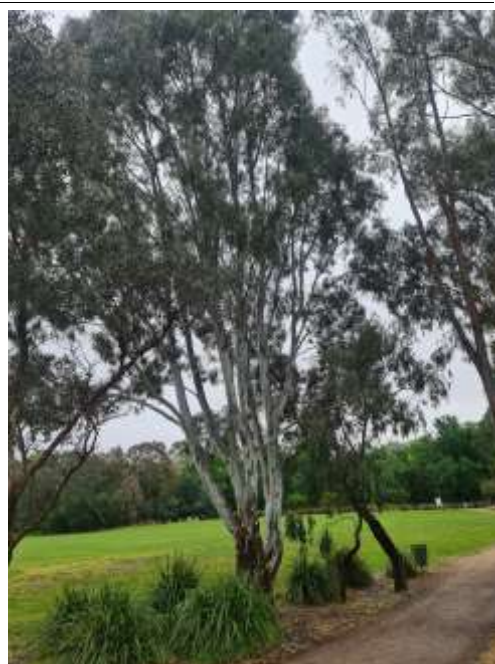
**Tree ID: 618****Genus / species:** *Eucalyptus camaldulensis*

**Height (m):** 25      **Structure:** Good  
**Width (m):** 12      **Health:** Good  
**DBH (cm):** 54 Measured **Maturity:** Mature  
**Origin:** Melbourne      **ULE (years):** > 60  
**Retained?:** Retained      **Form:** Good

**Retention Value:** Very high**Removal / retention reason:** N/A.**Amenity value:** High**Works Required:** Canopy lift.**SRZ (m):** 2.7      **Works priority:** Very low**TPZ (m):** 6.5      **Construction Proximity:** 0.1**mTPZ (m):**

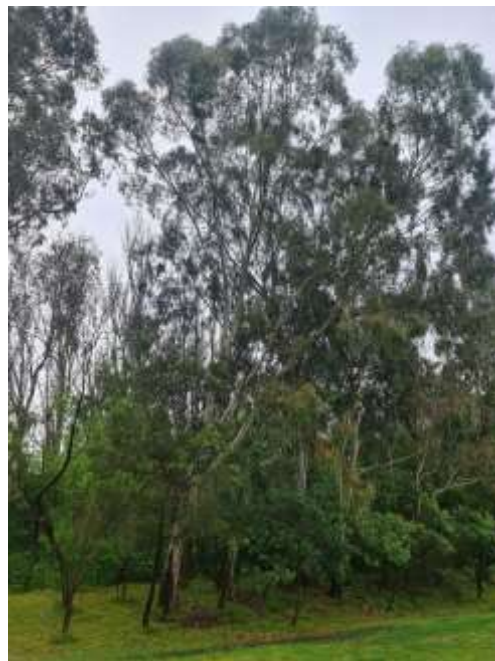
**Tree ID: 619****Genus / species:** *Acacia dealbata*

**Height (m):** 5      **Structure:** Fair  
**Width (m):** 4      **Health:** Good  
**DBH (cm):** 12 Estimated **Maturity:** Immature  
**Origin:** Melbourne      **ULE (years):** 15 - 30  
**Retained?:** Retained      **Form:** Fair

**Retention Value:** Low**Removal / retention reason:** N/A.**Amenity value:** Low**Works Required:** N/A.**SRZ (m):** 1.6      **Works priority:** N/A.**TPZ (m):** 2.0      **Construction Proximity:** 0.1**mTPZ (m):**

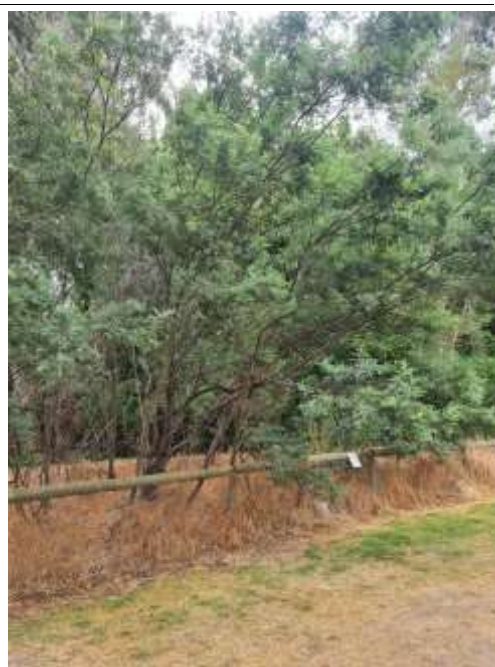
**Tree ID: 620****Genus / species:** *Acacia dealbata*

**Height (m):** 5      **Structure:** Fair  
**Width (m):** 4      **Health:** Good  
**DBH (cm):** 12 Measured **Maturity:** Immature  
**Origin:** Melbourne      **ULE (years):** 15 - 30  
**Retained?:** Retained      **Form:** Fair

**Retention Value:** Low**Removal / retention reason:** N/A.**Amenity value:** Low**Works Required:** N/A.**SRZ (m):** 1.6      **Works priority:** N/A.**TPZ (m):** 2.0      **Construction Proximity:** 0.1**mTPZ (m):**

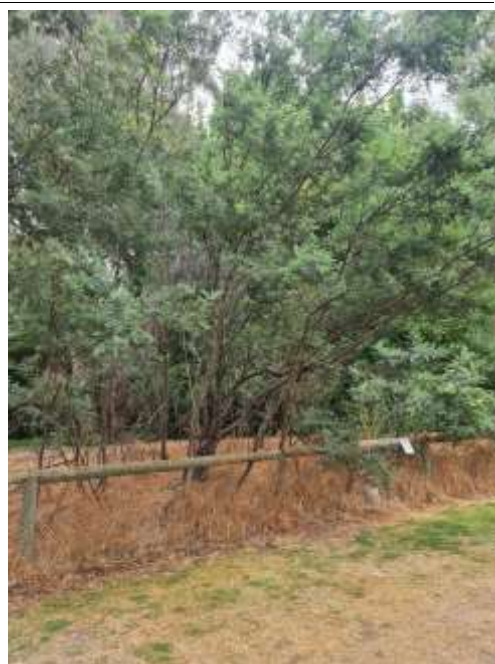
**Tree ID: 621****Genus / species:** *Acacia dealbata*

**Height (m):** 5      **Structure:** Fair  
**Width (m):** 4      **Health:** Good  
**DBH (cm):** 12 Measured **Maturity:** Immature  
**Origin:** Melbourne **ULE (years):** 15 - 30  
**Retained?:** Retained **Form:** Fair  
**Retention Value:** Low  
**Removal / retention reason:** N/A.  
**Amenity value:** Low  
**Works Required:** N/A.

**SRZ (m):** 1.6      **Works priority:** N/A.  
**TPZ (m):** 2.0      **Construction Proximity:** 0.1  
**mTPZ (m):**

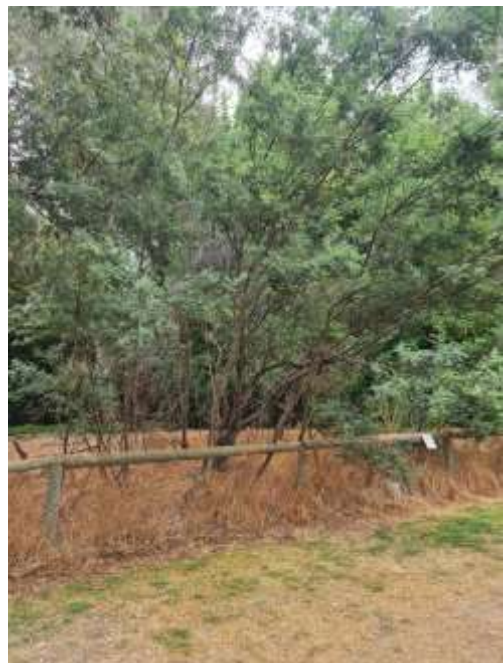
**Tree ID: 622****Genus / species:** *Acacia dealbata*

**Height (m):** 7      **Structure:** Fair  
**Width (m):** 5      **Health:** Fair  
**DBH (cm):** 26 Measured **Maturity:** Mature  
**Origin:** Melbourne **ULE (years):** 5 - 15  
**Retained?:** Retained **Form:** Fair  
**Retention Value:** Low  
**Removal / retention reason:** N/A.  
**Amenity value:** Low  
**Works Required:** Canopy lift.

**SRZ (m):** 2      **Works priority:** Very low  
**TPZ (m):** 3.1      **Construction Proximity:** 0.1  
**mTPZ (m):**

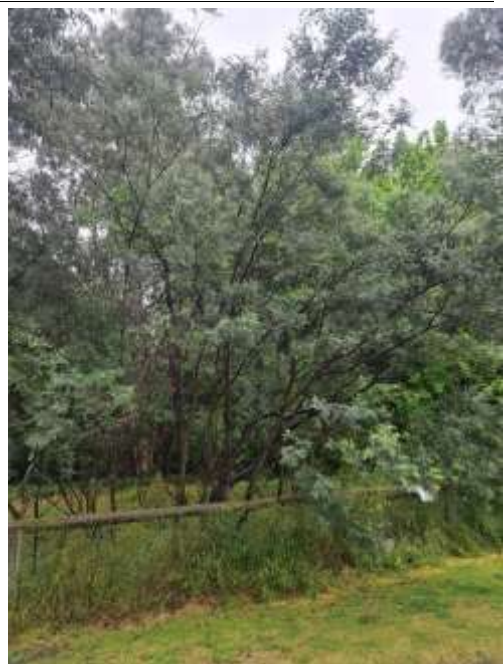
**Tree ID: 623****Genus / species:** *Acacia dealbata*

**Height (m):** 9      **Structure:** Good  
**Width (m):** 6      **Health:** Good  
**DBH (cm):** 30 Measured **Maturity:** Mature  
**Origin:** Melbourne **ULE (years):** 15 - 30  
**Retained?:** Retained **Form:** Good  
**Retention Value:** Low  
**Removal / retention reason:** N/A.  
**Amenity value:** Low  
**Works Required:** Canopy lift.

**SRZ (m):** 2.1      **Works priority:** Very low  
**TPZ (m):** 3.6      **Construction Proximity:** 0.1  
**mTPZ (m):**

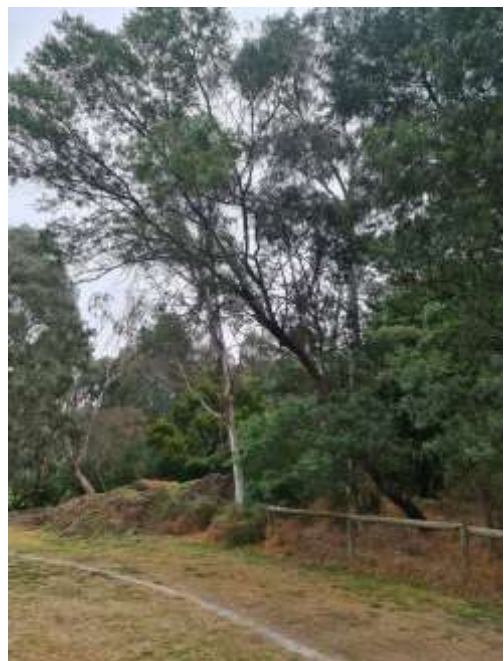
**Tree ID: 624****Genus / species:** *Eucalyptus sp.*

**Height (m):** 12      **Structure:** Good  
**Width (m):** 7      **Health:** Fair  
**DBH (cm):** 30 Measured **Maturity:** Mature  
**Origin:** Australian **ULE (years):** 30 - 60  
**Retained?:** Retained **Form:** Good

**Retention Value:** Moderate**Removal / retention reason:** N/A.**Amenity value:** Moderate**Works Required:** Canopy lift.**SRZ (m):** 2.1      **Works priority:** Very low**TPZ (m):** 3.6      **Construction Proximity:** 0.1**mTPZ (m):**

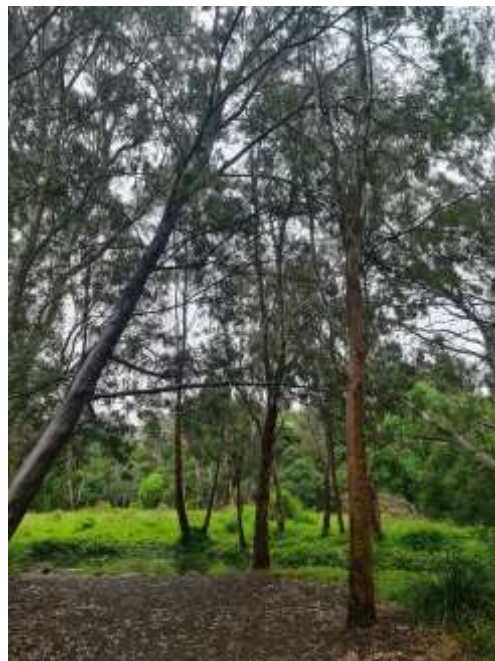
**Tree ID: 625****Genus / species:** *Eucalyptus sp.*

**Height (m):** 13      **Structure:** Good  
**Width (m):** 12      **Health:** Fair  
**DBH (cm):** 49 Measured **Maturity:** Mature  
**Origin:** Australian **ULE (years):** 30 - 60  
**Retained?:** Retained **Form:** Good

**Retention Value:** Moderate**Removal / retention reason:** N/A.**Amenity value:** Moderate**Works Required:** Canopy lift.**SRZ (m):** 2.6      **Works priority:** Very low**TPZ (m):** 5.9      **Construction Proximity:** 0.1**mTPZ (m):**

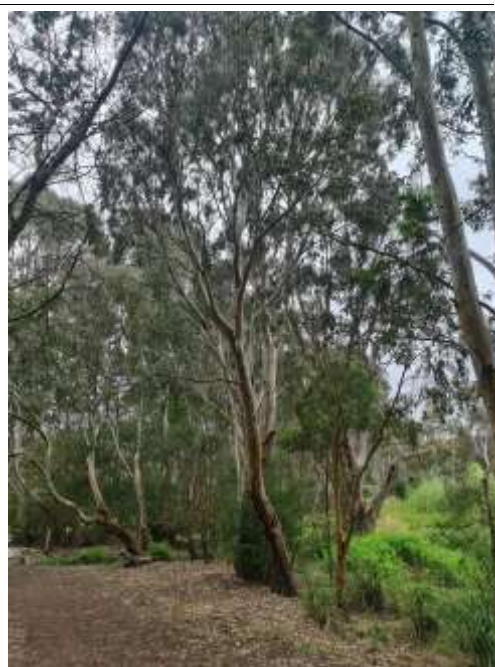
**Tree ID: 626****Genus / species:** *Eucalyptus sp.*

**Height (m):** 9      **Structure:** Fair  
**Width (m):** 12      **Health:** Good  
**DBH (cm):** 38 Measured **Maturity:** Mature  
**Origin:** Australian **ULE (years):** 15 - 30  
**Retained?:** Retained **Form:** Fair

**Retention Value:** Low**Removal / retention reason:** N/A.**Amenity value:** Low**Works Required:** Canopy lift.**SRZ (m):** 2.3      **Works priority:** Very low**TPZ (m):** 4.6      **Construction Proximity:** 0.1**mTPZ (m):**

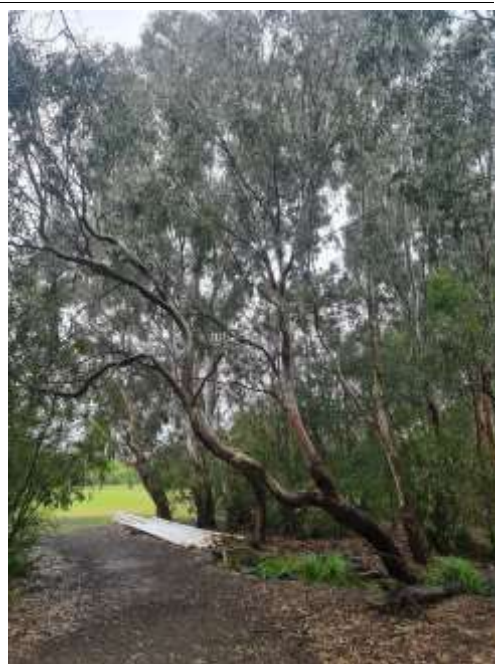
**Tree ID: 627****Genus / species:** *Eucalyptus sp.*

**Height (m):** 9      **Structure:** Fair  
**Width (m):** 7      **Health:** Fair  
**DBH (cm):** 30 Measured **Maturity:** Mature  
**Origin:** Australian **ULE (years):** 15 - 30  
**Retained?:** Retained **Form:** Fair

**Retention Value:** Low**Removal / retention reason:** N/A.**Amenity value:** Low**Works Required:** Canopy lift.**SRZ (m):** 2.1      **Works priority:** Very low**TPZ (m):** 3.6      **Construction Proximity:** 0.1**mTPZ (m):**

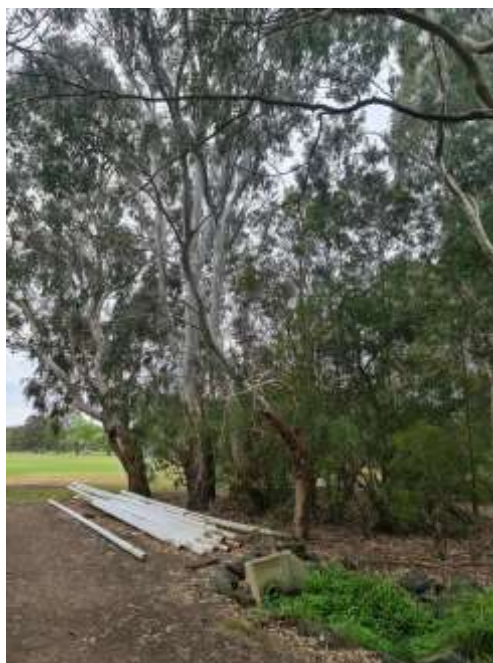
**Tree ID: 628****Genus / species:** *Eucalyptus sp.*

**Height (m):** 18      **Structure:** Good  
**Width (m):** 11      **Health:** Good  
**DBH (cm):** 59 Measured **Maturity:** Mature  
**Origin:** Australian **ULE (years):** 30 - 60  
**Retained?:** Retained **Form:** Good

**Retention Value:** High**Removal / retention reason:** N/A.**Amenity value:** High**Works Required:** Canopy lift.**SRZ (m):** 2.8      **Works priority:** Very low**TPZ (m):** 7.1      **Construction Proximity:** 0.1**mTPZ (m):**

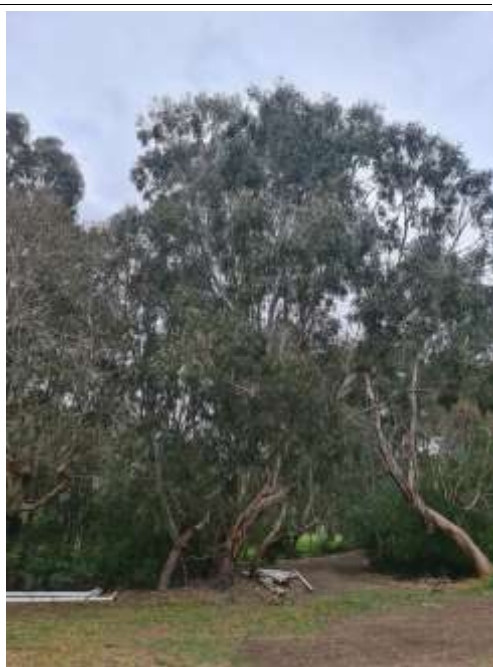
**Tree ID: 629****Genus / species:** *Acacia dealbata*

**Height (m):** 18      **Structure:** Fair  
**Width (m):** 9      **Health:** Good  
**DBH (cm):** 36 Measured **Maturity:** Mature  
**Origin:** Melbourne **ULE (years):** 15 - 30  
**Retained?:** Retained **Form:** Fair

**Retention Value:** High**Removal / retention reason:** N/A.**Amenity value:** High**Works Required:** Canopy lift.**SRZ (m):** 2.3      **Works priority:** Very low**TPZ (m):** 4.3      **Construction Proximity:** 0.1**mTPZ (m):**

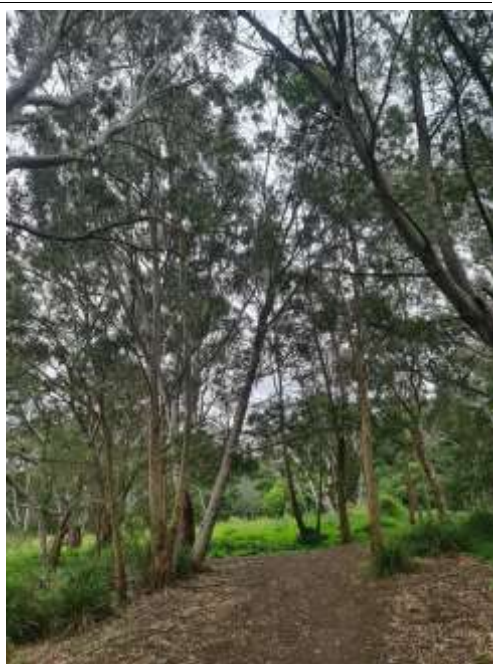
**Tree ID: 630****Genus / species:** *Pinus radiata*

**Height (m):** 18      **Structure:** Fair  
**Width (m):** 12      **Health:** Fair  
**DBH (cm):** 100 Measured **Maturity:** Mature  
**Origin:** Exotic      **ULE (years):** 15 - 30  
**Retained?:** Retained      **Form:** Fair

**Retention Value:** High**Removal / retention reason:** N/A.**Amenity value:** High**Works Required:** Canopy lift.**SRZ (m):** 3.5      **Works priority:** Very low**TPZ (m):** 12.0      **Construction Proximity:** 0.1**mTPZ (m):**

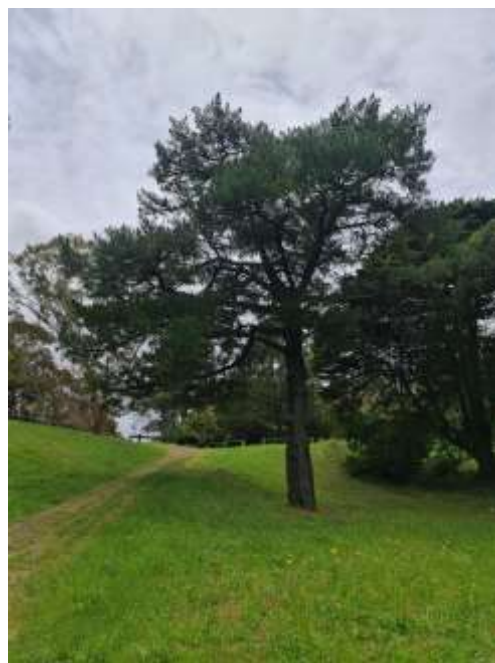
**Tree ID: 631****Genus / species:** *Eucalyptus sp.*

**Height (m):** 4      **Structure:** Fair  
**Width (m):** 8      **Health:** Fair  
**DBH (cm):** 23 Measured **Maturity:** Mature  
**Origin:** Australian      **ULE (years):** 15 - 30  
**Retained?:** Retained      **Form:** Fair

**Retention Value:** Very low**Removal / retention reason:** N/A.**Amenity value:** Very low**Works Required:** Canopy lift.**SRZ (m):** 1.9      **Works priority:** Very low**TPZ (m):** 2.8      **Construction Proximity:** 0.1**mTPZ (m):**

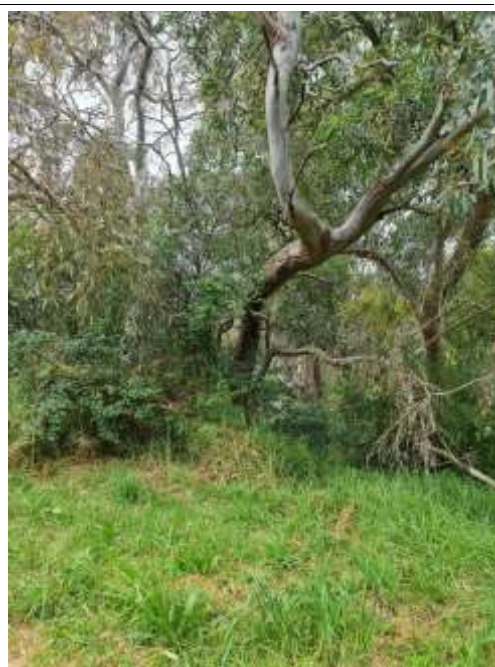
**Tree ID: 632****Genus / species:** *Eucalyptus sp.*

**Height (m):** 8      **Structure:** Fair  
**Width (m):** 8      **Health:** Fair  
**DBH (cm):** 30 Estimated **Maturity:** Mature  
**Origin:** Australian      **ULE (years):** 15 - 30  
**Retained?:** Retained      **Form:** Fair

**Retention Value:** Low**Removal / retention reason:** N/A.**Amenity value:** Low**Works Required:** Canopy lift.**SRZ (m):** 2.1      **Works priority:** Very low**TPZ (m):** 3.6      **Construction Proximity:** 0.1**mTPZ (m):**

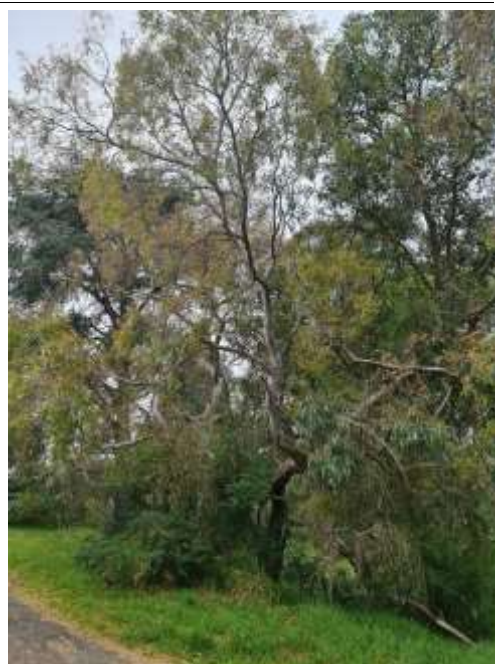
**Tree ID: 633****Genus / species:** *Prunus cerasifera*

**Height (m):** 4      **Structure:** Fair  
**Width (m):** 3      **Health:** Good  
**DBH (cm):** 25      **Estimated Maturity:** Mature  
**Origin:** Exotic      **ULE (years):** 15 - 30  
**Retained?:** Retained      **Form:** Fair  
**Retention Value:** Very low  
**Removal / retention reason:** N/A.  
**Amenity value:** Very low  
**Works Required:** Canopy lift.

**SRZ (m):** 1.9      **Works priority:** Very low  
**TPZ (m):** 3.0      **Construction Proximity:** 0.1  
**mTPZ (m):**

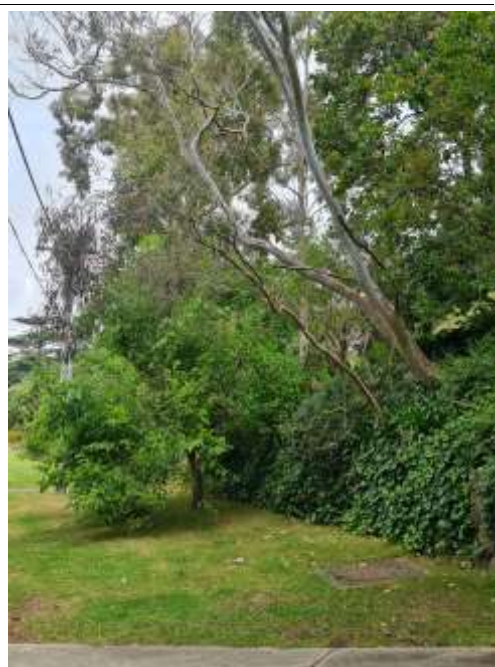
**Tree ID: 635****Genus / species:** *Morus alba*

Deciduous Mulberry

**Height (m):** 7      **Structure:** Good  
**Width (m):** 6      **Health:** Good  
**DBH (cm):** 24      **Measured Maturity:** Immature  
**Origin:** Exotic      **ULE (years):** 30 - 60  
**Retained?:** Retained      **Form:** Good  
**Retention Value:** Low  
**Removal / retention reason:** N/A.  
**Amenity value:** Low  
**Works Required:** Canopy lift.

**SRZ (m):** 1.9      **Works priority:** Very low  
**TPZ (m):** 2.9      **Construction Proximity:** 0.1  
**mTPZ (m):**

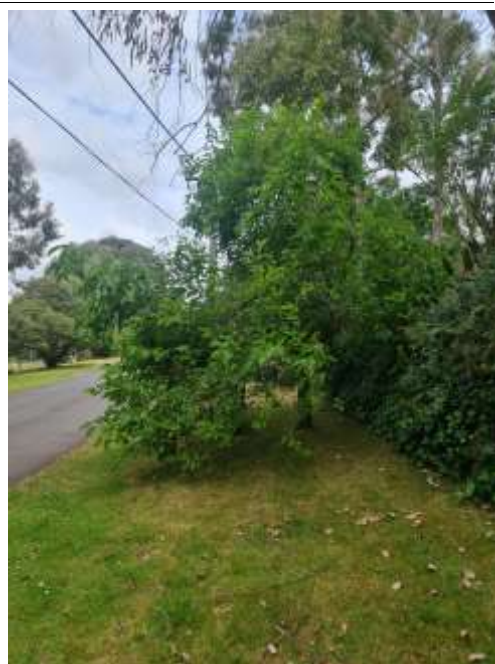
**Tree ID: 636****Genus / species:** *Eucalyptus* sp.

Evergreen Gum

**Height (m):** 24      **Structure:** Good  
**Width (m):** 16      **Health:** Good  
**DBH (cm):** 105 Measured **Maturity:** Mature  
**Origin:** Australian      **ULE (years):** 30 - 60  
**Retained?:** Retained      **Form:** Good

**Retention Value:** High**Removal / retention reason:** N/A.**Amenity value:** High**Works Required:** Canopy lift.**SRZ (m):** 3.6      **Works priority:** Very low**TPZ (m):** 12.6      **Construction Proximity:** 0.1**mTPZ (m):**

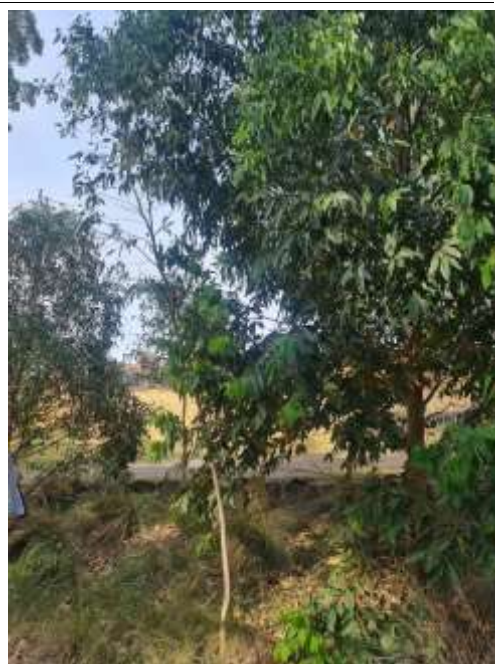
**Tree ID: 639****Genus / species:** *Eucalyptus* sp.

Evergreen Gum

**Height (m):** 3      **Structure:** Good  
**Width (m):** 2      **Health:** Good  
**DBH (cm):** 3 Measured **Maturity:** Immature  
**Origin:** Australian **ULE (years):** 15 - 30  
**Retained?:** Removed **Form:** Good  
**Retention Value:** Very low  
**Removal / retention reason:** N/A.  
**Amenity value:** Very low  
**Works Required:** N/A.

**SRZ (m):** 1.6      **Works priority:** Very low  
**TPZ (m):** 2.0      **Construction Proximity:** 0.1  
**mTPZ (m):**

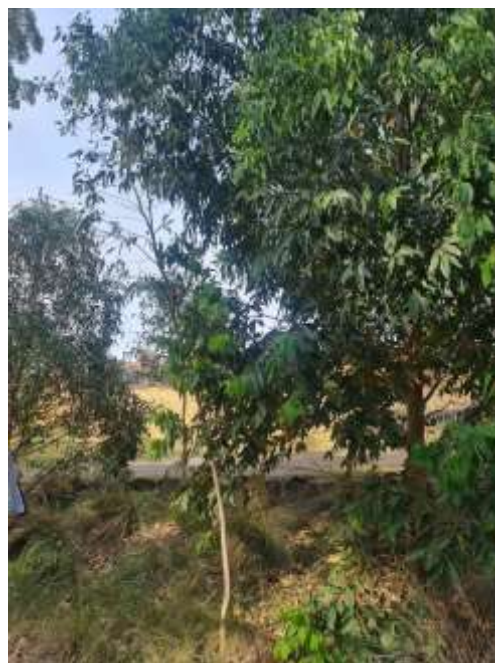
**Tree ID: 640****Genus / species:** *Eucalyptus* sp.

Evergreen Gum

**Height (m):** 3      **Structure:** Fair  
**Width (m):** 3      **Health:** Fair  
**DBH (cm):** 5 Estimated **Maturity:** Immature  
**Origin:** Australian **ULE (years):** 15 - 30  
**Retained?:** Removed **Form:** Fair  
**Retention Value:** Very low  
**Removal / retention reason:** N/A.  
**Amenity value:** Very low  
**Works Required:** N/A.

**SRZ (m):** 1.6      **Works priority:** Very low  
**TPZ (m):** 2.0      **Construction Proximity:** 0.1  
**mTPZ (m):**

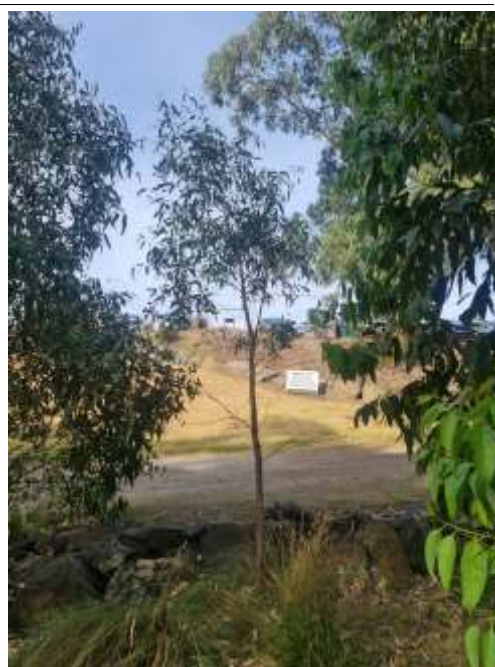
**Tree ID: 641****Genus / species:** *Eucalyptus* sp.

Evergreen Gum

**Height (m):** 3      **Structure:** Fair  
**Width (m):** 3      **Health:** Fair  
**DBH (cm):** 5 Measured **Maturity:** Immature  
**Origin:** Australian **ULE (years):** 15 - 30  
**Retained?:** Removed **Form:** Fair  
**Retention Value:** Very low  
**Removal / retention reason:** N/A.  
**Amenity value:** Very low  
**Works Required:** N/A.

**SRZ (m):** 1.6      **Works priority:** Very low  
**TPZ (m):** 2.0      **Construction Proximity:** 0.1  
**mTPZ (m):**

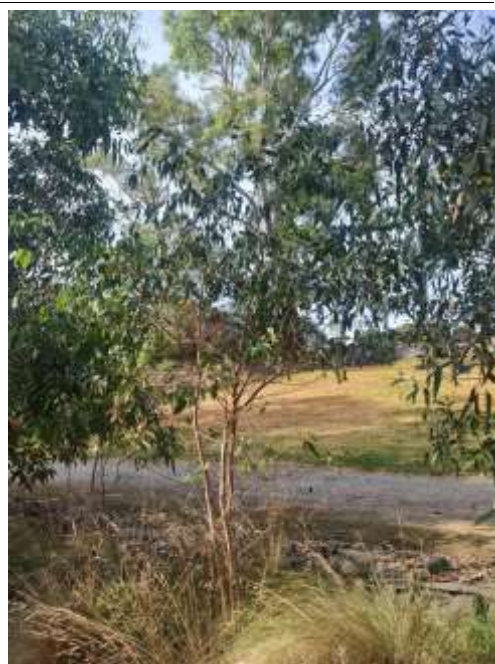
**Tree ID: 642****Genus / species:** *Eucalyptus* sp.

Evergreen Gum

**Height (m):** 3      **Structure:** Fair  
**Width (m):** 1      **Health:** Good  
**DBH (cm):** 5      Estimated **Maturity:** Immature  
**Origin:** Australian      **ULE (years):** 15 - 30  
**Retained?:** Removed      **Form:** Fair  
**Retention Value:** Very low  
**Removal / retention reason:** N/A.  
**Amenity value:** Very low  
**Works Required:** N/A.

**SRZ (m):** 1.6      **Works priority:** Very low  
**TPZ (m):** 2.0      **Construction Proximity:** 0.1  
**mTPZ (m):**

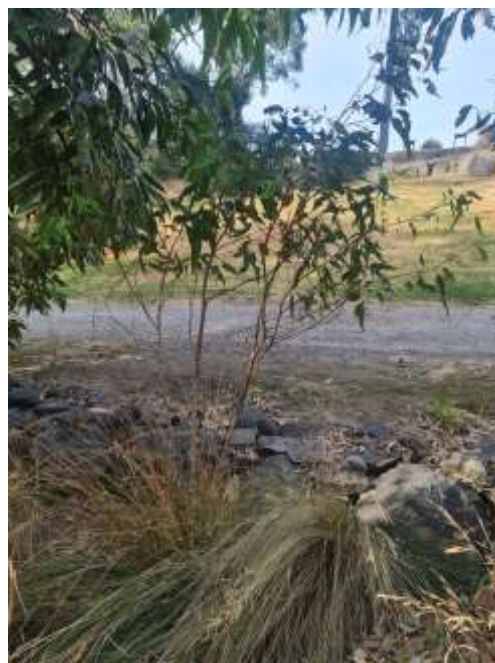
**Tree ID: 643****Genus / species:** *Eucalyptus botryoides*

Evergreen Southern Mahogany

**Height (m):** 8      **Structure:** Good  
**Width (m):** 5      **Health:** Good  
**DBH (cm):** 13      Measured **Maturity:** Immature  
**Origin:** Victorian      **ULE (years):** 30 - 60  
**Retained?:** Retained      **Form:** Good  
**Retention Value:** Low  
**Removal / retention reason:** N/A.  
**Amenity value:** Low  
**Works Required:** Canopy lift.

**SRZ (m):** 1.6      **Works priority:** Very low  
**TPZ (m):** 2.0      **Construction Proximity:** 0.1  
**mTPZ (m):**

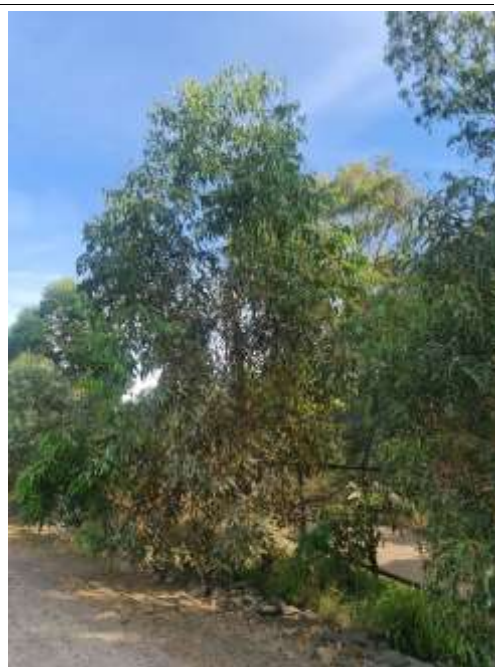
**Tree ID: 644****Genus / species:** *Eucalyptus* sp.

Evergreen Gum

**Height (m):** 2      **Structure:** Good  
**Width (m):** 1      **Health:** Good  
**DBH (cm):** 2      Measured **Maturity:** Immature  
**Origin:** Australian      **ULE (years):** 15 - 30  
**Retained?:** Removed      **Form:** Good  
**Retention Value:** Very low  
**Removal / retention reason:** N/A.  
**Amenity value:** Very low  
**Works Required:** N/A.

**SRZ (m):** 1.6      **Works priority:** Very low  
**TPZ (m):** 2.0      **Construction Proximity:** 0.1  
**mTPZ (m):**

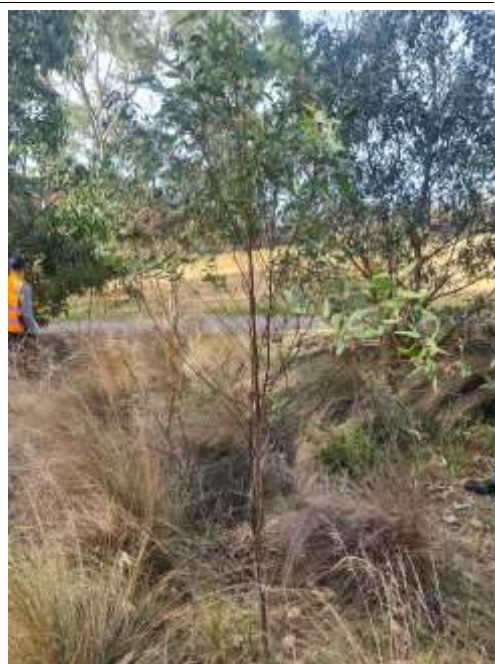
**Tree ID: 645****Genus / species:** *Eucalyptus sp.*

Evergreen Gum

**Height (m):** 5      **Structure:** Good  
**Width (m):** 3      **Health:** Good  
**DBH (cm):** 8 Measured **Maturity:** Immature  
**Origin:** Australian **ULE (years):** 15 - 30  
**Retained?:** Retained **Form:** Good

**Retention Value:** Low**Removal / retention reason:** N/A.**Amenity value:** Low**Works Required:** Canopy lift.**SRZ (m):** 1.6      **Works priority:** Very low**TPZ (m):** 2.0      **Construction Proximity:** 0.1**mTPZ (m):**

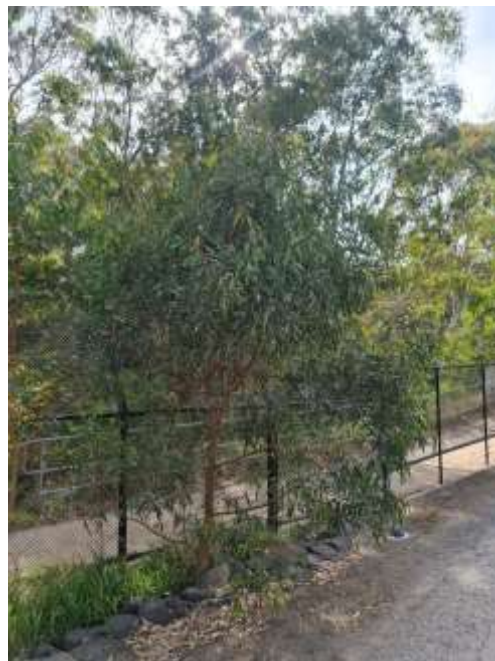
**Tree ID: 646****Genus / species:** *Unknown sp.*

Unknown Unknown

**Height (m):** 4      **Structure:** Fair  
**Width (m):** 2      **Health:** Poor  
**DBH (cm):** 6 Measured **Maturity:** Immature  
**Origin:** Unknown **ULE (years):** 5 - 15  
**Retained?:** Removed **Form:** Fair

**Retention Value:** Very low**Removal / retention reason:** N/A.**Amenity value:** Very low**Works Required:** N/A.**SRZ (m):** 1.6      **Works priority:** Very low**TPZ (m):** 2.0      **Construction Proximity:** 0.1**mTPZ (m):**

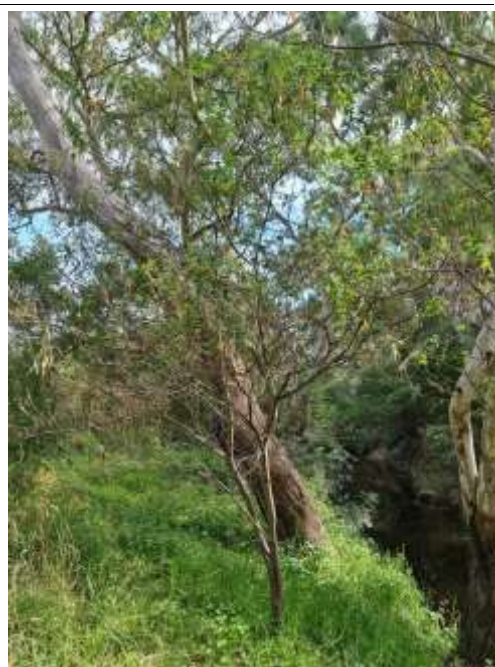
**Tree ID: 647****Genus / species:** *Unknown sp.*

Unknown Unknown

**Height (m):** 4      **Structure:** Fair  
**Width (m):** 3      **Health:** Poor  
**DBH (cm):** 7 Estimated **Maturity:** Immature  
**Origin:** Unknown **ULE (years):** 5 - 15  
**Retained?:** Removed **Form:** Fair

**Retention Value:** Very low**Removal / retention reason:** N/A.**Amenity value:** Very low**Works Required:** N/A.**SRZ (m):** 1.6      **Works priority:** Very low**TPZ (m):** 2.0      **Construction Proximity:** 0.1**mTPZ (m):**

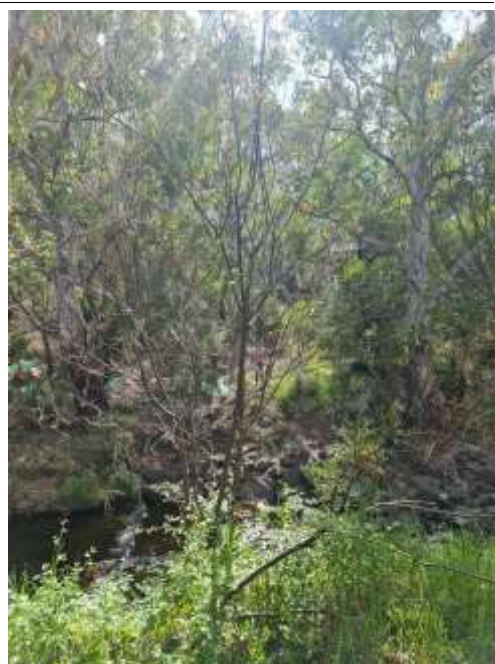
**Tree ID: 648****Genus / species:** *Eucalyptus* sp.

Evergreen Gum

**Height (m):** 20      **Structure:** Good  
**Width (m):** 8      **Health:** Good  
**DBH (cm):** 45 Measured **Maturity:** Mature  
**Origin:** Australian **ULE (years):** 30 - 60  
**Retained?:** Retained **Form:** Good

**Retention Value:** High**Removal / retention reason:** N/A.**Amenity value:** High**Works Required:** N/A.**SRZ (m):** 2.5      **Works priority:** Very low**TPZ (m):** 5.4      **Construction Proximity:** 0.1**mTPZ (m):**

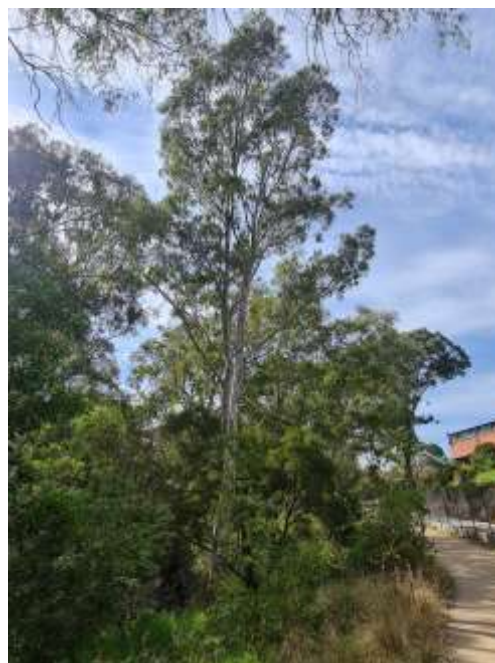
**Tree ID: 649****Genus / species:** *Acacia melanoxylon*

Evergreen Blackwood

**Height (m):** 4      **Structure:** Good  
**Width (m):** 1      **Health:** Good  
**DBH (cm):** 5 Measured **Maturity:** Immature  
**Origin:** Melbourne **ULE (years):** 15 - 30  
**Retained?:** Removed **Form:** Good

**Retention Value:** Very low**Removal / retention reason:** N/A.**Amenity value:** Very low**Works Required:** N/A.**SRZ (m):** 1.6      **Works priority:** Very low**TPZ (m):** 2.0      **Construction Proximity:** 0.1**mTPZ (m):**

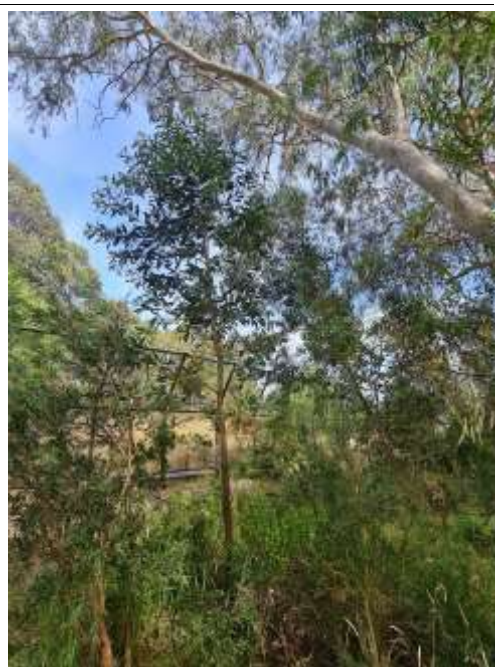
**Tree ID: 650****Genus / species:** *Acacia melanoxylon*

Evergreen Blackwood

**Height (m):** 4      **Structure:** Good  
**Width (m):** 1      **Health:** Fair  
**DBH (cm):** 5 Measured **Maturity:** Immature  
**Origin:** Melbourne **ULE (years):** 15 - 30  
**Retained?:** Removed **Form:** Good

**Retention Value:** Very low**Removal / retention reason:** N/A.**Amenity value:** Very low**Works Required:** N/A.**SRZ (m):** 1.6      **Works priority:** Very low**TPZ (m):** 2.0      **Construction Proximity:** 0.1**mTPZ (m):**

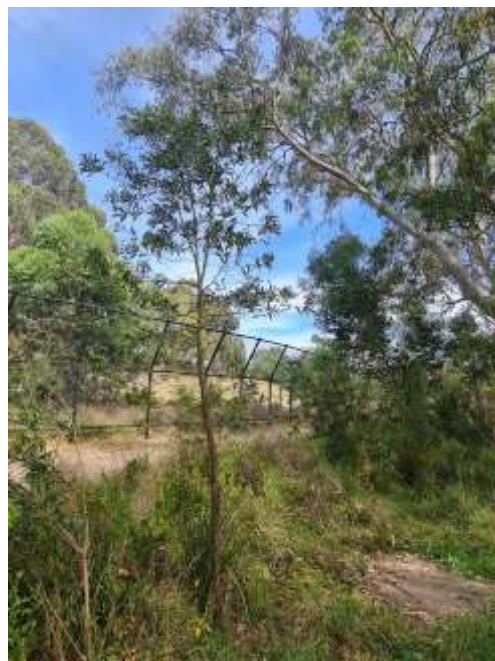
**Tree ID: 651****Genus / species:** *Acacia melanoxylon*

Evergreen Blackwood

**Height (m):** 4      **Structure:** Fair  
**Width (m):** 2      **Health:** Fair  
**DBH (cm):** 5      Measured **Maturity:** Immature  
**Origin:** Melbourne      **ULE (years):** 15 - 30  
**Retained?:** Removed      **Form:** Good  
**Retention Value:** Very low  
**Removal / retention reason:** N/A.  
**Amenity value:** Very low  
**Works Required:** N/A.

**SRZ (m):** 1.6      **Works priority:** Very low  
**TPZ (m):** 2.0      **Construction Proximity:** 0.1  
**mTPZ (m):**

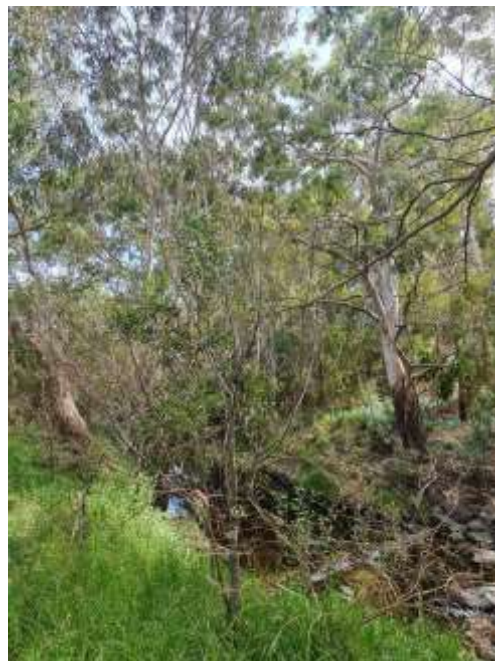
**Tree ID: 652****Genus / species:** *Acacia melanoxylon*

Evergreen Blackwood

**Height (m):** 4      **Structure:** Good  
**Width (m):** 2      **Health:** Fair  
**DBH (cm):** 5      Measured **Maturity:** Immature  
**Origin:** Melbourne      **ULE (years):** 15 - 30  
**Retained?:** Removed      **Form:** Good  
**Retention Value:** Very low  
**Removal / retention reason:** N/A.  
**Amenity value:** Very low  
**Works Required:** N/A.

**SRZ (m):** 1.6      **Works priority:** Very low  
**TPZ (m):** 2.0      **Construction Proximity:** 0.1  
**mTPZ (m):**

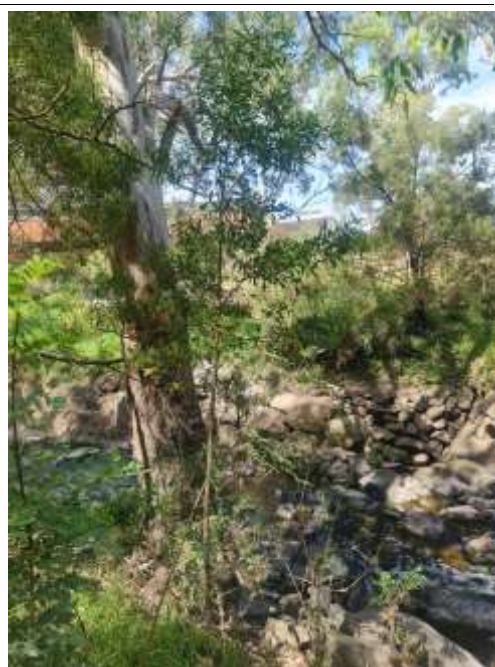
**Tree ID: 653****Genus / species:** *Juglans sp.*

Deciduous Walnut

**Height (m):** 8      **Structure:** Good  
**Width (m):** 6      **Health:** Good  
**DBH (cm):** 18      Measured **Maturity:** Mature  
**Origin:** Exotic      **ULE (years):** 30 - 60  
**Retained?:** Retained      **Form:** Good  
**Retention Value:** Low  
**Removal / retention reason:** N/A.  
**Amenity value:** Low  
**Works Required:** Canopy lift.

**SRZ (m):** 1.7      **Works priority:** Very low  
**TPZ (m):** 2.2      **Construction Proximity:** 0.1  
**mTPZ (m):**

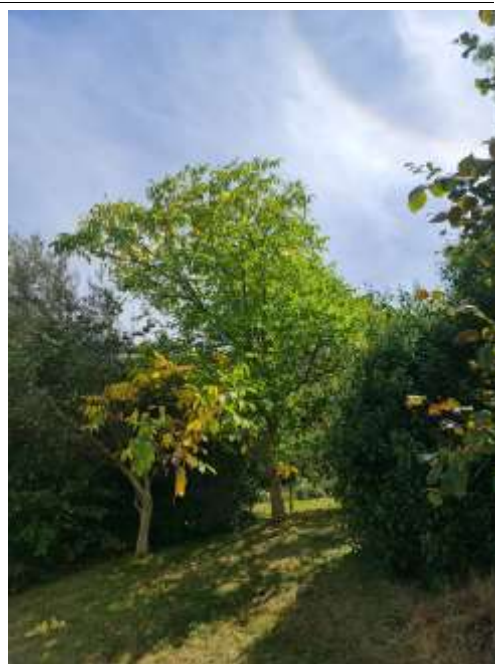
**Tree ID: 654****Genus / species:** *Fraxinus angustifolia*

Deciduous      Narrow Leaf Ash

**Height (m):** 14      **Structure:** Good  
**Width (m):** 10      **Health:** Good  
**DBH (cm):** 55      Measured **Maturity:** Mature  
**Origin:** Exotic      **ULE (years):** 15 - 30  
**Retained?:** Retained      **Form:** Good

**Retention Value:** Moderate**Removal / retention reason:** N/A.**Amenity value:** Moderate**Works Required:** Canopy lift.**SRZ (m):** 2.7      **Works priority:** Very low**TPZ (m):** 6.6      **Construction Proximity:** 0.1**mTPZ (m):**

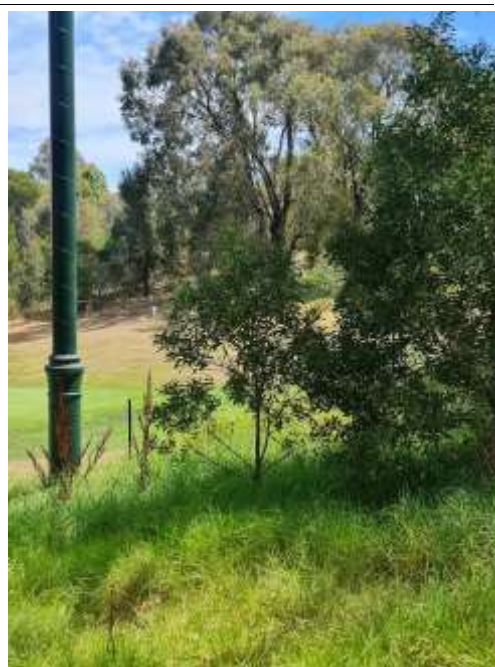
**Tree ID: 656****Genus / species:** *Eucalyptus camaldulensis*

Evergreen      River Red Gum

**Height (m):** 22      **Structure:** Fair  
**Width (m):** 12      **Health:** Good  
**DBH (cm):** 68      Measured **Maturity:** Mature  
**Origin:** Melbourne      **ULE (years):** > 60  
**Retained?:** Retained      **Form:** Good

**Retention Value:** Very high**Removal / retention reason:** N/A.**Amenity value:** High**Works Required:** N/A.**SRZ (m):** 2.9      **Works priority:** Very low**TPZ (m):** 8.2      **Construction Proximity:** 0.1**mTPZ (m):**

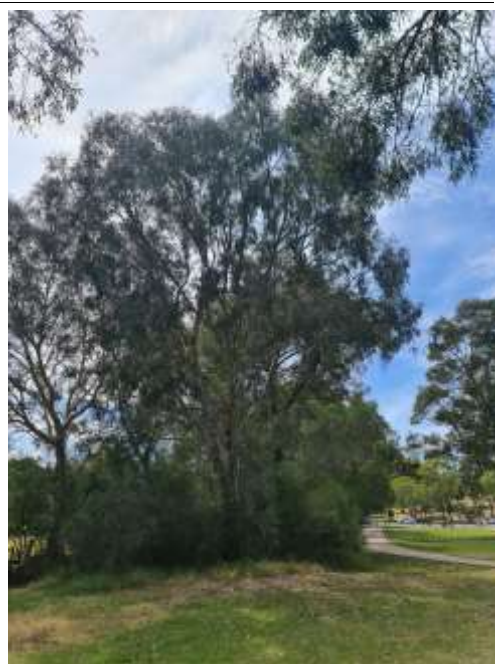
**Tree ID: 657****Genus / species:** *Melaleuca styphelioides*

Evergreen Prickly Paperbark

**Height (m):** 11      **Structure:** Fair  
**Width (m):** 7      **Health:** Good  
**DBH (cm):** 54 Measured **Maturity:** Mature  
**Origin:** Australian      **ULE (years):** 30 - 60  
**Retained?:** Retained      **Form:** Good

**Retention Value:** Moderate**Removal / retention reason:** N/A.**Amenity value:** Moderate**Works Required:** N/A.**SRZ (m):** 2.7      **Works priority:** Very low**TPZ (m):** 6.5      **Construction Proximity:** 0.1**mTPZ (m):**

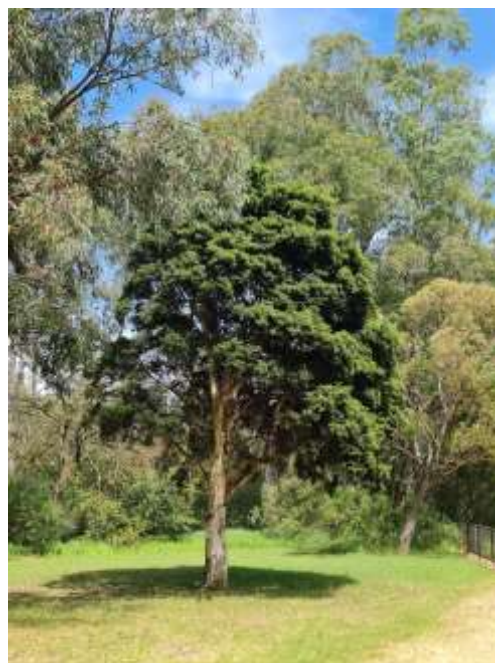
**Tree ID: 658****Genus / species:** *Eucalyptus sideroxylon*

Evergreen Red Ironbark

**Height (m):** 19      **Structure:** Fair  
**Width (m):** 12      **Health:** Good  
**DBH (cm):** 89 Measured **Maturity:** Mature  
**Origin:** Victorian      **ULE (years):** 30 - 60  
**Retained?:** Retained      **Form:** Good

**Retention Value:** High**Removal / retention reason:** N/A.**Amenity value:** High**Works Required:** N/A.**SRZ (m):** 3.4      **Works priority:** Very low**TPZ (m):** 10.7      **Construction Proximity:** 0.1**mTPZ (m):**

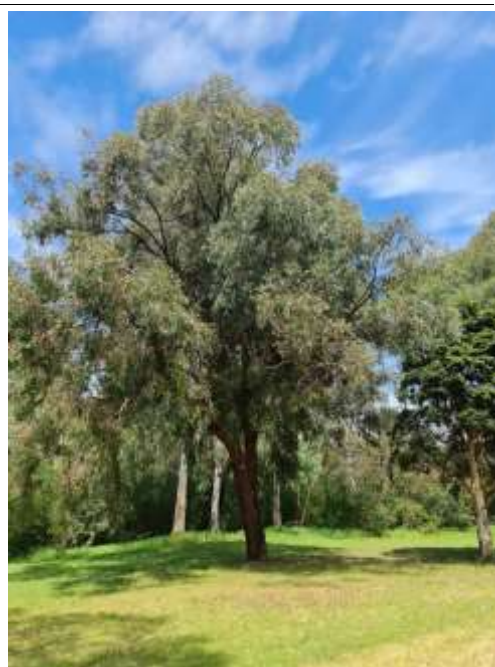
**Tree ID: 659****Genus / species:** *Eucalyptus* sp.

Evergreen Gum

**Height (m):** 3      **Structure:** Fair  
**Width (m):** 3      **Health:** Poor  
**DBH (cm):** 5 Measured **Maturity:** Immature  
**Origin:** Australian      **ULE (years):** 5 - 15  
**Retained?:** Removed      **Form:** Poor

**Retention Value:** Very low**Removal / retention reason:** N/A.**Amenity value:** Very low**Works Required:** N/A.**SRZ (m):** 1.6      **Works priority:** Very low**TPZ (m):** 2.0      **Construction Proximity:** 0.1**mTPZ (m):**

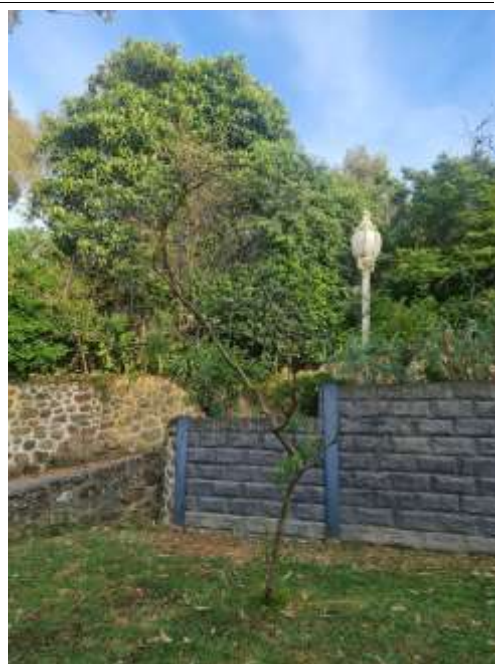
**Tree ID: 660****Genus / species:** *Eucalyptus camaldulensis*

Evergreen River Red Gum

<b>Height (m):</b>	23	<b>Structure:</b>	Good
<b>Width (m):</b>	20	<b>Health:</b>	Good
<b>DBH (cm):</b>	132 Measured	<b>Maturity:</b>	Mature
<b>Origin:</b>	Melbourne	<b>ULE (years):</b>	> 60
<b>Retained?:</b>	Retained	<b>Form:</b>	Good

**Retention Value:** Very high**Removal / retention reason:** N/A.**Amenity value:** High**Works Required:** Canopy lift.**SRZ (m):** 3.9 **Works priority:** Very low**TPZ (m):** 15.0 **Construction Proximity:** 0.1**mTPZ (m):**

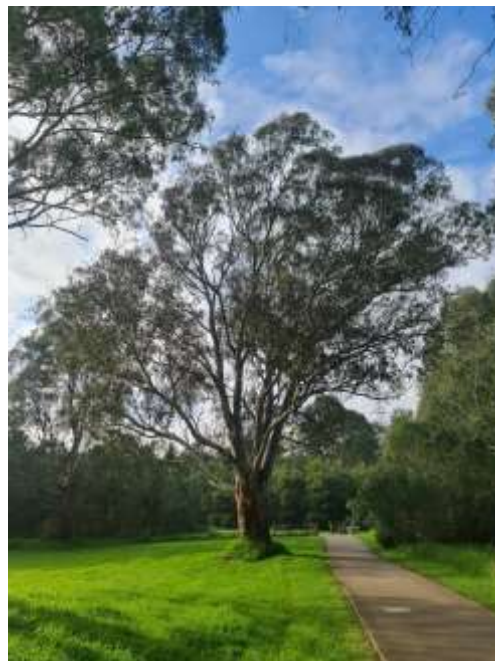
**Tree ID: 661****Genus / species:** *Eucalyptus camaldulensis*

Evergreen River Red Gum

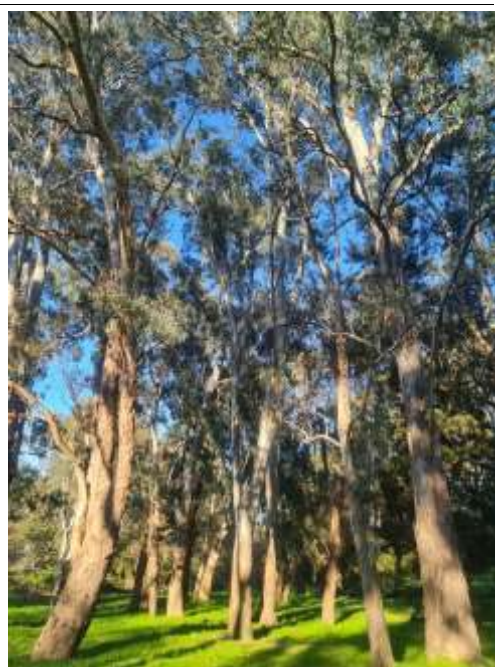
**Tree ID: 662****Genus / species:** *Eucalyptus camaldulensis*

Evergreen River Red Gum

<b>Height (m):</b>	30	<b>Structure:</b>	Fair
<b>Width (m):</b>	24	<b>Health:</b>	Good
<b>DBH (cm):</b>	79 Measured	<b>Maturity:</b>	Mature
<b>Origin:</b>	Melbourne	<b>ULE (years):</b>	> 60
<b>Retained?:</b>	Retained	<b>Form:</b>	Good

**Retention Value:** Very high**Removal / retention reason:** N/A.**Amenity value:** High**Works Required:** N/A.**SRZ (m):** 3.2 **Works priority:** N/A**TPZ (m):** 9.5 **Construction Proximity:** 0.1**mTPZ (m):**

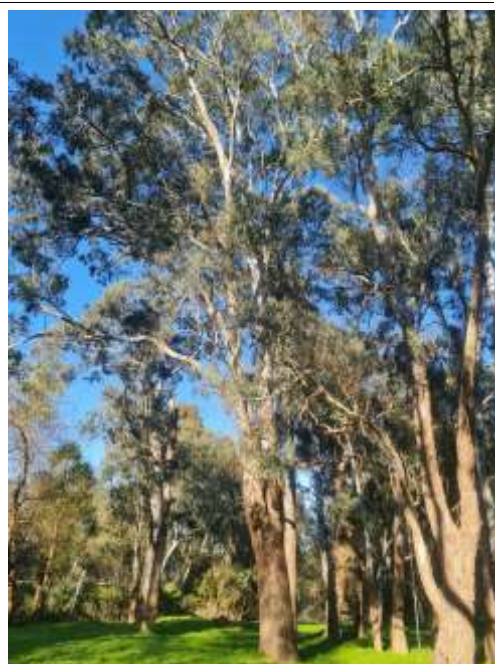
**Tree ID: 663****Genus / species:** *Eucalyptus camaldulensis*

Evergreen River Red Gum

**Retention Value:** Very high**Removal / retention reason:** N/A.**Amenity value:** High**Works Required:** N/A.

**SRZ (m):** 3.2      **Works priority:** N/A  
**TPZ (m):** 9.6      **Construction Proximity:** 0.1  
**mTPZ (m):**

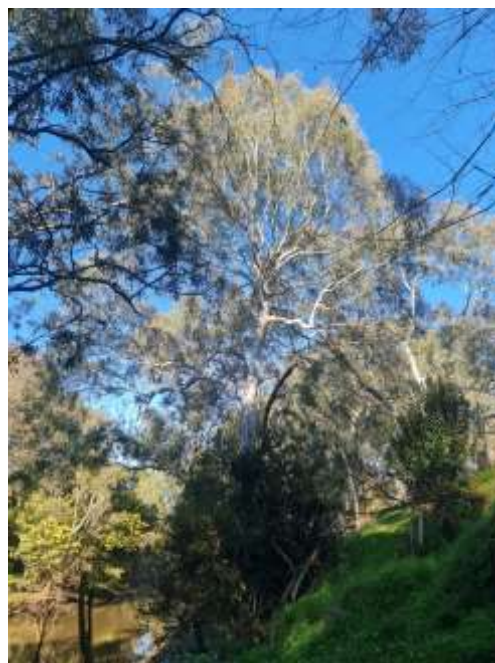
**Tree ID: 664****Genus / species:** *Eucalyptus camaldulensis*

Evergreen River Red Gum

**Retention Value:** Very high**Removal / retention reason:** N/A.**Amenity value:** High**Works Required:** N/A.

**SRZ (m):** 3.2      **Works priority:** N/A  
**TPZ (m):** 9.6      **Construction Proximity:** 0.1  
**mTPZ (m):**

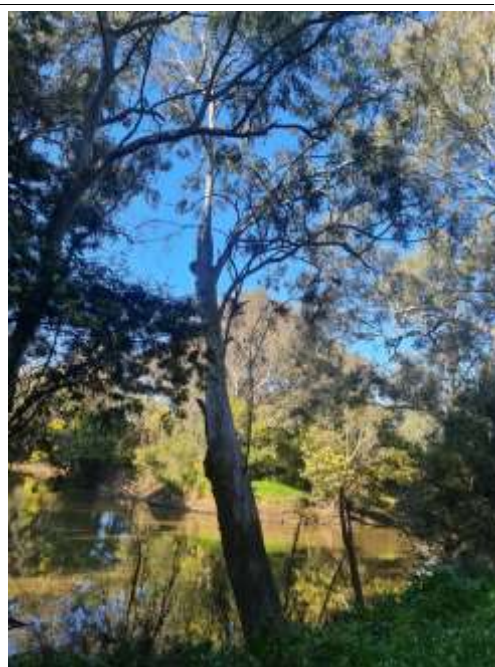
**Tree ID: 665****Genus / species:** *Eucalyptus camaldulensis*

Evergreen River Red Gum

**Retention Value:** High**Removal / retention reason:** N/A.**Amenity value:** High**Works Required:** N/A.

**SRZ (m):** 3      **Works priority:** N/A  
**TPZ (m):** 9.0      **Construction Proximity:** 0.1  
**mTPZ (m):**

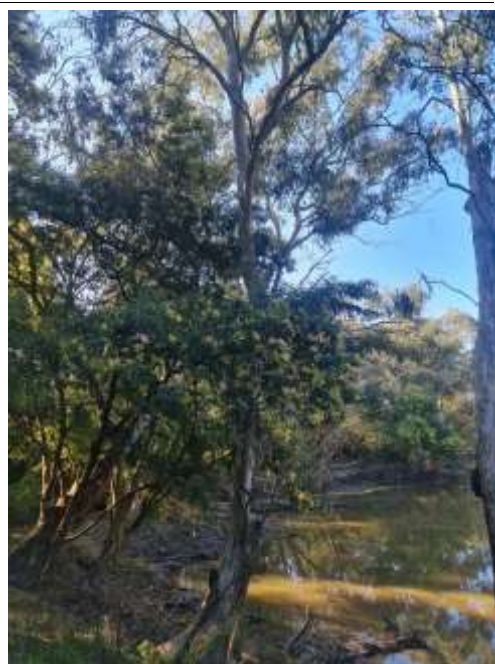
**Tree ID: 666****Genus / species:** *Eucalyptus camaldulensis*

Evergreen River Red Gum

**Removal / retention reason:** N/A.**Amenity value:** High**Works Required:** N/A.

**SRZ (m):** 3.4      **Works priority:** N/A  
**TPZ (m):** 10.8      **Construction Proximity:** 0.1  
**mTPZ (m):**

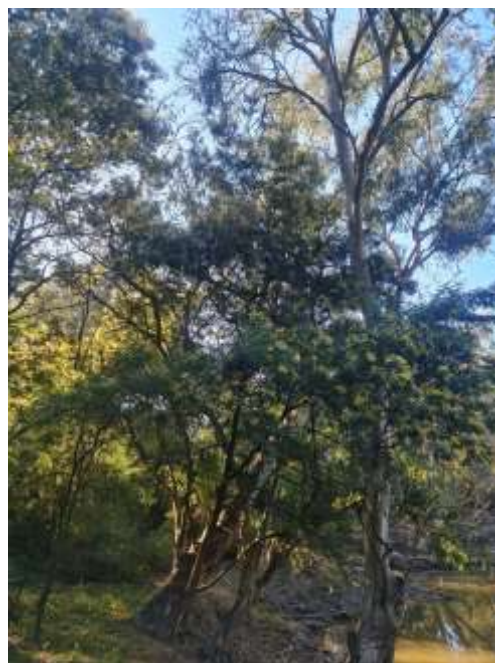
**Tree ID: 667****Genus / species:** *Eucalyptus leucoxylon*

Evergreen Yellow Gum

**Removal / retention reason:** N/A.**Amenity value:** High**Works Required:** N/A.

**SRZ (m):** 3.8      **Works priority:** N/A  
**TPZ (m):** 14.4      **Construction Proximity:** 0.1  
**mTPZ (m):**
