## **Nation Partners**

# **Northern Sewers Relining Project Southern Section**

## **Construction Impact Report**

**Wednesday 4<sup>th</sup> December 2024**

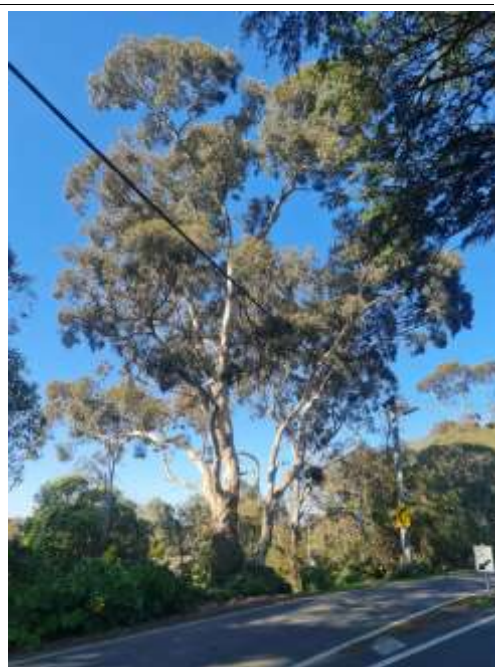
**Tree ID: 668****Genus / species:** *Eucalyptus leucoxylon*

Evergreen Yellow Gum

**Removal / retention reason:** N/A.**Amenity value:** Moderate**Works Required:** N/A.

**SRZ (m):** 2.8      **Works priority:** N/A  
**TPZ (m):** 7.2      **Construction Proximity:** 0.1  
**mTPZ (m):**

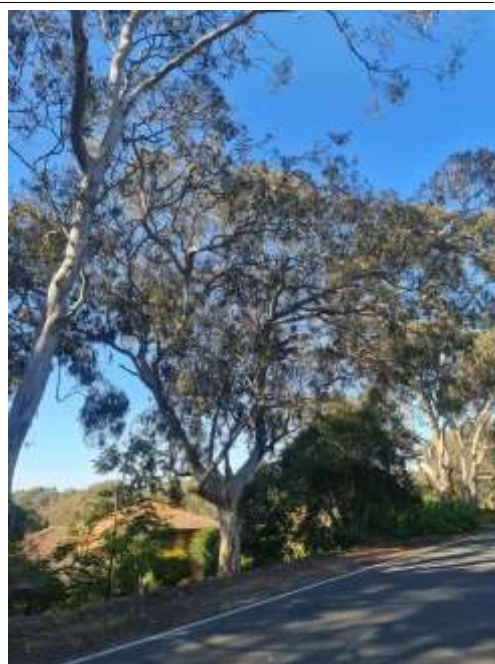
**Tree ID: 669****Genus / species:** *Eucalyptus leucoxylon*

Evergreen Yellow Gum

**Height (m):** 14      **Structure:** Fair  
**Width (m):** 13      **Health:** Fair  
**DBH (cm):** 67 Measured **Maturity:** Mature  
**Origin:** Melbourne **ULE (years):** 30 - 60  
**Retained?:** Retained **Form:** Fair  
**Retention Value:** Moderate  
**Removal / retention reason:** N/A.  
**Amenity value:** Moderate  
**Works Required:** N/A.

**SRZ (m):** 2.9      **Works priority:** N/A  
**TPZ (m):** 8.0      **Construction Proximity:** 0.1  
**mTPZ (m):**

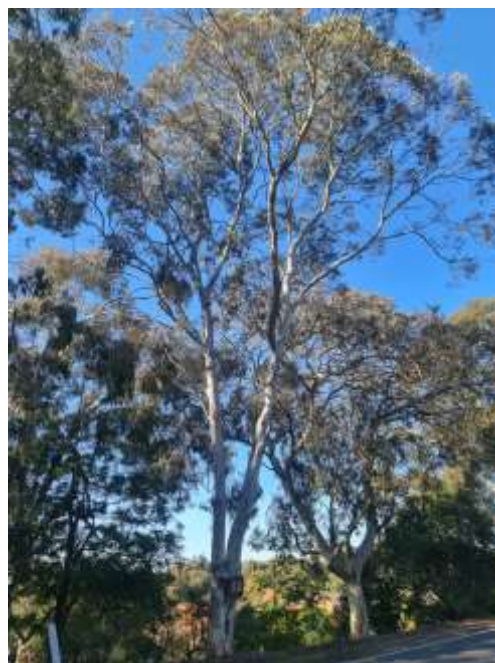
**Tree ID: 670****Genus / species:** *Eucalyptus leucoxylon*

Evergreen Yellow Gum

**Height (m):** 18      **Structure:** Good  
**Width (m):** 14      **Health:** Good  
**DBH (cm):** 102 Measured **Maturity:** Mature  
**Origin:** Melbourne **ULE (years):** > 60  
**Retained?:** Retained **Form:** Fair  
**Retention Value:** Very high  
**Removal / retention reason:** N/A.  
**Amenity value:** High  
**Works Required:** N/A.

**SRZ (m):** 3.5      **Works priority:** N/A  
**TPZ (m):** 12.2      **Construction Proximity:** 0.1  
**mTPZ (m):**

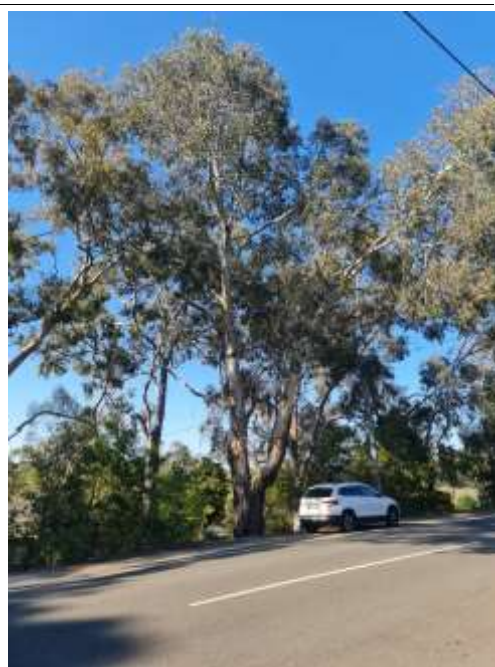
**Tree ID: 671****Genus / species:** *Eucalyptus leucoxylon*

Evergreen Yellow Gum

**Height (m):** 15      **Structure:** Fair  
**Width (m):** 14      **Health:** Good  
**DBH (cm):** 64 Measured **Maturity:** Mature  
**Origin:** Melbourne **ULE (years):** 30 - 60  
**Retained?:** Retained **Form:** Fair  
**Retention Value:** High  
**Removal / retention reason:** N/A.  
**Amenity value:** High  
**Works Required:** N/A.

**SRZ (m):** 2.8      **Works priority:** N/A  
**TPZ (m):** 7.7      **Construction Proximity:** 0.1  
**mTPZ (m):**

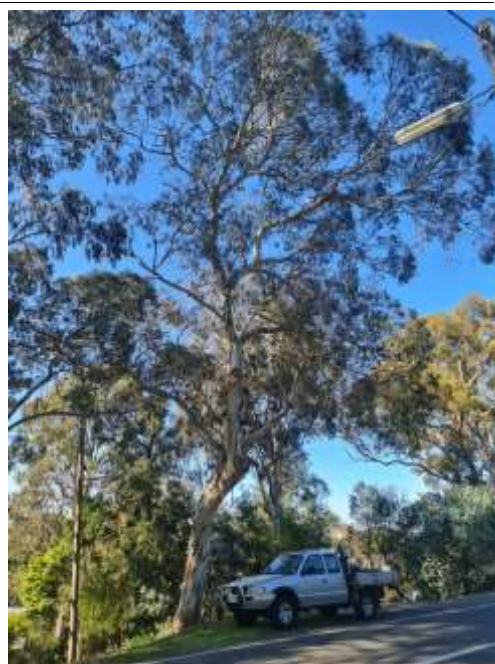
**Tree ID: 672****Genus / species:** *Eucalyptus camaldulensis*

Evergreen River Red Gum

**Retention Value:** High**Removal / retention reason:** N/A.**Amenity value:** High**Works Required:** N/A.

**SRZ (m):** 3.2      **Works priority:** N/A  
**TPZ (m):** 9.6      **Construction Proximity:** 0.1  
**mTPZ (m):**

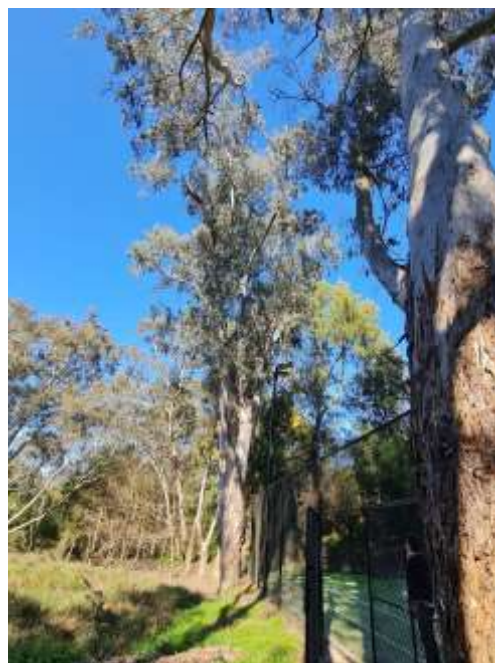
**Tree ID: 673****Genus / species:** *Eucalyptus sp.*

Evergreen Gum

**Retention Value:** Very low**Removal / retention reason:** N/A.**Amenity value:** Low**Works Required:** N/A.

**SRZ (m):** 3.4      **Works priority:** N/A  
**TPZ (m):** 10.8      **Construction Proximity:** 0.1  
**mTPZ (m):**

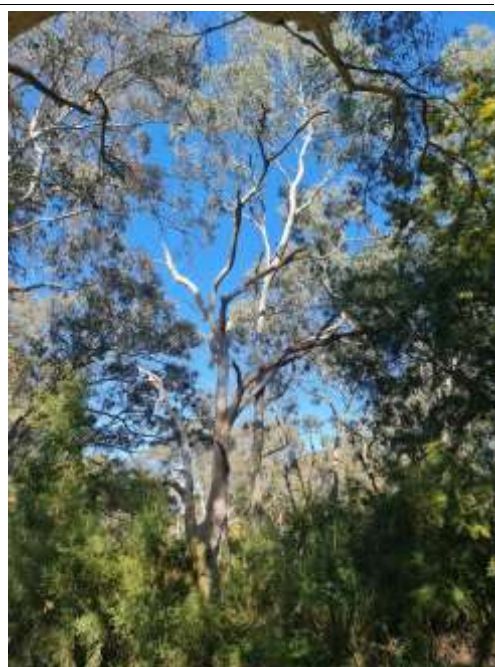
**Tree ID: 674****Genus / species:** *Eucalyptus camaldulensis*

Evergreen River Red Gum

**Retention Value:** Very high**Removal / retention reason:** N/A.**Amenity value:** High**Works Required:** N/A.

**SRZ (m):** 3.3      **Works priority:** N/A  
**TPZ (m):** 10.6      **Construction Proximity:** 0.1  
**mTPZ (m):**

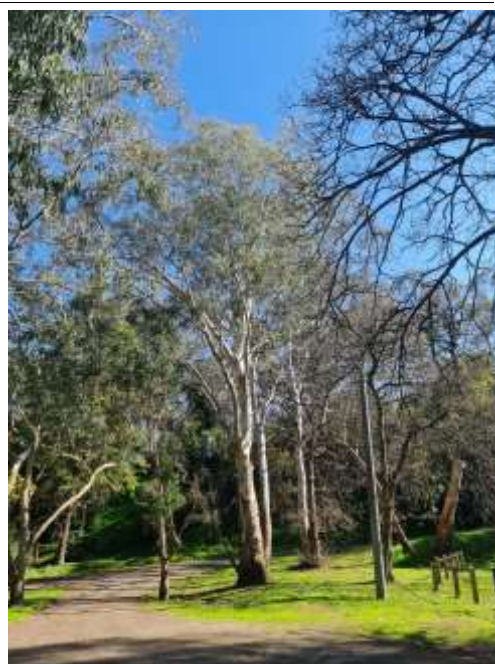
**Tree ID: 675****Genus / species:** *Eucalyptus sp.*

Evergreen Gum

**Height (m):** 5      **Structure:** Good  
**Width (m):** 2      **Health:** Poor  
**DBH (cm):** 81 Measured **Maturity:** Over mature  
**Origin:** Australian **ULE (years):** 0  
**Retained?:** Retained **Form:** Poor  
**Retention Value:** Very low  
**Removal / retention reason:** N/A.  
**Amenity value:** Very low  
**Works Required:** N/A.

**SRZ (m):** 3.2      **Works priority:** N/A  
**TPZ (m):** 9.7      **Construction Proximity:** 0.1  
**mTPZ (m):**

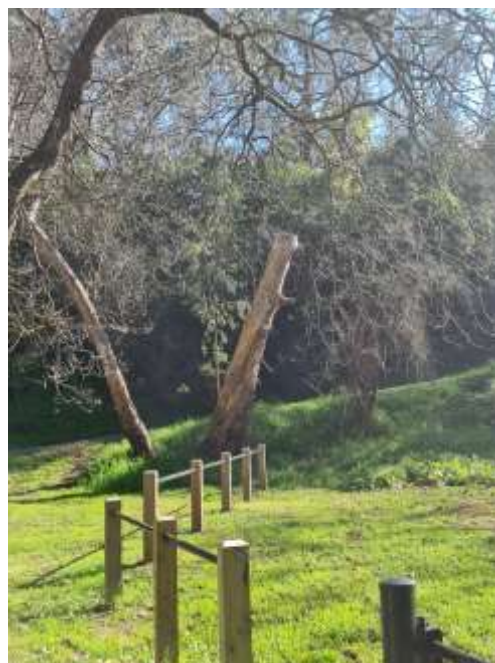
**Tree ID: 676****Genus / species:** *Eucalyptus camaldulensis*

Evergreen River Red Gum

**Height (m):** 24      **Structure:** Good  
**Width (m):** 20      **Health:** Good  
**DBH (cm):** 100 Measured **Maturity:** Mature  
**Origin:** Melbourne **ULE (years):** > 60  
**Retained?:** Retained **Form:** Good  
**Retention Value:** Very high  
**Removal / retention reason:** N/A.  
**Amenity value:** High  
**Works Required:** N/A.

**SRZ (m):** 3.5      **Works priority:** N/A  
**TPZ (m):** 12.0      **Construction Proximity:** 0.1  
**mTPZ (m):**

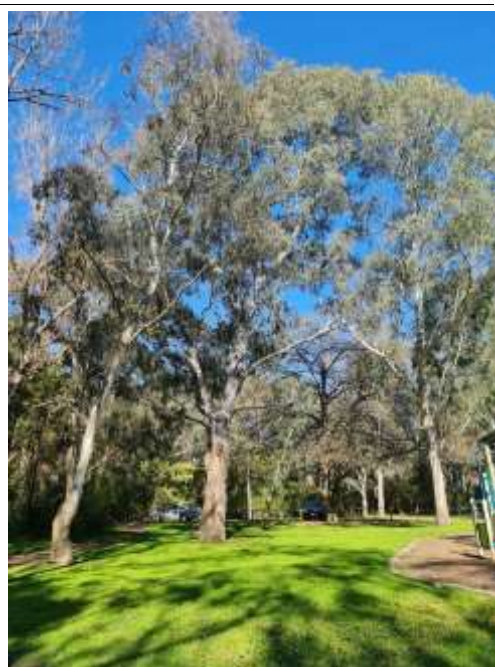
**Tree ID: 677****Genus / species:** *Eucalyptus camaldulensis*

Evergreen River Red Gum

**Height (m):** 24      **Structure:** Good  
**Width (m):** 18      **Health:** Fair  
**DBH (cm):** 86 Measured **Maturity:** Mature  
**Origin:** Melbourne **ULE (years):** 30 - 60  
**Retained?:** Retained **Form:** Good  
**Retention Value:** High  
**Removal / retention reason:** N/A.  
**Amenity value:** High  
**Works Required:** N/A.

**SRZ (m):** 3.3      **Works priority:** N/A  
**TPZ (m):** 10.3      **Construction Proximity:** 0.1  
**mTPZ (m):**

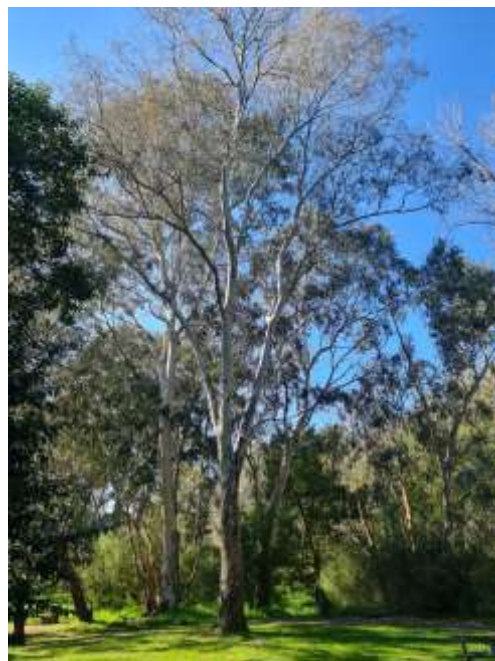
**Tree ID: 678****Genus / species:** *Eucalyptus camaldulensis*

Evergreen River Red Gum

**Retention Value:** Very high**Removal / retention reason:** N/A.**Amenity value:** High**Works Required:** N/A.

**SRZ (m):** 3.4      **Works priority:** N/A  
**TPZ (m):** 11.2      **Construction Proximity:** 0.1  
**mTPZ (m):**

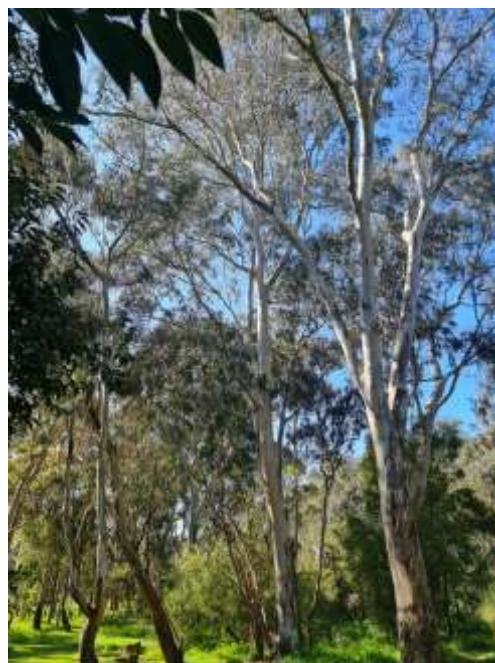
**Tree ID: 679****Genus / species:** *Eucalyptus camaldulensis*

Evergreen River Red Gum

**Retention Value:** Very high**Removal / retention reason:** N/A.**Amenity value:** High**Works Required:** N/A.

**SRZ (m):** 3.5      **Works priority:** N/A  
**TPZ (m):** 12.1      **Construction Proximity:** 0.1  
**mTPZ (m):**

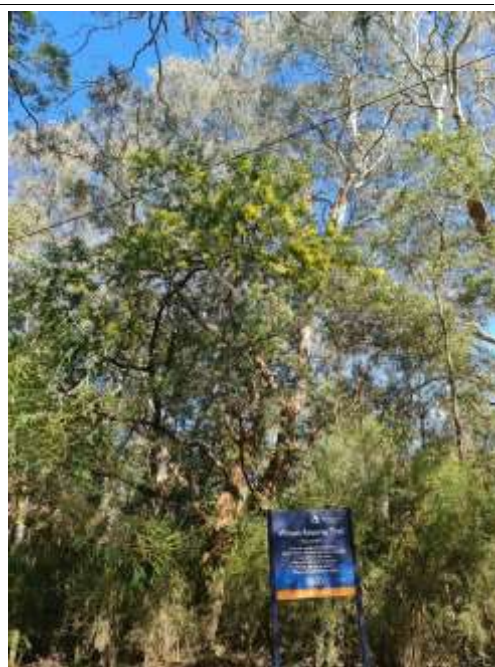
**Tree ID: 680****Genus / species:** *Eucalyptus camaldulensis*

Evergreen River Red Gum

**Retention Value:** Very high**Removal / retention reason:** N/A.**Amenity value:** High**Works Required:** N/A.

**SRZ (m):** 3.4      **Works priority:** N/A  
**TPZ (m):** 10.8      **Construction Proximity:** 0.1  
**mTPZ (m):**

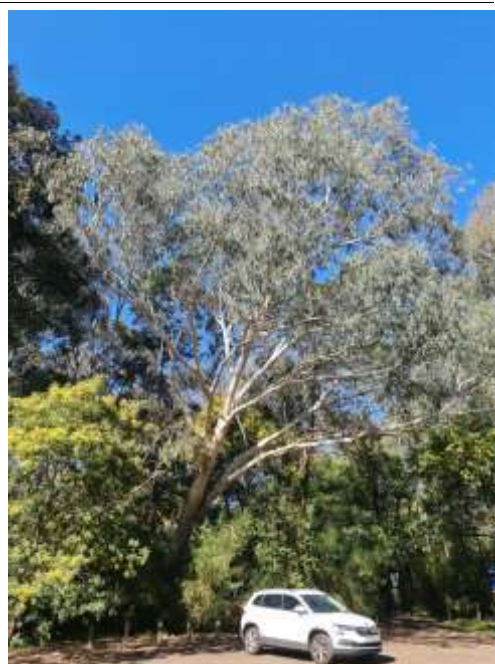
**Tree ID: 681****Genus / species:** *Eucalyptus camaldulensis*

Evergreen River Red Gum

**Retention Value:** High**Removal / retention reason:** N/A.**Amenity value:** High**Works Required:** N/A.

**SRZ (m):** 3.6      **Works priority:** N/A  
**TPZ (m):** 13.0      **Construction Proximity:** 0.1  
**mTPZ (m):**

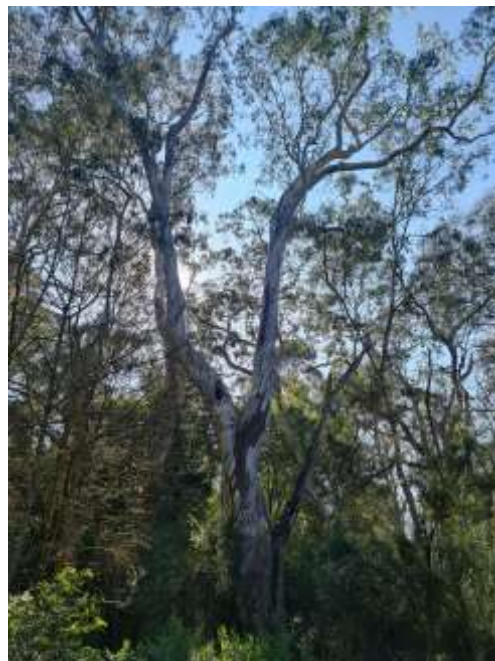
**Tree ID: 682****Genus / species:** *Eucalyptus camaldulensis*

Evergreen River Red Gum

**Retention Value:** High**Removal / retention reason:** N/A.**Amenity value:** Moderate**Works Required:** N/A.

**SRZ (m):** 3.3      **Works priority:** N/A  
**TPZ (m):** 10.2      **Construction Proximity:** 0.1  
**mTPZ (m):**

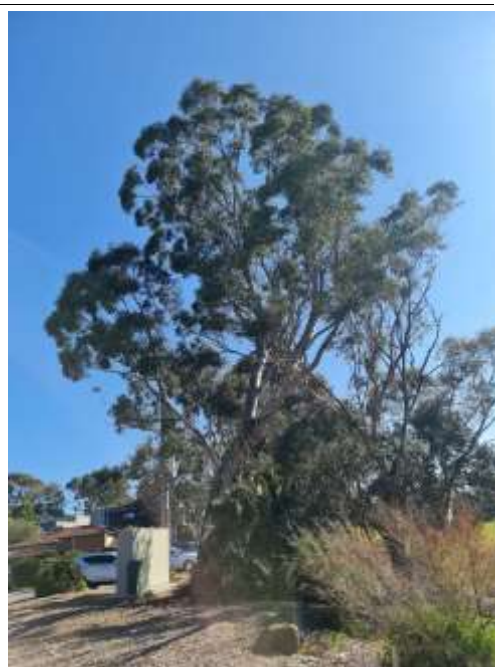
**Tree ID: 683****Genus / species:** *Eucalyptus camaldulensis*

Evergreen River Red Gum

**Retention Value:** Very high**Removal / retention reason:** N/A.**Amenity value:** High**Works Required:** N/A.

**SRZ (m):** 3.7      **Works priority:** N/A  
**TPZ (m):** 13.8      **Construction Proximity:** 0.1  
**mTPZ (m):**

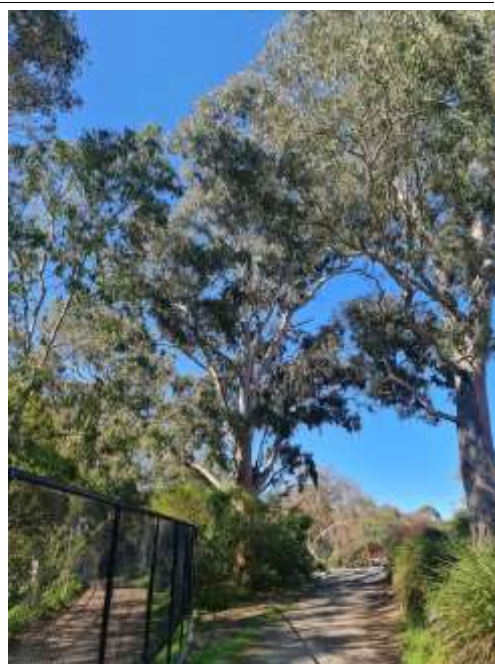
**Tree ID: 684****Genus / species:** *Eucalyptus camaldulensis*

Evergreen River Red Gum

**Height (m):** 14      **Structure:** Fair  
**Width (m):** 8      **Health:** Poor  
**DBH (cm):** 80      **Estimated Maturity:** Over mature  
**Origin:** Melbourne      **ULE (years):** 15 - 30  
**Retained?:** Retained      **Form:** Poor  
**Retention Value:** Low  
**Removal / retention reason:** N/A.  
**Amenity value:** Low  
**Works Required:** N/A.

**SRZ (m):** 3.2      **Works priority:** N/A  
**TPZ (m):** 9.6      **Construction Proximity:** 0.1  
**mTPZ (m):**

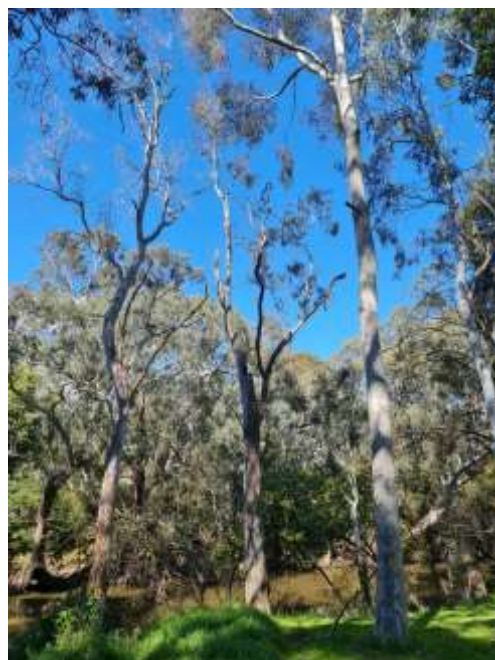
**Tree ID: 685****Genus / species:** *Eucalyptus camaldulensis*

Evergreen River Red Gum

**Height (m):** 22      **Structure:** Good  
**Width (m):** 18      **Health:** Good  
**DBH (cm):** 94      **Measured Maturity:** Mature  
**Origin:** Melbourne      **ULE (years):** > 60  
**Retained?:** Retained      **Form:** Good  
**Retention Value:** Very high  
**Removal / retention reason:** N/A.  
**Amenity value:** High  
**Works Required:** N/A.

**SRZ (m):** 3.4      **Works priority:** N/A  
**TPZ (m):** 11.3      **Construction Proximity:** 0.1  
**mTPZ (m):**

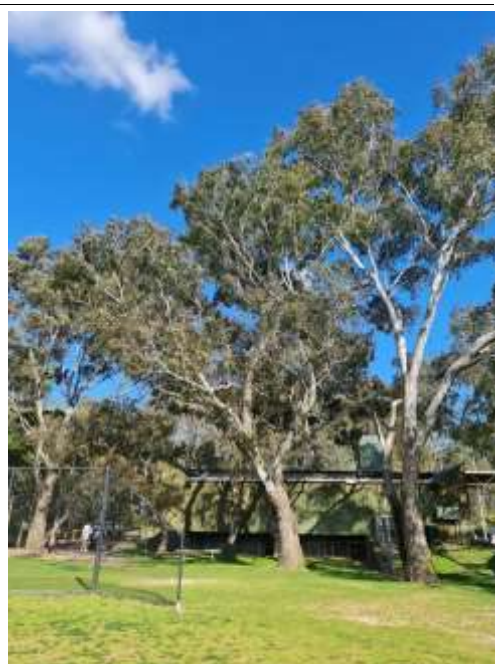
**Tree ID: 686****Genus / species:** *Eucalyptus camaldulensis*

Evergreen River Red Gum

**Height (m):** 22      **Structure:** Good  
**Width (m):** 18      **Health:** Good  
**DBH (cm):** 84      **Measured Maturity:** Mature  
**Origin:** Melbourne      **ULE (years):** > 60  
**Retained?:** Retained      **Form:** Good  
**Retention Value:** Very high  
**Removal / retention reason:** N/A.  
**Amenity value:** High  
**Works Required:** N/A.

**SRZ (m):** 3.3      **Works priority:** N/A  
**TPZ (m):** 10.1      **Construction Proximity:** 0.1  
**mTPZ (m):**

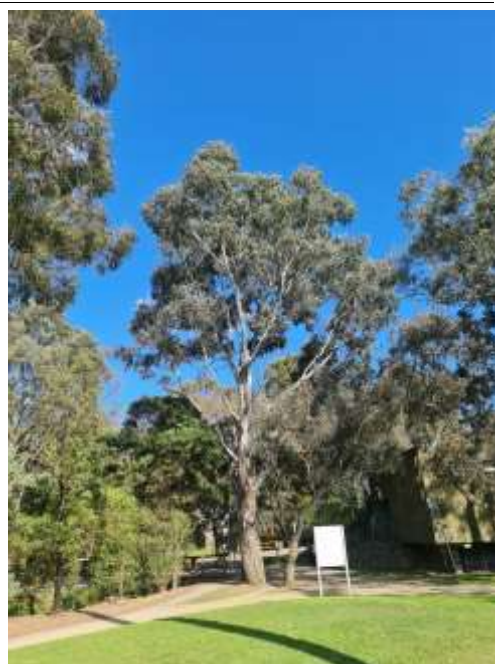
**Tree ID: 687****Genus / species:** *Eucalyptus camaldulensis*

Evergreen River Red Gum

**Retention Value:** Very high**Removal / retention reason:** N/A.**Amenity value:** High**Works Required:** N/A.

**SRZ (m):** 3.4      **Works priority:** N/A  
**TPZ (m):** 10.8      **Construction Proximity:** 0.1  
**mTPZ (m):**

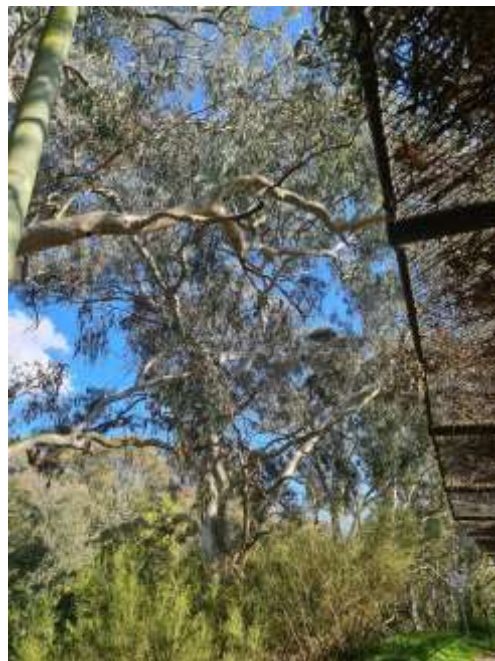
**Tree ID: 688****Genus / species:** *Eucalyptus camaldulensis*

Evergreen River Red Gum

**Retention Value:** Very high**Removal / retention reason:** N/A.**Amenity value:** High**Works Required:** N/A.

**SRZ (m):** 3.5      **Works priority:** N/A  
**TPZ (m):** 12.0      **Construction Proximity:** 0.1  
**mTPZ (m):**

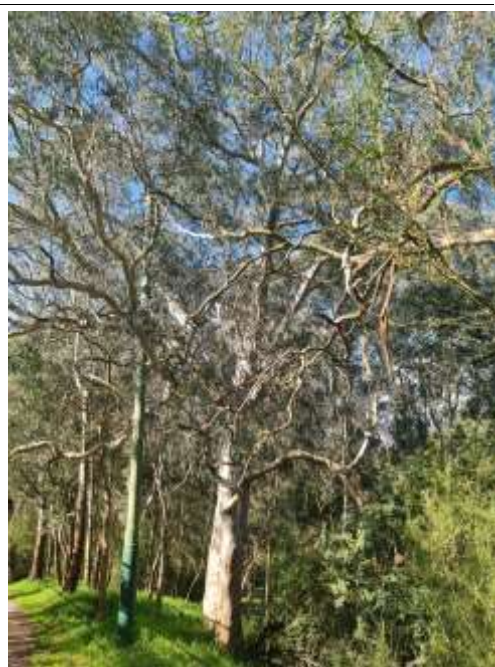
**Tree ID: 690****Genus / species:** *Eucalyptus camaldulensis*

Evergreen River Red Gum

**Retention Value:** Very high**Removal / retention reason:** N/A.**Amenity value:** High**Works Required:** N/A.

**SRZ (m):** 4.1      **Works priority:** N/A  
**TPZ (m):** 15.0      **Construction Proximity:** 0.1  
**mTPZ (m):**

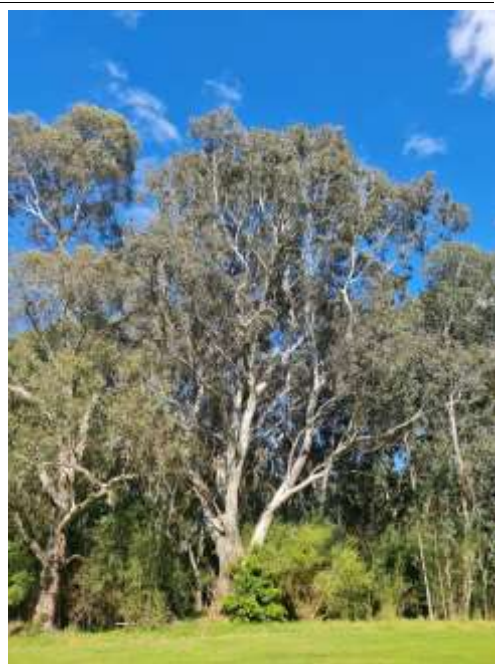
**Tree ID: 691****Genus / species:** *Eucalyptus camaldulensis*

Evergreen River Red Gum

**Retention Value:** Very high**Removal / retention reason:** N/A.**Amenity value:** High**Works Required:** N/A.

**SRZ (m):** 3.4      **Works priority:** N/A  
**TPZ (m):** 10.8      **Construction Proximity:** 0.1  
**mTPZ (m):**

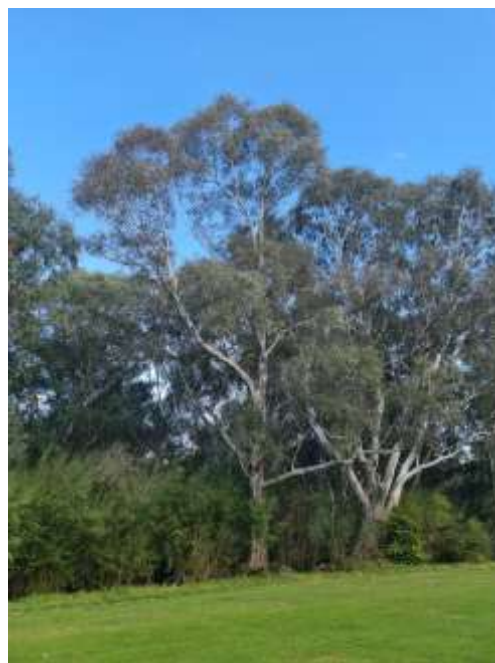
**Tree ID: 692****Genus / species:** *Eucalyptus camaldulensis*

Evergreen River Red Gum

**Retention Value:** High**Removal / retention reason:** N/A.**Amenity value:** High**Works Required:** N/A.

**SRZ (m):** 3.6      **Works priority:** N/A  
**TPZ (m):** 13.2      **Construction Proximity:** 0.1  
**mTPZ (m):**

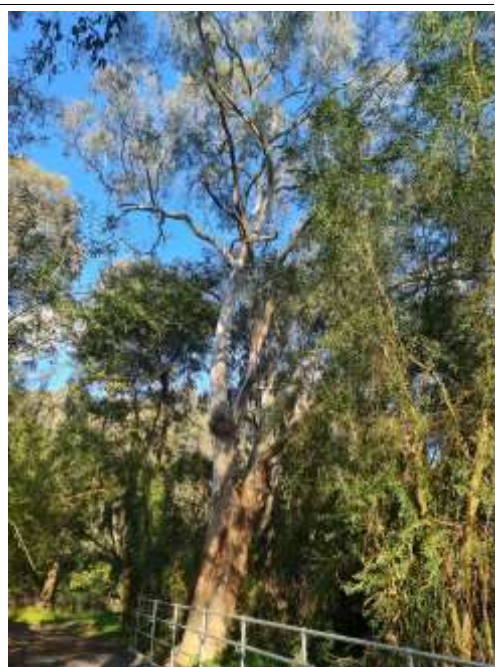
**Tree ID: 693****Genus / species:** *Eucalyptus camaldulensis*

Evergreen River Red Gum

**Retention Value:** Very high**Removal / retention reason:** N/A.**Amenity value:** High**Works Required:** N/A.

**SRZ (m):** 3.7      **Works priority:** N/A  
**TPZ (m):** 13.3      **Construction Proximity:** 0.1  
**mTPZ (m):**

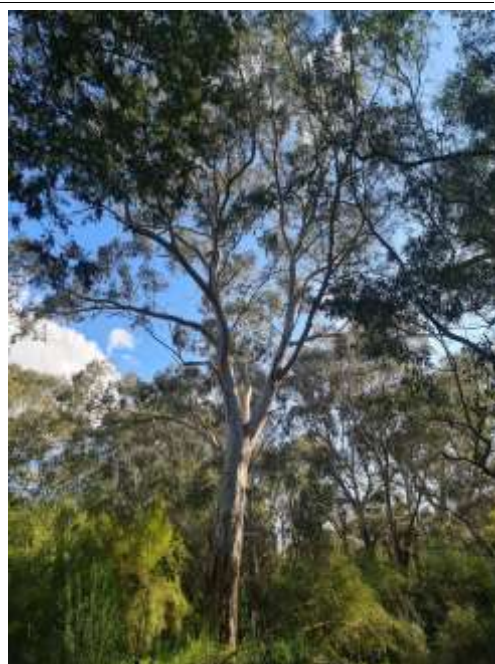
**Tree ID: 694****Genus / species:** *Eucalyptus camaldulensis*

Evergreen River Red Gum

**Retention Value:** Very high**Removal / retention reason:** N/A.**Amenity value:** High**Works Required:** N/A.

<b>SRZ (m):</b>	3.2	<b>Works priority:</b>	N/A
<b>TPZ (m):</b>	9.6	<b>Construction Proximity:</b>	0.1
<b>mTPZ (m):</b>

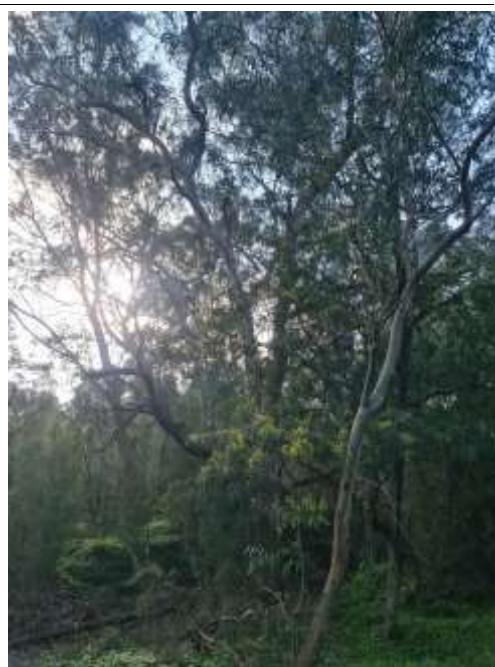
**Tree ID: 696****Genus / species:** *Eucalyptus camaldulensis*

**Retention Value:** High**Removal / retention reason:** N/A.**Amenity value:** High**Works Required:** N/A.

<b>SRZ (m):</b>	4.2	<b>Works priority:</b>	N/A
<b>TPZ (m):</b>	15.0	<b>Construction Proximity:</b>	0.1
<b>mTPZ (m):</b>

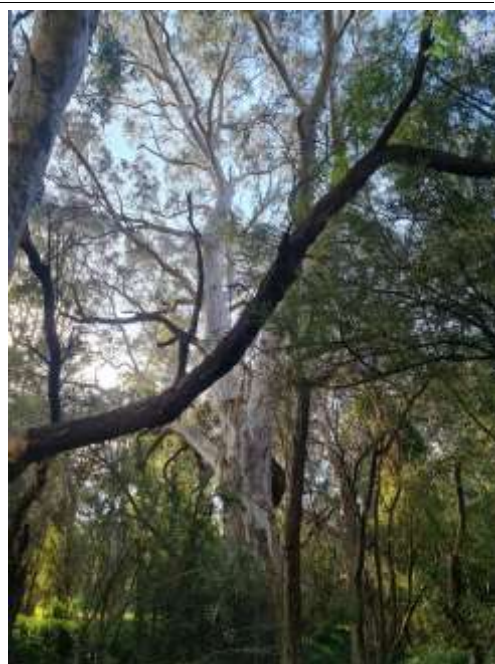
**Tree ID: 697****Genus / species:** *Eucalyptus camaldulensis*

**Retention Value:** Very high**Removal / retention reason:** N/A.**Amenity value:** High**Works Required:** N/A.

**SRZ (m):** 3.5      **Works priority:** N/A  
**TPZ (m):** 12.0      **Construction Proximity:** 0.1  
**mTPZ (m):**

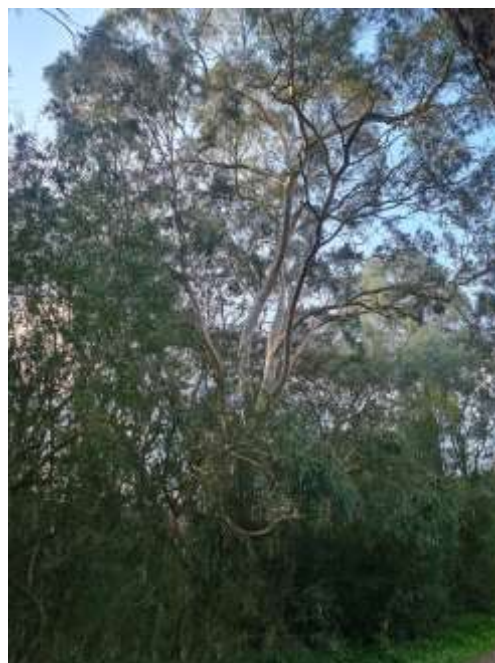
**Tree ID: 698****Genus / species:** *Eucalyptus camaldulensis*

**Retention Value:** Very high**Removal / retention reason:** N/A.**Amenity value:** High**Works Required:** N/A.

**SRZ (m):** 3      **Works priority:** N/A  
**TPZ (m):** 8.6      **Construction Proximity:** 0.1  
**mTPZ (m):**

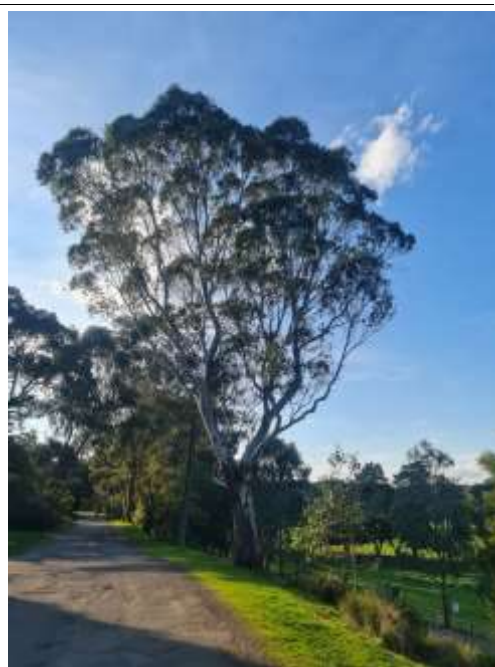
**Tree ID: 699****Genus / species:** *Eucalyptus camaldulensis*

**Retention Value:** Very high**Removal / retention reason:** N/A.**Amenity value:** High**Works Required:** N/A.

**SRZ (m):** 3.5      **Works priority:** N/A  
**TPZ (m):** 11.6      **Construction Proximity:** 0.1  
**mTPZ (m):**

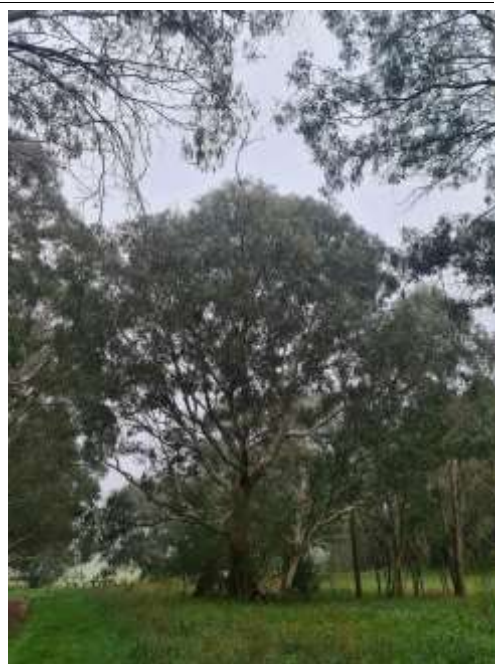
**Tree ID: 700****Genus / species:** *Eucalyptus camaldulensis*

**Retention Value:** Very high**Removal / retention reason:** N/A.**Amenity value:** High**Works Required:** N/A.

**SRZ (m):** 3.5      **Works priority:** N/A  
**TPZ (m):** 11.6      **Construction Proximity:** 0.1  
**mTPZ (m):**

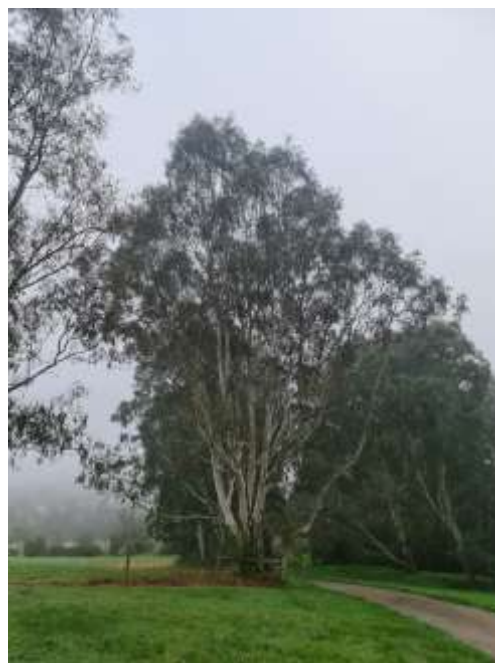
**Tree ID: 701****Genus / species:** *Eucalyptus camaldulensis*

**Retention Value:** Very high**Removal / retention reason:** N/A.**Amenity value:** High**Works Required:** N/A.

**SRZ (m):** 3.2      **Works priority:** N/A  
**TPZ (m):** 9.4      **Construction Proximity:** 0.1  
**mTPZ (m):**

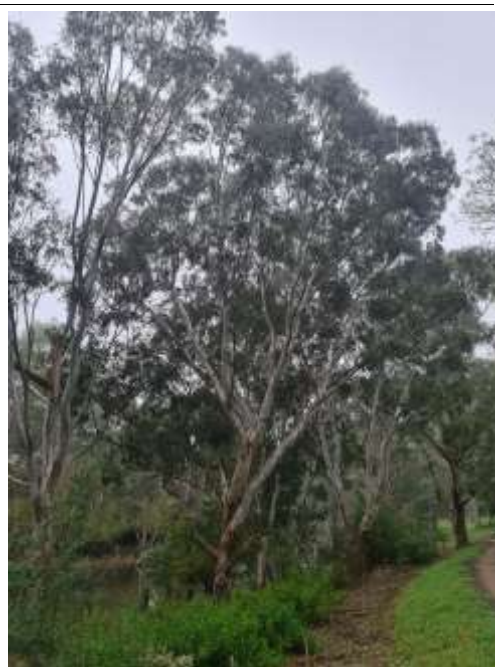
**Tree ID: 702****Genus / species:** *Eucalyptus camaldulensis*

**Retention Value:** Moderate**Removal / retention reason:** N/A.**Amenity value:** Moderate**Works Required:** N/A.

**SRZ (m):** 2.7      **Works priority:** N/A  
**TPZ (m):** 6.6      **Construction Proximity:** 0.1  
**mTPZ (m):**

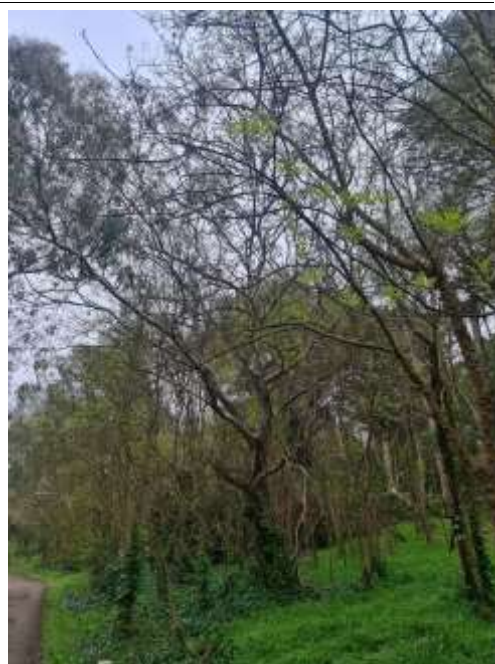
**Tree ID: 703****Genus / species:** *Eucalyptus camaldulensis*

**Retention Value:** Very high**Removal / retention reason:** N/A.**Amenity value:** High**Works Required:** N/A.

**SRZ (m):** 3.2      **Works priority:** N/A  
**TPZ (m):** 9.5      **Construction Proximity:** 0.1  
**mTPZ (m):**

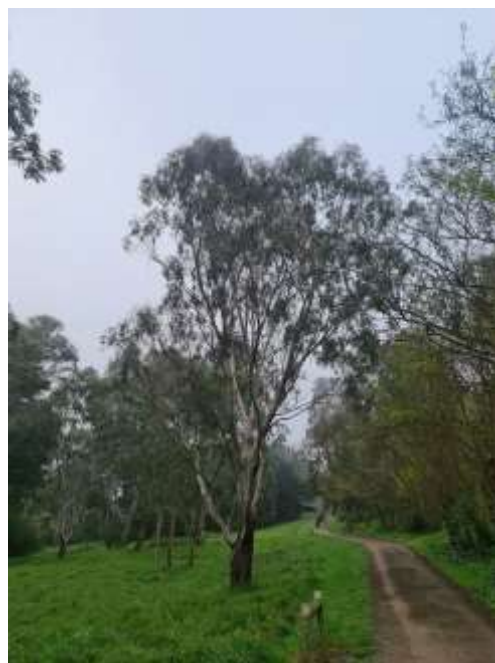
**Tree ID: 704****Genus / species:** *Eucalyptus camaldulensis*

**Retention Value:** Very high**Removal / retention reason:** N/A.**Amenity value:** High**Works Required:** N/A.

**SRZ (m):** 3.9      **Works priority:** N/A  
**TPZ (m):** 15.0      **Construction Proximity:** 0.1  
**mTPZ (m):**

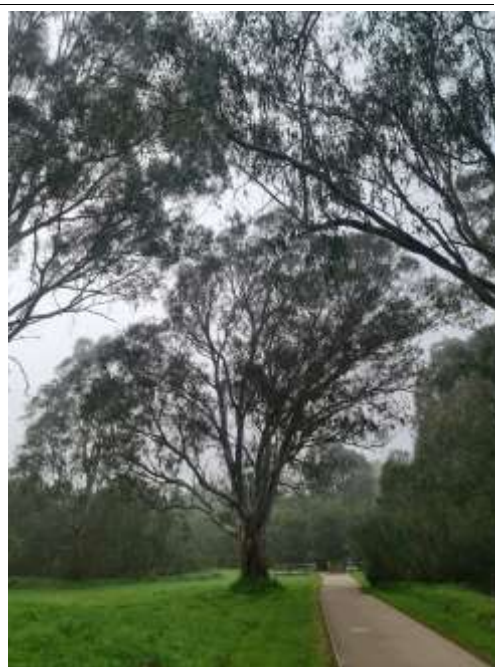
**Tree ID: 705****Genus / species:** *Eucalyptus camaldulensis*

**Retention Value:** Moderate**Removal / retention reason:** N/A.**Amenity value:** Moderate**Works Required:** N/A.

**SRZ (m):** 2.8      **Works priority:** N/A  
**TPZ (m):** 7.1      **Construction Proximity:** 0.1  
**mTPZ (m):**

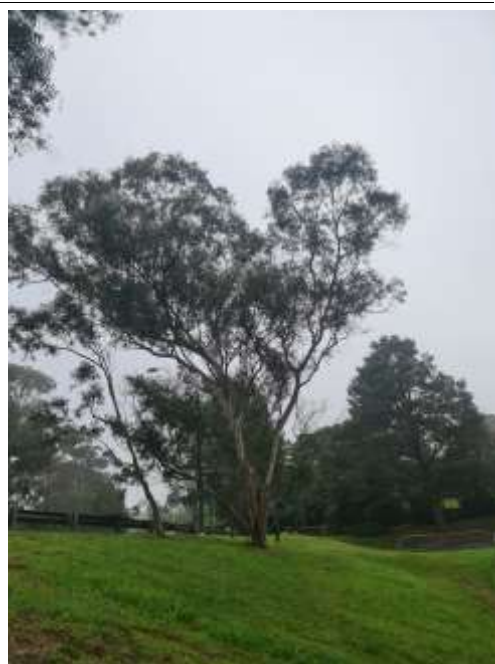
**Tree ID: 706****Genus / species:** *Eucalyptus camaldulensis*

**Height (m):** 7      **Structure:** Good  
**Width (m):** 4      **Health:** Good  
**DBH (cm):** 16 Measured **Maturity:** Immature  
**Origin:** Melbourne **ULE (years):** > 60  
**Retained?:** Retained **Form:** Good  
**Retention Value:** Moderate  
**Removal / retention reason:** N/A.  
**Amenity value:** Low  
**Works Required:** N/A.

**SRZ (m):** 1.6      **Works priority:** N/A  
**TPZ (m):** 2.0      **Construction Proximity:** 0.1  
**mTPZ (m):**

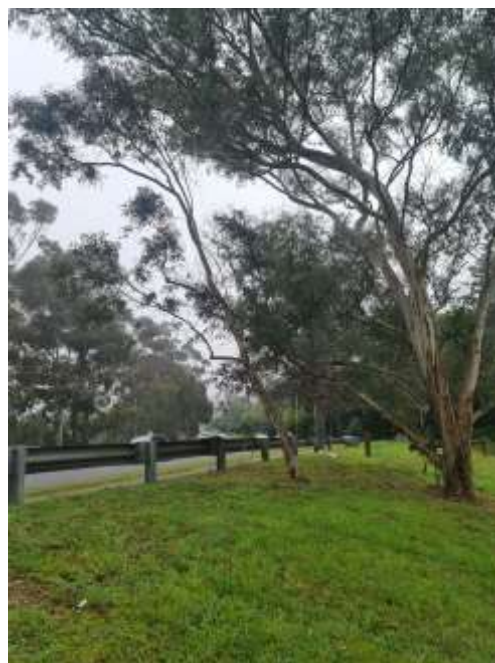
**Tree ID: 707****Genus / species:** *Eucalyptus melliodora*

**Height (m):** 16      **Structure:** Good  
**Width (m):** 13      **Health:** Good  
**DBH (cm):** 99 Measured **Maturity:** Mature  
**Origin:** Melbourne **ULE (years):** > 60  
**Retained?:** Retained **Form:** Good  
**Retention Value:** Very high  
**Removal / retention reason:** N/A.  
**Amenity value:** High  
**Works Required:** N/A.

**SRZ (m):** 3.5      **Works priority:** N/A  
**TPZ (m):** 11.9      **Construction Proximity:** 0.1  
**mTPZ (m):**

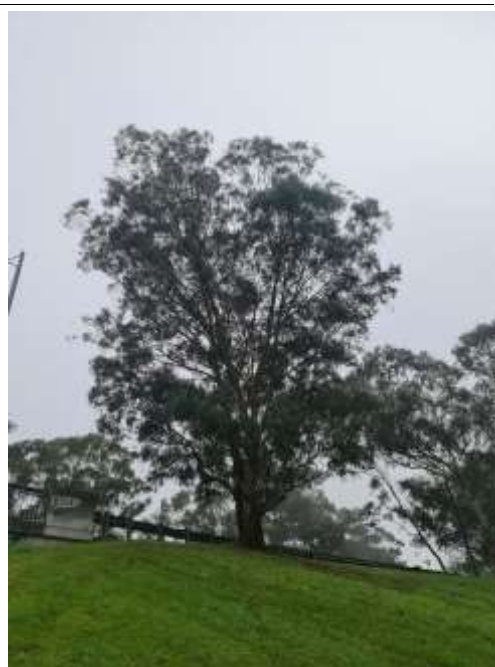
**Tree ID: 708****Genus / species:** *Eucalyptus camaldulensis*

**Height (m):** 29      **Structure:** Good  
**Width (m):** 20      **Health:** Good  
**DBH (cm):** 99 Measured **Maturity:** Mature  
**Origin:** Melbourne **ULE (years):** > 60  
**Retained?:** Retained **Form:** Good  
**Retention Value:** Very high  
**Removal / retention reason:** N/A.  
**Amenity value:** High  
**Works Required:** N/A.

**SRZ (m):** 3.5      **Works priority:** N/A  
**TPZ (m):** 11.9      **Construction Proximity:** 0.1  
**mTPZ (m):**

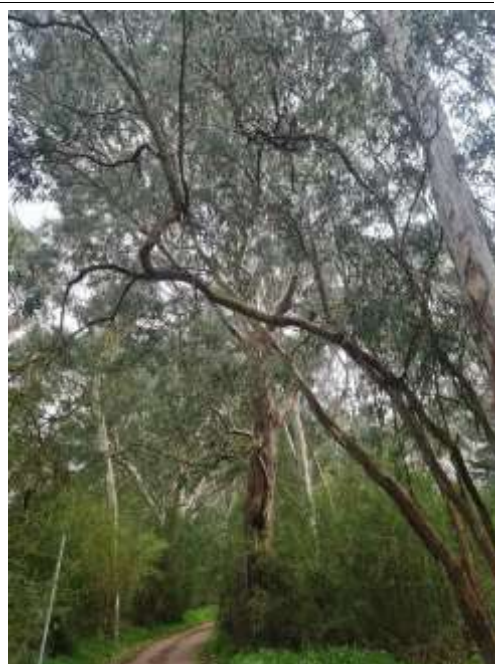
**Tree ID: 709****Genus / species:** *Eucalyptus camaldulensis*

**Retention Value:** Very high**Removal / retention reason:** N/A.**Amenity value:** High**Works Required:** N/A.

**SRZ (m):** 3.5      **Works priority:** N/A  
**TPZ (m):** 11.9      **Construction Proximity:** 0.1  
**mTPZ (m):**

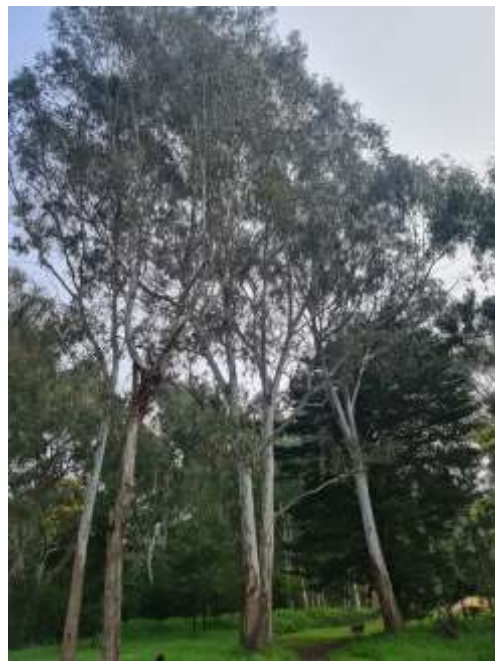
**Tree ID: 710****Genus / species:** *Eucalyptus camaldulensis*

**Retention Value:** Very high**Removal / retention reason:** N/A.**Amenity value:** High**Works Required:** N/A.

**SRZ (m):** 4      **Works priority:** N/A  
**TPZ (m):** 15.0      **Construction Proximity:** 0.1  
**mTPZ (m):**

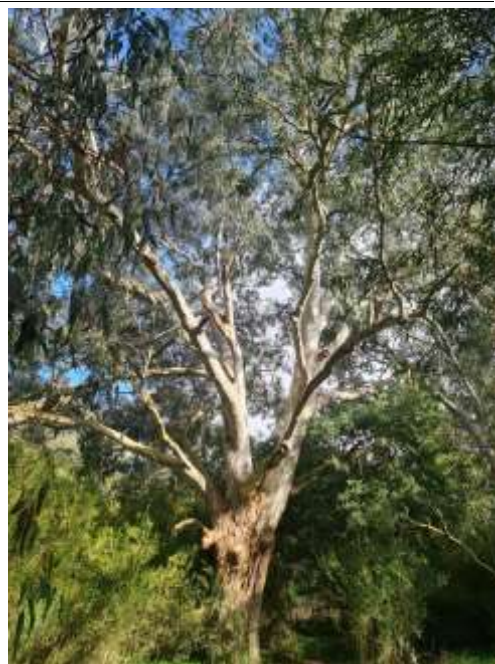
**Tree ID: 711****Genus / species:** *Eucalyptus camaldulensis*

**Retention Value:** Very high**Removal / retention reason:** N/A.**Amenity value:** High**Works Required:** N/A.

**SRZ (m):** 4.1      **Works priority:** N/A  
**TPZ (m):** 15.0      **Construction Proximity:** 0.1  
**mTPZ (m):**

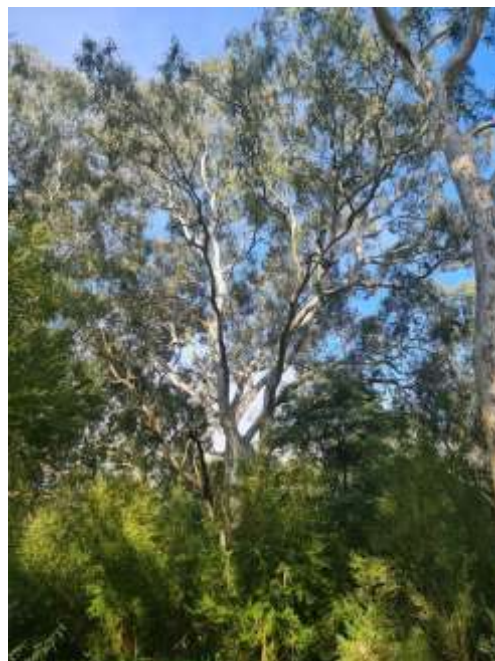
**Tree ID: 712****Genus / species:** *Eucalyptus camaldulensis*

**Retention Value:** Very high**Removal / retention reason:** N/A.**Amenity value:** High**Works Required:** N/A.

**SRZ (m):** 4.1      **Works priority:** N/A  
**TPZ (m):** 15.0      **Construction Proximity:** 0.1  
**mTPZ (m):**

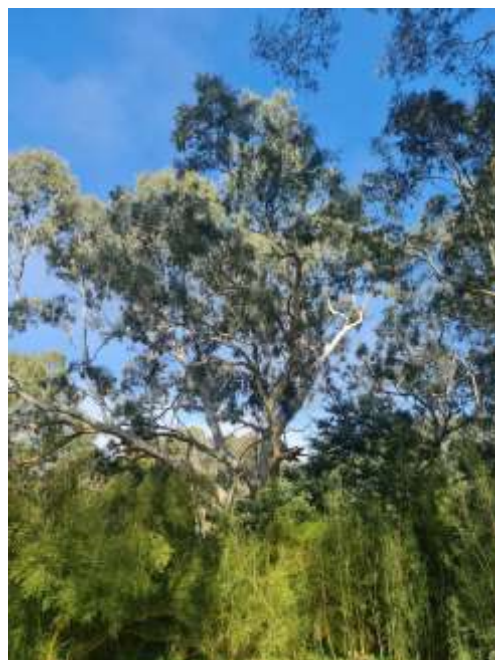
**Tree ID: 713****Genus / species:** *Eucalyptus camaldulensis*

**Retention Value:** Very high**Removal / retention reason:** N/A.**Amenity value:** High**Works Required:** N/A.

**SRZ (m):** 3.7      **Works priority:** N/A  
**TPZ (m):** 13.9      **Construction Proximity:** 0.1  
**mTPZ (m):**

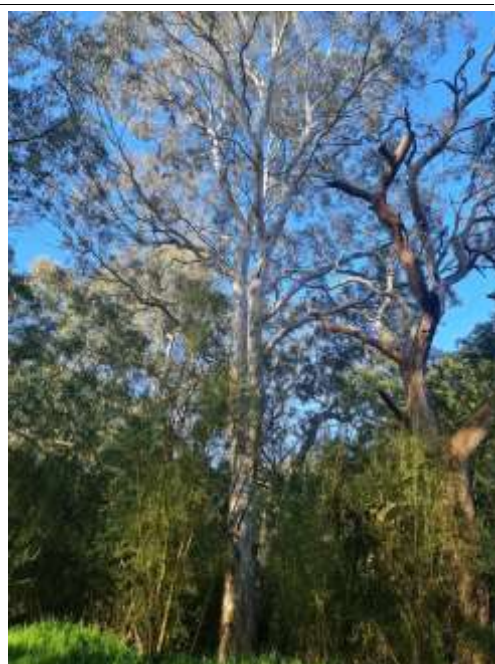
**Tree ID: 714****Genus / species:** *Eucalyptus camaldulensis*

**Retention Value:** Very high**Removal / retention reason:** N/A.**Amenity value:** High**Works Required:** N/A.

**SRZ (m):** 3.4      **Works priority:** N/A  
**TPZ (m):** 10.8      **Construction Proximity:** 0.1  
**mTPZ (m):**

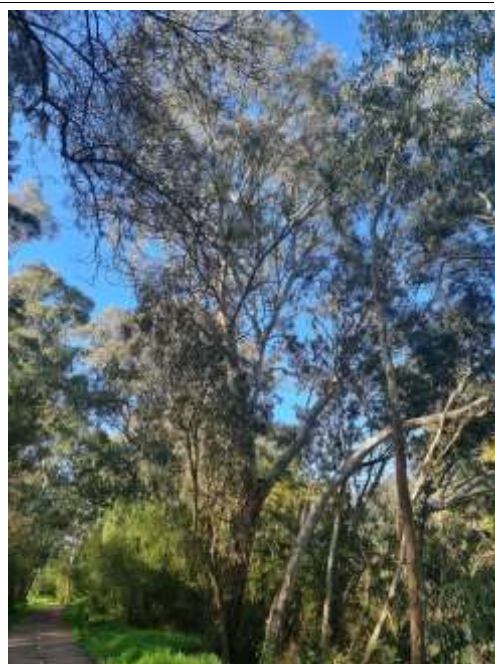
**Tree ID:** 715

**Genus / species:** *Eucalyptus camaldulensis*

**TPZ (m):** 11.0 **Construction Proximity:** 0.1
