Quantification of coastal bank erosion rates in Western Port

Final report

April 2014

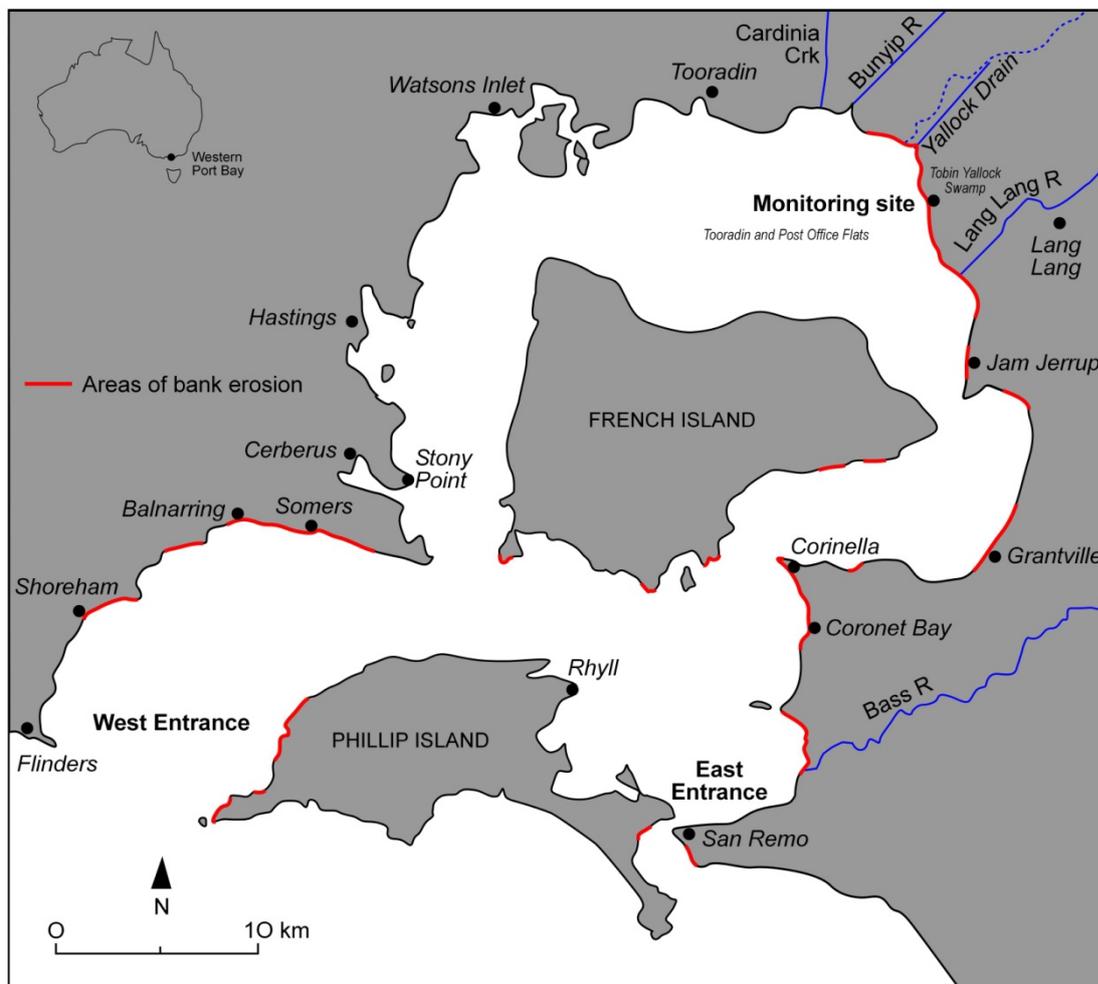
Figure 1. Western Port (also known as Westernport Bay) showing the major areas of coastal erosion in red identified from the latest Google Earth imagery. Coastal erosion includes beach erosion, erosion of sand dunes on the foreshore and erosion of clay banks such as at the monitoring site near Lang Lang.

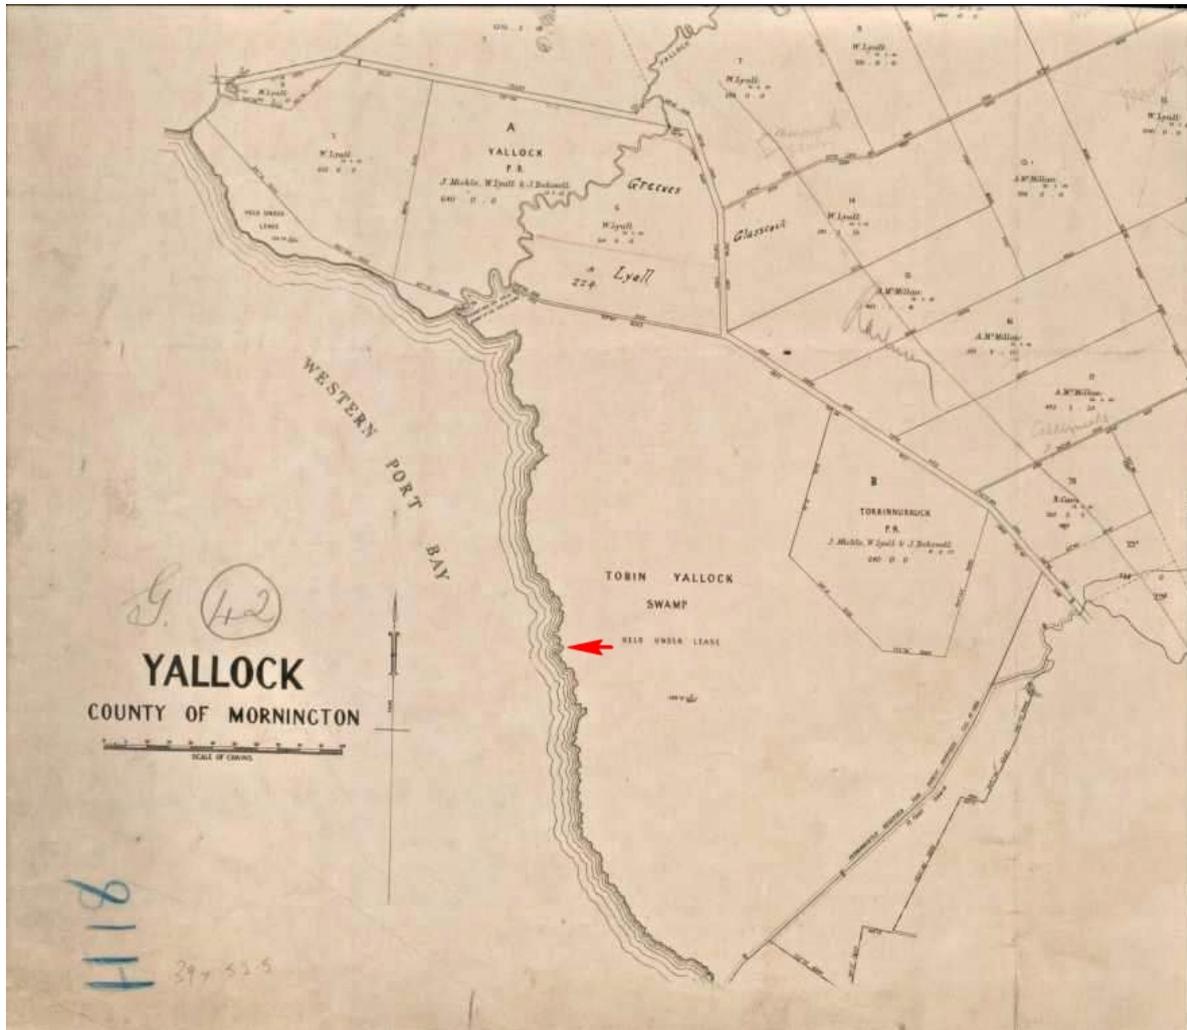
Figure 2. 1888 Department of Crown Lands and Survey Yallock Parish map, showing the Lang Lang River channel (bottom-right), Yallock Creek (top-centre) and a strongly crenulated coastline. The approximate location of the monitoring site is indicated by the red arrow.

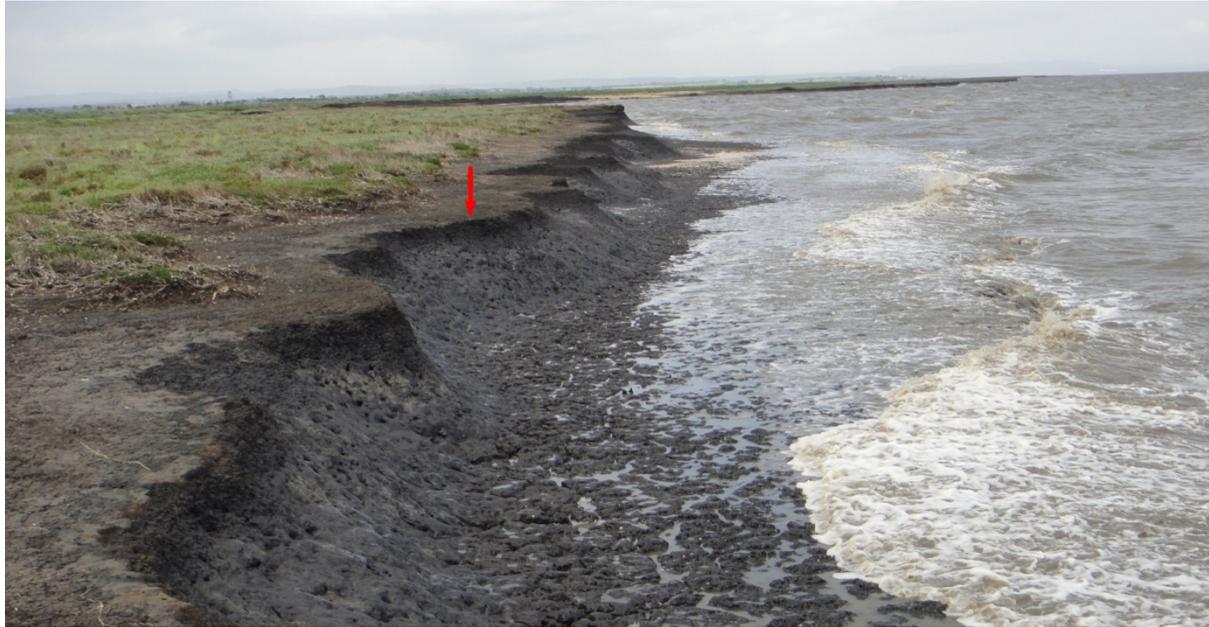
Figure 3. Typical bank profile where the vegetation and uppermost sediment has been stripped back from the bank edge exposing a distinctive thin reddish unit overlying massive grey clays. The true edge of the banks is indicated by the red arrow.

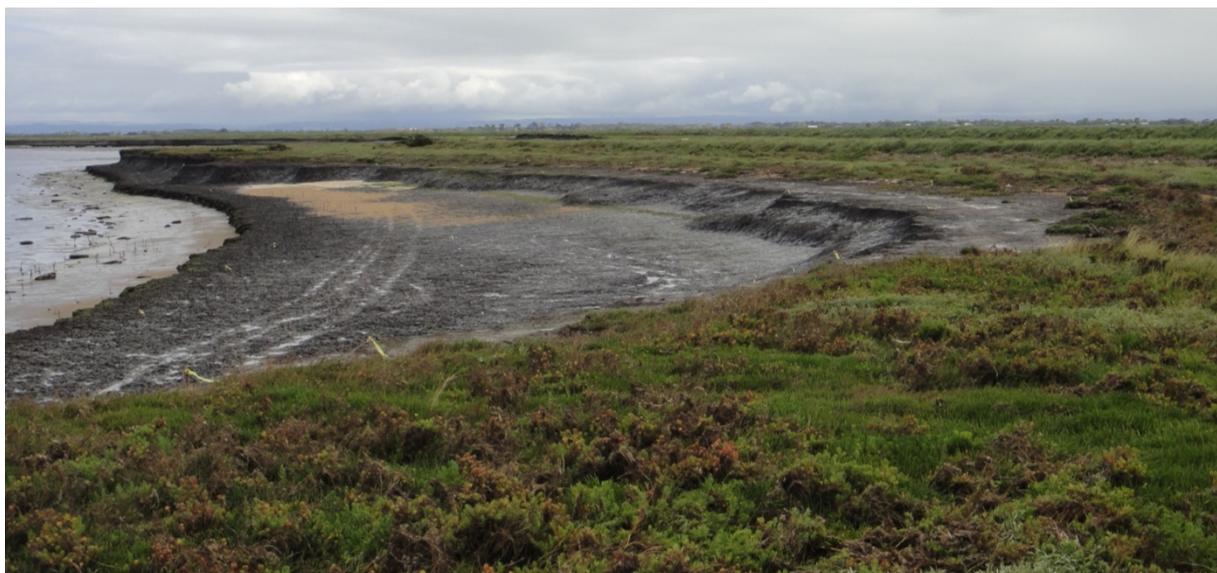
Figure 4. View of the monitoring site at low tide looking north. In the image is a small crenulation with steeply sloping upper banks, a lower bench of ~ 0.5 m high, eroded material on the tidal flats (clay balls) and vertical-benched banks in the distance.

The site that was selected is ~ 800 m north of the main road/track access point to the coastline. It included a small crenulation and two headlands covering a distance of 175 m (UTM, 0368347, 5764251) (Fig. 4). The site was deemed to be representative of the Lang Lang coastline and hence would provide: i) reliable estimates of erosion rates that are transferable to other areas of the coastline, ii) a good understanding of the conditions during which erosion takes place, and iii) a good understanding of the erosion processes acting on all of the main geomorphic units.

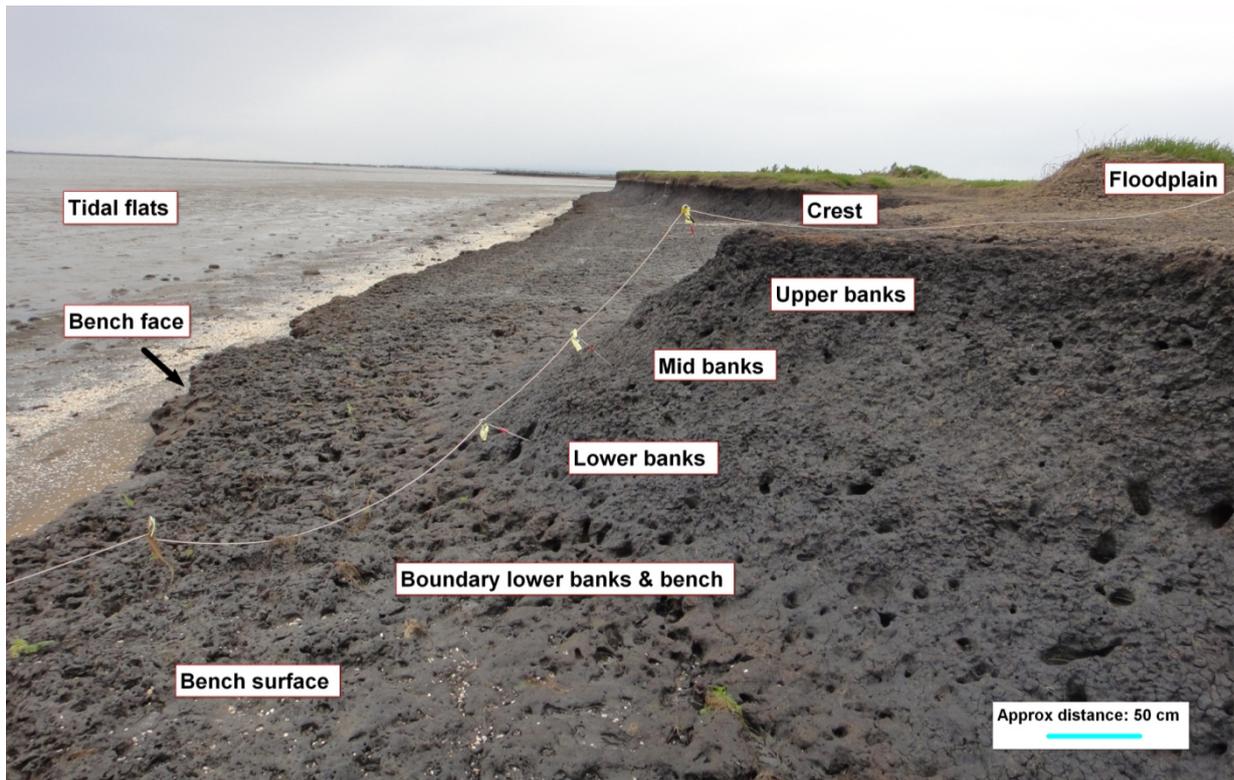
Figure 5. Example of one of the erosion pin transects, showing the geomorphic units identified. The units were also used to classify the heights reached during each high tide.

One hundred 1 m stainless steel erosion pins were installed at the monitoring site to obtain point measurements of erosion over time (Fig. 5). The erosion pins were organised into 12 profiles (or transects), that extend around the crenulation and adjacent headlands. Between 7 and 10 pins were used per profile, positioned according to the geometry of the banks and pushed into the banks perpendicular to the surface. The first and last pins in the profile were positioned on the floodplain at the edge of the vegetation, and in the tidal flat, respectively. For these pins, 20 cm was left exposed. For all other pins, 10 cm was left exposed. All erosion pins were identified with stainless steel tags numbered from 0 to 100 and tied together with rope to prevent any losses. A tape and clinometer survey of the profiles was also undertaken to define the geometry of the banks and note the position and number of the erosion pins in each profile.

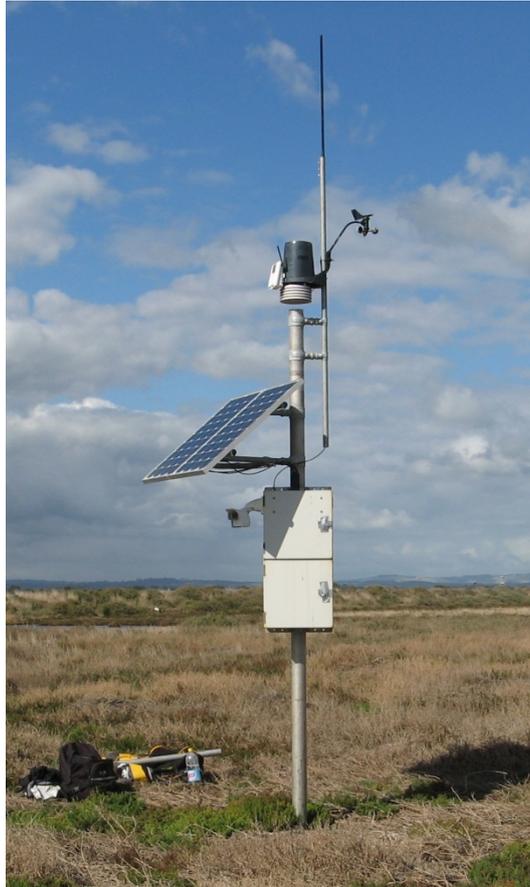
Figure 6. Monitoring camera, solar panels and weather station installed at the site.

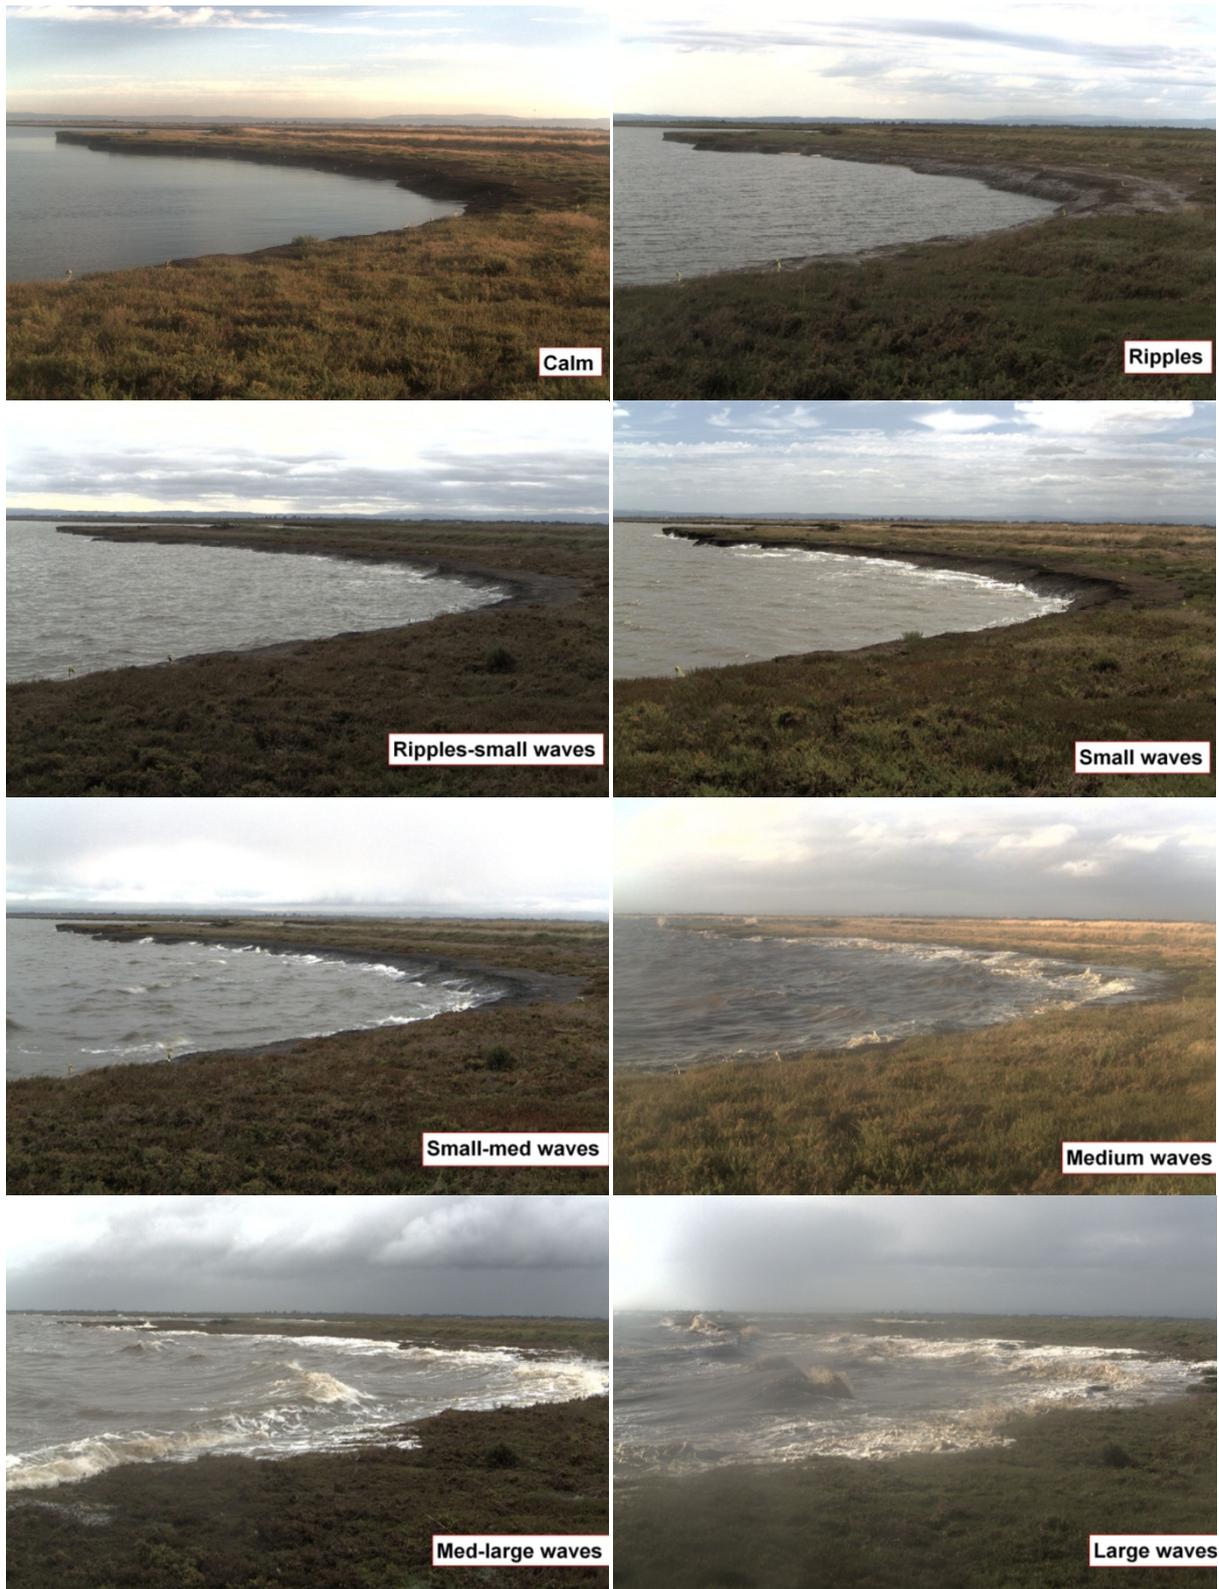
Figure 7. Examples of the classification system used to characterise the wave conditions during each high tide.

The camera images were analysed to determine changes in the banks over the 12 months. The images were also analysed to characterise the height reached during each high tide (using the classification shown in Fig. 5) and the prevailing wave conditions during each high tide (using the classification shown in Fig. 7).

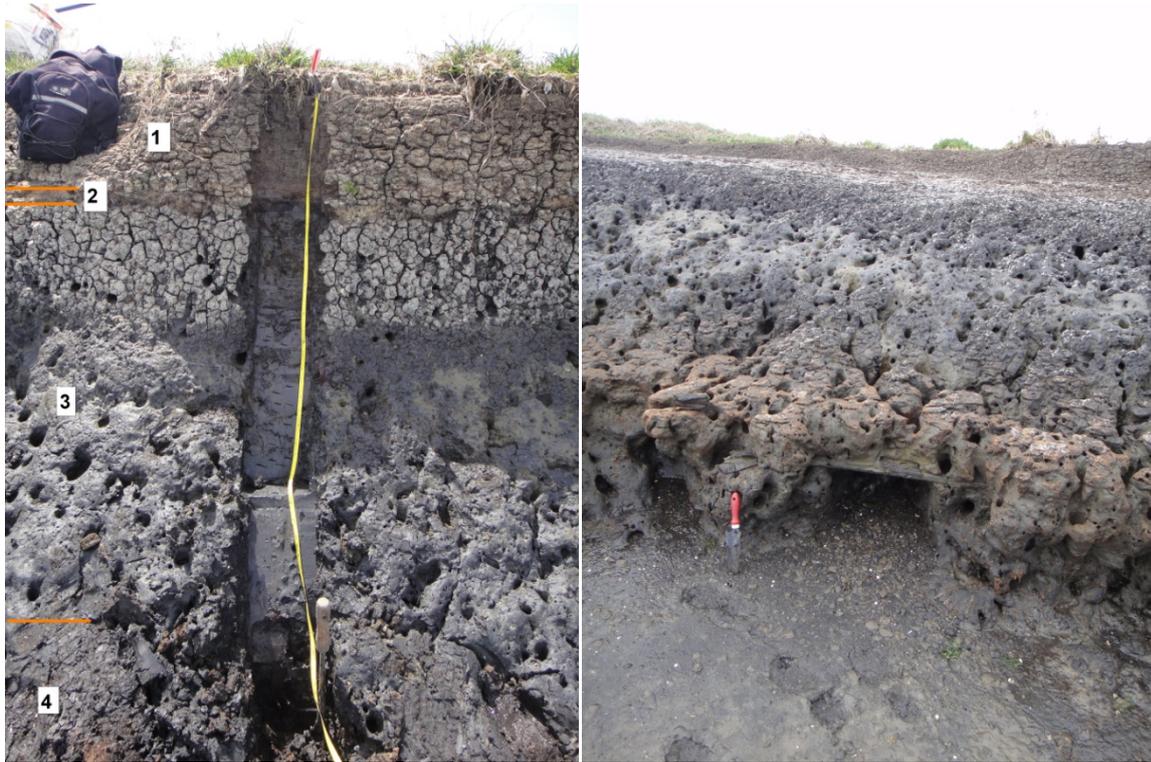
Figure 8. Left: Bank profile sampled at the monitoring site showing 4 of the 5 sedimentary layers and prominent surface cracking. Right: Bank profile near the Lang Lang River, with a large piece of buried wood marking the boundary between a red-brown organic-rich clay layer and the lowermost grey clay unit.

A bank exposure at the monitoring site was analysed to characterise the sedimentary layers and obtain samples for laboratory analysis (Fig. 8). In-situ coring was also undertaken to provide additional stratigraphically-intact samples, however, the coring had poor results. Core retrieval proved unsuccessful for a number of cores with the sediment failing to stay in the core barrel, whereas the retrieved cores were compressed both through hammering the corer into the ground and removing the core from the barrel. No deep cores (≥ 2 m) were successfully retrieved.

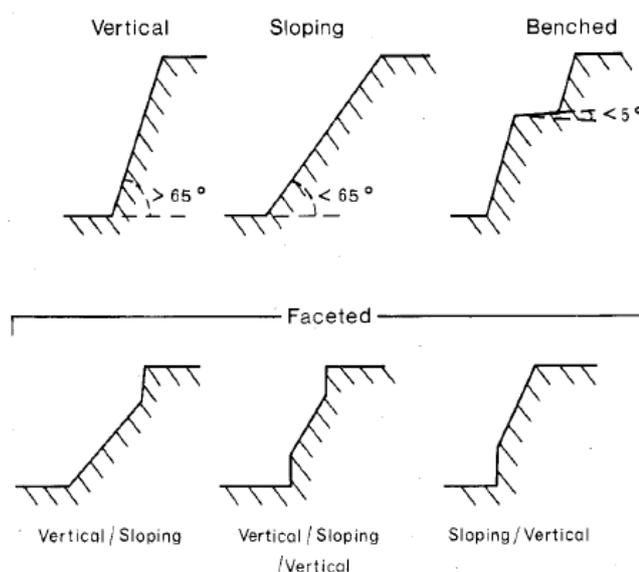
Figure 9. Generic classification of bank slope profiles (Source: Crouch, 1987).

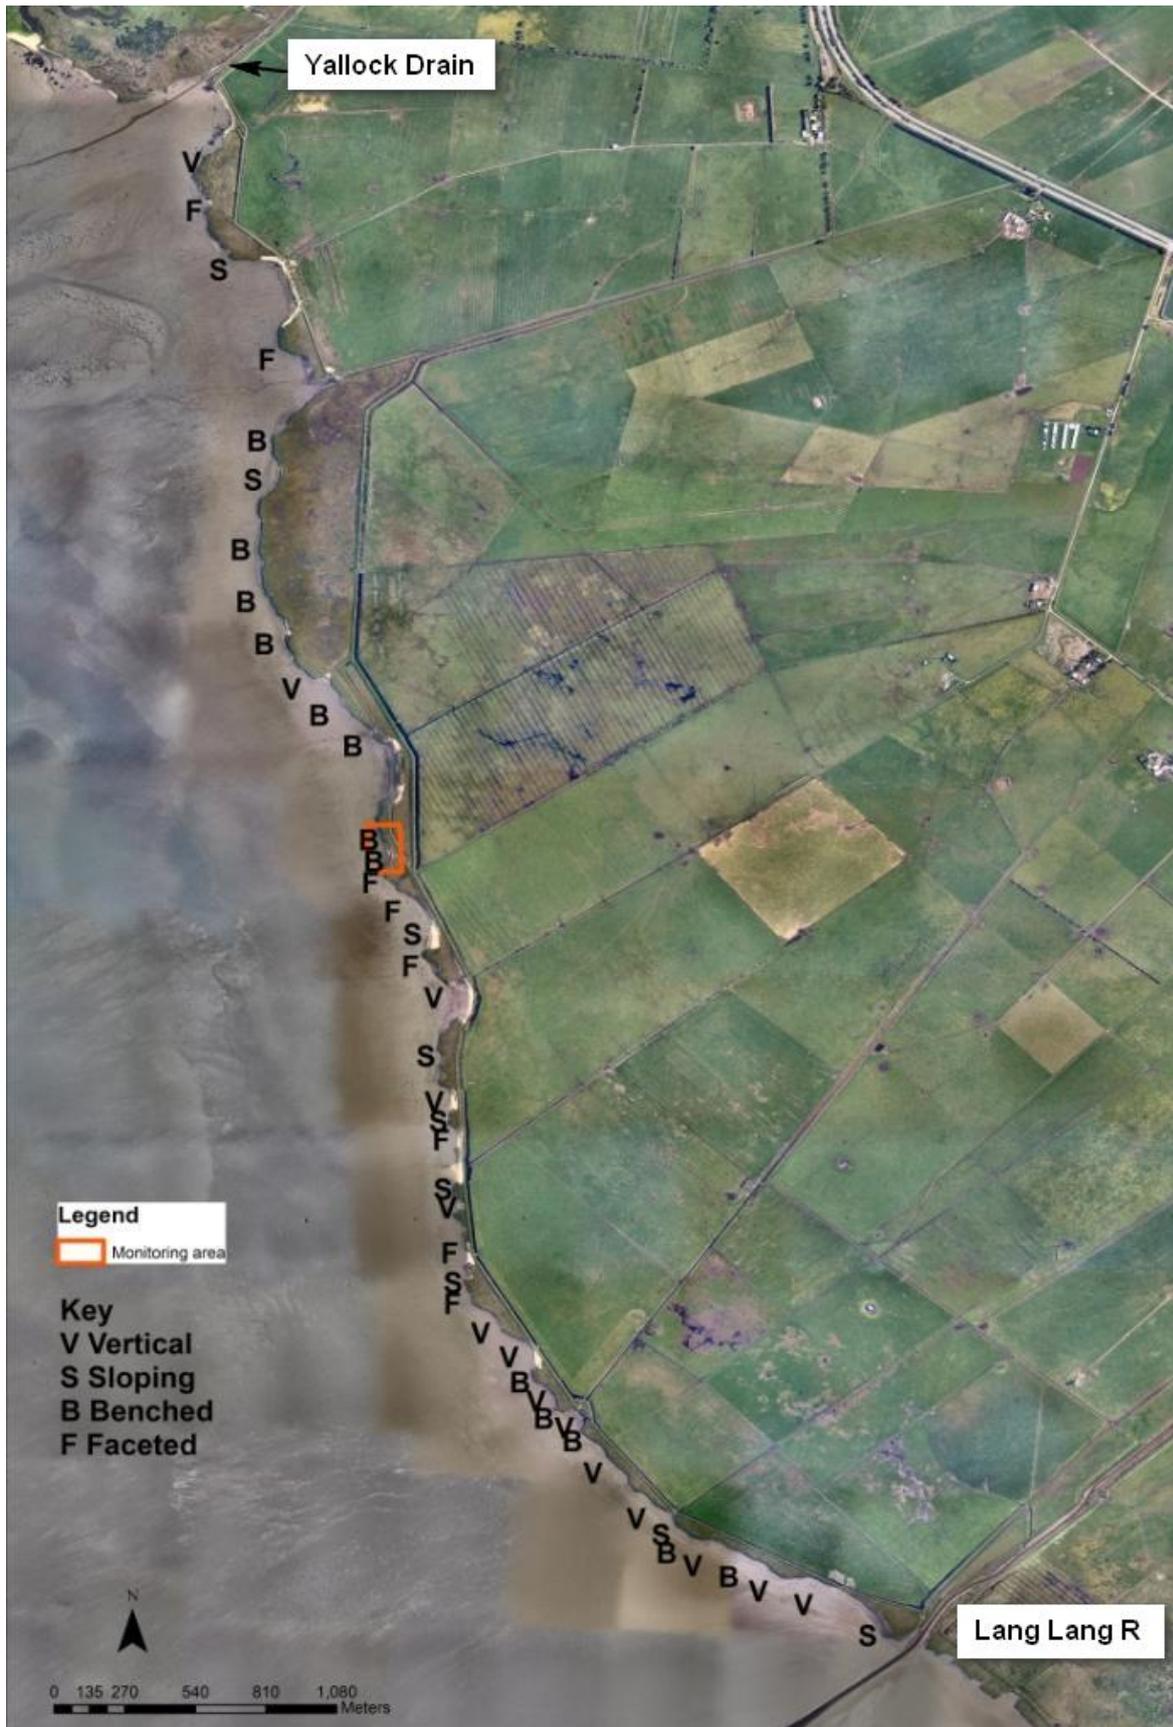
Figure 10. Classification of bank profiles between the Yallock Drain and the Lang Lang River.

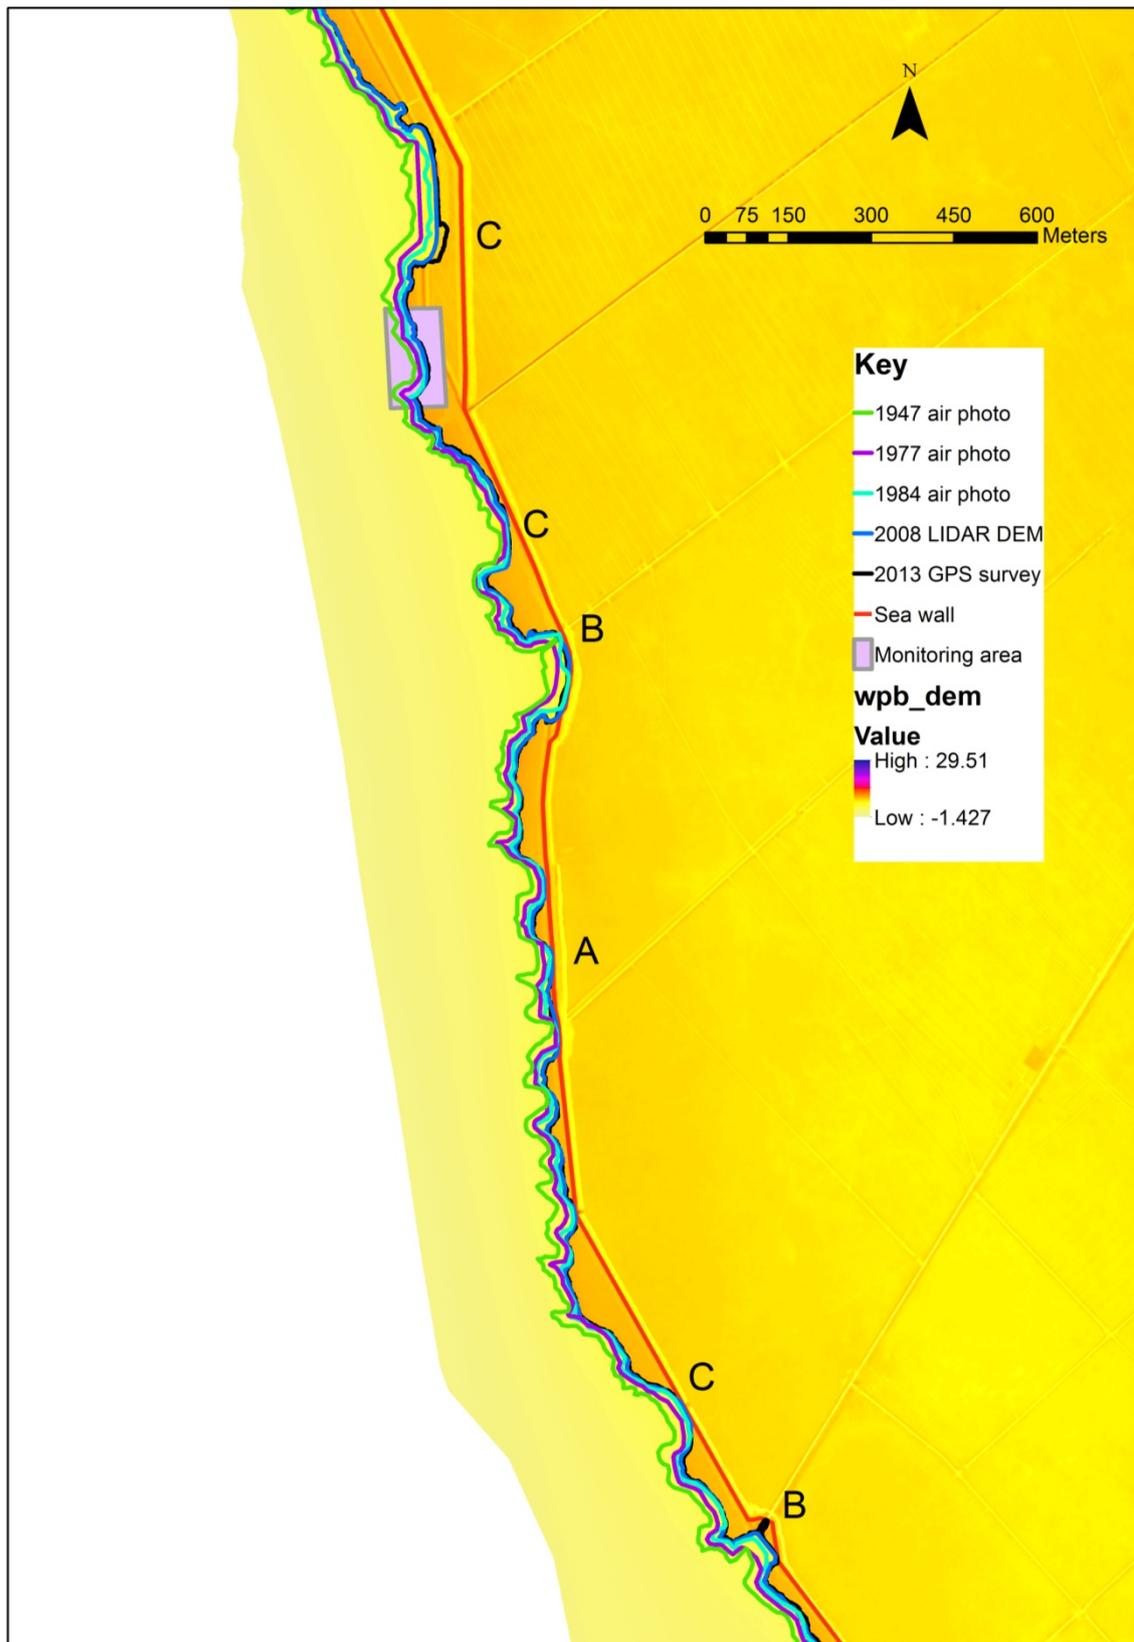
Figure 11. Snap-shot of the historical air photo analysis showing the smoothing of the headlands and retreat of the banks over time. Labels are as follows: 'A' indicates the general area where there has been pronounced smoothing of headlands and crenulations over time; 'B' indicates areas of enhanced erosion due to the drain outlets; 'C' indicates the very large crenulations which are, or have in the past, threatened the sea wall. The air photo mapping indicates the position of the upper edge of the banks.

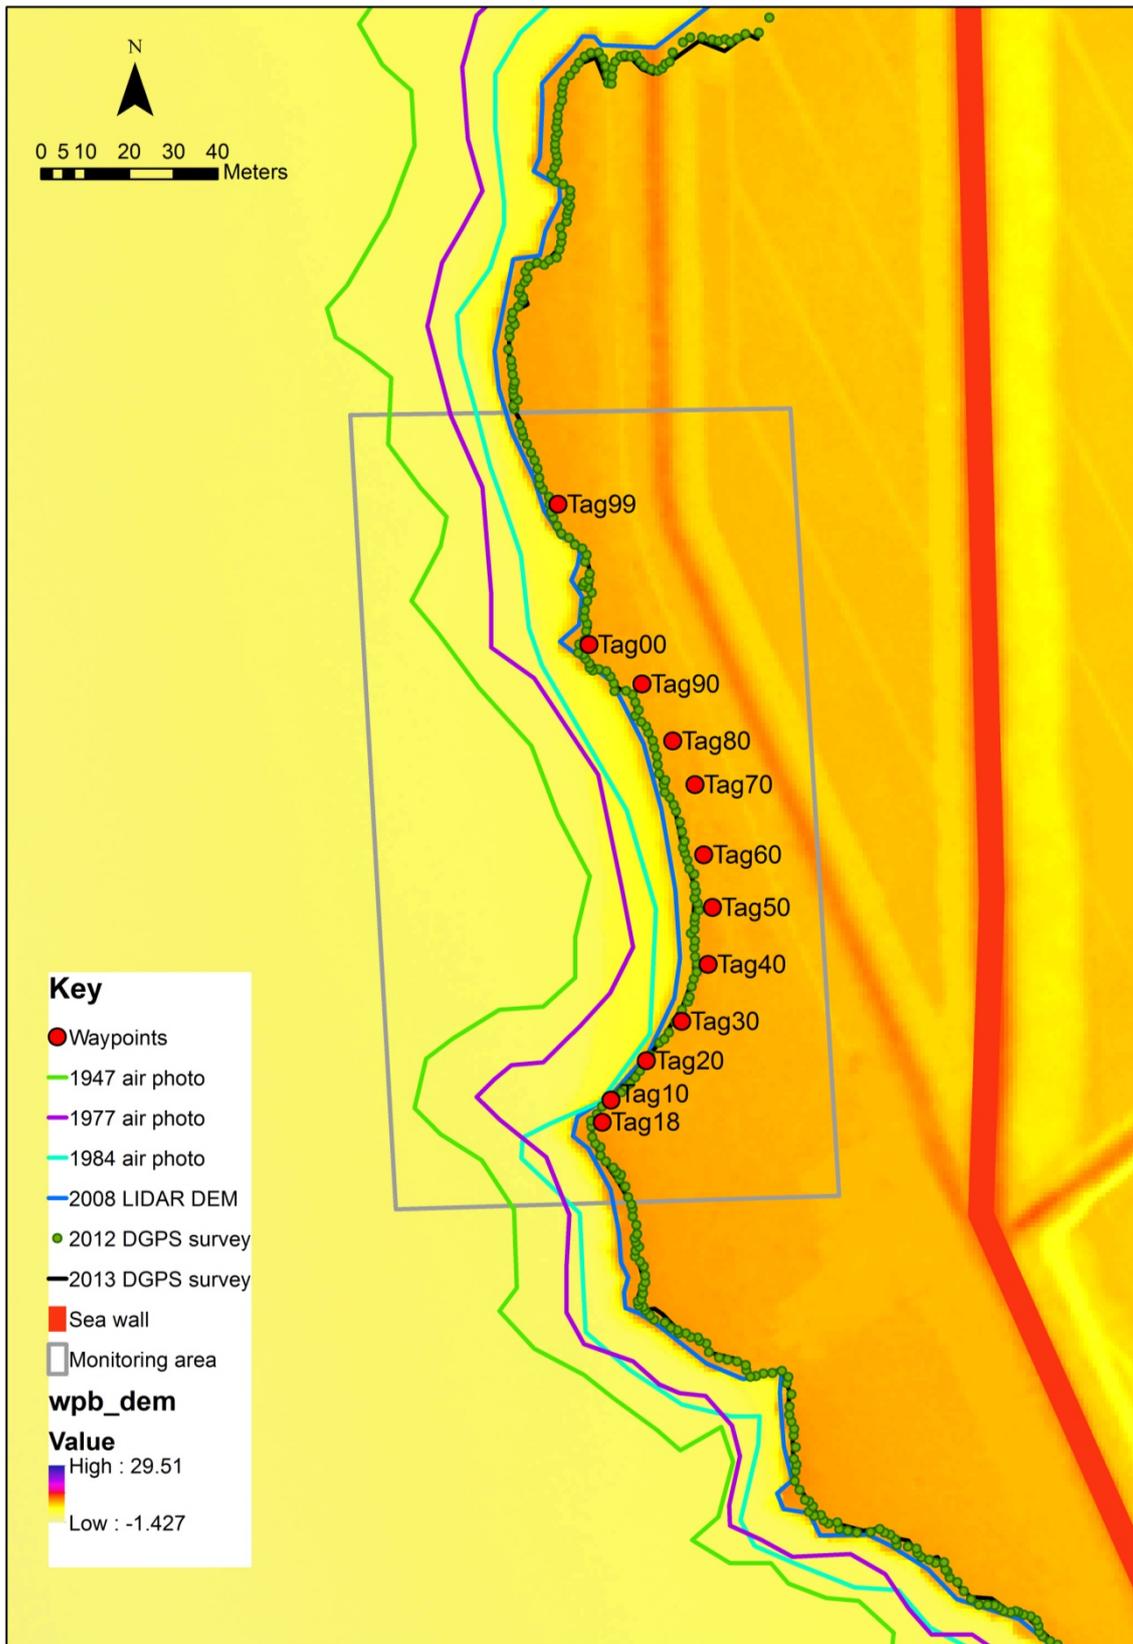
Figure 12. Change in the position of the upper edge of the banks at the monitoring site between 1947, 1977, 1984, 2008, 2012 and 2013. The location of the first pin in each erosion pin profile is also shown.

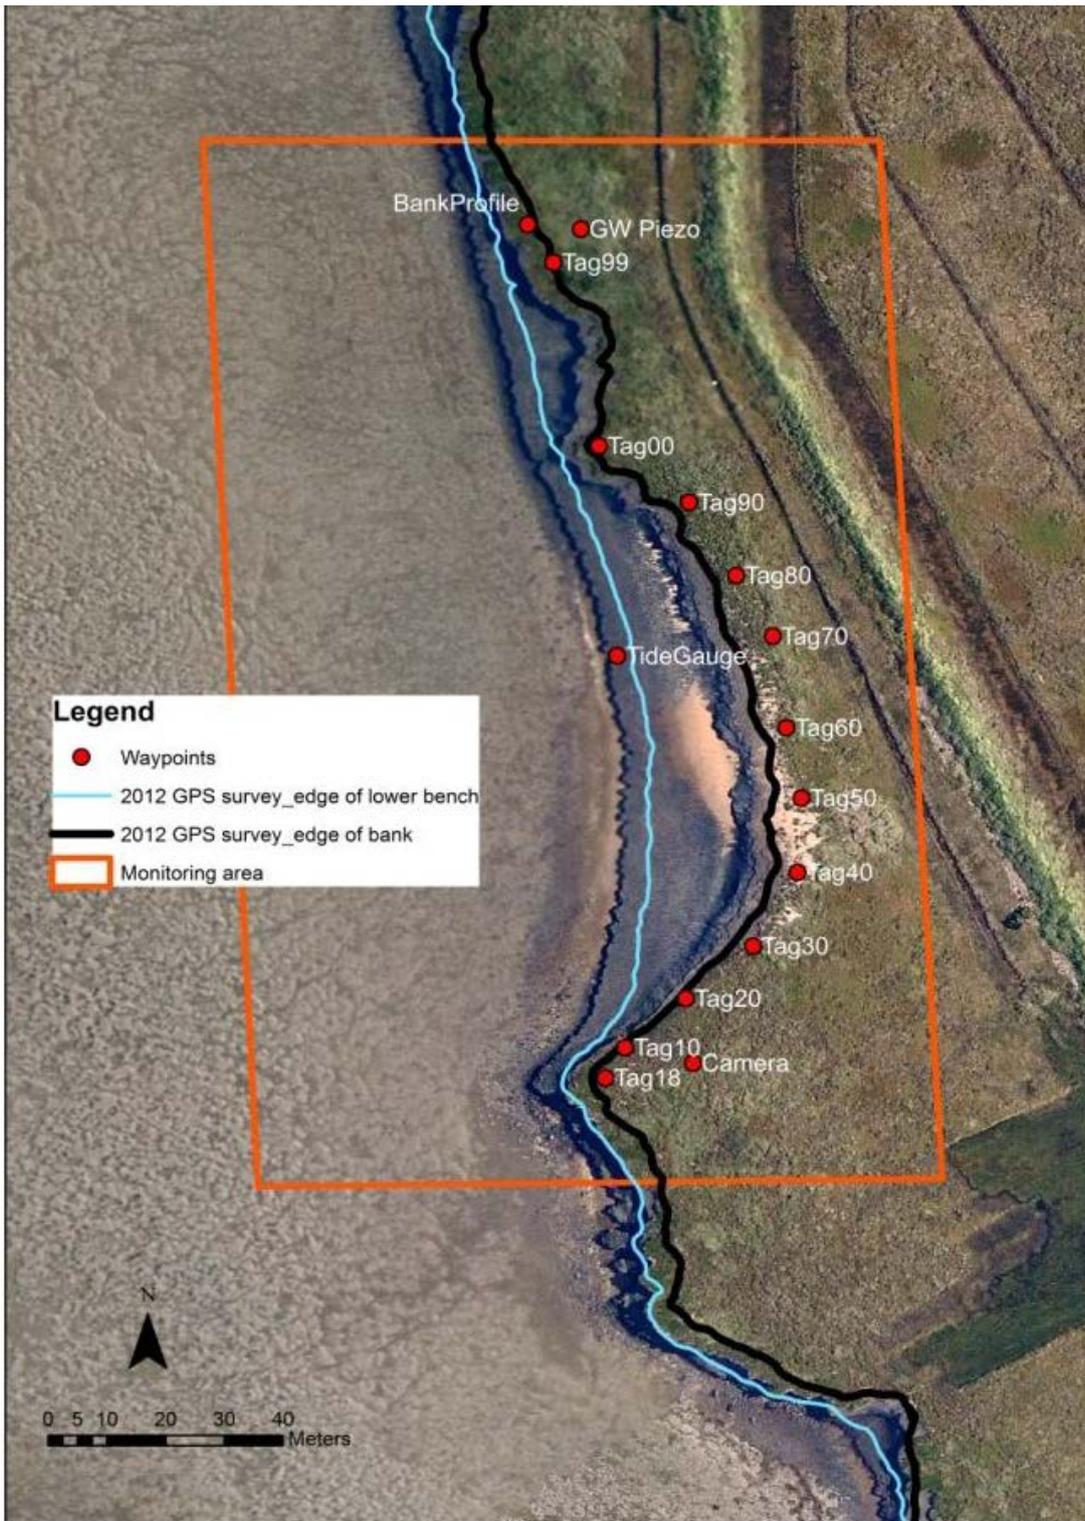
Figure 13. Erosion monitoring site showing the edge of the banks (jagged black line) and edge of the lower bench (light blue line) as surveyed in October 2012. The location of the first erosion pin in each profile, camera, groundwater piezometer, tide gauge and bank profile analysed are also shown. The image in the background is a 2008-9 air photo which shows some sand deposition on the bench surface and floodplain at the centre of the crenulation. The air photo also shows the position of the edge of the bench and top of the banks in 2008-9. The length of the coastline from BankProfile to Tag18 is 175 m.

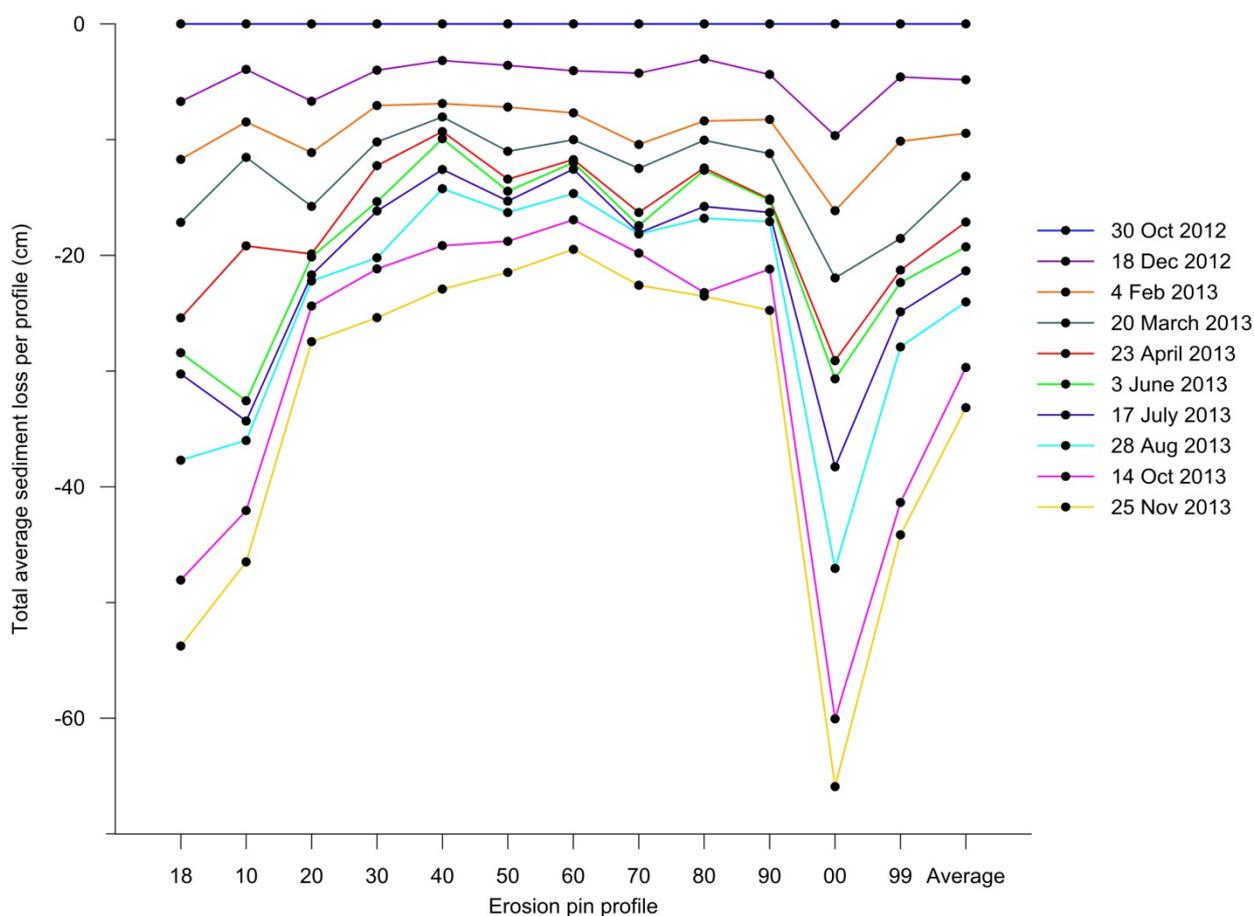
Figure 14. Total average sediment loss per erosion pin profile since the start of monitoring.

On a smaller spatial scale, the amount of sediment loss by profile varied considerably over the 12 months (Fig. 14). The profiles with the highest average losses (greater than the 33.2 cm average) were 18, 10, 00 and 99. Profile 00 on the northern headland recorded the maximum average loss of 65.9 cm over the 12 months followed by profile 18 on the southern headland which recorded 53.8 cm of sediment loss. However it should be noted that these profiles also experienced the most number of pins dislodged, particularly for the July, August and October measurements, so the figures may be an under- (or over-) estimate of the true erosion that occurred. In contrast, the profiles with the lowest average losses were 50, 60 and 70, which are located at the apex of the crenulations, while the minimum total average erosion recorded was 19.5 cm at profile 60.

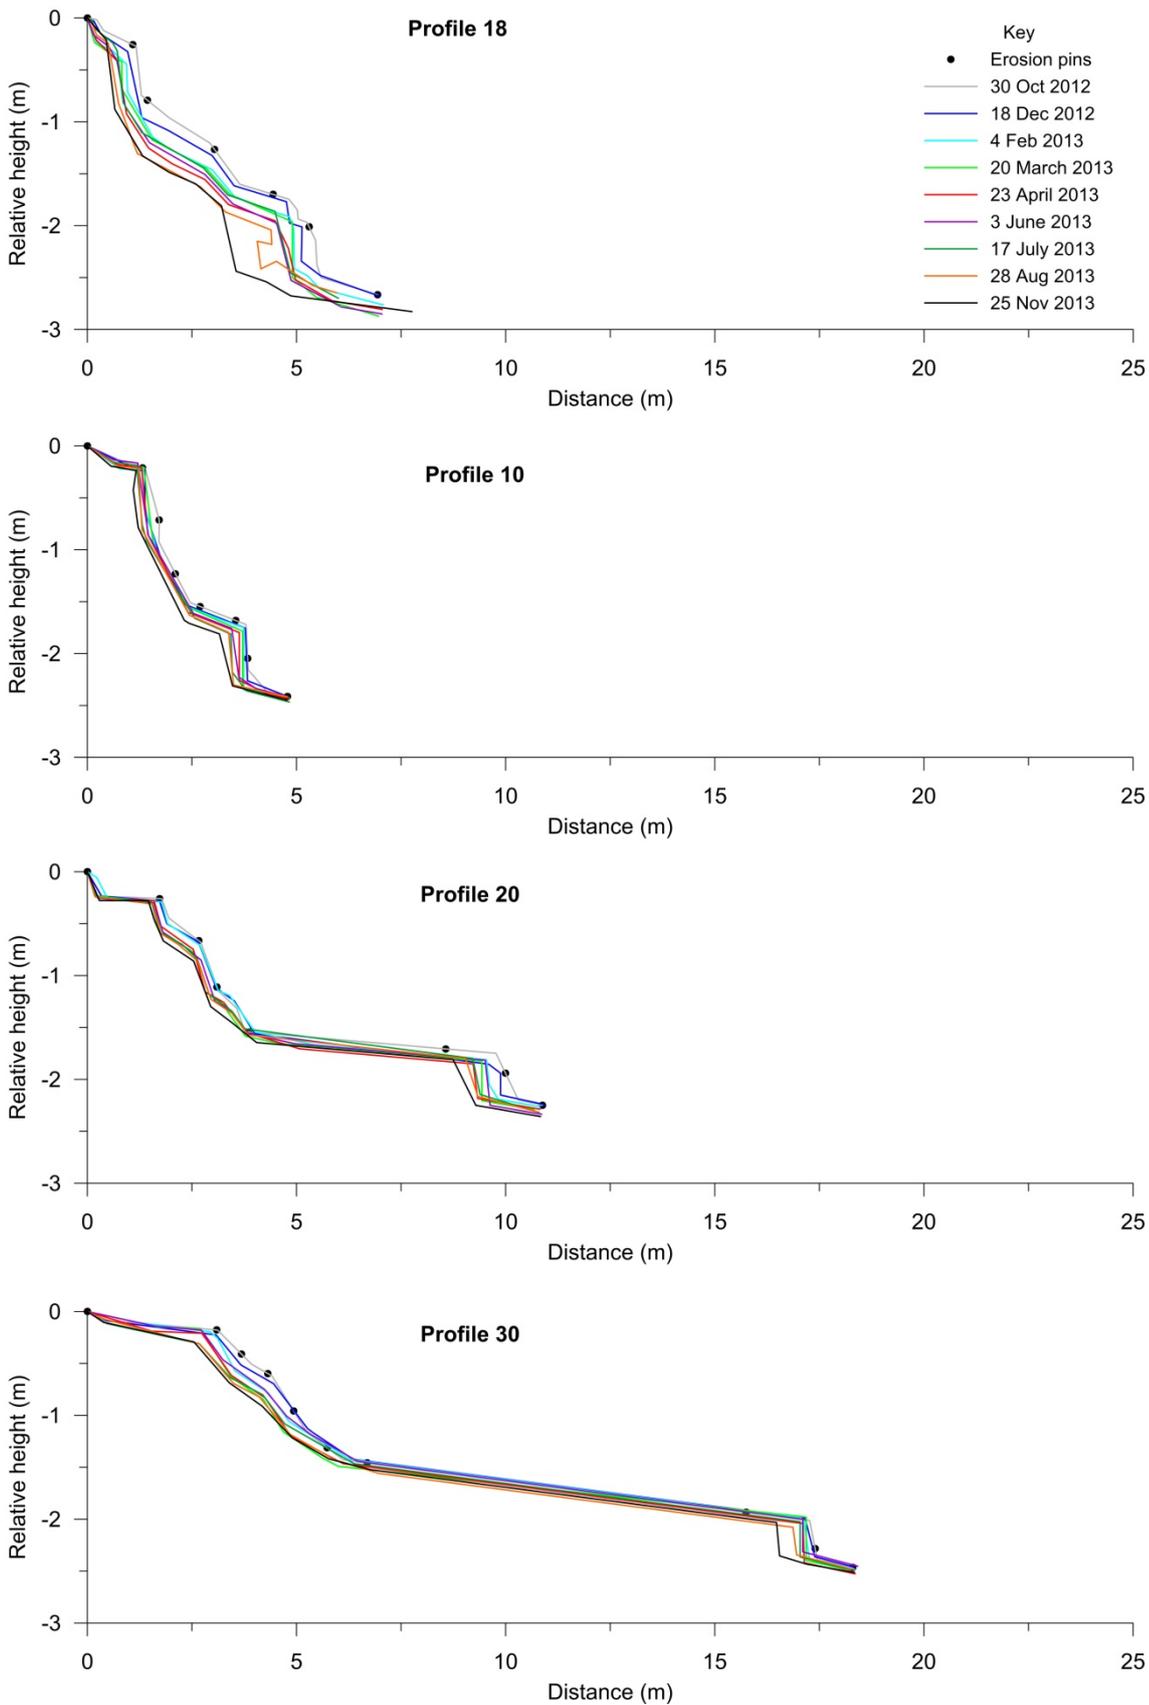
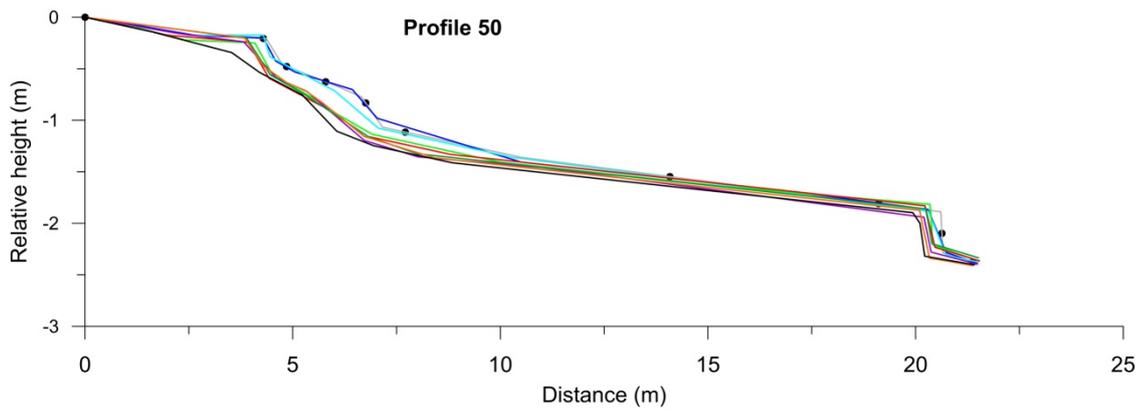
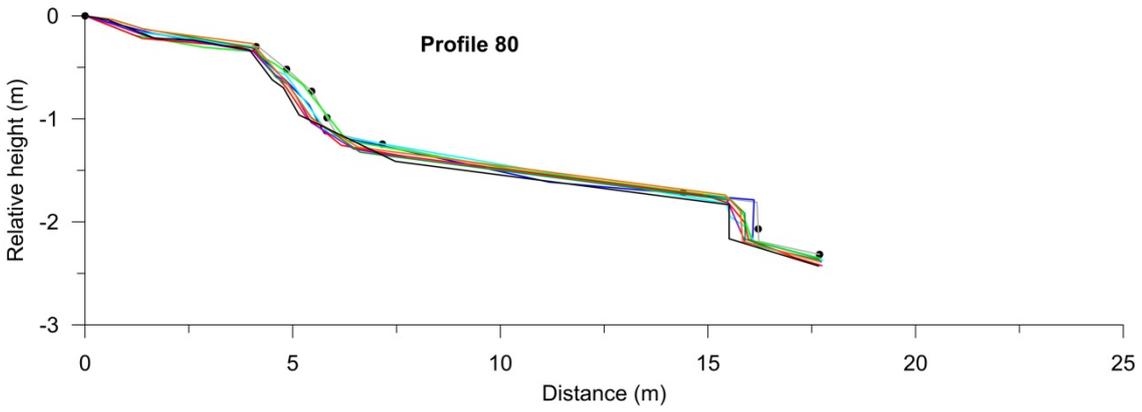
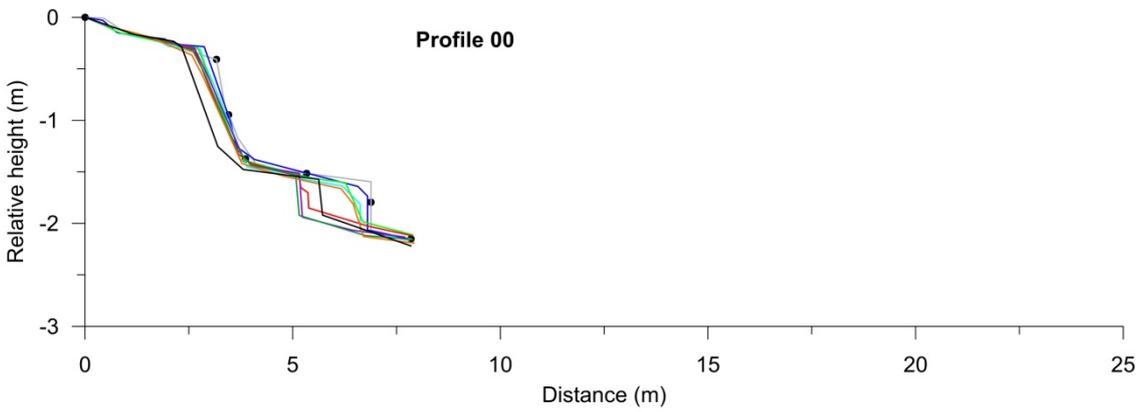
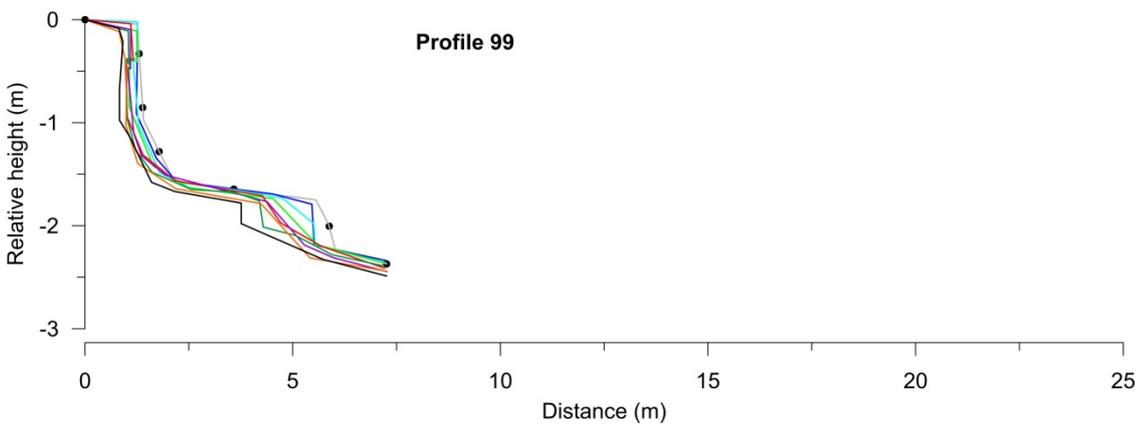
Figure 15. Trends in sediment loss across 8 of the 12 profiles showing parallel retreat of the steeper sub-vertical parts of the banks and minimal downwards erosion of the floodplain and bench surface. Profiles 50, 60, 70 and 90 (not shown) are similar to profiles 50 and 80. The surveys of profiles 18 and 00 show some variability in chronology, particularly on the bench, due to the dislodgement of some pins and re-setting of the transects in as close to their original position as possible. Note the long wave run-up on the bench surface in Profiles 30 to 80.
