Quantification of coastal bank erosion rates in Western Port

Final report

April 2014

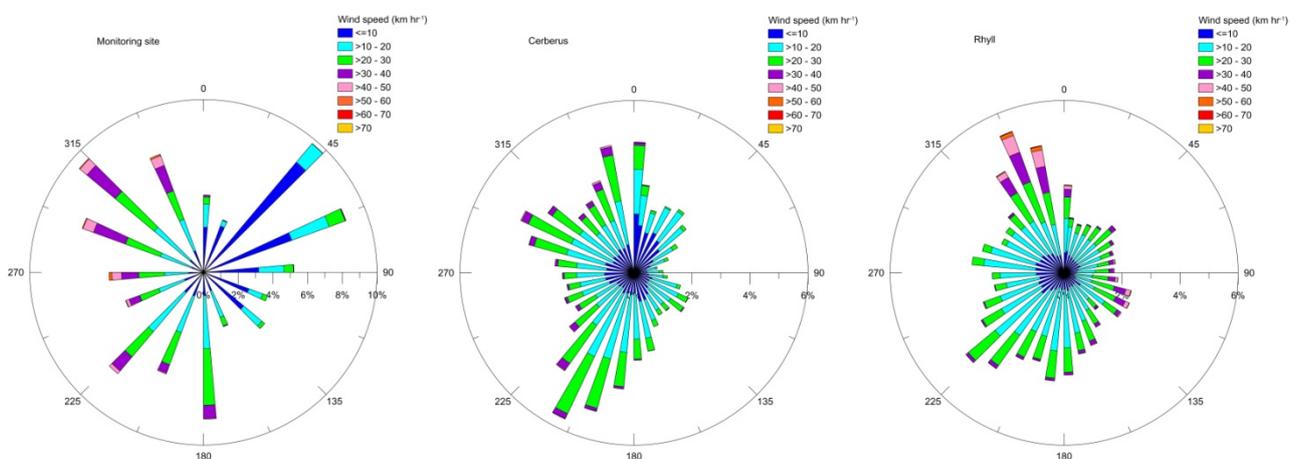
Figure 16. Patterns of average daily wind speed and direction at the monitoring site (~ 13 months data), Cerberus (22 years data) and Rhyll (22 years data). The stacked colours represent increasing wind speeds, while the length of the bars indicates the proportion of winds from each direction.

The observed wind data from the monitoring site, Cerberus and Rhyll show relatively similar, well defined patterns in average and maximum wind speed and direction (Figures 16 and 17). The dominant wind directions at the monitoring site are NNW to WNW (including the strongest winds of $> 70 \text{ km hr}^{-1}$), S to SW and NE to ENE (very light winds). These are consistent with Cerberus and Rhyll which show dominant winds from the N to WNW and S to SW, and a higher proportion of higher speed winds. There is some variability between the sites which probably reflects localised influences such as topography and shielding. The maximum wind gust recorded at the monitoring site was 98.2 km hr^{-1} (on two occasions) and these were from a W and WNW direction.

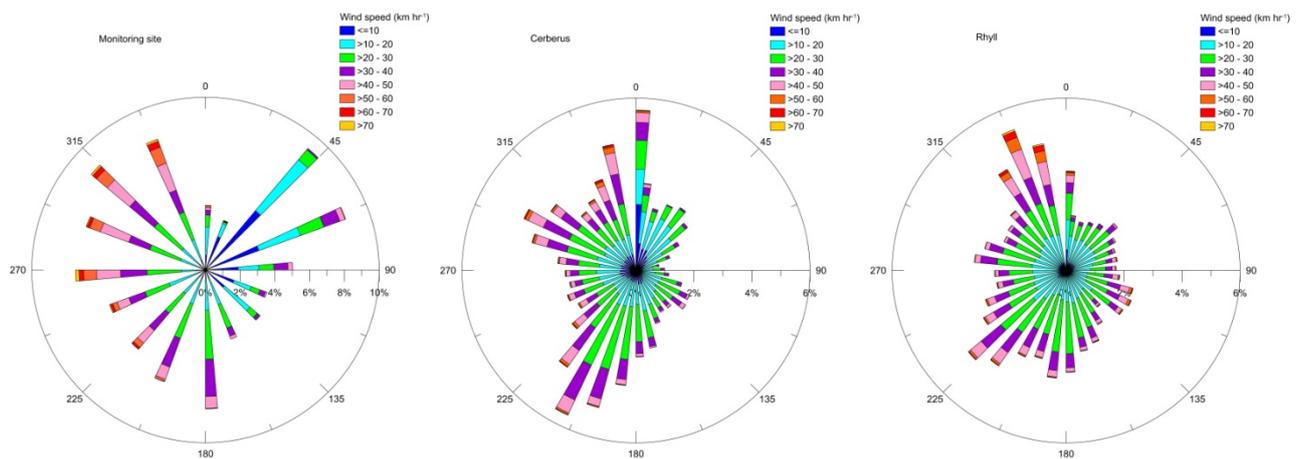
Figure 17. Patterns of highest daily wind speeds at the monitoring site (~ 13 months data), Cerberus (22 years data) and Rhyll (22 years data). The stacked colours represent increasing wind speeds, while the length of the bars indicates the proportion of winds from each direction.

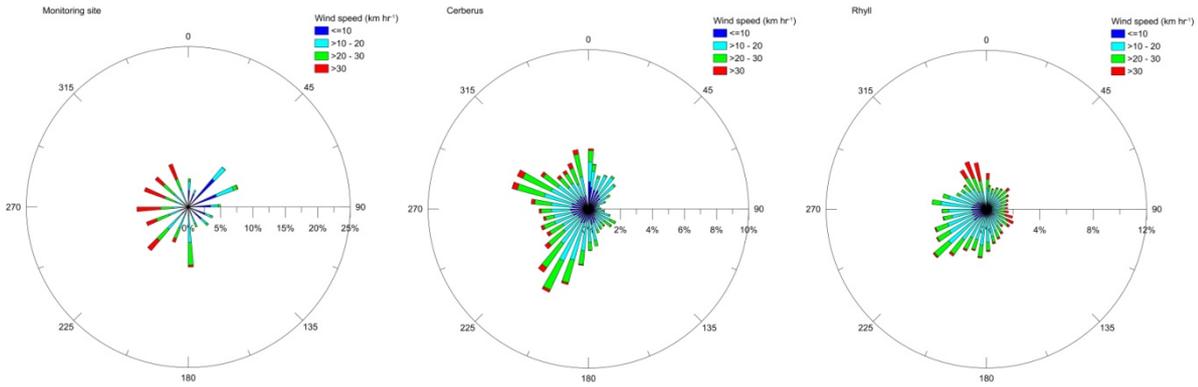
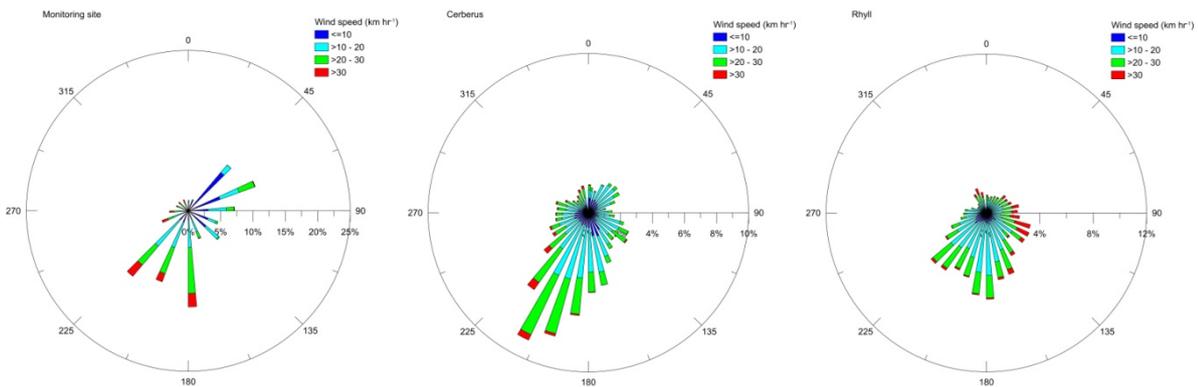
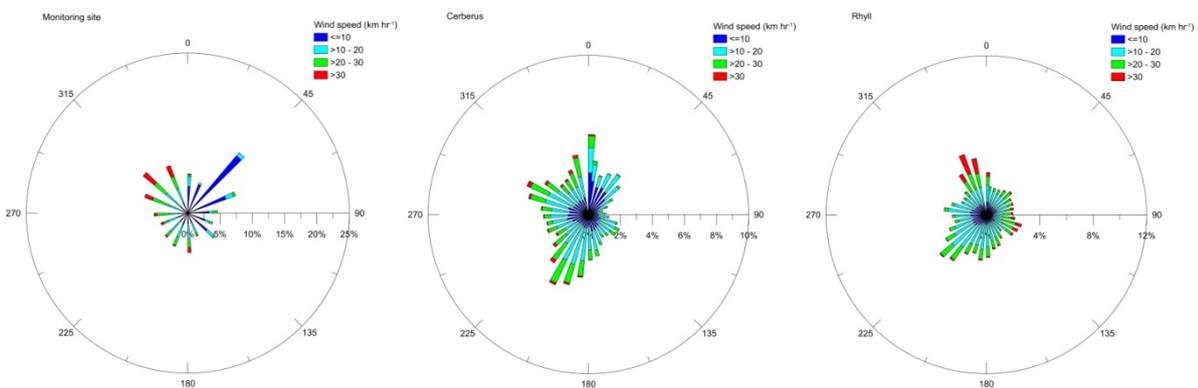
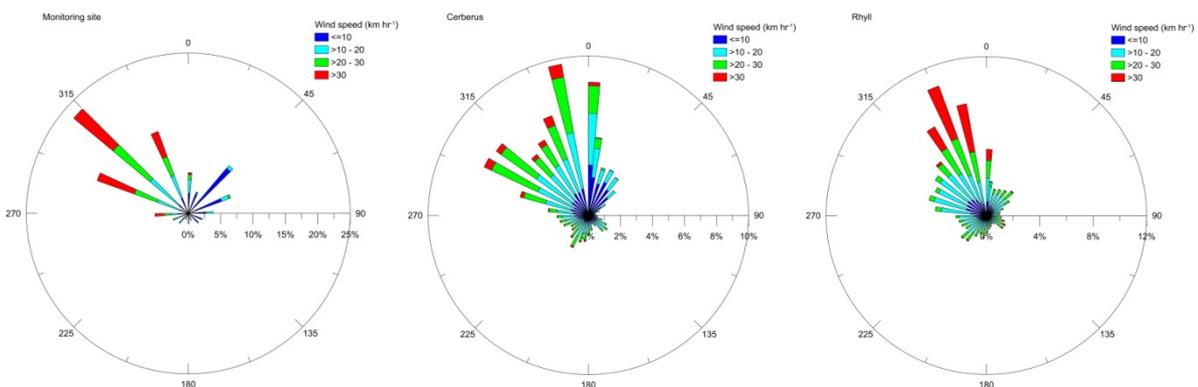
Figure 18. Seasonal trends in daily wind speed and direction at the monitoring site, Cerberus and Rhyll. The stacked colours represent increasing wind speeds, while the length of the bars indicates the proportion of winds from each direction.

There is very good agreement between the sites in terms of seasonal wind speeds and directions, which reveal strong seasonal trends (Figure 18). In summer, stronger winds are predominantly from S to SW, while in winter these shift to a clear N to WNW direction. In autumn and spring, the dominant wind directions are more variable, with a dominant westwards direction (NNW to SSW). There appears to be very little difference between the autumn and spring patterns, except that the winds in spring appear slightly more westwards and are slightly stronger than in autumn. It is hypothesised that the autumn and spring patterns reflect the transitioning between the strong summer and winter wind directions. At all locations, the highest proportion of strong winds, were recorded in the winter months.

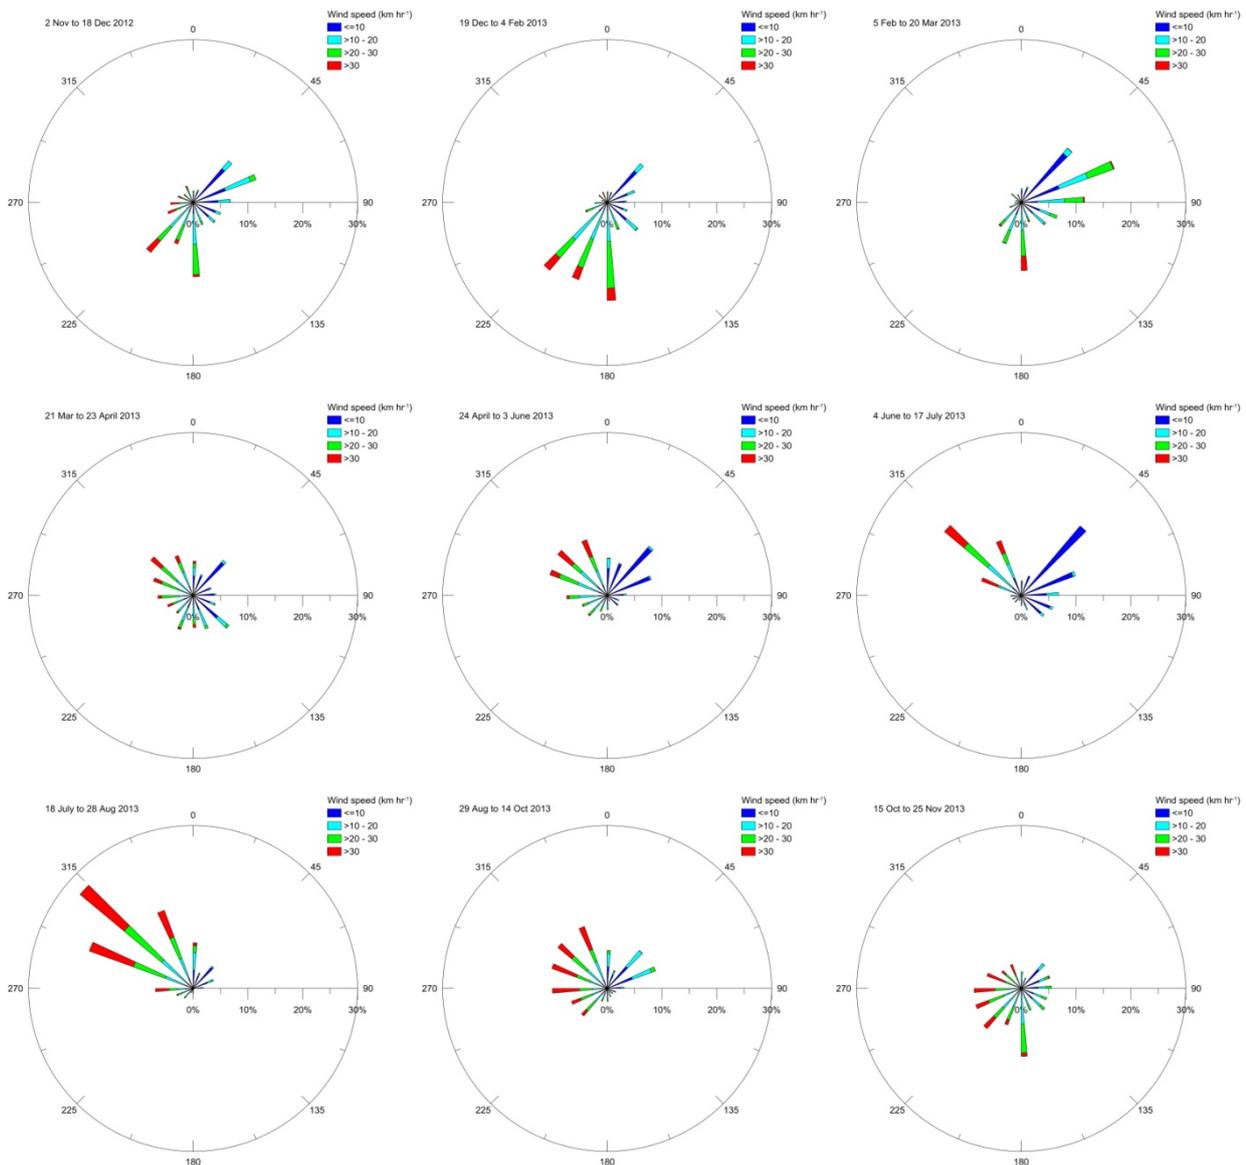
Figure 19. Differences in wind speed and direction at the monitoring site between erosion pin measurements. The stacked colours represent increasing wind speeds, while the length of the bars indicates the proportion of winds from each direction.

The wind conditions for the days between each erosion pin measurement are shown in Fig 19. These mirror the seasonal patterns shown in Fig 18, with the largest proportion of the strongest winds from the ~NW direction occurring in the winter months (4 June-17 July; 18 July-28 Aug), while the summer months (19 Dec- 4 Feb) show the strong dominance of the S to SW winds. Light winds from the NE seem to be a consistent occurrence throughout the year.

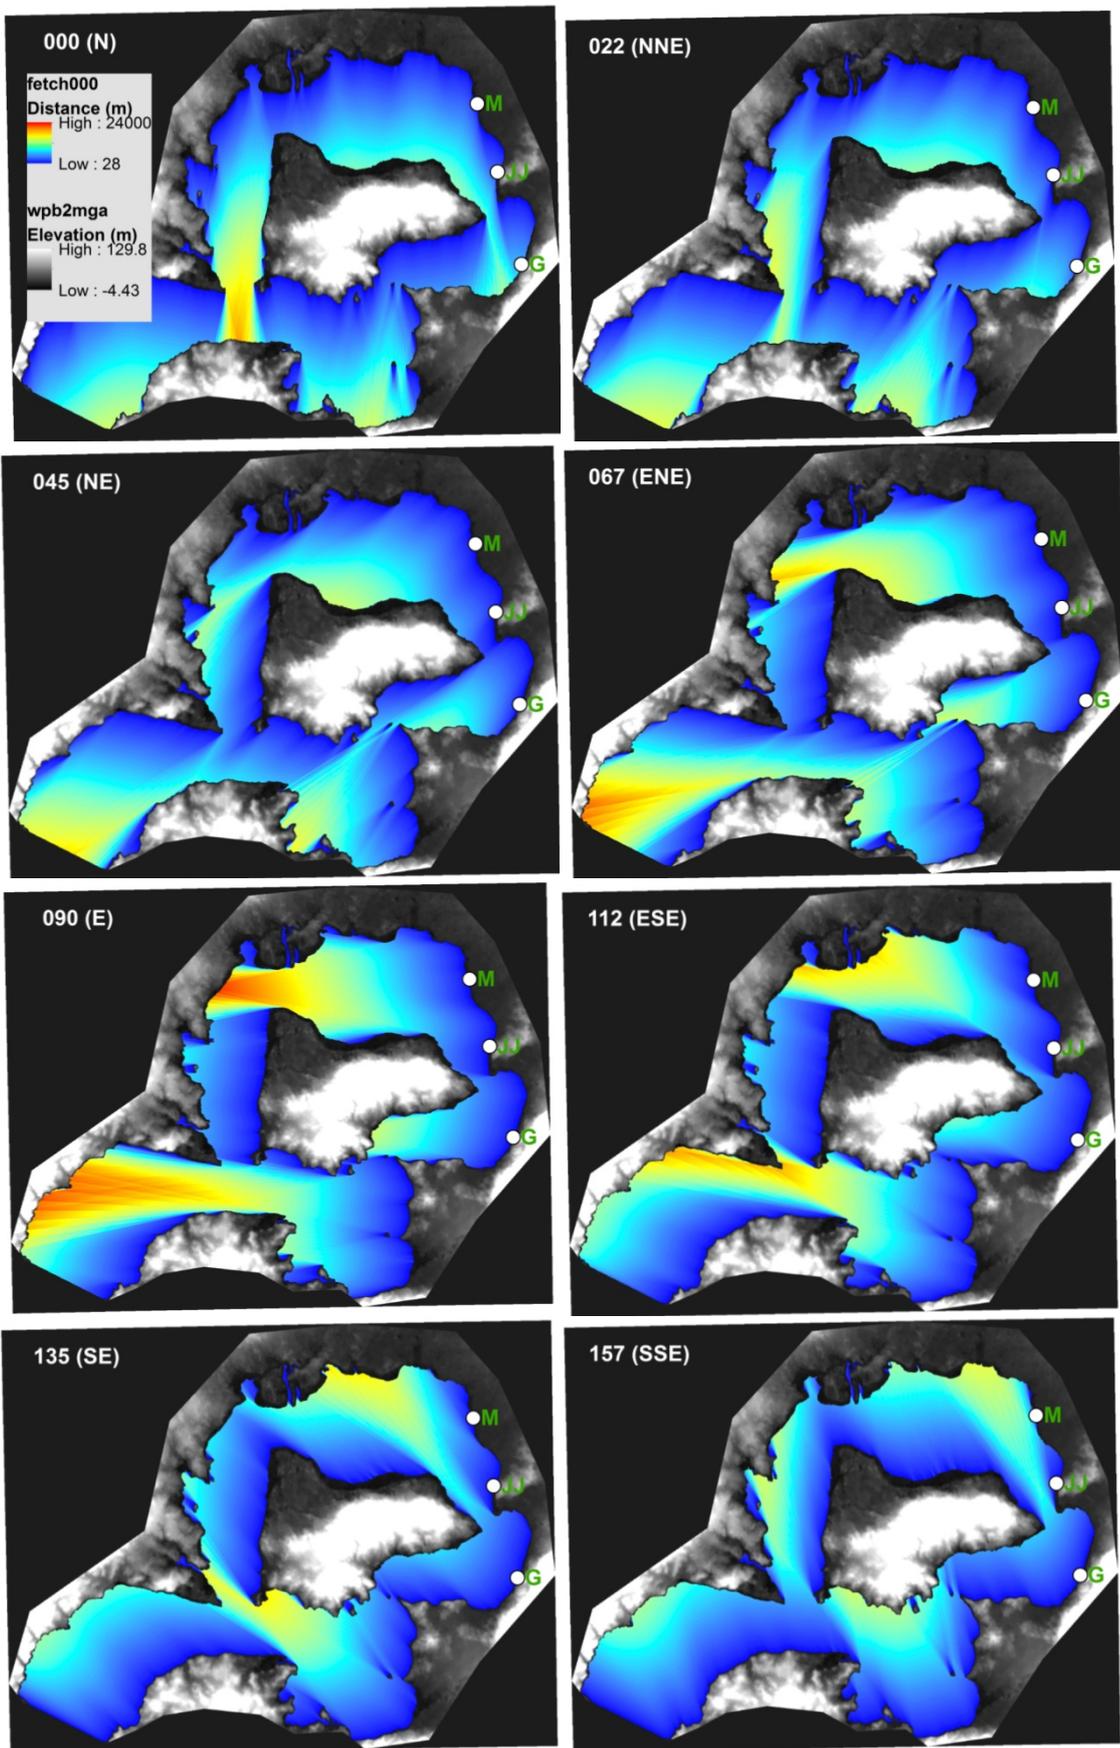
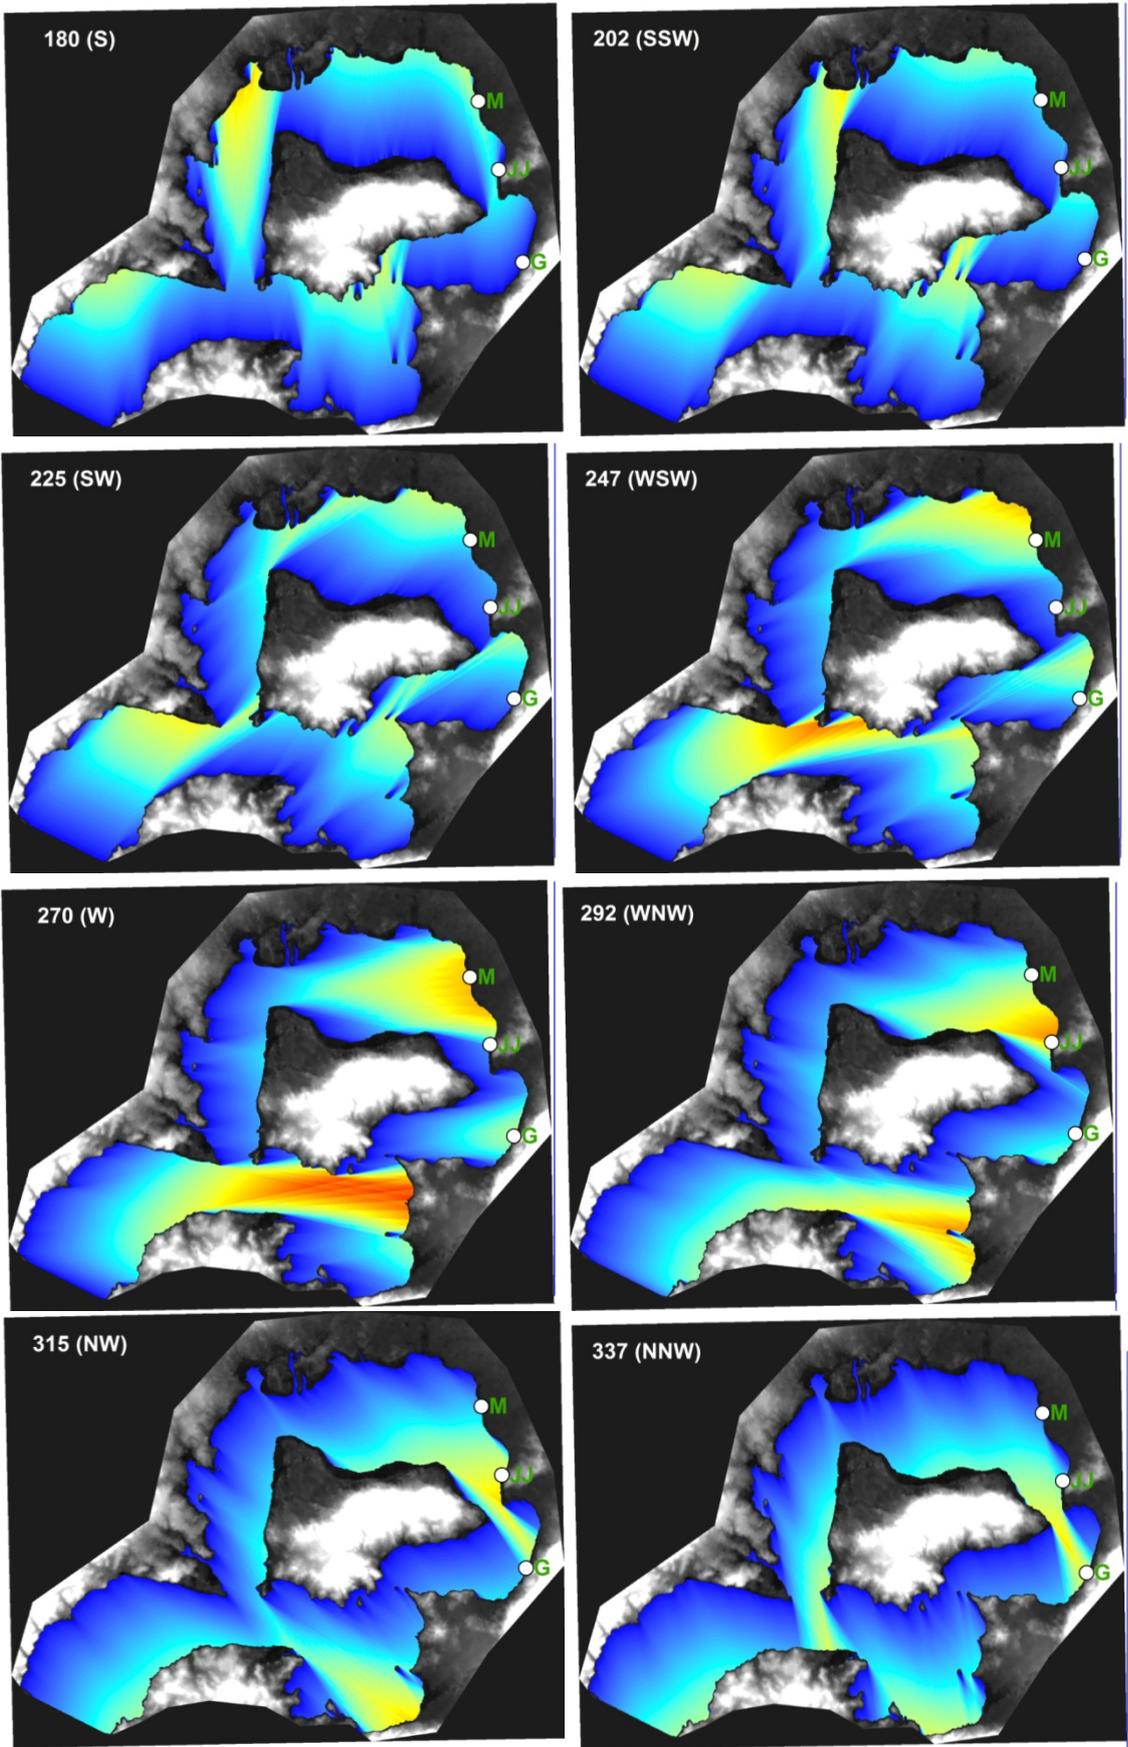
Figure 20. Patterns of fetch for each wind direction. The scale for all plots is shown in the plot labelled 000, while M is Monitoring site, JJ is Jam Jerrup and G is Grantville. The areas of the bay that have the longest fetch are indicated by red-orange, while dark blue indicates the shortest fetch. Note how these patterns change with wind direction.

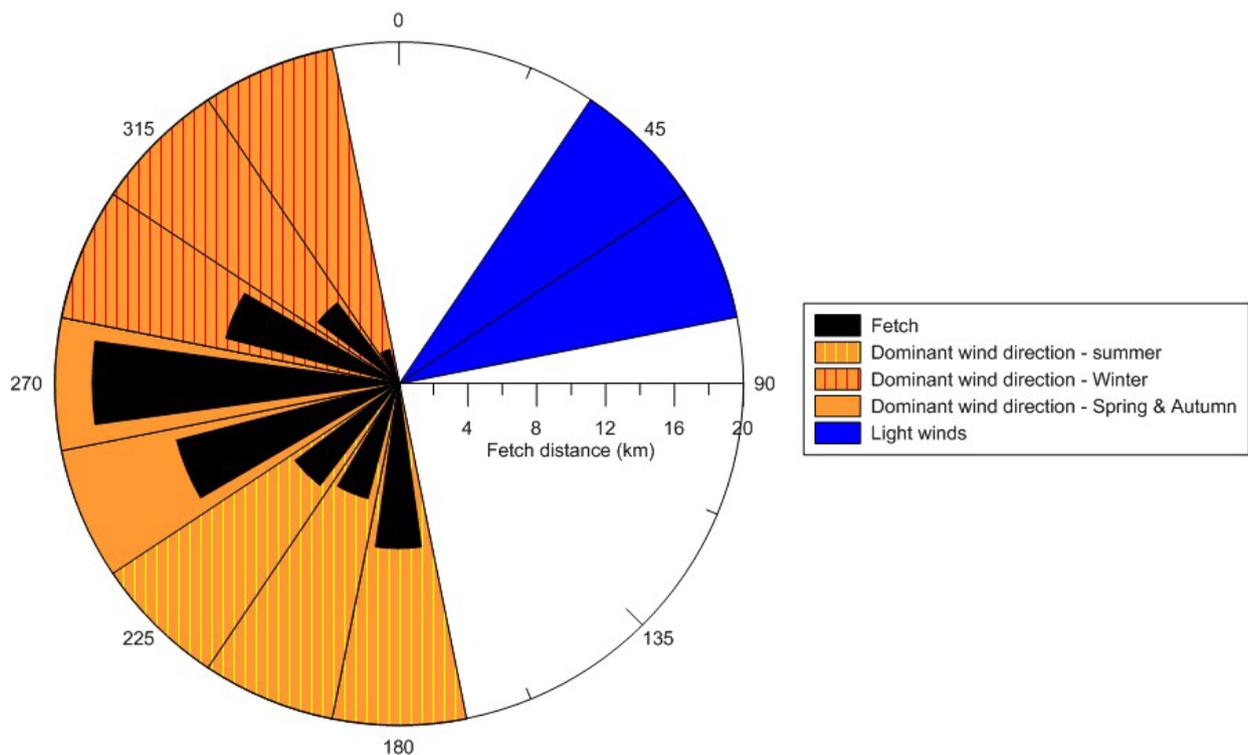
Figure 21. Summary of the seasonal wind patterns and fetch for each direction at the monitoring site. The data shows that winds from the W and WSW in autumn and spring have the longest fetch, followed by winds from the WNW in winter (& spring and autumn) and southerly winds in summer (& spring and autumn). Winds from these directions have the potential to generate greater wave heights compared to winds of similar speeds from different directions. The light winds from the ~ NE that were recorded throughout the year, have ~ zero fetch and hence no impact on erosion at the monitoring site.

At the monitoring site, a summary of the seasonal patterns of wind direction, compared to fetch (Fig 21), highlights the importance of these factors on wind-wave potential and likely erosion rates. Winds from the W and WSW in autumn and spring have the longest fetch (17.7 km and 13.3 km, respectively), followed by winds from the WNW in winter, autumn and spring (10.4 km) and southerly winds in summer, autumn and spring (9.7 km). Comparison with the erosion pin data shows that the monitoring period that recorded the highest erosion rates (29 Aug – 14 Oct) also recorded the largest proportion of the strongest westerly winds thus supporting the role of fetch as a major factor. The relatively high summer erosion rates, compared to the lower erosion rates recorded in winter, also in part can be explained by fetch and the prevailing wind conditions recorded at the site over the ~13 months. However, the patterns are not entirely clear for all of

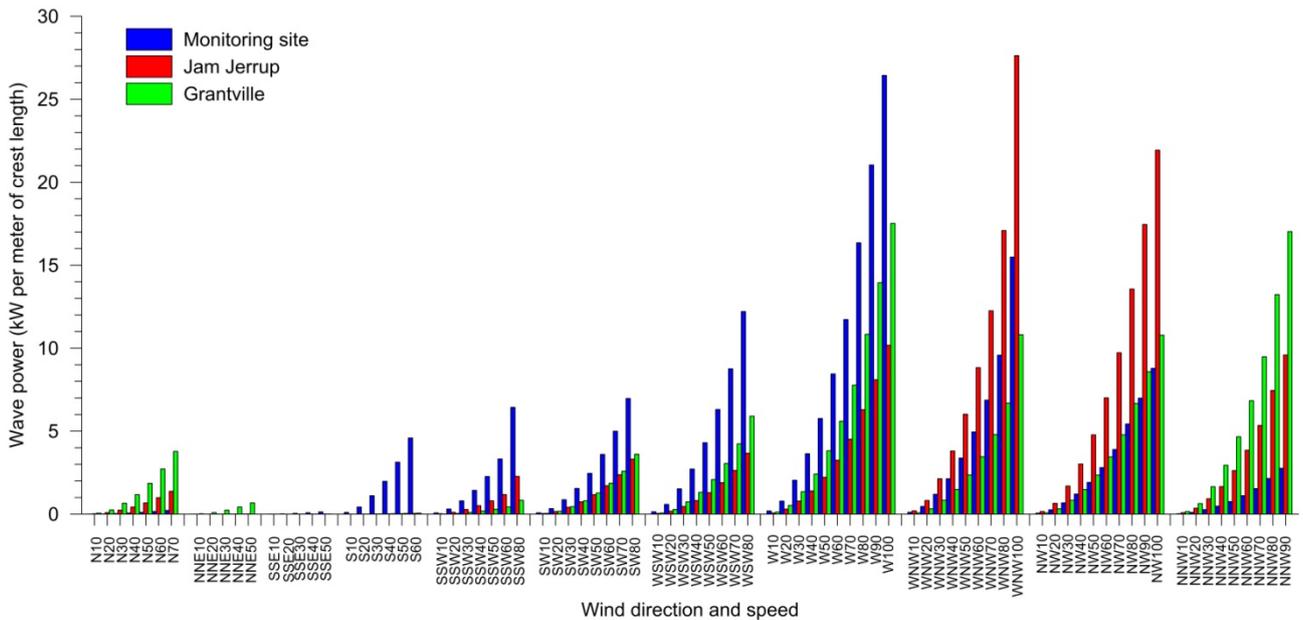
Figure 22. Maximum wave power predictions for different wind speeds ($10\text{--}100\text{ km h}^{-1}$) and directions at the monitoring site, Jam Jerrup and Grantville, assuming a water depth of 2 m which is equivalent to the maximum high tide recorded. The wave power predictions for winds from the NE, ENE, E, ESE and SE are not shown since these values are $< 0.1\text{ kW m}^{-1}$ for all wind speeds.

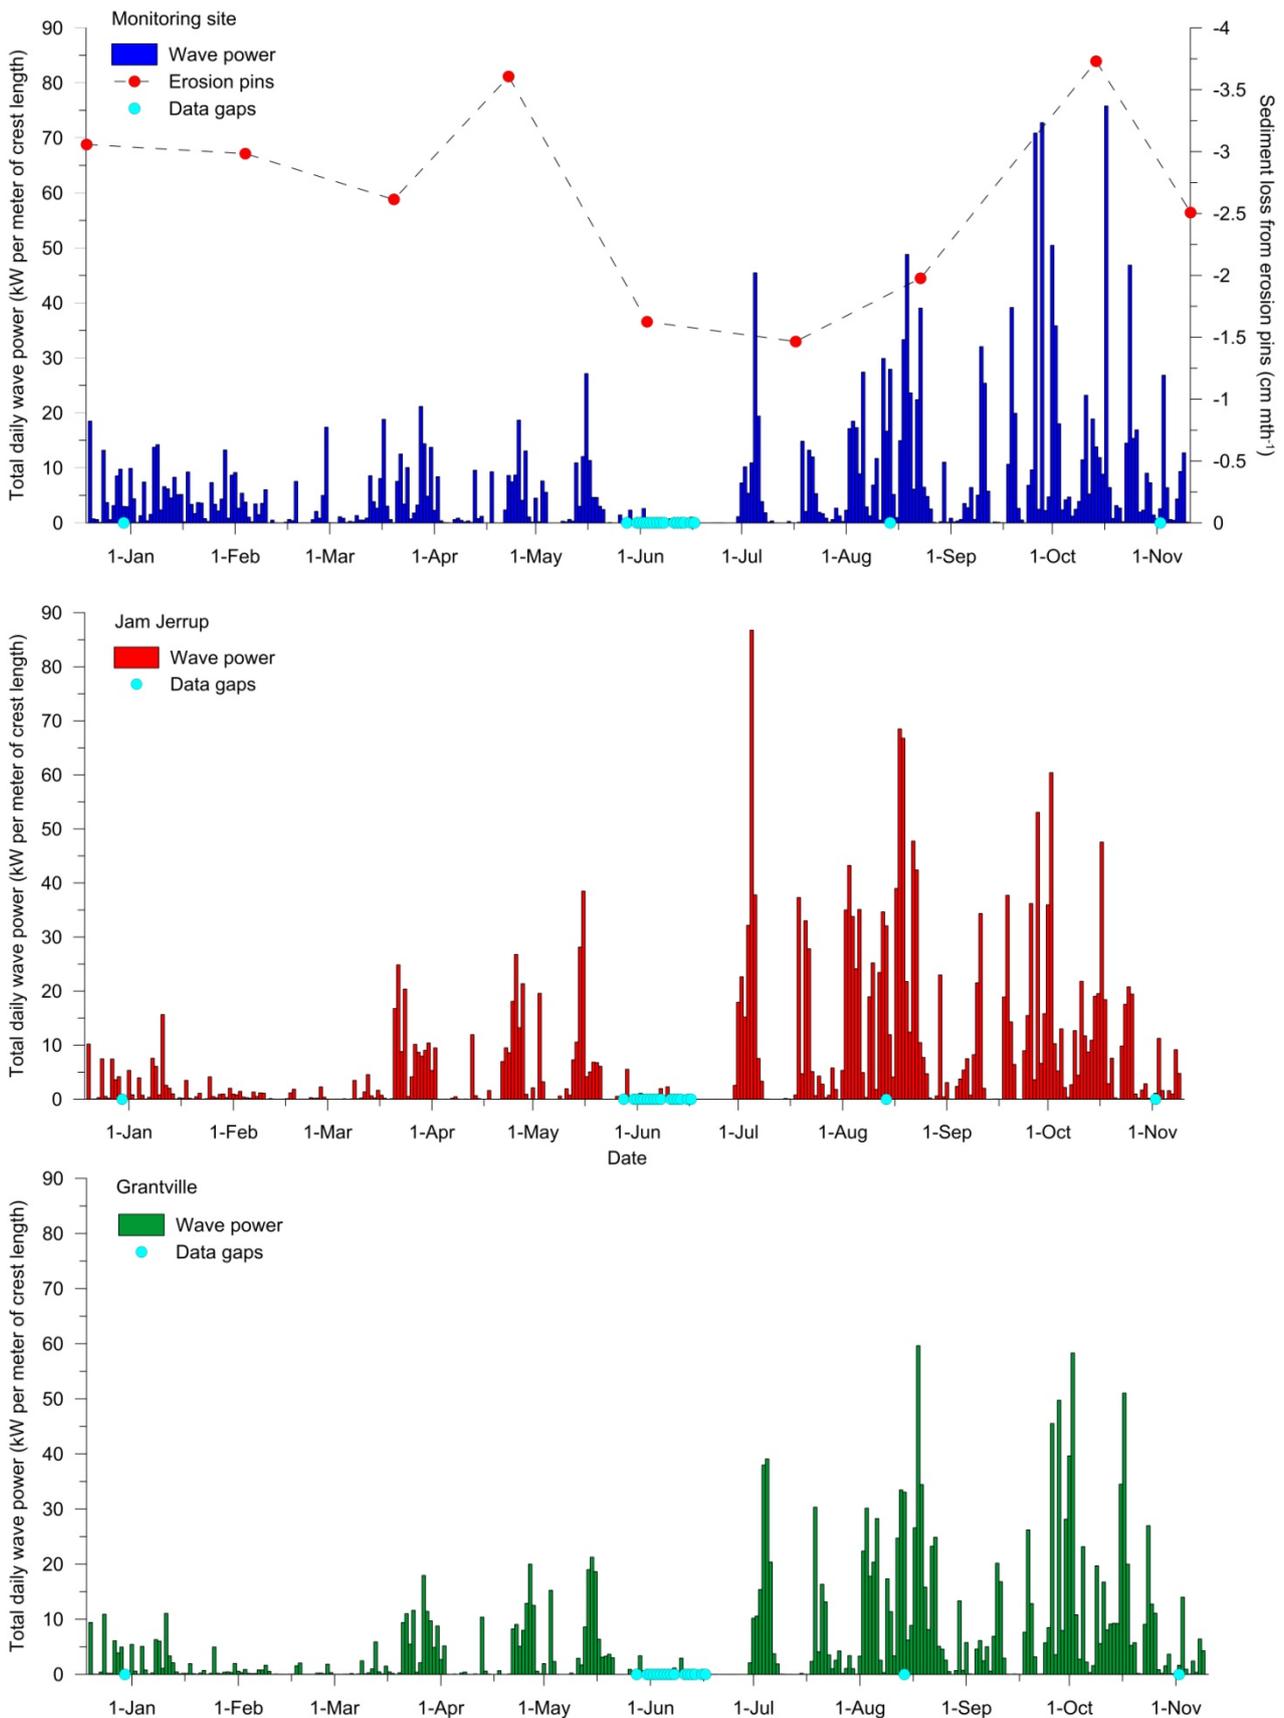
Figure 23. Total daily wave power at the monitoring site, Jam Jerrup and Grantville. Wave power was calculated using the wind speed-direction and tide data, and modelled fetch and wave heights. Data gaps shown in the plots are due to gaps in the wind speed-direction data. These were due to occasional problems with the weather station.

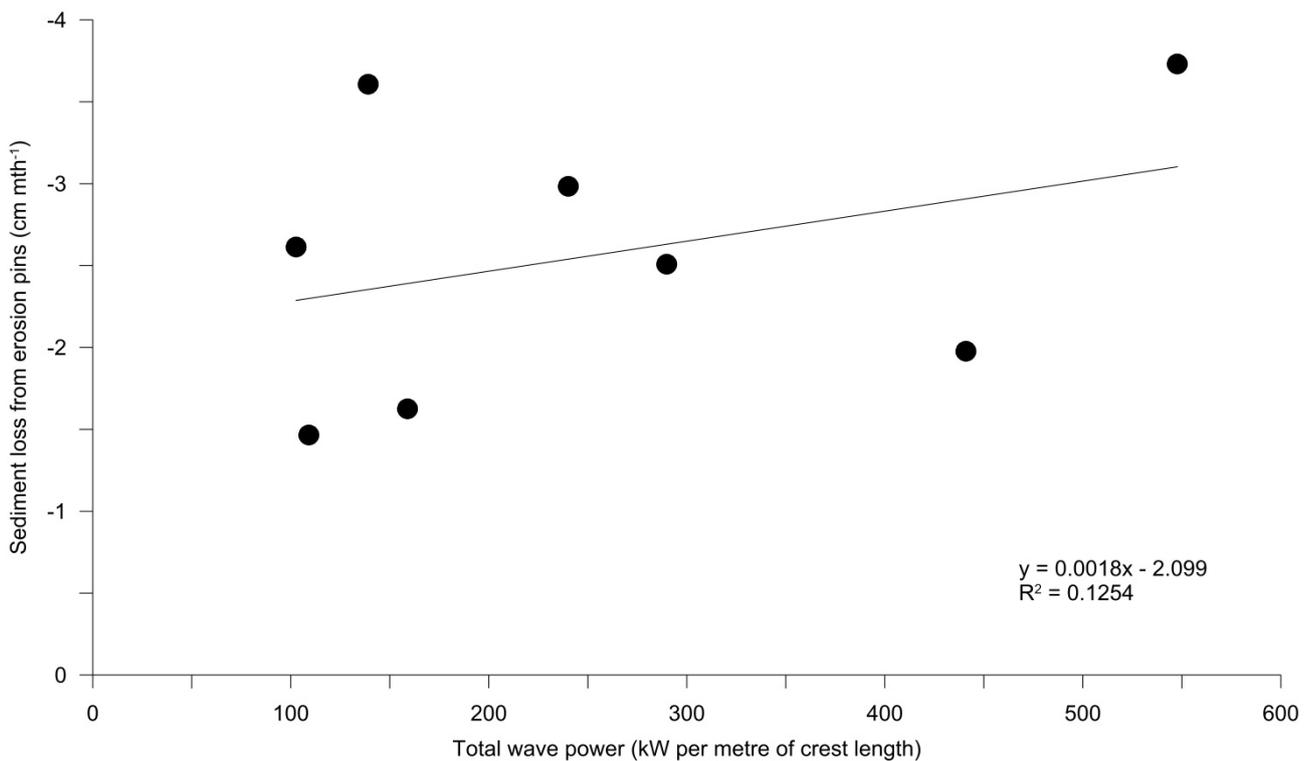
Figure 24. Sediment loss versus wave power at the monitoring site, summed to represent totals for the erosion pin measurement periods. The data show a weak positive relationship between sediment loss and wave power.

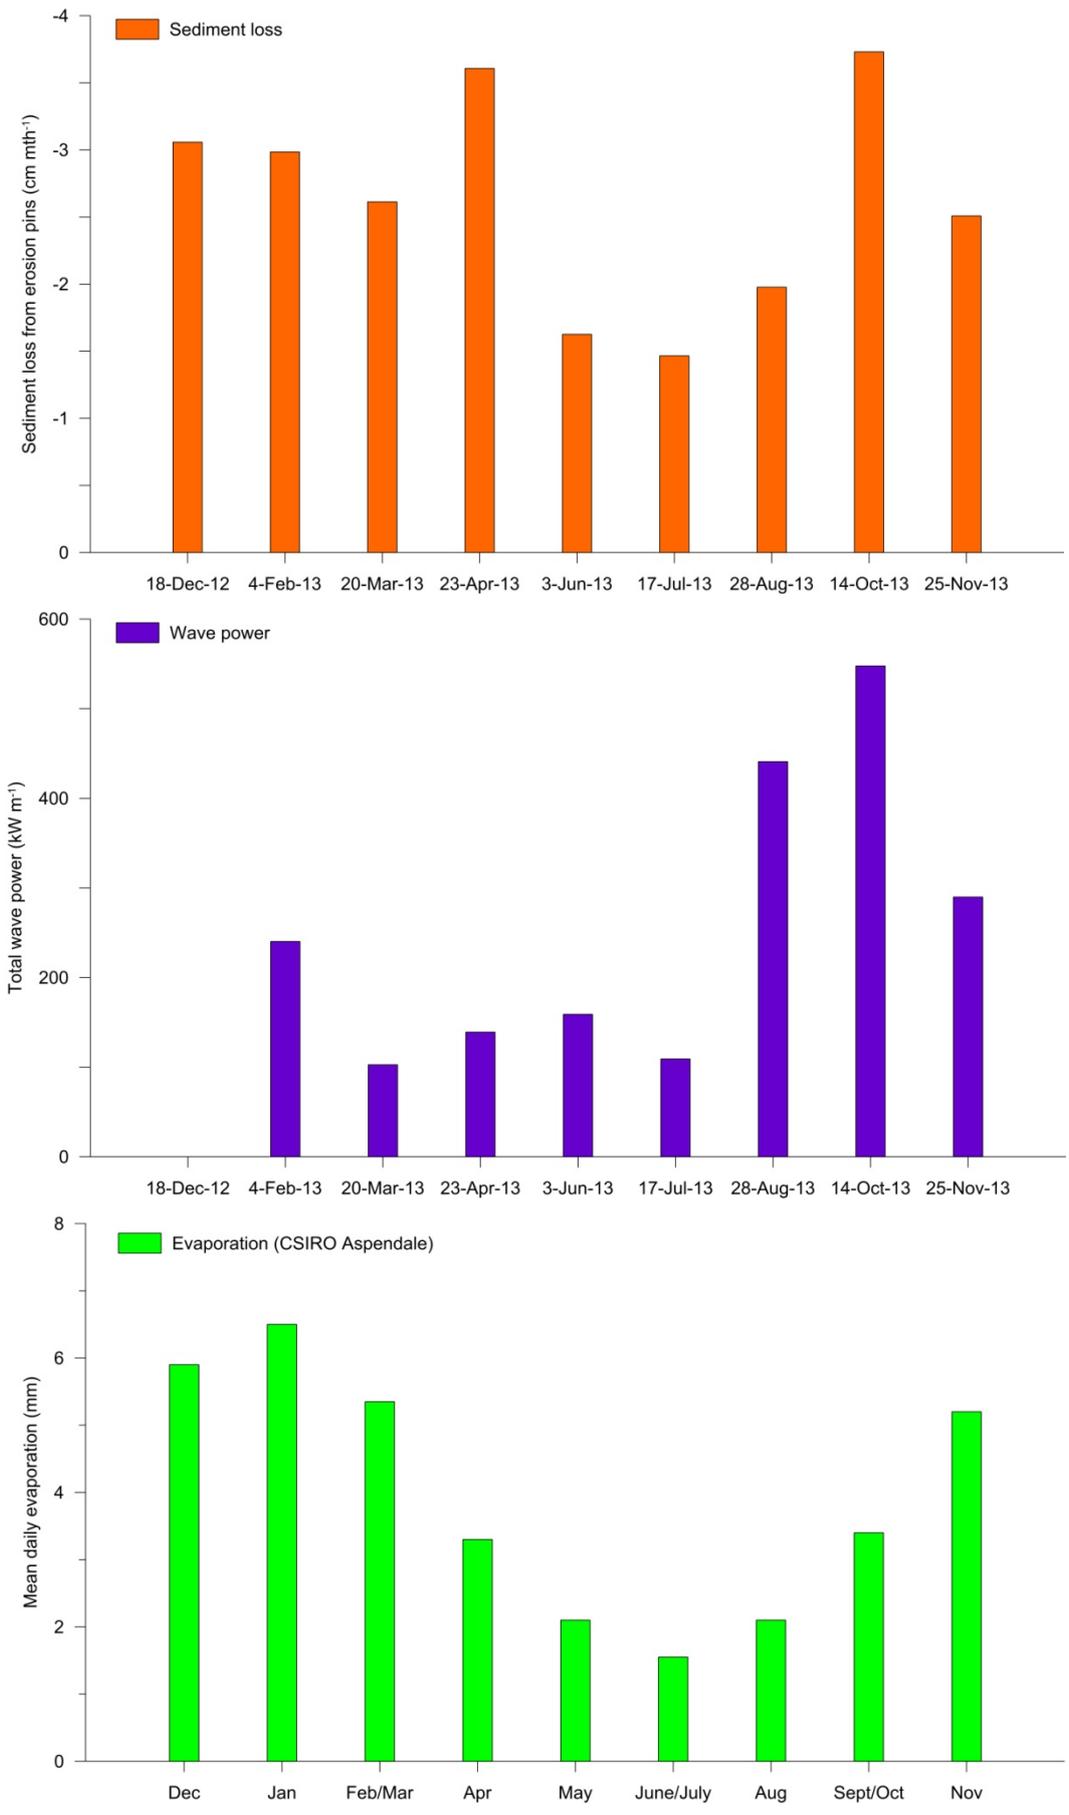
Figure 25. Sediment loss and total wave power for each erosion pin measurement period at the monitoring site, compared to monthly trends in evaporation recorded at the nearby CSIRO Aspendale station.

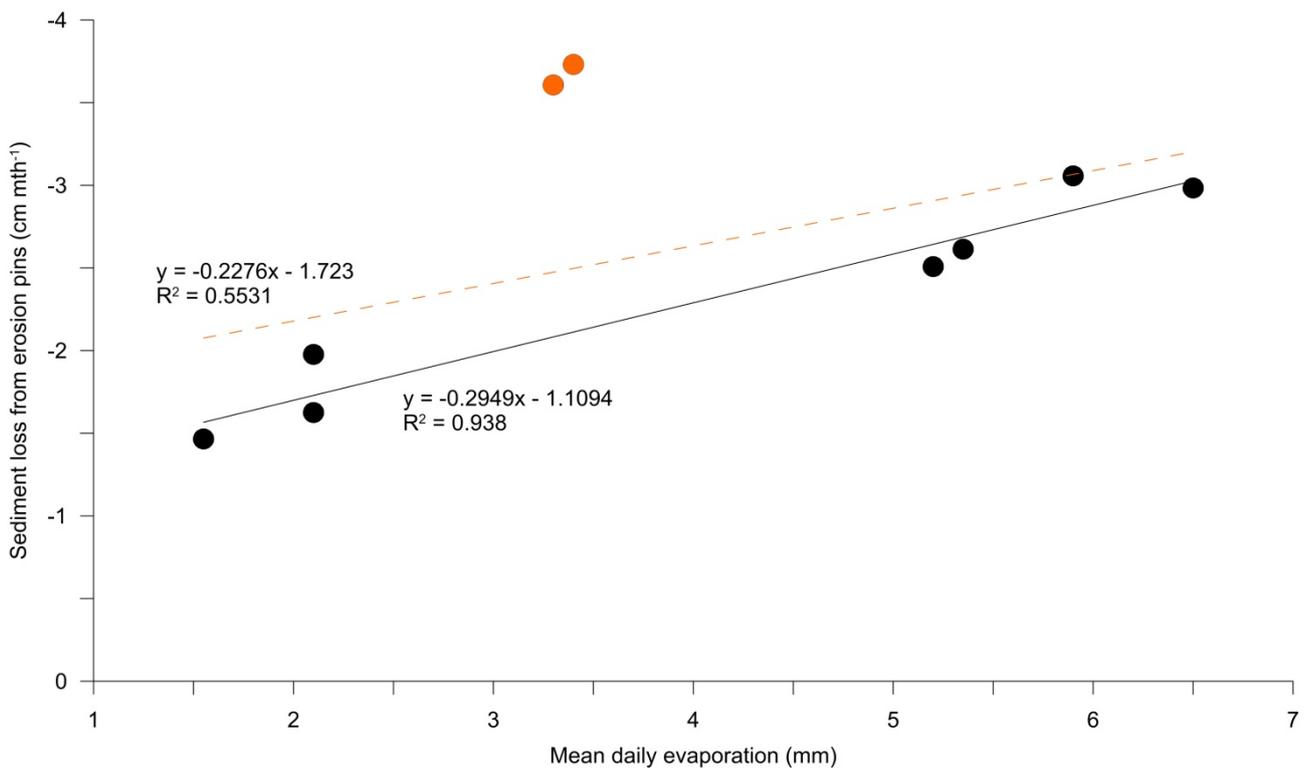
Figure 26. Sediment loss versus evaporation recorded at the nearby CSIRO Aspendale station. The orange line indicates the trend through all the data. The black line indicates the trend through the data coloured black, excluding the two orange points which represent the 23 April and 14 October erosion pin measurements. With the exception of the April and October measurements, there is a very good correlation between sediment loss and evaporation, with evaporation affecting the degree of cracking of the surface through shrink-swell of the clays. For the April and October measurements, in addition to evaporation, other factors such as wave power appear to influence erosion rate.

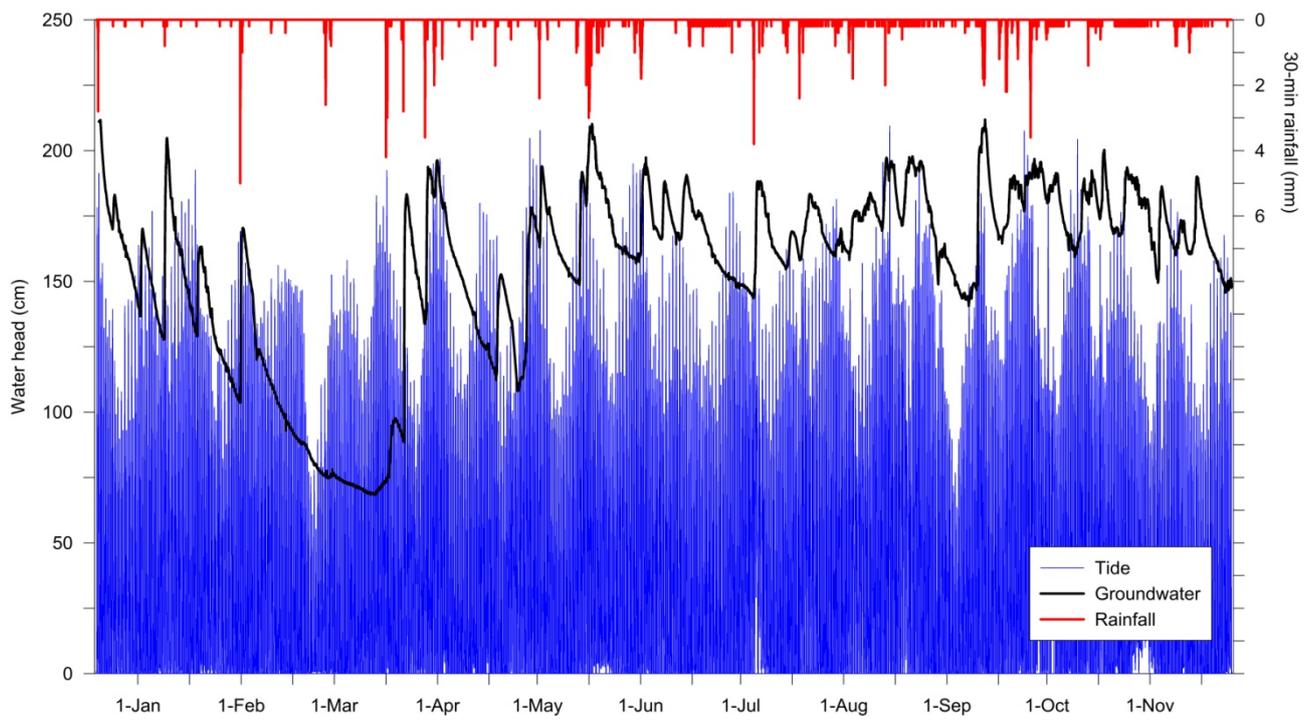
Figure 27. Groundwater levels, tide heights and rainfall at the monitoring site. Note, the groundwater data were corrected for AHD so that they are directly comparable with the tide data.

On the basis of the groundwater results and the consistency in the sedimentology of the banks over 8.6 km, we conclude that pore water pressure is not a causal factor of bank erosion at Lang Lang. We would expect that similar findings would apply to other sites around the bay with a similar sedimentology. However, where sites have a different sedimentology, pore water pressure created by rapid fluctuations in groundwater and tide heights may still be an important factor in bank erosion.
