REPORT:

Merricks Creek Estuary investigation and options analysis

October 2015

Alluvium 2015, Merricks Creek Estuary investigation and options analysis. Report prepared for Melbourne Water.

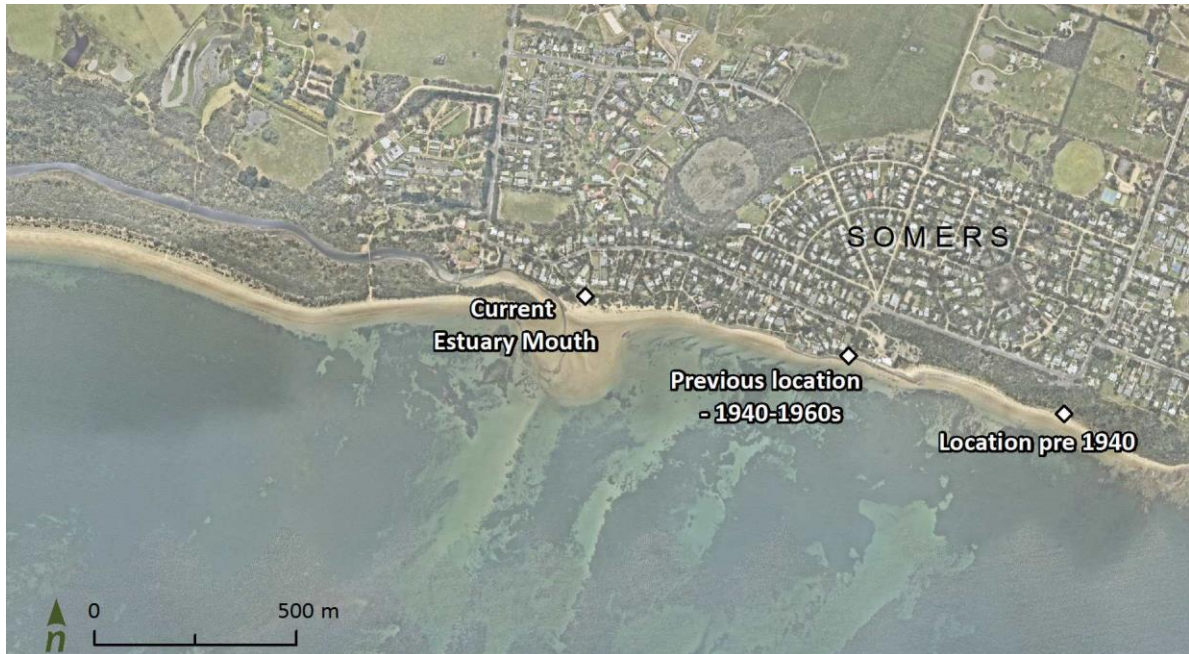
Figure 6. Estuary mouth locations through time

Prior to the 1940's the mouth of the Merricks Creek Estuary was located approximately 1 km further east than the current location (see DLS 1959; GHD 2003). Up until this time, the estuary would regularly bar over and break-out along various other locations along the sand berm (Figure 6 and Figure 7).

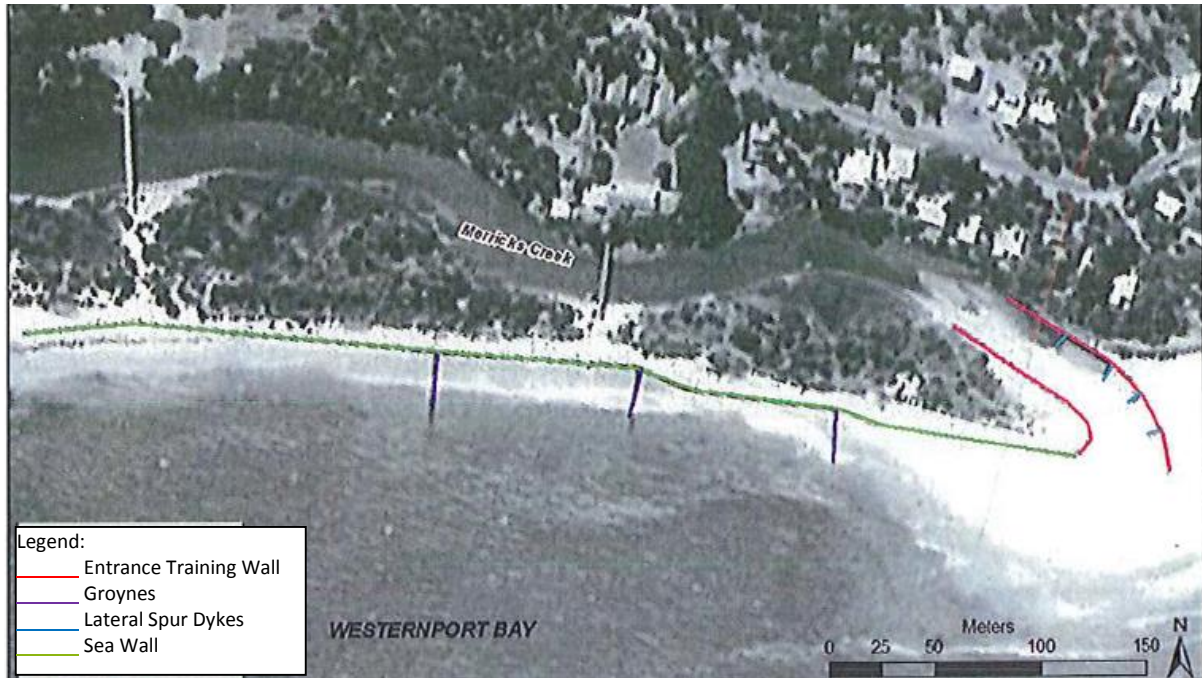
From the 1960s to 1975, coastal engineering work were undertaken to 'fix' the estuary mouth at its current location. These works included:

- timber training walls with lateral spur dykes at the estuary mouth, and
- a sea wall with lateral groynes on the west beach (Figure 8).

Figure 8. Works undertaken 1960-1975 – aerial photo ~1977 (Water Technology 2011) timber training wall shown in red and timber sea wall shown in green

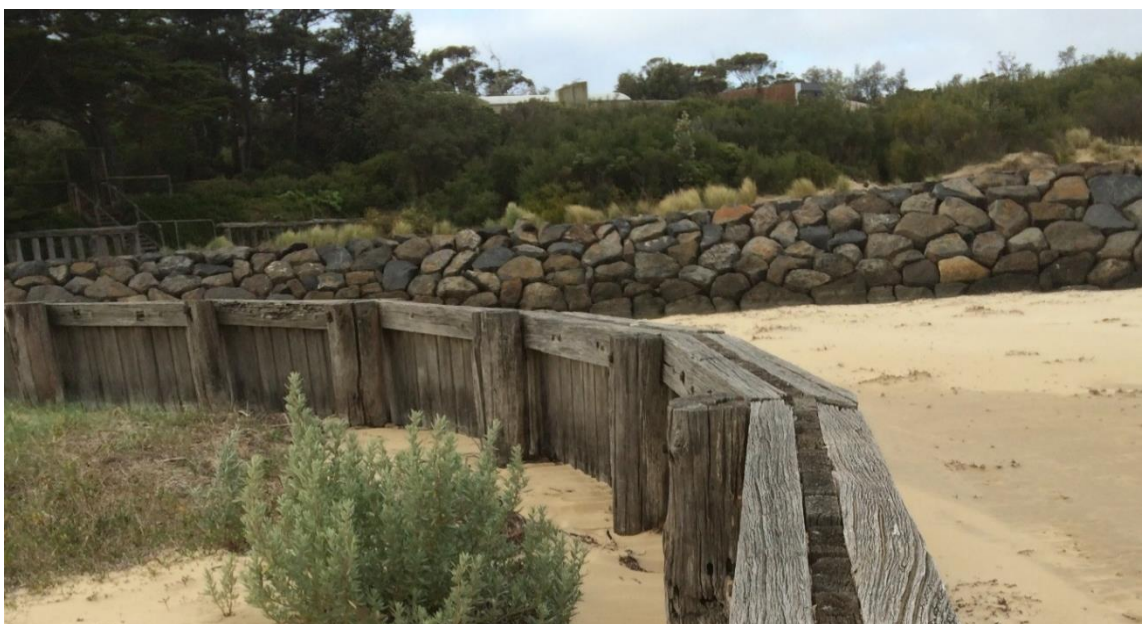
From the 1970s to 2010, the estuary was typically closed to the ocean, with intermittent periods where the sand bar at the estuary mouth would break open before again closing. In 2011/2012 the failing timber structure on the east side of the mouth was replaced with a rock structure (Figure 9) to ensure the continued protection of the adjacent houses.

Figure 9. Rock wall and timber structure, looking across mouth from west to east (old timber structure on west side of estuary in foreground, with new rock wall on east side in the middle ground) (Source: Alluvium, 2015)

The rock wall built in 2011/12 could be contributing to a change in the balance of energy that drives sediment transport (erosion versus deposition) at the estuary mouth. The previous timber wall (replaced by the current rock wall) included a number of lateral timber groynes that protruded into estuary channel, providing a degree of 'roughness' that affected tidal and rainfall flows near the estuary mouth. This roughness is associated with the absorption of energy from runoff, tidal and wave energy and sediment deposition and accumulation. The newer rock wall does not feature this lateral roughness. This absence of roughness could be causing flow energy to be expended in local scour against the rock wall, resulting in a more deeply incised channel and reduced trapping of sand near the estuary mouth extending the duration of the estuary opening.

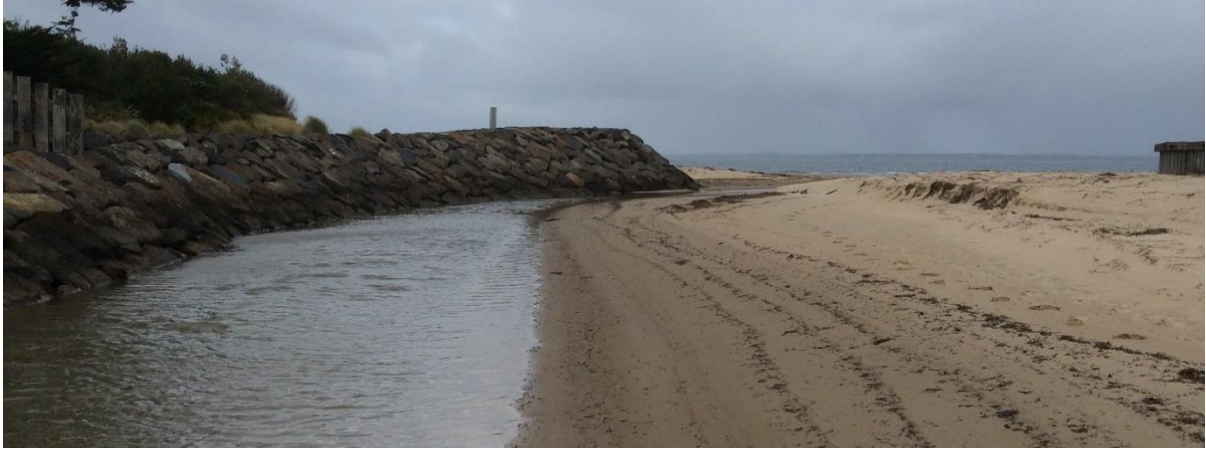
Also observed is wave and tidal scour adjacent to the wall, as observed by the channel of water present along the rock wall in Figure 11.

Figure 11. *Estuary mouth, looking downstream (south)*

A channel has been observed to have been scoured adjacent to the recently constructed rock wall.

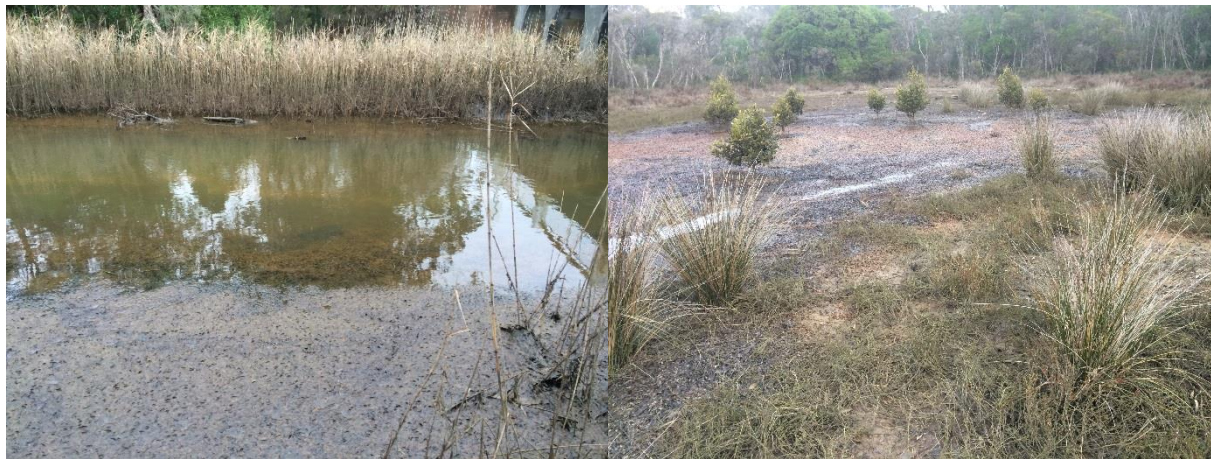
Black sludge and a persistent odour have been observed in the lower reaches of Merricks Creek. The odour is thought to be consistent with that of hydrogen sulfide (rotten egg) gas, and is likely to be resulting from the black sludge.

Figure 12. *Seagrass and black sludge in estuary through reach 1(left) and 2 (right) (August 2015)*

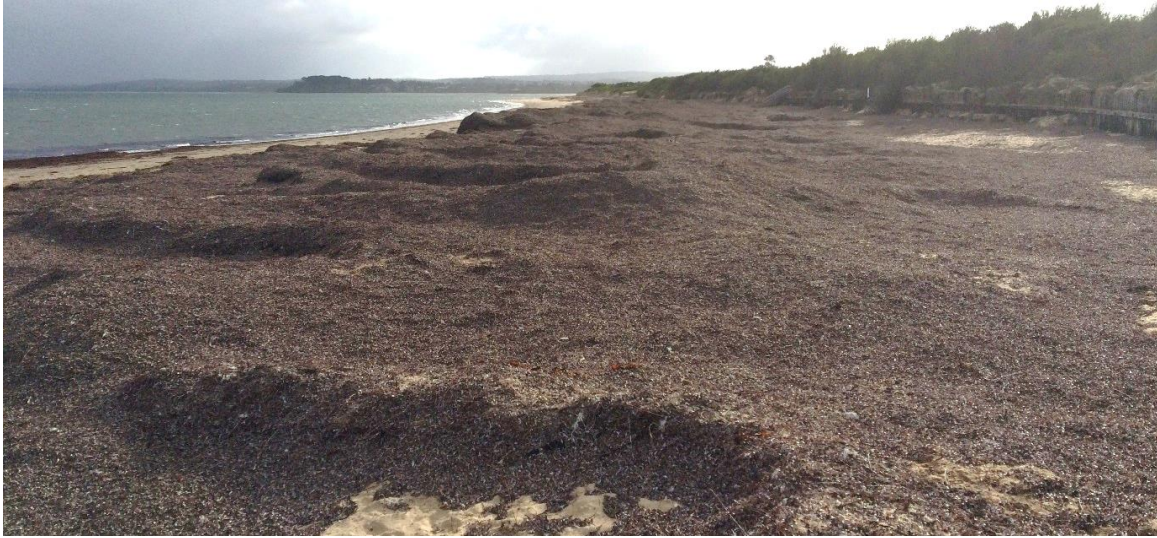
Seagrass has been observed building up on the west beach and also throughout the estuary. The sea grass is dead material that, when exposed to air, dries out and is readily transported through water movement.

Figure 13. *Balnarring Beach looking west from mouth showing accumulation of dead sea grass (August 2015)*

Alluvium has found the primary source of organic matter driving the hydrogen sulfide production in the estuary to be seagrass. We have found sea grass to build up on the Balnarring Beach around August/September and to then be transported through longshore (lateral) drift to the mouth of the open estuary. The daily tidal action into and out from the open estuary results in the transport of this sea grass into the Merricks Creek Estuary, where it accumulates. Organic material in the estuary is also sourced from catchment inflows and existing deposits. However, we found the volume of sea grass to have accumulated in the estuary to be several orders of magnitude (100 to 1000 times) more than the volume derived from catchment sources.

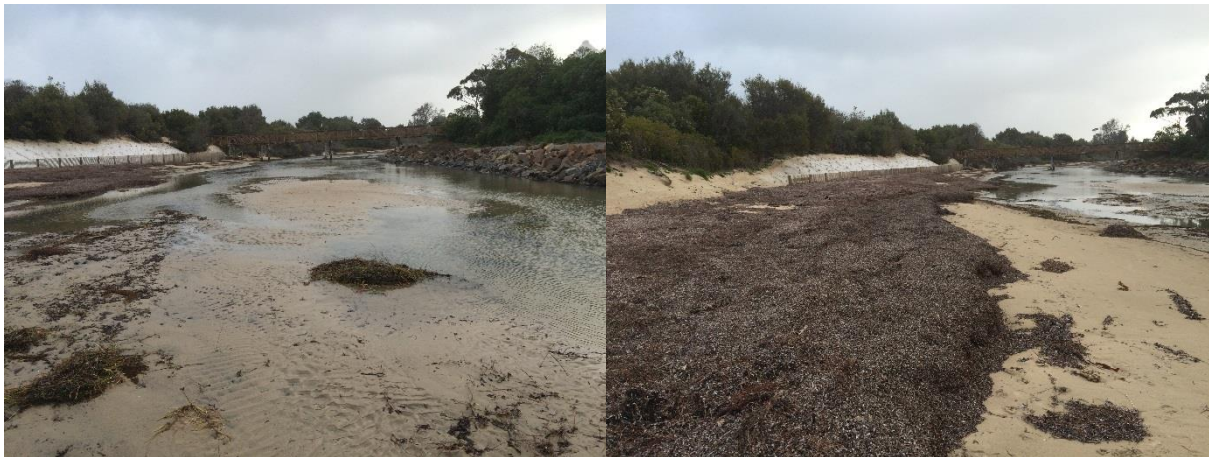
Figure 14. *Seagrass in estuary through reach 1 (August 2015)*

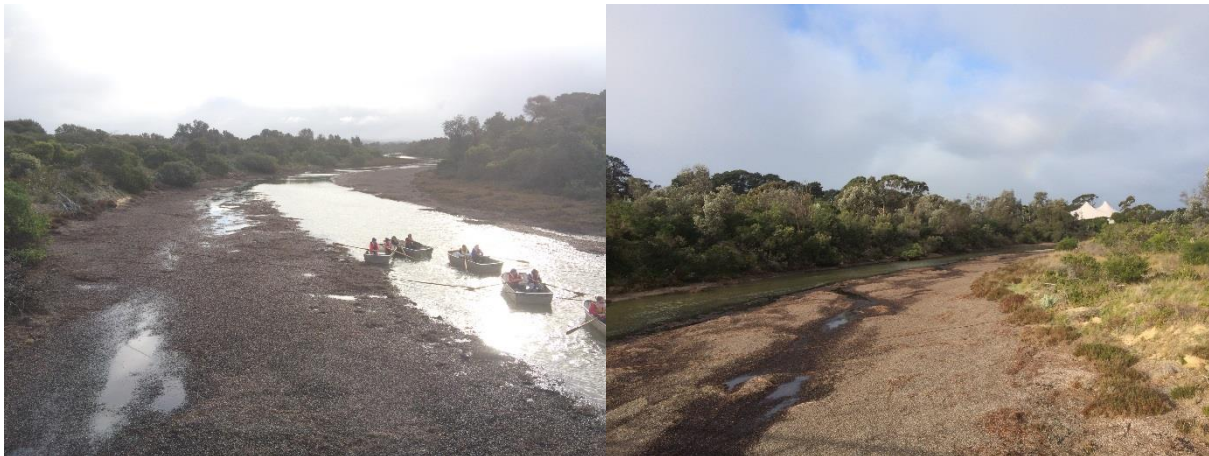
Figure 15. *Seagrass in estuary through reach 2 (August 2015)*

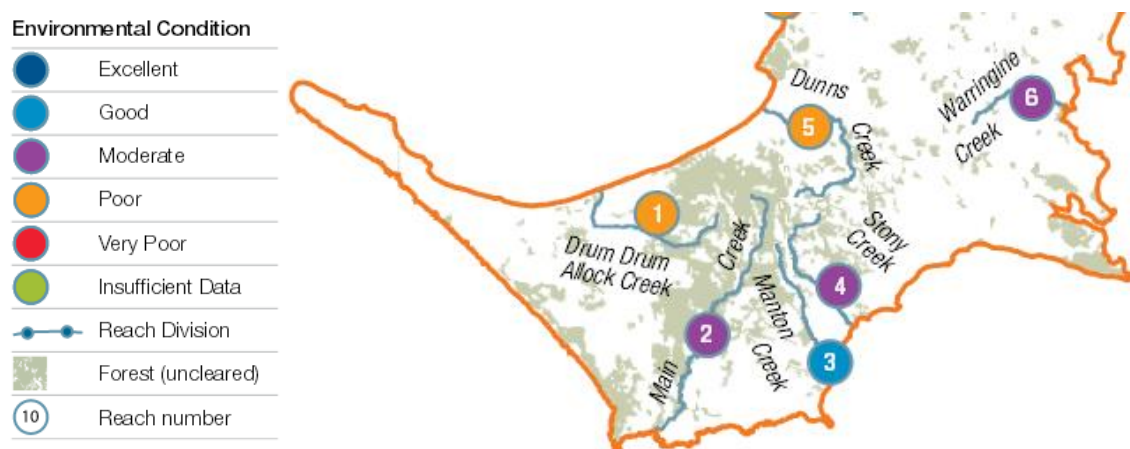
The Index of stream condition undertaken across Victoria, includes the streams of the Mornington Peninsular, but not Merricks Creek. Figure 16 shows neighbouring Stoney Creek and Warringine Creek to have been assessed as being in ‘moderate’ condition (DEPI 2010).

Figure 16: Index of stream condition results Source: DEPI 2010

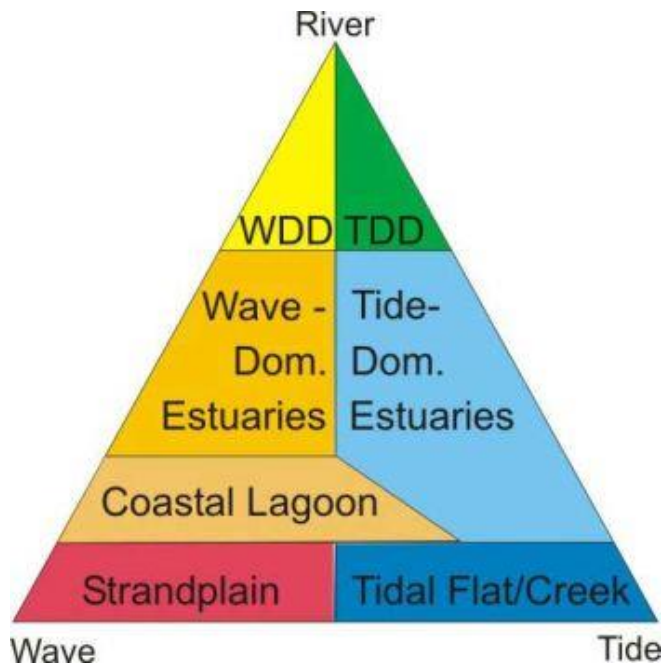
An estuary's geomorphology, and hence its shape and form, are influenced by wave, tide and river forces. The relationship between these forces and estuary form are shown in Figure 18.

Figure 18 Relationship between river, wave and tide on estuary type (from: OzCoasts 2015)

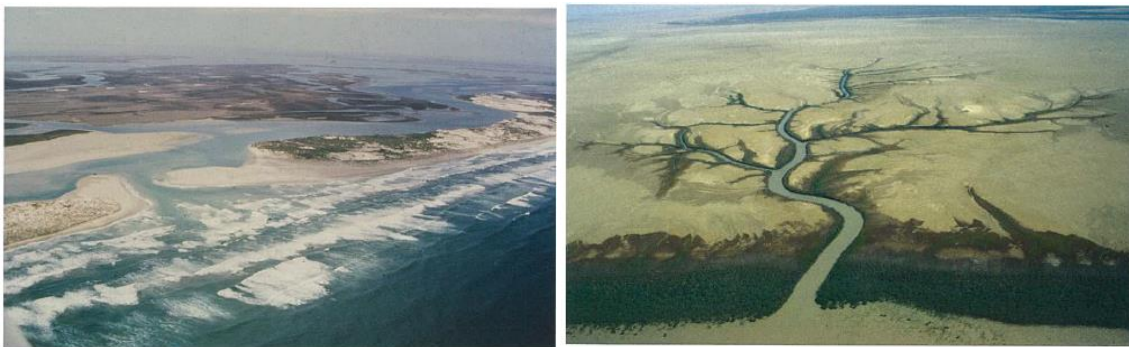
Figure 19 Examples of wave dominated (left) and tide dominated (right) estuaries (from Short and Woodroffe 2009)

Wave dominated estuaries are shaped by the force and sediment transport of oceanic waves. Sediment 'dumped' by large wave action results in the development of a sand berm (or bar) across the mouth of the estuary, closing it off from the ocean at the high tide line. Periods of high river inflows from the catchment then break open the berm, opening the estuary to the ocean again. Wave dominated estuaries and related coastal lagoons are often referred to as 'intermittently closed and open lake lagoons' (ICOLL) and are common around the exposed coasts of southern Australia with high wave energy and limited tidal range. Just over half of Victorian estuaries have entrances that are naturally closed by sand bars from time to time (Corangamite CMA 2012). For example the Anglesea, Snowy and Gellibrand River estuaries are all ICOLL estuaries.

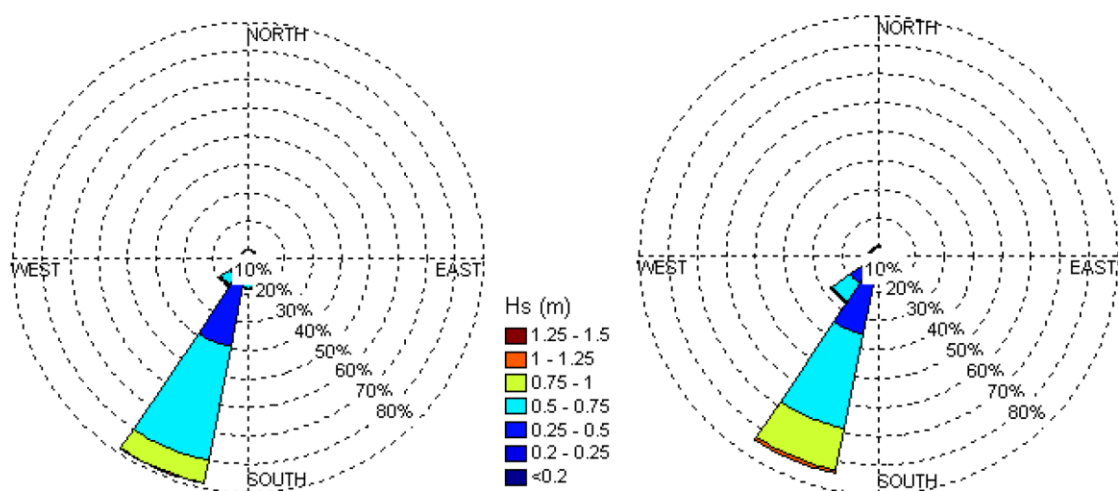
Waves are associated with the transportation of sediment and the closing of ICOLLs. There is limited wave data available for Victoria's coasts. Past studies on of wave direction show swells enter Westernport Bay from a south-westerly direction.

Figure 20. Wave Roses – Summer (2003) and Winter (2003) (Water Technology 2014)

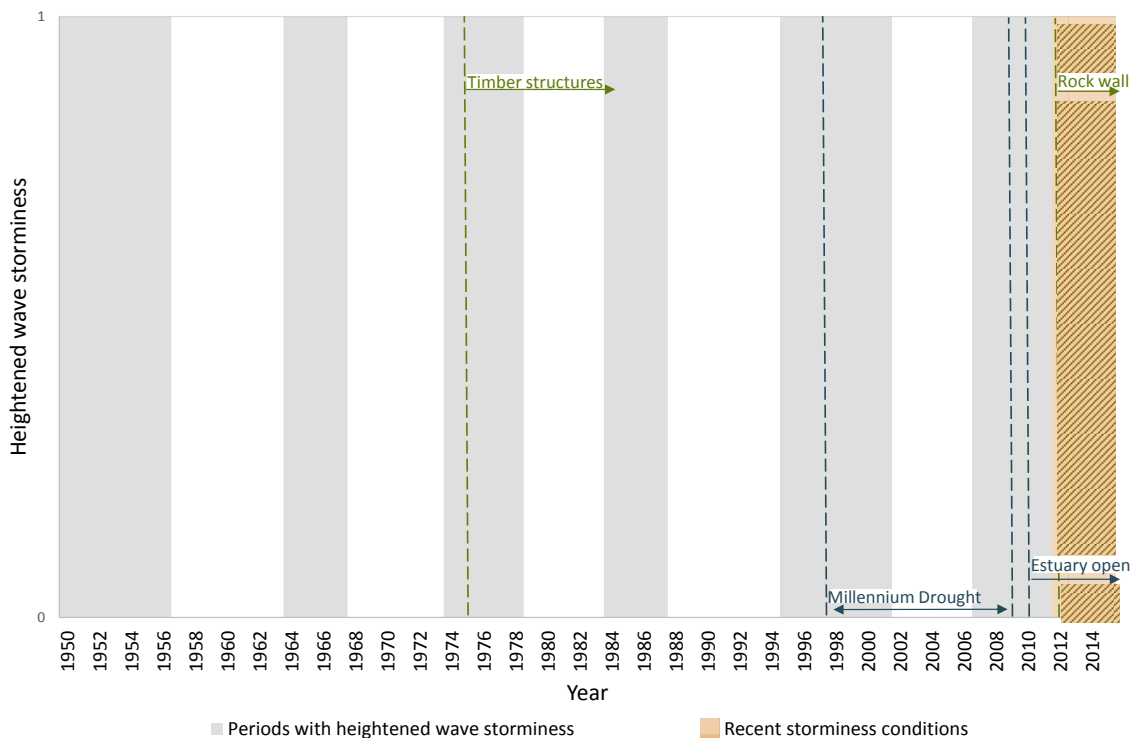
Figure 21. Storminess data 1950 to 2015. Grey shading indicates formal monitoring (source: Water Technology 2014), hatched area indicates anecdotal evidence (Christine Lachlan Arrowsmith pers comm).

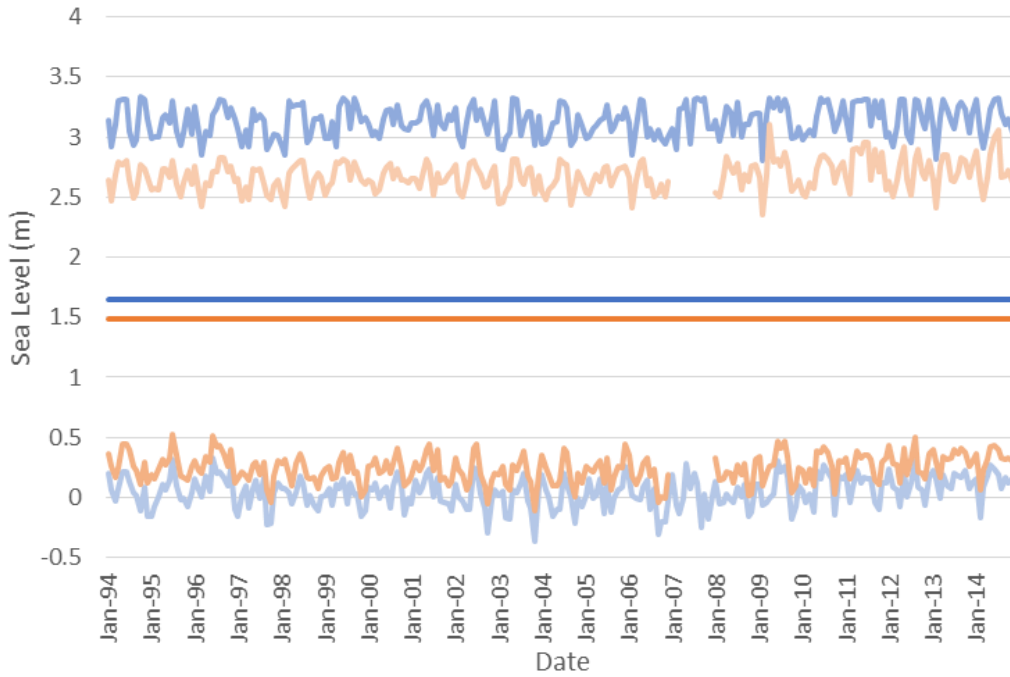
Westernport Bay is a protected, tide dominated bay. Westernport Bay has significantly greater tidal variation than other sites across Victoria. A comparison between Westernport Bay and Lorne is provided in Figure 22. The average tidal difference from 1994 to 2014 for Sandy Point (Crib Point) in Westernport Bay was 3.1m, compared to that of Lorne which was 2.4m.

Figure 22. Tidal variations (m) over the past 20 years at Sandy Point, Westernport Bay (Blue) and Lorne (Orange). Lighter colour indicate minimum and maximum tides, bold straight lines indicate the mean average sea level across period.

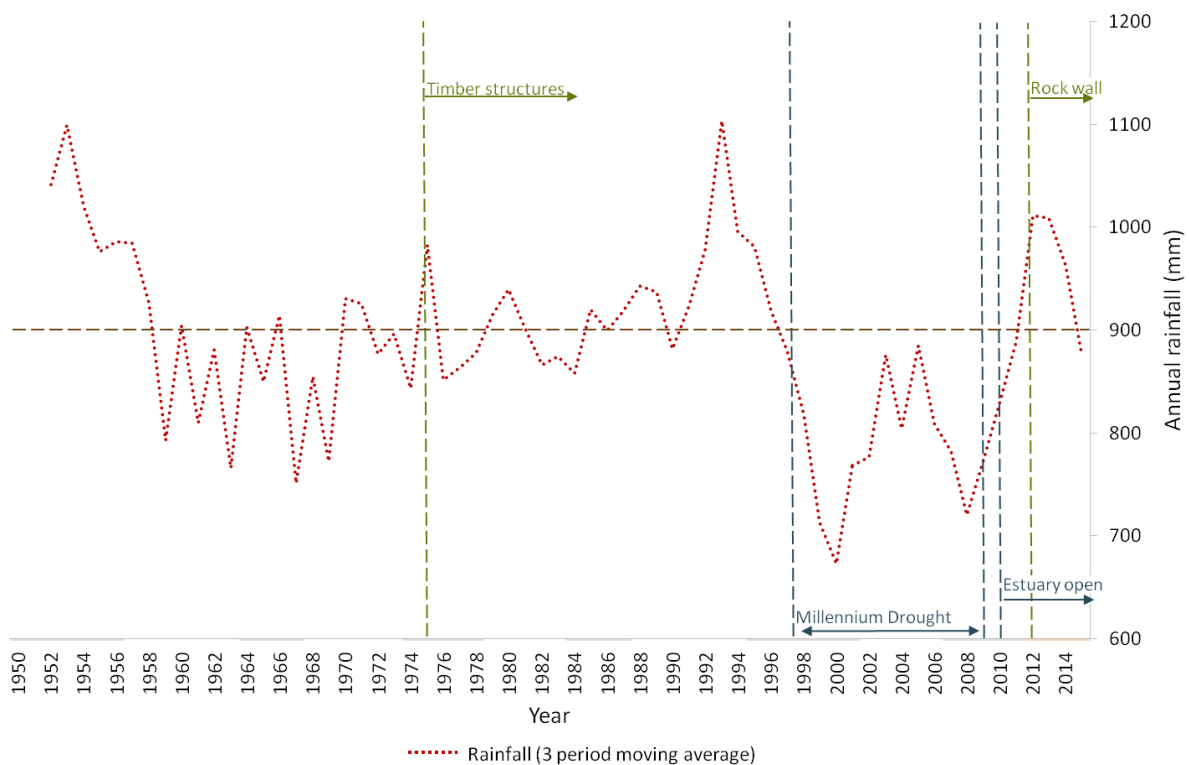
Annual rainfall data was taken from the nearby Shoreham gauge and a 3 year moving average is derived, displayed in Figure 24. The data shows highly variable climatic conditions for both the catchment and coast have varied over the past 65 years. The station has a mean annual rainfall of 905mm (median of 915mm). Low annual rainfall was recorded during the Millennium Drought, from 1997 - 2009 (BoM 2015a), with a return to above average rainfall from 2010 to 2014. This above average rainfall was consistent with La Niña events. We are now seeing a recent return of below average rainfall.

Figure 24. Shoreham rainfall data 1950 - 2015. Mean annual rainfall over period = 905mm (Source: BoM 2015a)

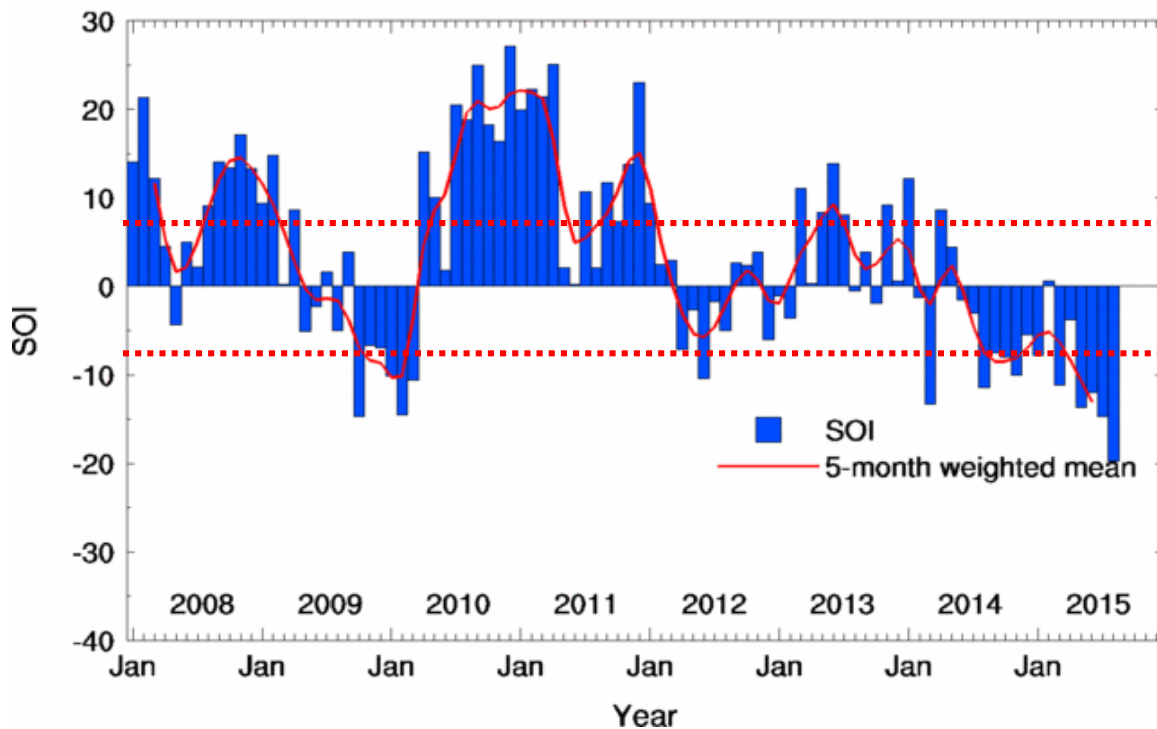
The end of the Millennium Drought was marked by the start of the 2010 to 2012 La Niña event, Australia's wettest 24 month period on record. Sustained positive values of the Southern Oscillation Index (SOI) above +8 are typical of a La Niña episode and sustained negative values below -8 are typical of an El Niño. Figure 25 shows the La Niña period between 2010 and 2012 and the neutral period following. The SOI below -8 observable from 2015 onward indicates the beginning of an El Niño episode. As this strengthens, eastern Australia is expected to experience below - average winter- spring rainfall with the episode peaking at the end of the year (BoM 2015b).

Figure 25. Southern Oscillation Index (BoM 2015b)

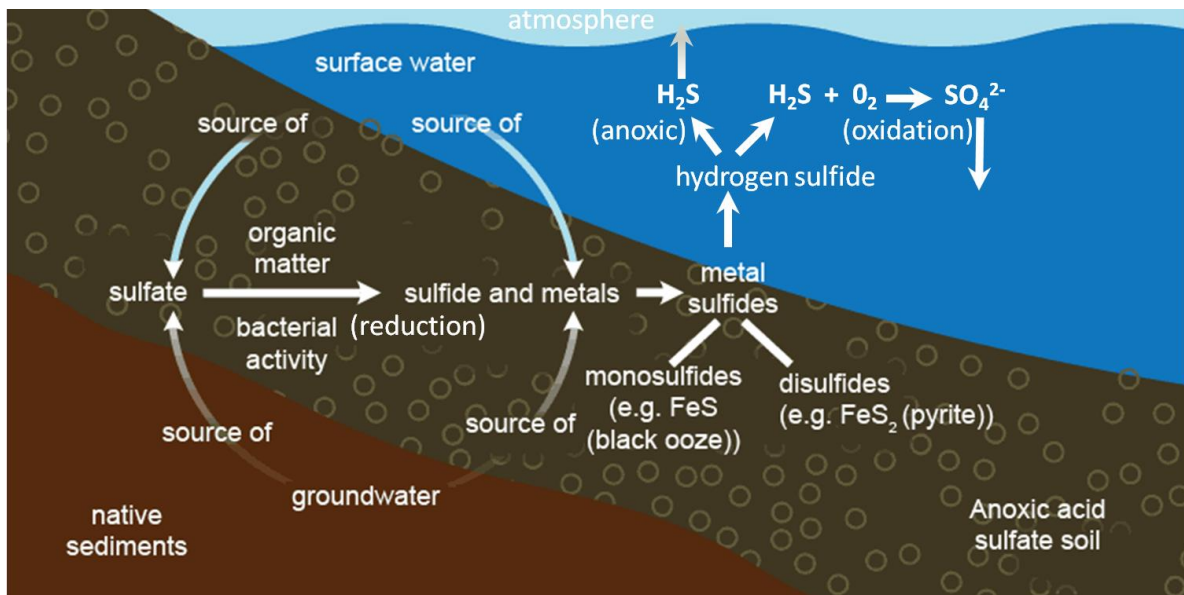
It is most likely that the odour occurring at Merricks Creek Estuary is resulting from the H_2S released from both the anoxic decomposition of contemporary organic material when inundated and the release of H_2S during low tide. Fundamental to the anoxic decomposition process is a source of contemporary organic material.

Figure 27. Sulfate reduction occurs when organic material is decomposed in anoxic conditions, releasing hydrogen sulfide into the atmosphere (source: adapted from EPHC 2011).

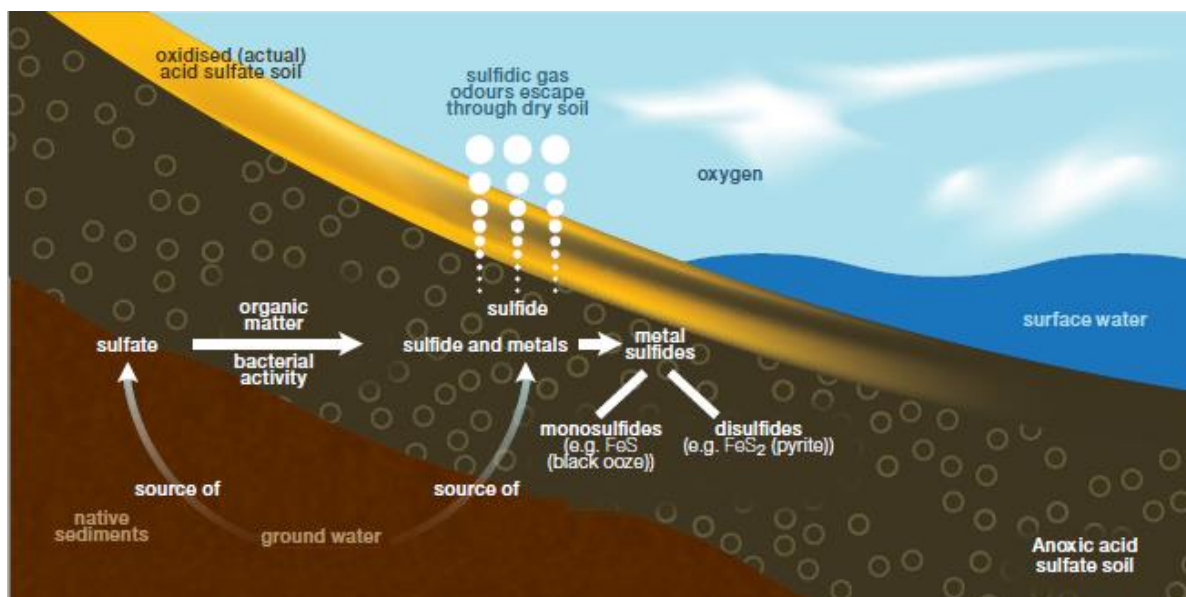
Figure 28. Exposure and release of sulfide in a drying scenario (source: EPHC 2011).

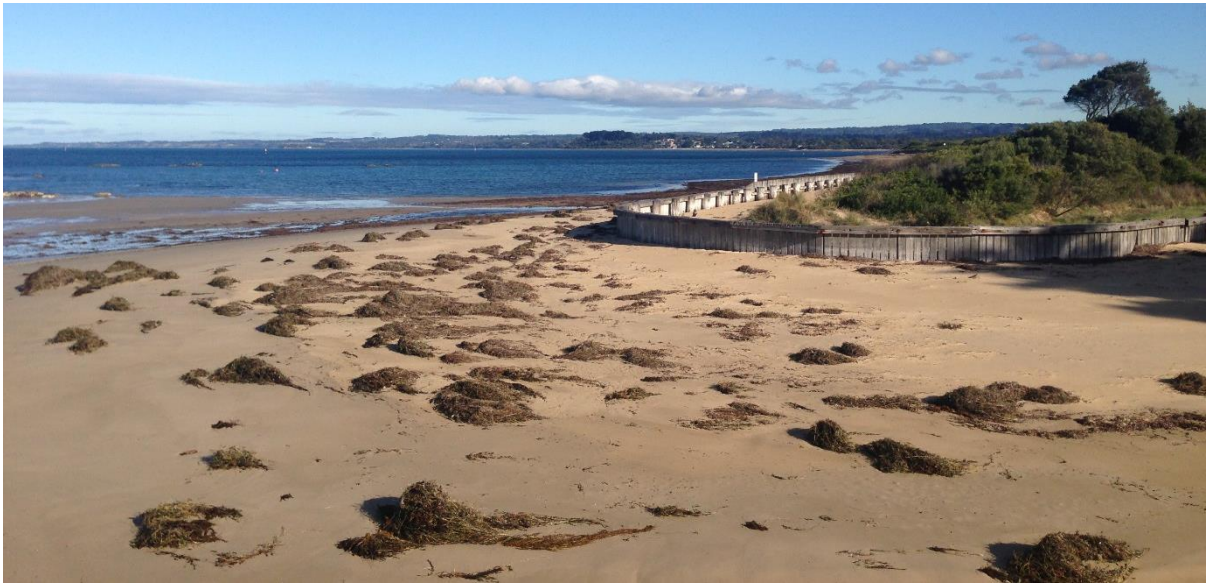
- circular current patterns in this location of Westernport Bay
- swell waves from a south westerly direction
- longshore drift. While significant longshore drift of sand has not been observed, sea grass is more easily transported and has been observed to move eastward along the beach.

Figure 29. Sea grass deposits at mouth, looking west to Balnarring Beach

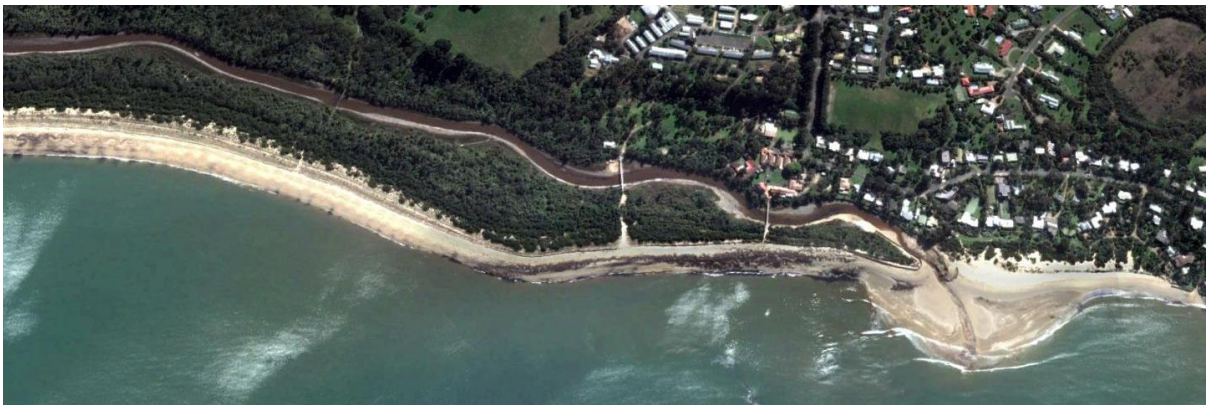
Figure 30. Aerial view of sea grass deposits on Balnarring Beach (September 2012) Sea grass is observed as the dark colour on the beach

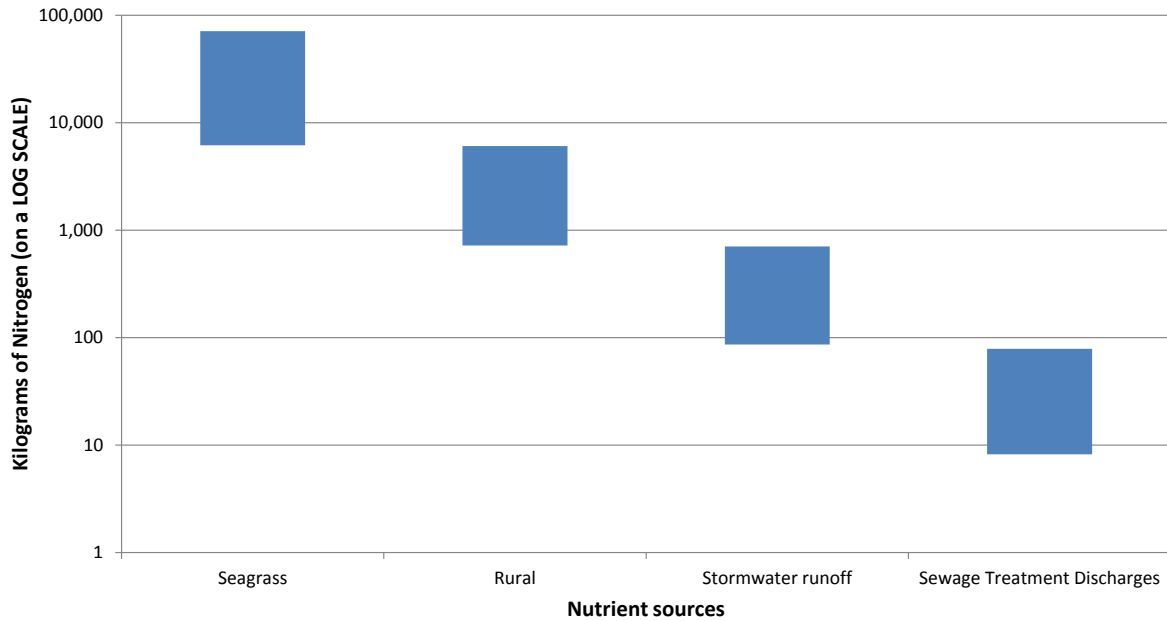
To assist with this investigation we have assessed the relative contributions of organic material supplied to the estuary from seagrass, legacy sewage treatment discharge and current stormwater and urban runoff. We identified the likely inputs of sea grass based on the extent of current sea grass deposits observed within the estuary and an assumption that sea grass entering the system each year would fully decompose in that year. Loads from sewerage discharge, stormwater and rural runoff have been based on standard parameters for these pollutant loads. The factor that can be most readily compared between these sources is nitrogen. We estimate the nitrogen load from the sea grass within the estuary was order(s) of magnitude greater than the loads derived from other sources (refer Figure 31). Attachment C details the calculations used to determine catchment loads.

Figure 31 Relative loads of nutrients into Merricks Creek Estuary (Note this is a log scale)

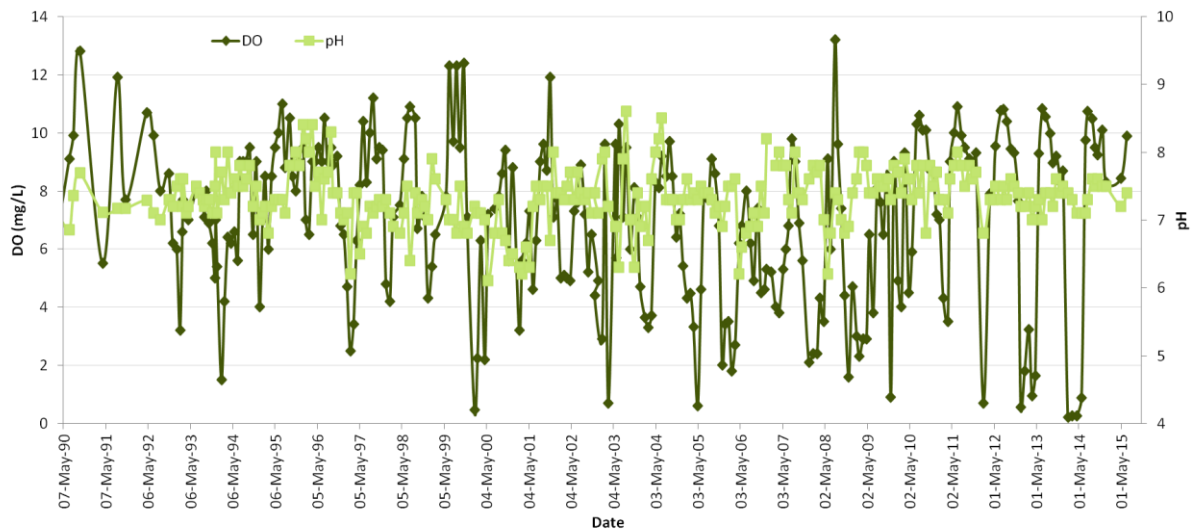
The dissolved oxygen and pH data for Reach 2 of Merricks Creek upstream of the estuary show isolated incidents of low dissolved oxygen and generally neutral or slightly alkaline water conditions.

Figure 32. Dissolved Oxygen and pH in Merricks Creek at Balnarring Bridge Road - reach 2 (Source: Estuary Watch)

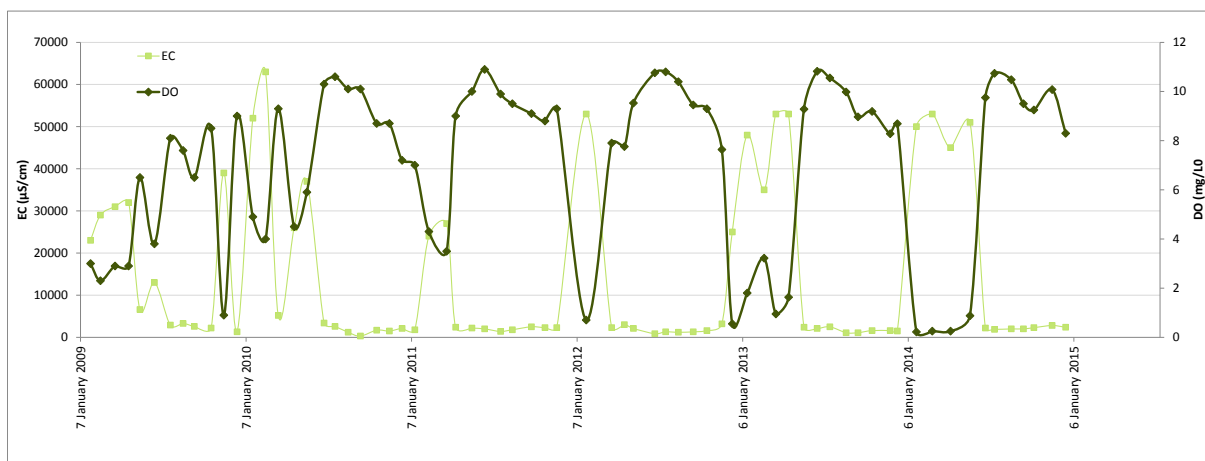
Low dissolved oxygen events are more likely when estuaries are closed to the ocean. Under these conditions, the water backs up behind the sand berm and can become stagnant. High nutrient loads and warm weather can exacerbate these events.

Figure 33. Dissolved Oxygen and EC in Merricks Creek at Balnarring Bridge Road - reach 2 (Source: Estuary Watch)

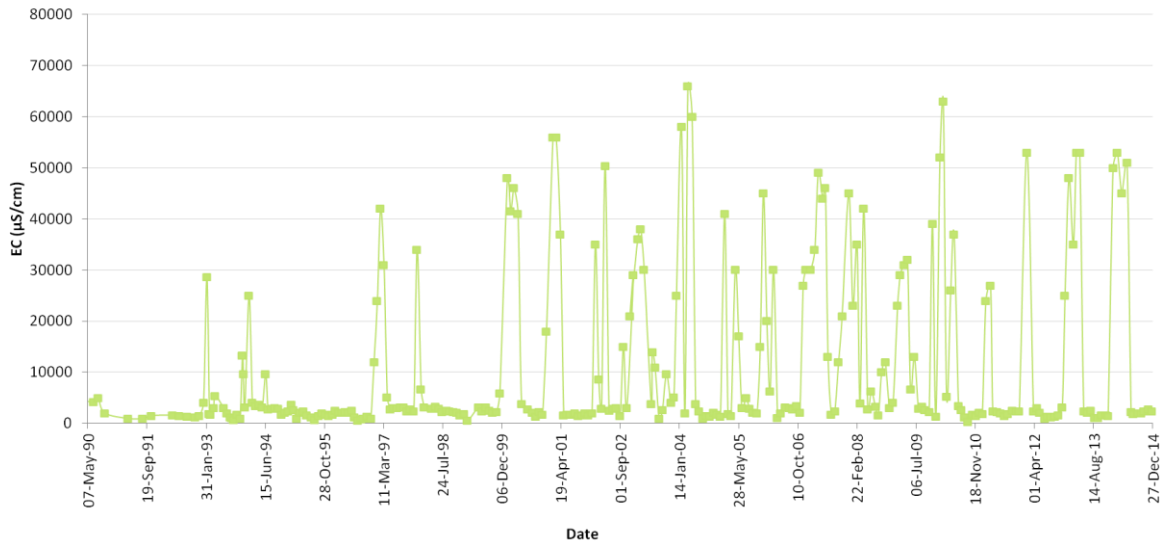
The salinity levels in reach 2 of the Merricks Creek Estuary are provided in Figure 34. Seasonal variations in salinity reflect the relationship between catchment flows and sea water intrusion, with the troughs representing periods when the fresher catchment flows dominate the reach.

Figure 34: Salinity (EC) in Merricks Creek at Balnarring Bridge Road - reach 2 (Source: Estuary Watch)

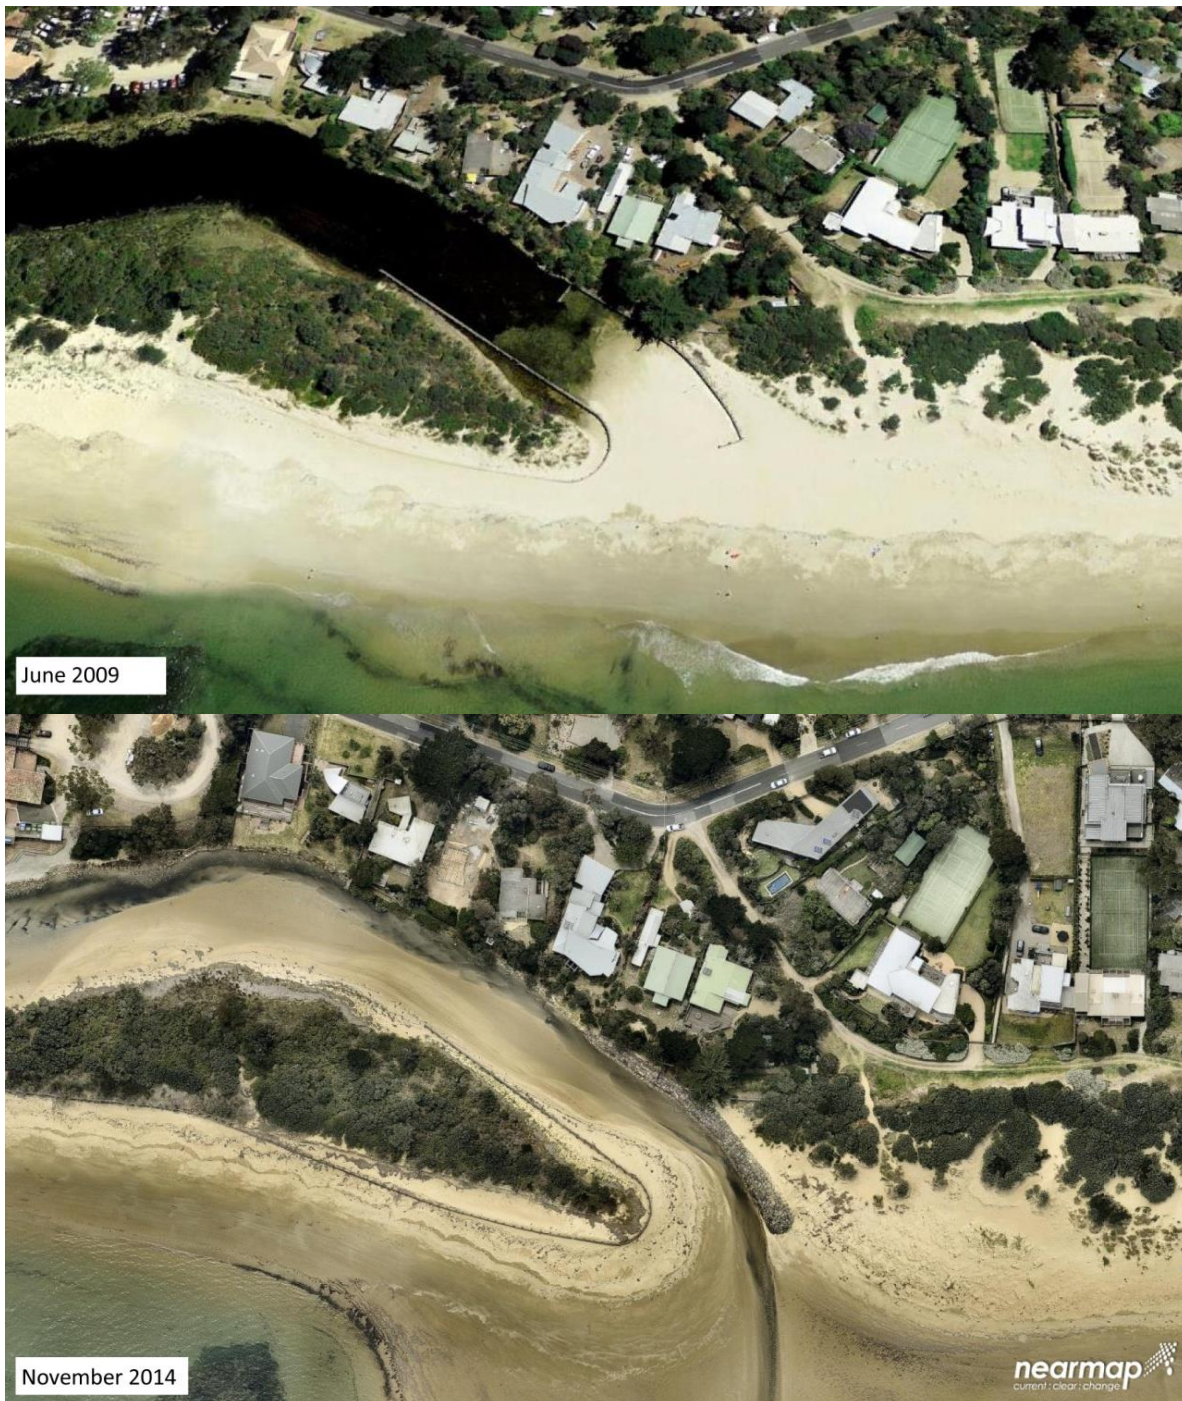
The build up of sand in reach 1 is evident in recent images of the estuary (refer Figure 35).

Figure 35 2009 and 2014 aerial images showing sand accumulation in Reach 1

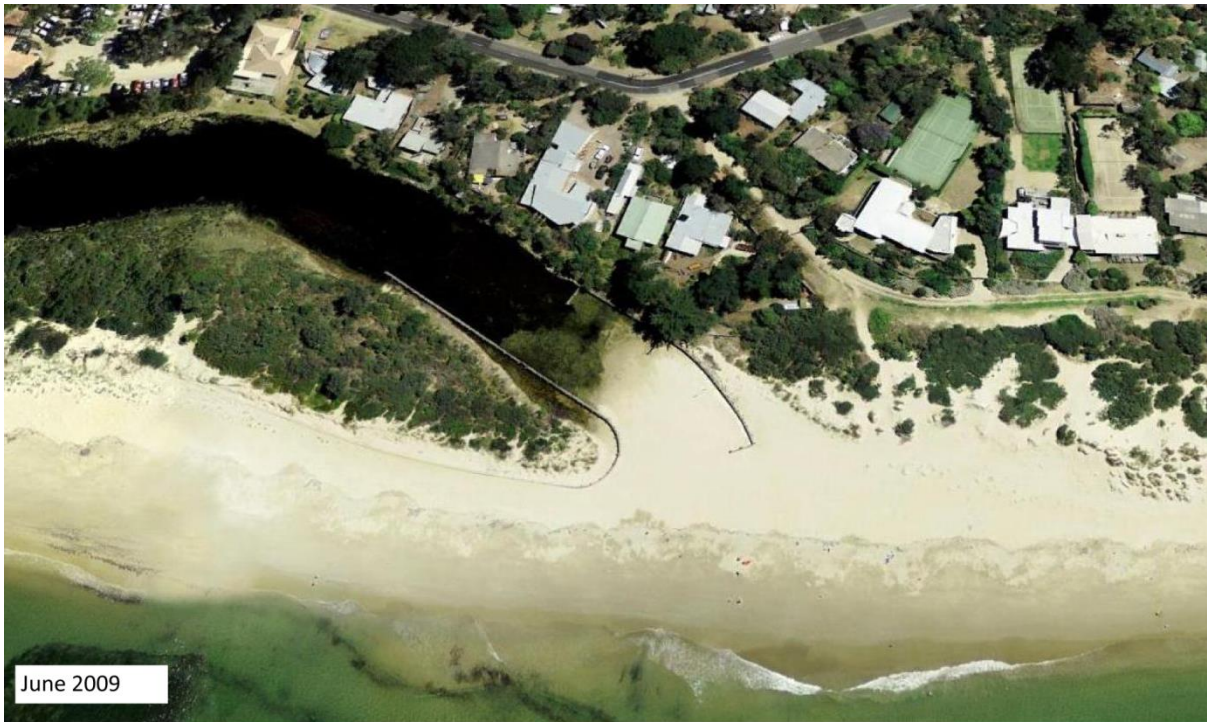
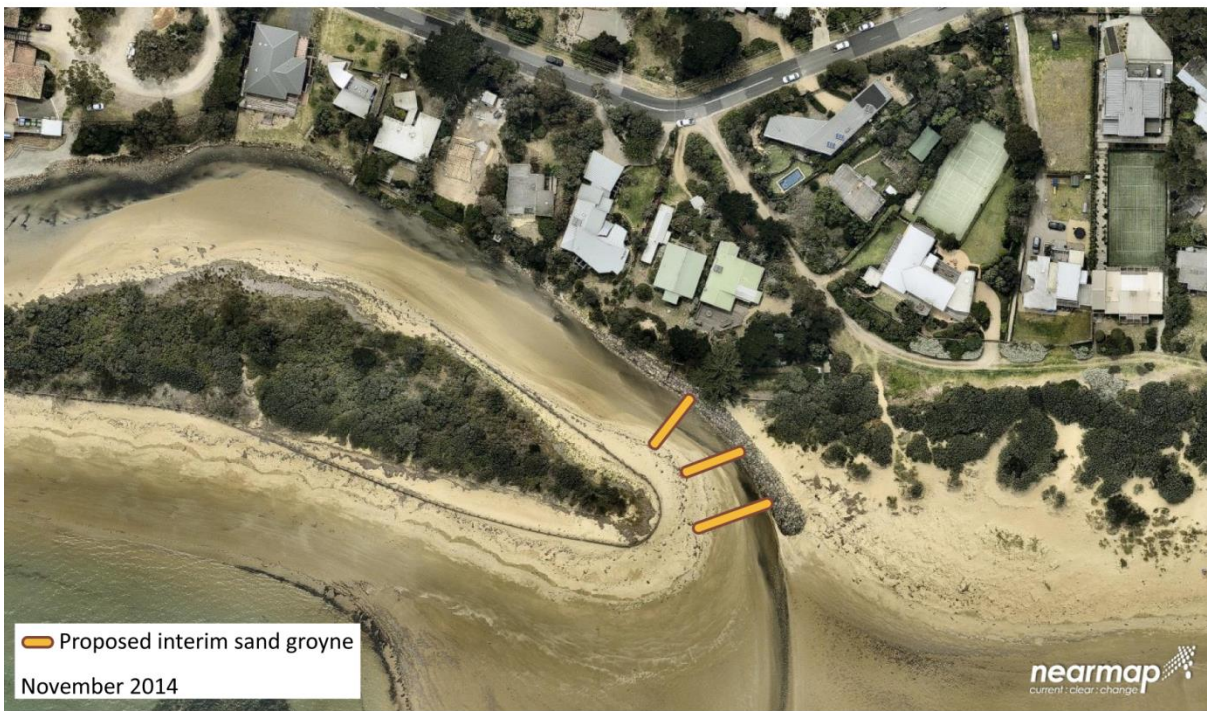
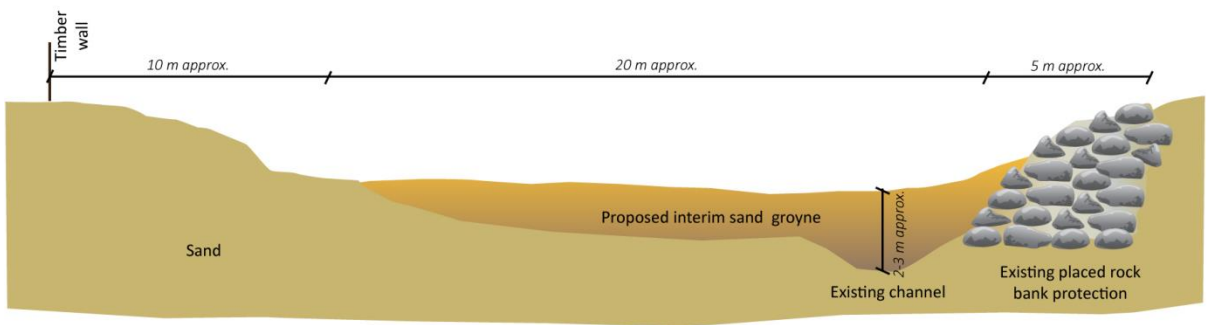
Figure 37 Proposed interim works comprising lateral sand bag / rock groynes replicating previous timber groynes
