REPORT:

Merricks Creek Estuary investigation and options analysis

October 2015

Alluvium 2015, Merricks Creek Estuary investigation and options analysis. Report prepared for Melbourne Water.

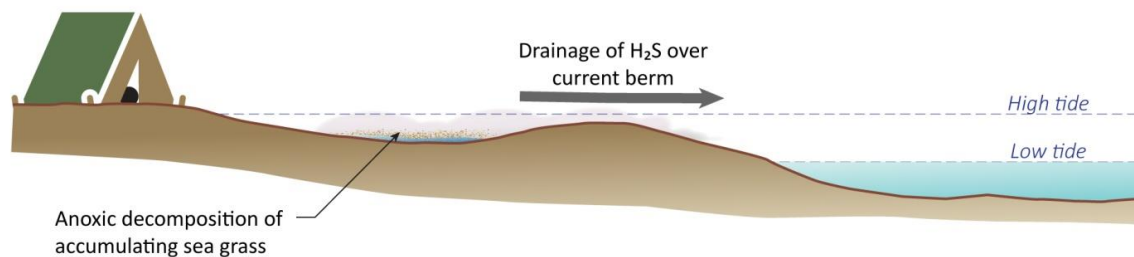
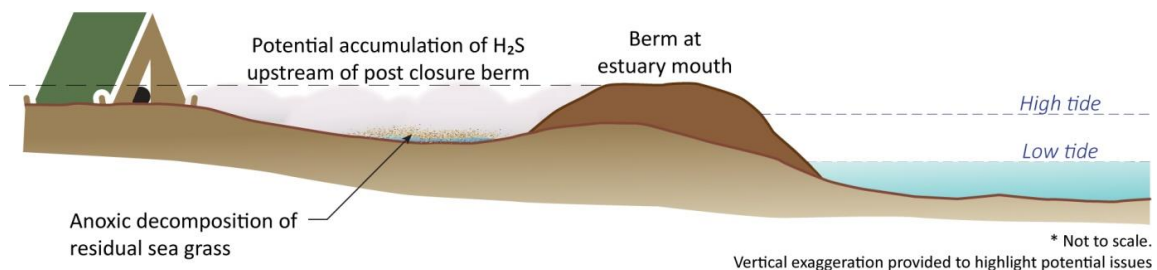
Current conditions - open estuary

Potential conditions - following estuary closure

Figure 38. Potential for hydrogen sulfide accumulation following estuary closure

Over the period that the estuary has been open, the hazard associated with this settling has been low as the gas drains out through the open estuary mouth, preventing any significant accumulations. There is a risk that on a windless evening, the sand berm that has closed the estuary may prevent such 'drainage', allowing the accumulation of hydrogen sulfide.

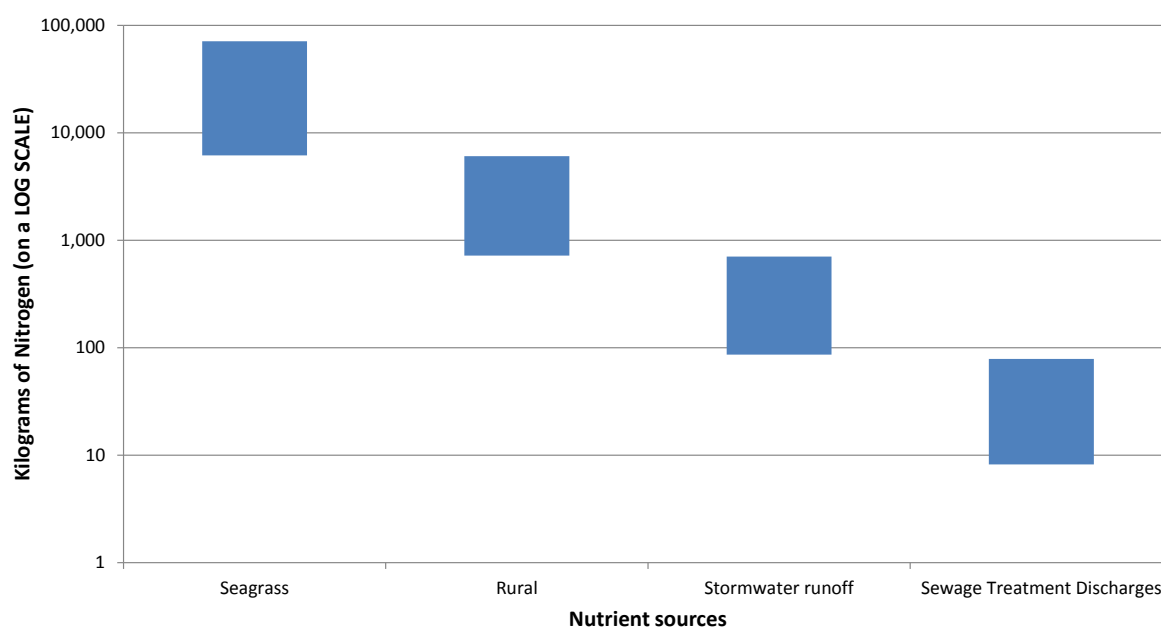
As there is a lot of uncertainty and variability around these parameters, some sensitivity analysis was conducted to test “high” and “low” parameters. This provides an indicative range (on an annual basis).

Figure 39. Relative loads of nutrients into Merricks Creek Estuary (Note this is a log scale)
