AM PLA Power Line Bushfire Mitigation Plan Plan

June 2025

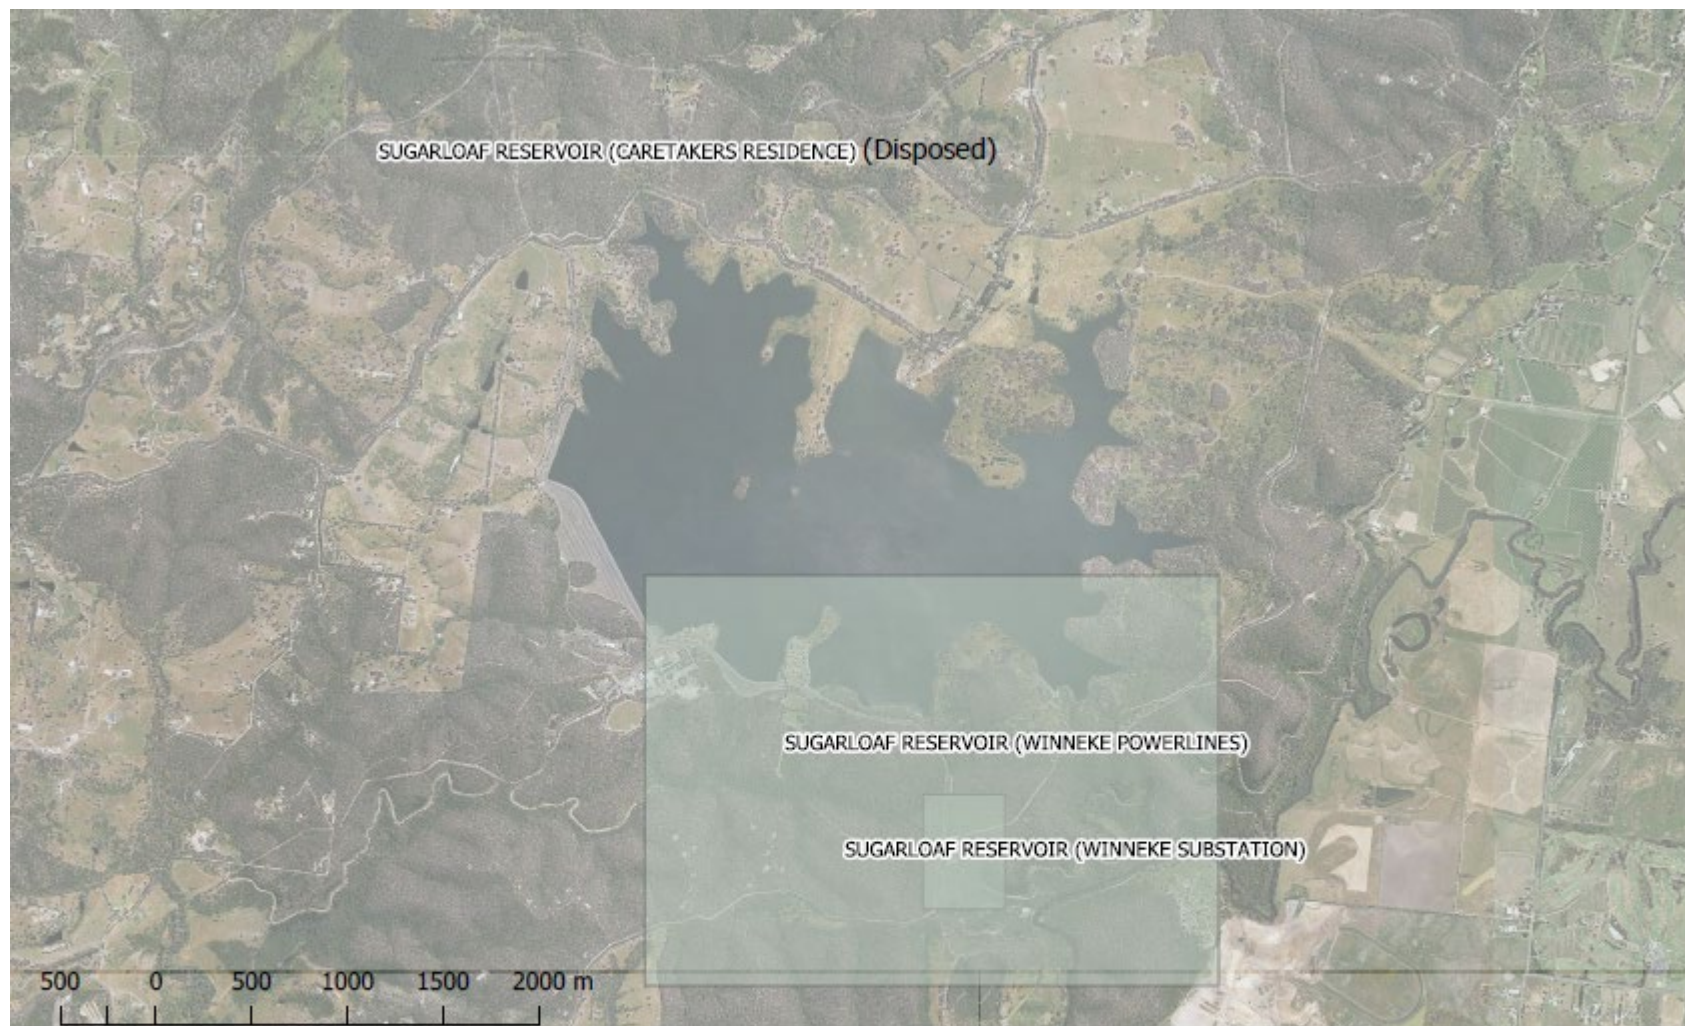
Electric Line Clearance -Sugarloaf

Power line location maps are stored in Inflo at the following locations. The images have been reproduced on the following pages so that they can be observed directly from this plan.
