# Power Line Bushfire Mitigation

## Plan

June 2025

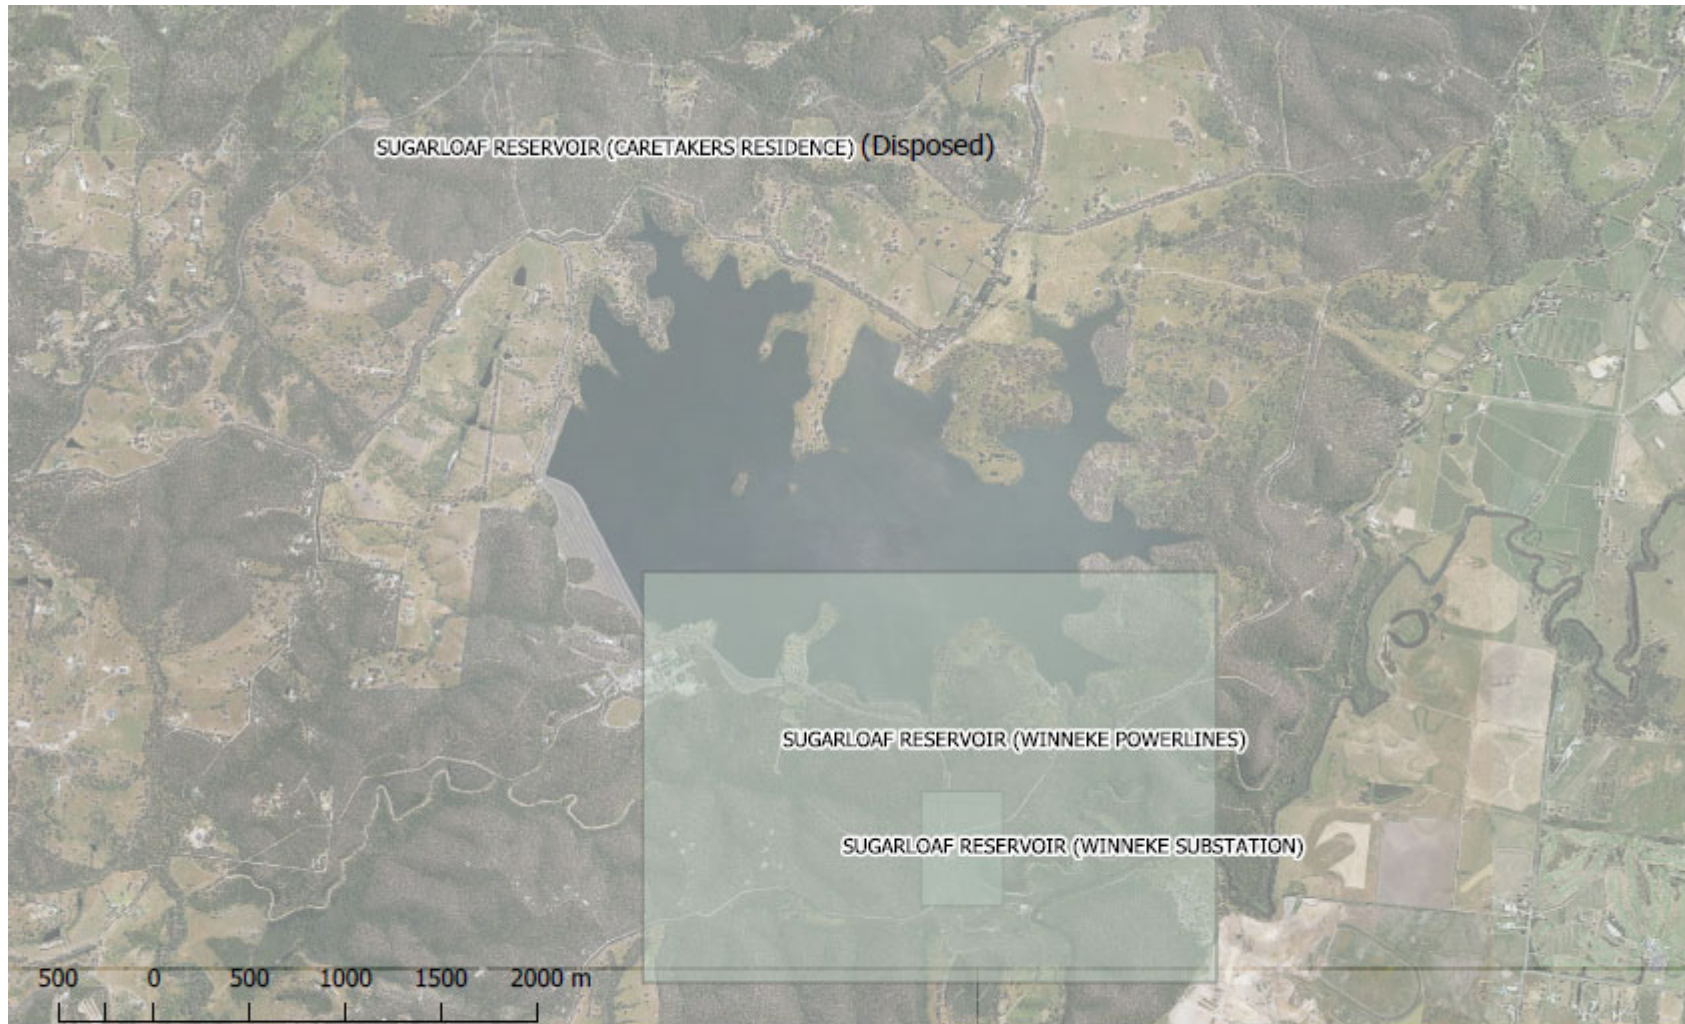
## Appendix B: At Risk Power Line Location Maps

Power line location maps are stored in Info at the following locations. The images have been reproduced on the following pages so that they can be observed directly from this plan.

- Sugarloaf Reservoir Overview OH line
- Sugarloaf Electricity\_Poles\_Cables\_Labelled\_Map.pdf
- Bells Portal Poles\_Cables\_Labelled\_Map.pdf

The location and details of power lines and poles are shown in Appendix B: At Risk Power Line Location Maps
