LIVING RIVERS WSUD ASSET AUDIT

MAY 2017

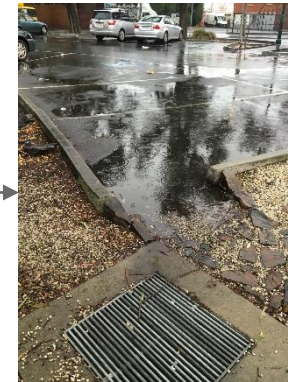
Asset 33
Overflow pit level flush with inlet level

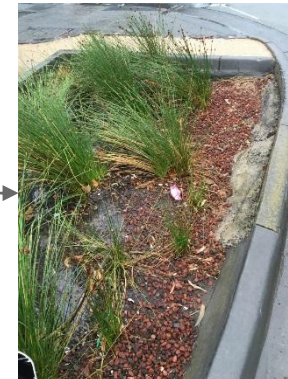
Asset 50
Surface not flat – some area not engaged

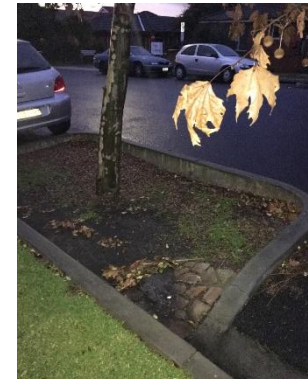
Asset 65
Surface level of filter media higher than inlet level

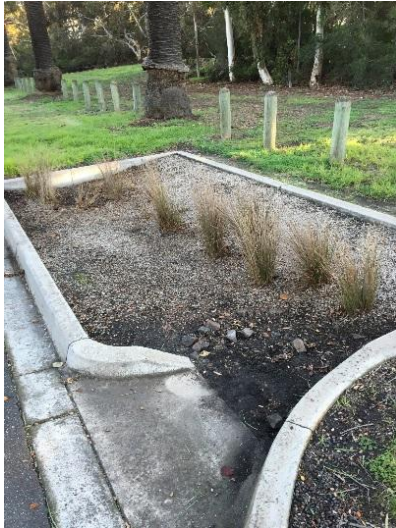
Asset 24
Plants in poor health and poor cover

Planting success can be achieved by ensuring the design specifies an appropriate plant density, regular maintenance (e.g. replacing dead and diseased plants, infilling gaps in vegetation), and more attention during the plant establishment period.

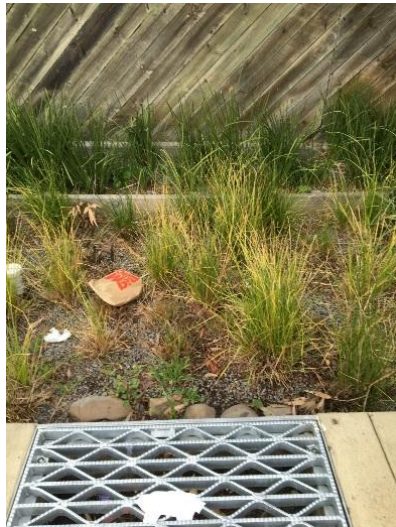
Asset 45
Plants with moderate health and approx. 50 % cover

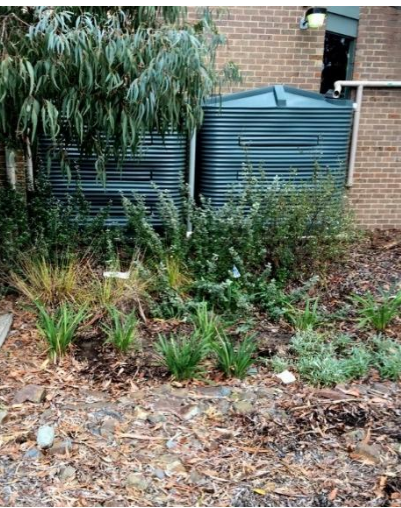
Asset 30

- Poor plant diversity (1 species) and poor vegetation cover (< 40 %) and consequently poor perception of care and 'greenness'.

Assets in poor condition generally have poor vegetation cover and require complete replanting to improve aesthetics.

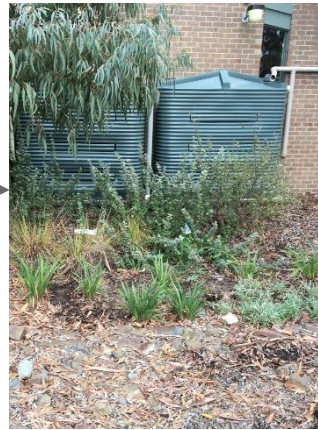
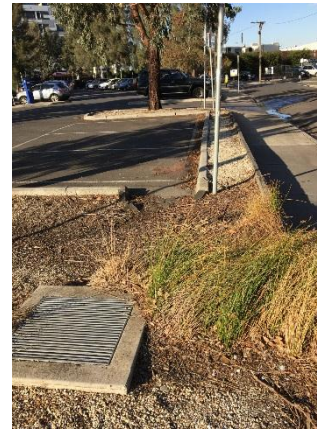
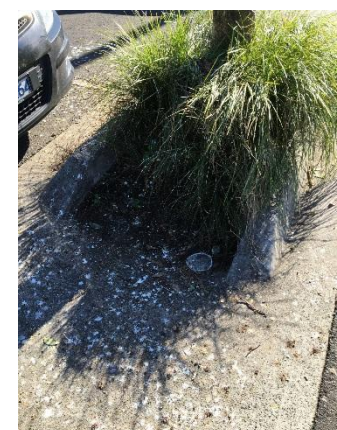
Poor perception associated with poor vegetation cover, and often with moderate leaf litter and rubbish. 1 asset had high leaf litter load and another had nuisance fauna

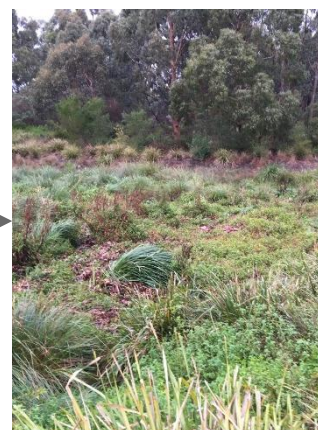
Asset 54

Moderate perception associated with moderate vegetation cover, poor or no maintenance (e.g. overgrown plants or excessive pruning), and leaf litter, rubbish or weed present

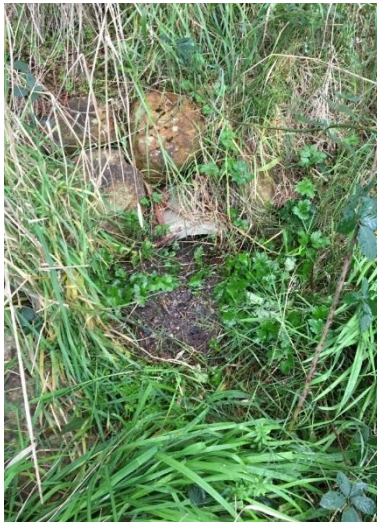
2 out of the 13 wetlands audited have completely blocked inlets and another 2 wetlands have partially blocked inlets. Maintenance is required to unblock and keep inlets functional.

Asset 86
Completely blocked inlet

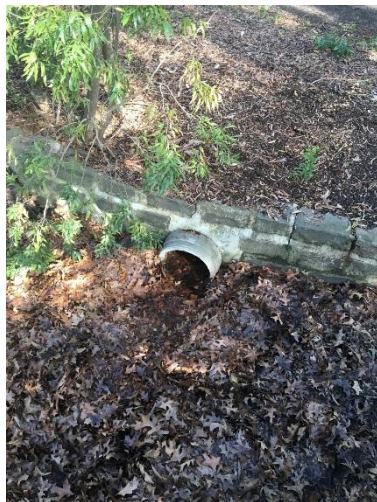
Asset 83
Partially blocked inlet

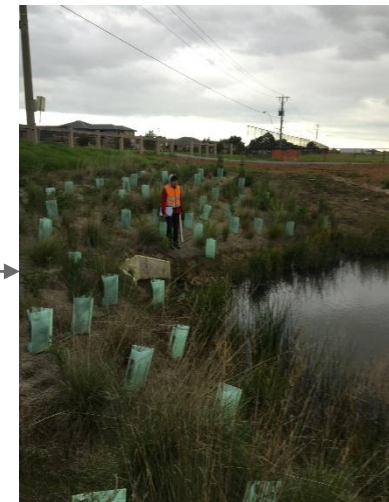
Asset 80
Functioning inlet – no blockages

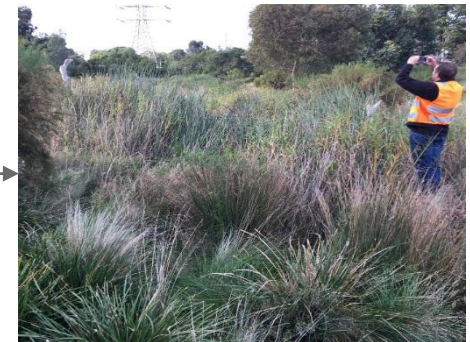
Asset 76
Plants in good health and close to 100 % cover

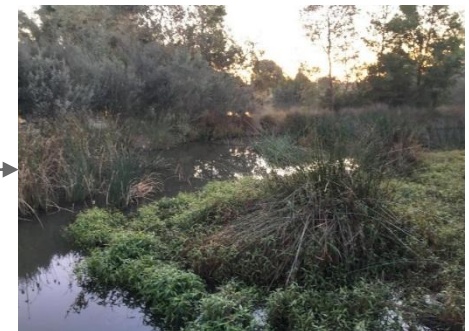
Asset 74
Planted areas with 50-70% plant cover

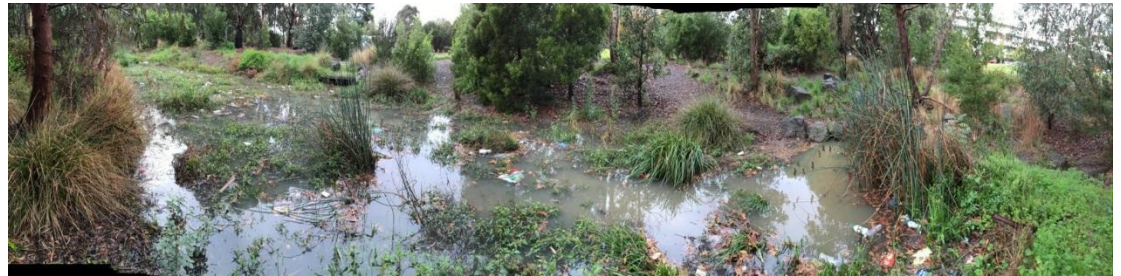
Asset 81

Poor perception of care associated with a combination poor vegetation cover (both macrophyte zone and batters), weed cover and rubbish.

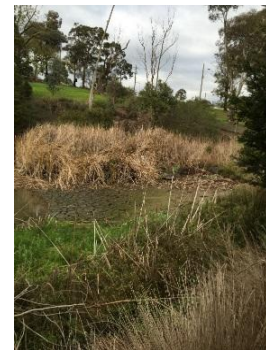
Asset 82

Moderate perception of care associated with significant presence of dead vegetation, significant section of batters and landscaped area requiring vegetation.

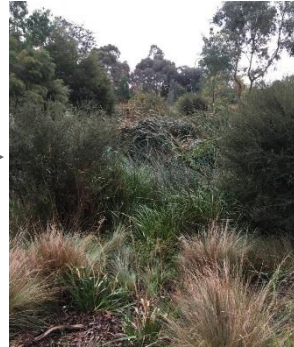
Asset 84 (Overgrown veg)

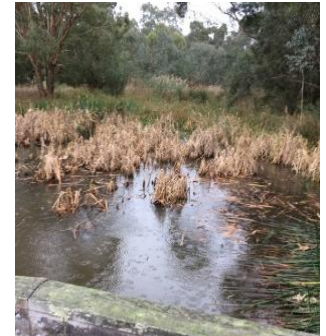
Asset 82 (Plant die-off)

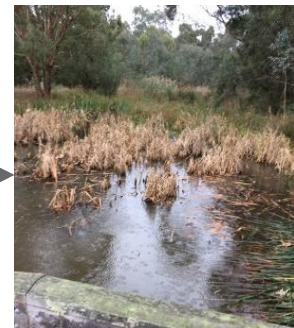
Plant stress and die-
off in wetland
